**State of Louisiana
Department of Natural Resources
Coastal Restoration Division and
Coastal Engineering Division**

2004 Operations, Maintenance, and Monitoring Report

NAOMI OUTFALL MANAGEMENT and BARATARIA BAY WATERWAY EAST

State Project Numbers BA-03c and BA-26
Priority Project Lists 5 and 6

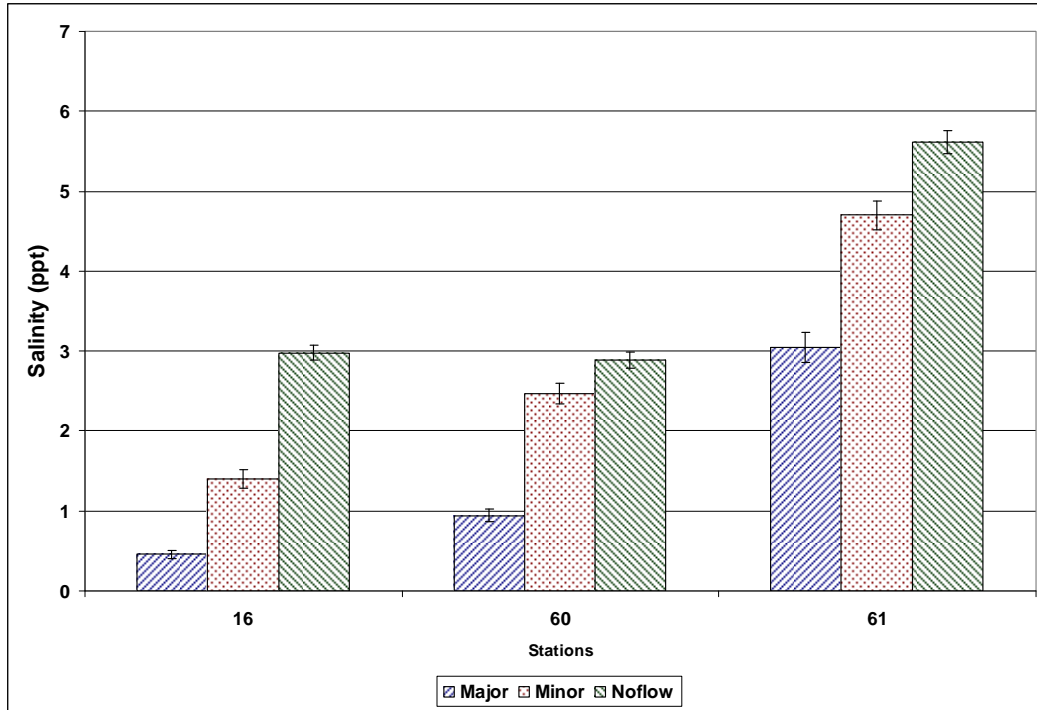
Mean daily salinity measured at the continuous recorders was lower during periods when all siphons were in either major or minor operation vs. no-flow, indicating that the siphons are capable of reducing salinity in the project area (Figure 4). However, salinity during these periods was influenced by factors other than siphon operation, particularly normal seasonal variability within the Barataria Basin (Swenson and Swarzenski 1995; Wiseman et. al. 1990; Conner and Day 1987). For example, salinity levels in the project area were highest in the spring and fall (Figure 5). During a drought from September 1999 through December 2000 mean yearly salinity levels in the project area increased greatly while siphon operation decreased substantially due to low river stage (Figure 6). Siphon operation is a function of river stage; thus, ability to control salinity during drought or normal low river stages (e.g. late summer and fall) was limited. The drought had a confounding effect on the results of the analysis of pre- and post-construction salinity data for the outfall management project. Pre-construction salinity levels were higher than post-construction levels at continuous recorder stations both within and just outside the project area (Figure 7). The drought effect was eliminated by using salinity data from the Barataria Bay Waterway (Station BA01-10, Figure 2) as a reference. The difference in salinity was calculated from the project and reference stations for the entire data set [i.e., (project - reference)], thereby creating a new variable called “difference”. The difference in mean monthly salinity was compared between the pre- and post-construction periods using a paired T-test based on the BACIP (Before-After Control-Impact Paired) model (Underwood 1994 and Smith 2002; Table 1a and Figure 1d, respectively).

Figure 4. BA-03c mean (\pm SE) salinity for the period 1999-2003 for 3 operational categories at YSI continuous recorder stations (major discharge $>1,072 \text{ ft}^3\text{s}^{-1}$; minor discharge $>0, <1,072 \text{ ft}^3\text{s}^{-1}$; no flow = $0 \text{ ft}^3\text{s}^{-1}$).

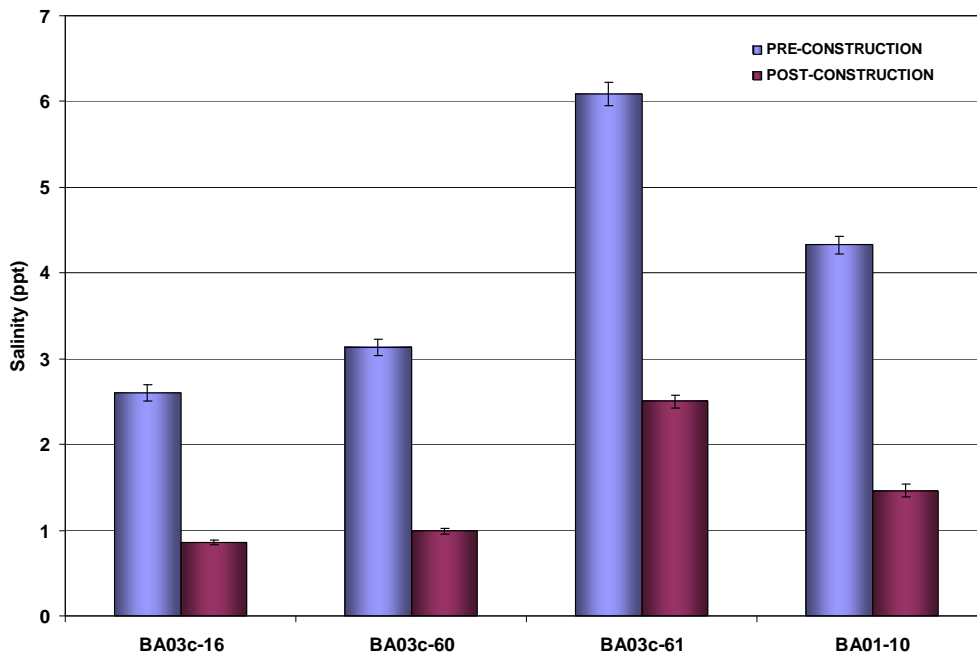
Stations 16 and 60 had consistently lower salinity than the reference station (Figure 7). It was assumed that if the water control structures were reducing salinity intrusions from BBW, and at the same time increasing the residence time of (diverted) fresh water from the siphons in the project area (i.e., a project impact), then the salinity difference would be greater after the installation of the structures. In contrast station 61 had a consistently higher salinity than the reference station. Thus, we assumed that if there was a project impact (i.e., fresher in project) then the salinity difference would be smaller during the post-construction time period. Results of these analyses indicated that the salinity “difference” was not significantly different between pre- and post-construction periods for station 16 ($P=0.0575$) and station 60 ($P=0.3893$). However, at station 61 the salinity “difference” was significantly smaller ($P=0.0137$), during the post construction period (Figure 8). This suggests that the project structures may have benefited the project area by increasing the freshwater retention and reducing saltwater intrusion in the area (as designed). However, it should be noted that the differences observed between periods were very small (< 1.5 ppt) and likely did not have an ecological effect on the project area (e.g., vegetation community). In addition, siphon flow was greater during the post-construction period and likely affected salinity in the area and interpretation of the tests.

Figure 7. Mean monthly salinity during pre-construction (05/01/1999 – 08/15/2002) and post-construction (08/15/2002 – 12/31/2003) for project and reference (BA01-10) stations.

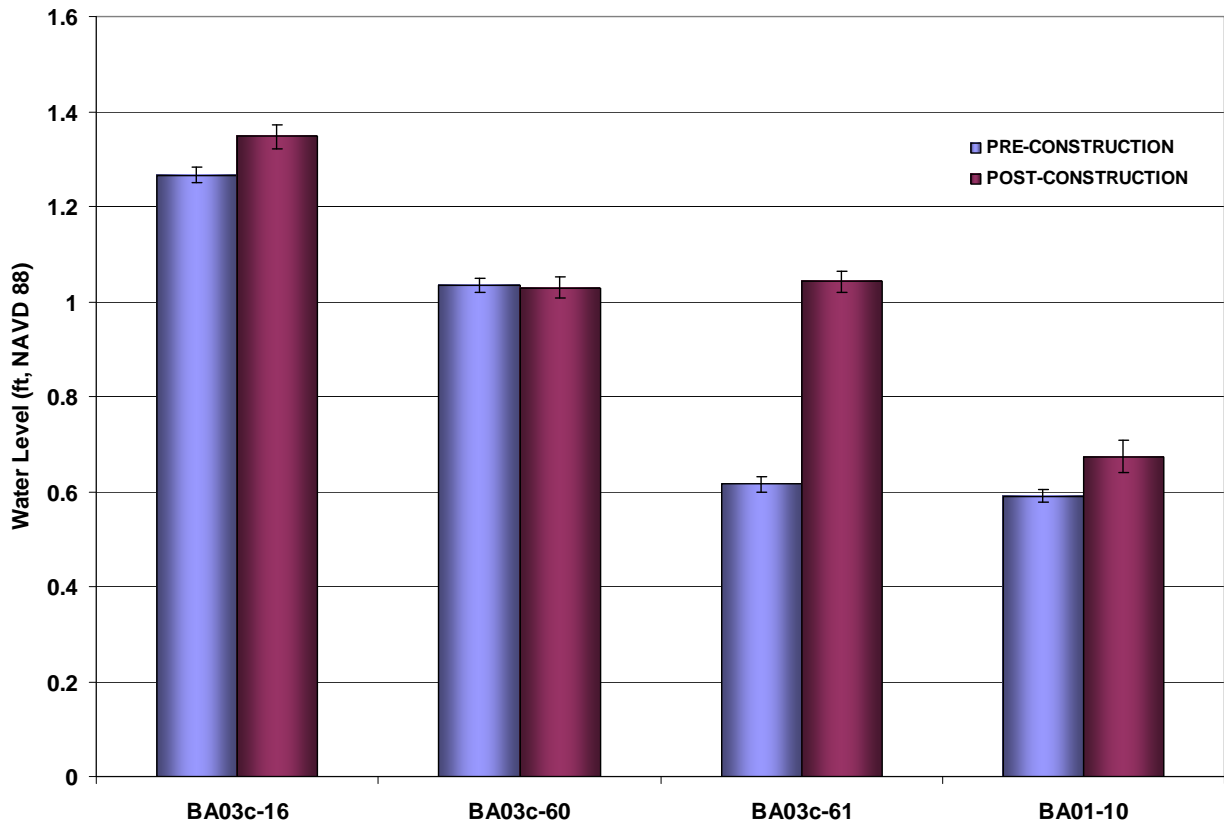
Pre and post-construction water levels for the outfall management project indicated that water levels had changed very little. Differences between pre-construction and post-construction water levels at station 16, 60, and 10 were ≤ 1 inch, but a difference of 6 inches was noted for station 61 (Figure 9).

Figure 9. Mean monthly water levels during pre-construction (05/01/1999 – 08/15/2002) and post-construction (08/15/2002 – 12/31/2003) for project and reference area.
