2011 Annual Inspection Report

Hopedale Hydrologic Restoration

State Project Number PO-24
Priority Project List 8

February 1, 2012
St. Bernard Parish

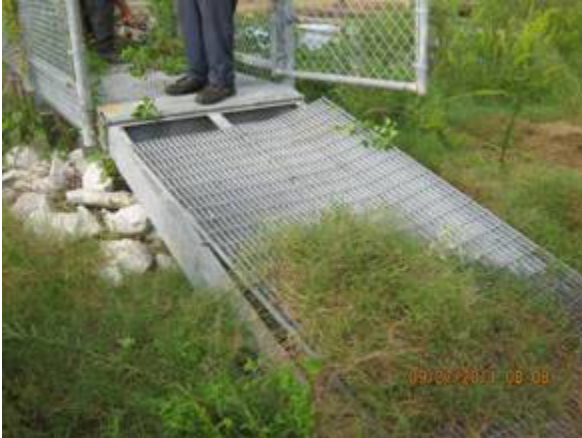
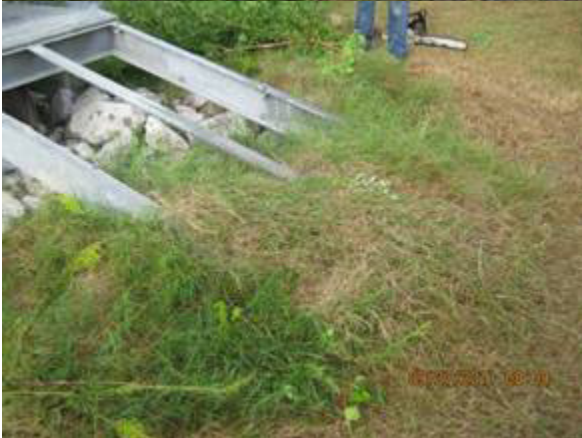
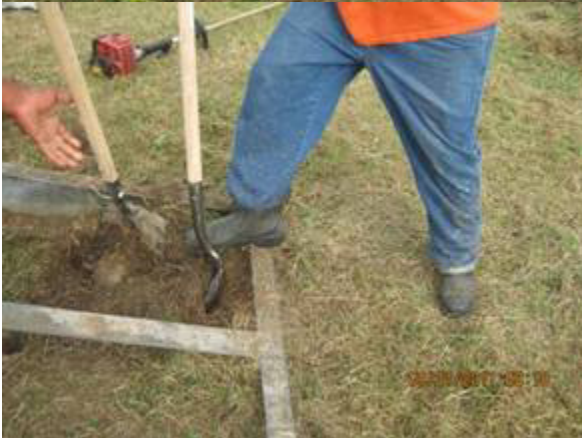
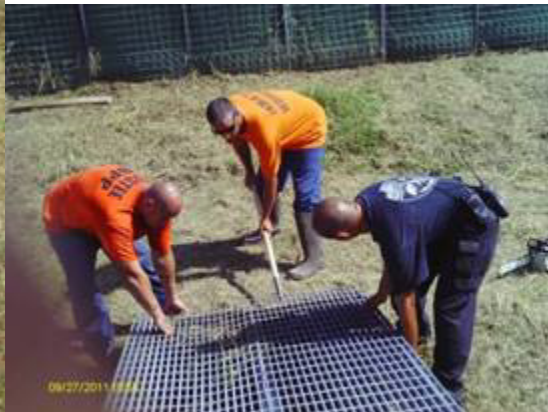
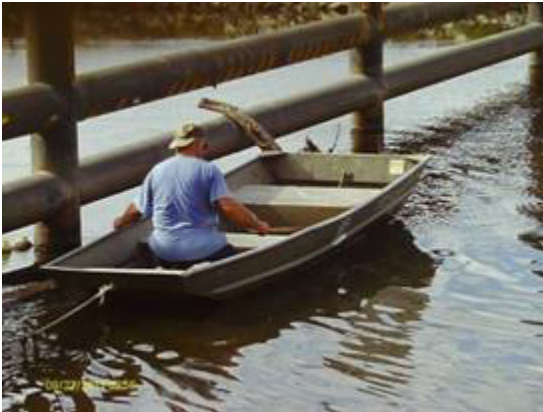
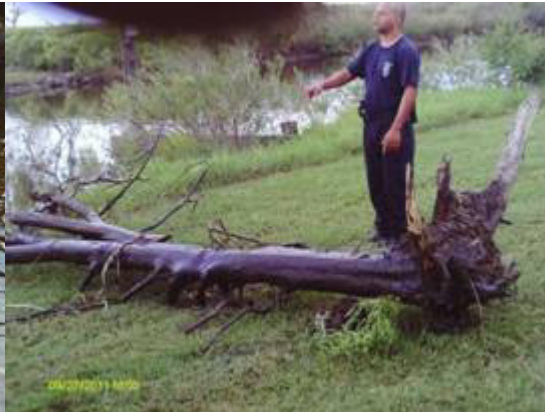
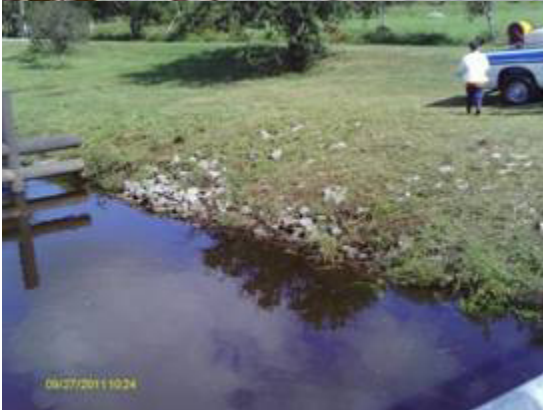
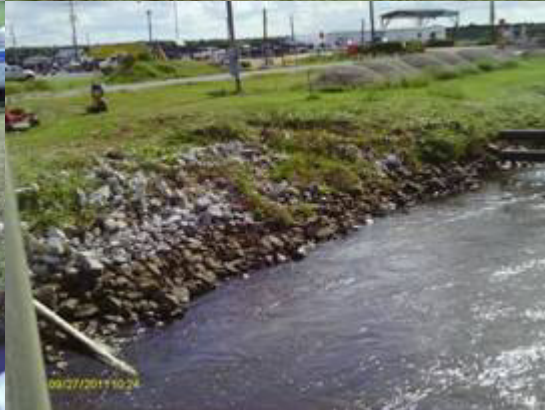
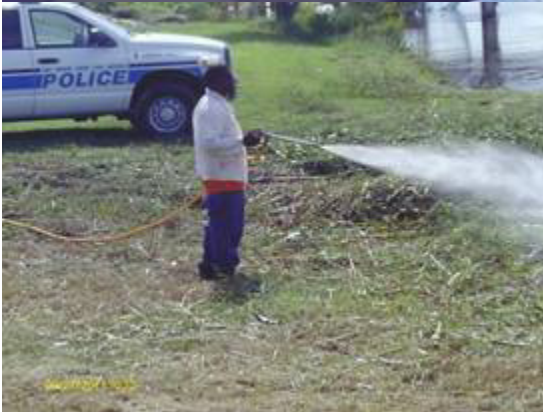
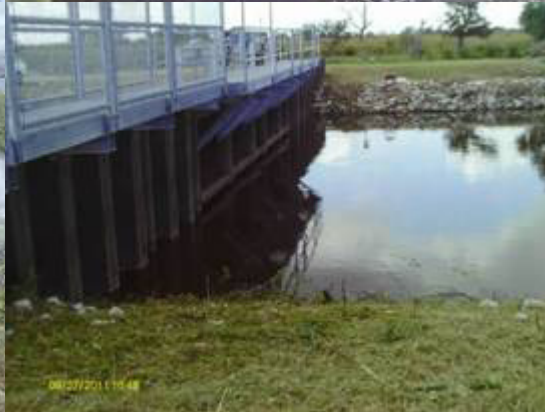
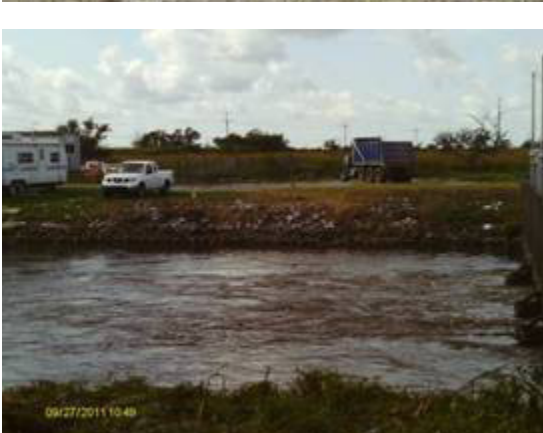
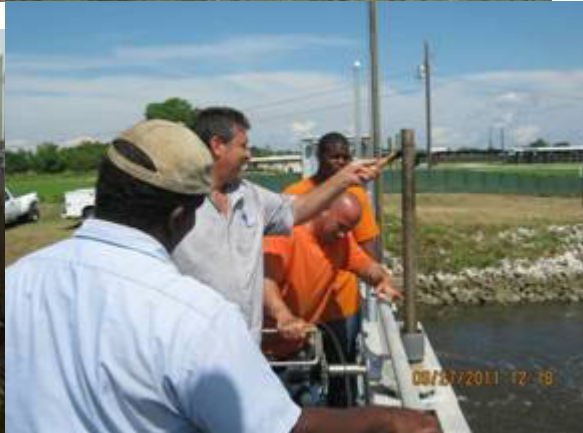
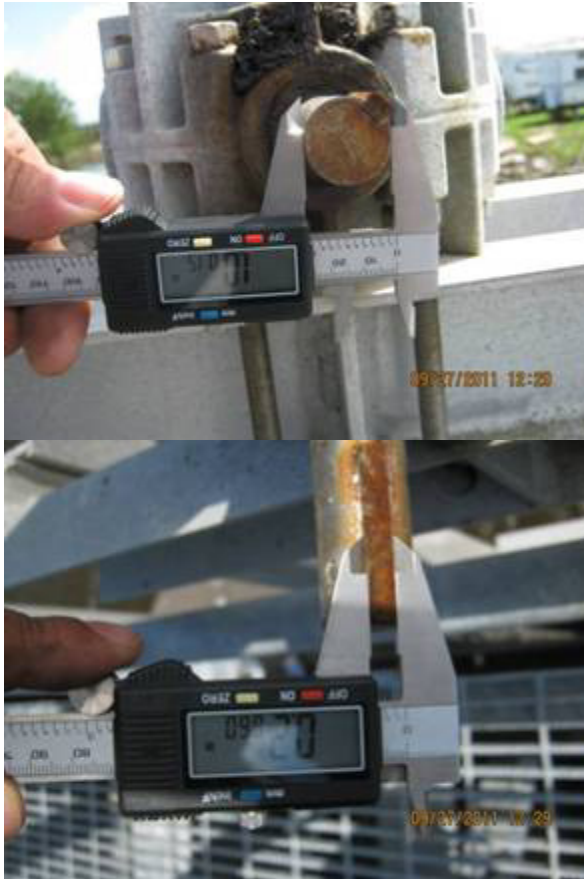
The unwanted vegetation was cleared and the area was sprayed to prevent more unwanted vegetation in the near future. Debris was cleared from around the structure and the ramp was repaired as it had been dislodged by excess vegetation. The gates were operated for functionality and all passed. The actuator needs to be worked on to improve functionality and the gate stem covers will be replaced this year.

We removed 2 large trees, 1 from the far outside structure and 1 from the far inside structure. We also removed several small trees growing through the rip rap. Let me know if you need more photos. I have them!

We also affected repairs to the grating ramp to the structure which had fallen away from the structure.
