**State of Louisiana
Coastal Protection and Restoration
Authority**

**2016 Operations, Maintenance,
and Monitoring Report**

**Caernarvon Diversion Outfall
Management (BS-03a)**

July 28, 2016
Plaquemines Parish

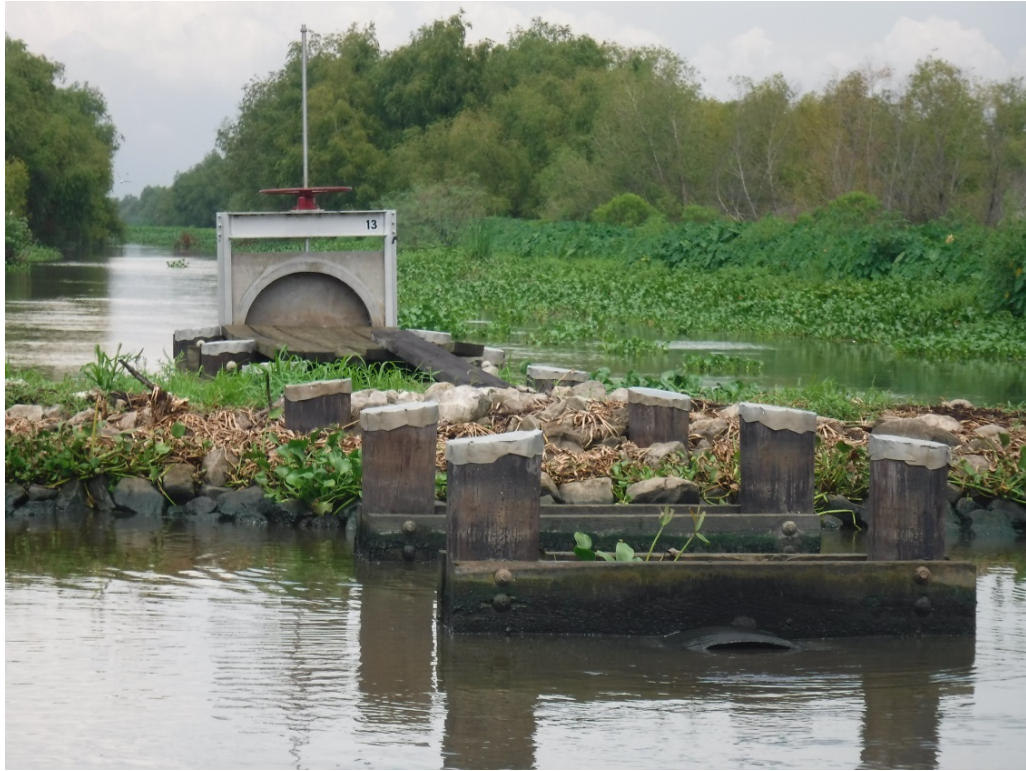
Photo No. 1, Site 13

The CPRA recommends repair of the decks at structures #13 and #50. The deck at structure #13 is not attached to the supports at one end, and the deck at structure #50 is bowed with one plank detached.
