### **2025/2026 Annual Inspection Report**

### **BLACK BAYOU CULVERTS HYDROLOGIC RESTORATION PROJECT (CS-29)**

State Project Number CS-29  
Priority Project List 9

January 27<sup>th</sup>, 2026  
Calcasieu and Cameron Parishes

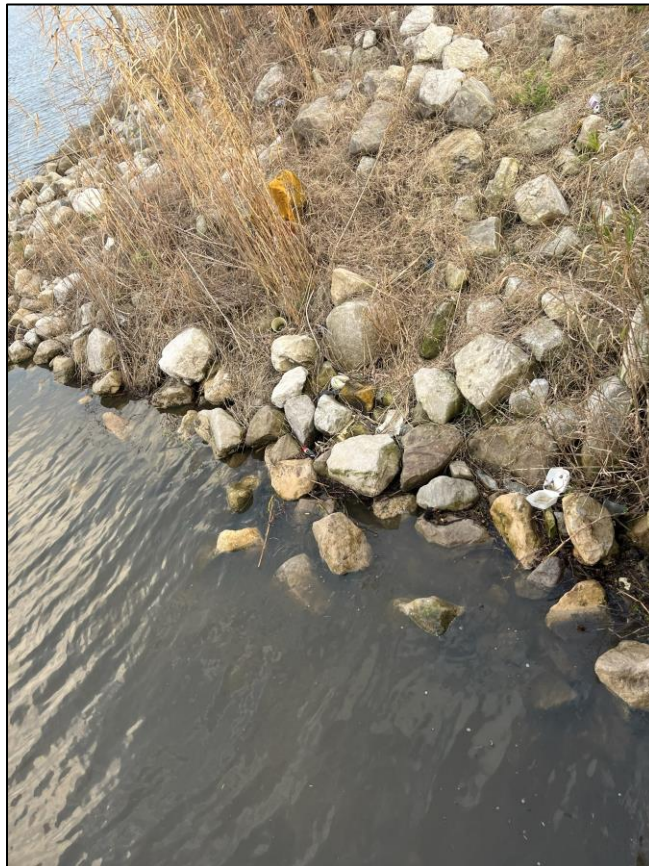
The visible rock rip rap was in good condition. (Photos: Appendix B)

**B8. East Side of Structure – South Riprap**

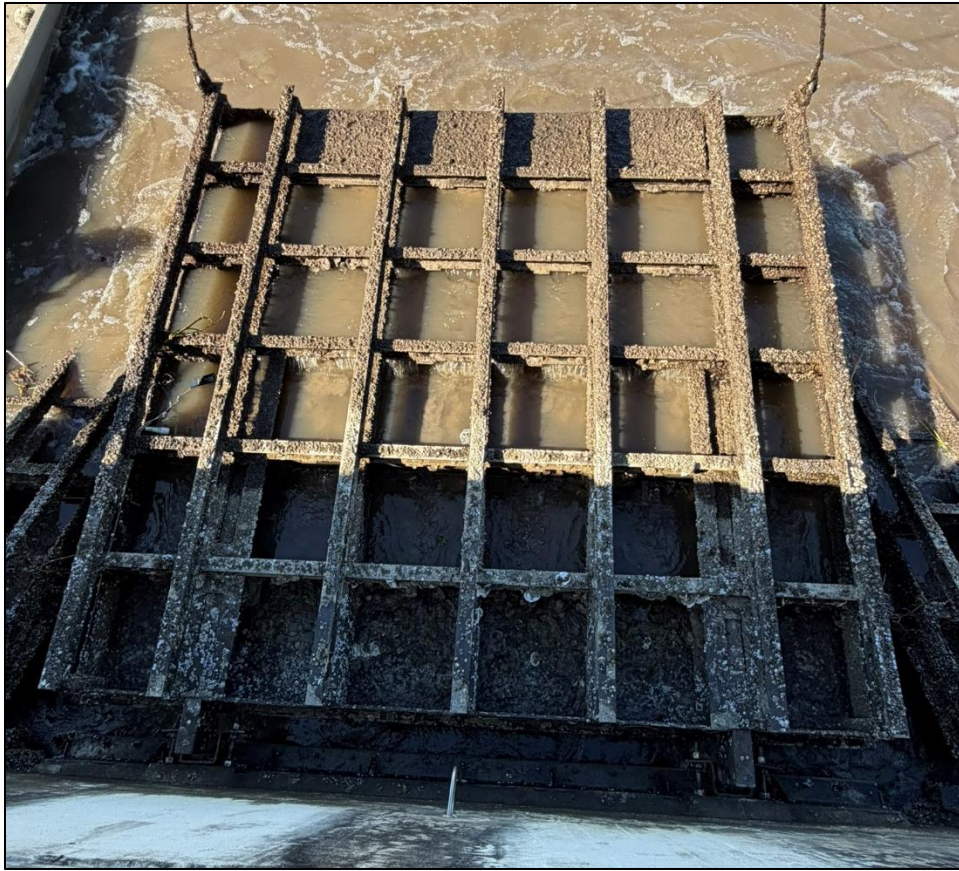
B	With all the locking rings on the gate intact, barring issues with the rings on the receiving gate frame, there should be no issues locking this gate in the closed position.			
C	A new padlock was installed through the shackle of the lifting cables once the gate was lowered.			
D	Observed an increase in the growth of marine vegetation on the gate surface from that observed during last year's inspection.			
E	At the time of inspection, a 10' pole was found inserted through the locking rings on the structure. This suggest the gate was tampered with in attempt to keep the gate in the open position and is the likely cause of the damaged rings on the flapgate. These rings were repaired in June 2025.			
F

**5a. Gate No. 5 – Top View**

**June-July 2025 Simon and Delany:** Gate No. 5 & 9; this maintenance even included all materials, labor, equipment, and transportation necessary to remove, fabricate parts, (new locking rings), repair work including welding and coating, reinstall, and field adjust flap gate for proper fit. At this same time, the contractor fabricated 2 new locking pins and 10 new lifting cables. These 2 locking rings were to replace the ones that were

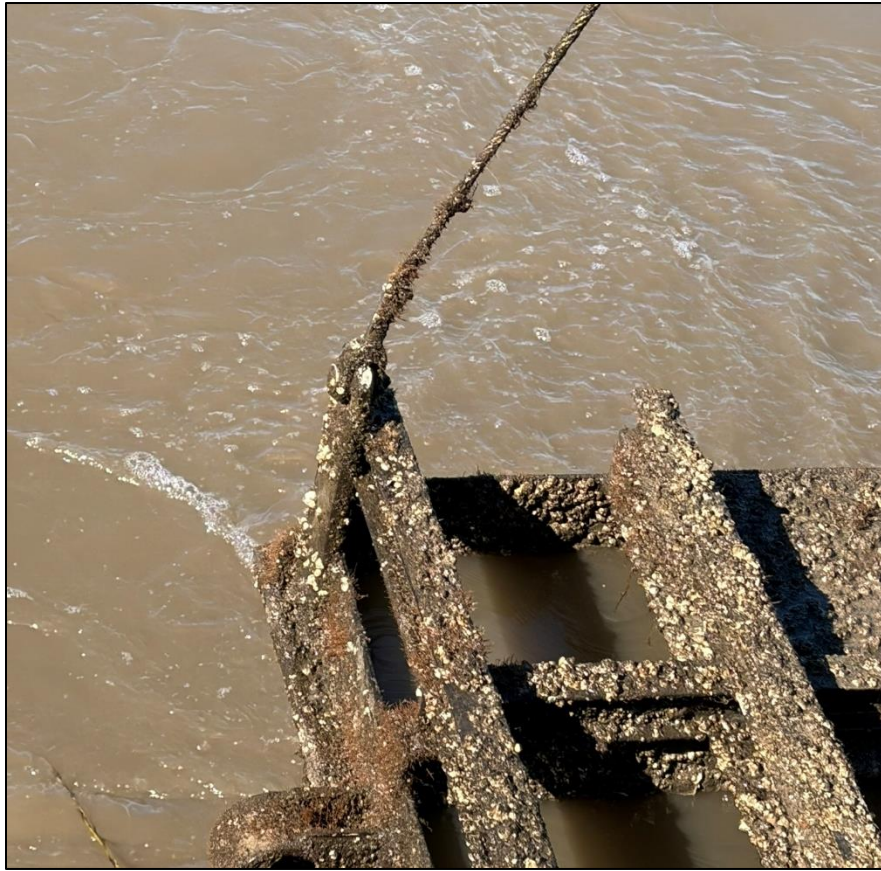
**5e. Gate No. 5 – Lifting eye, shackle and cable - South side of Gate**

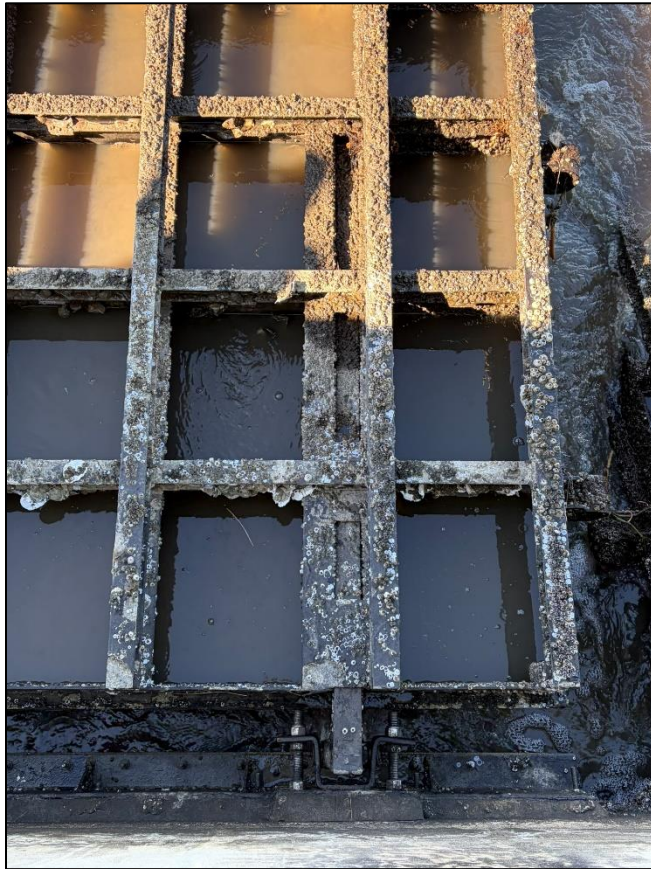
**5g. Gate No. 5 – Hinge Assembly and Stop Plate – North Side**

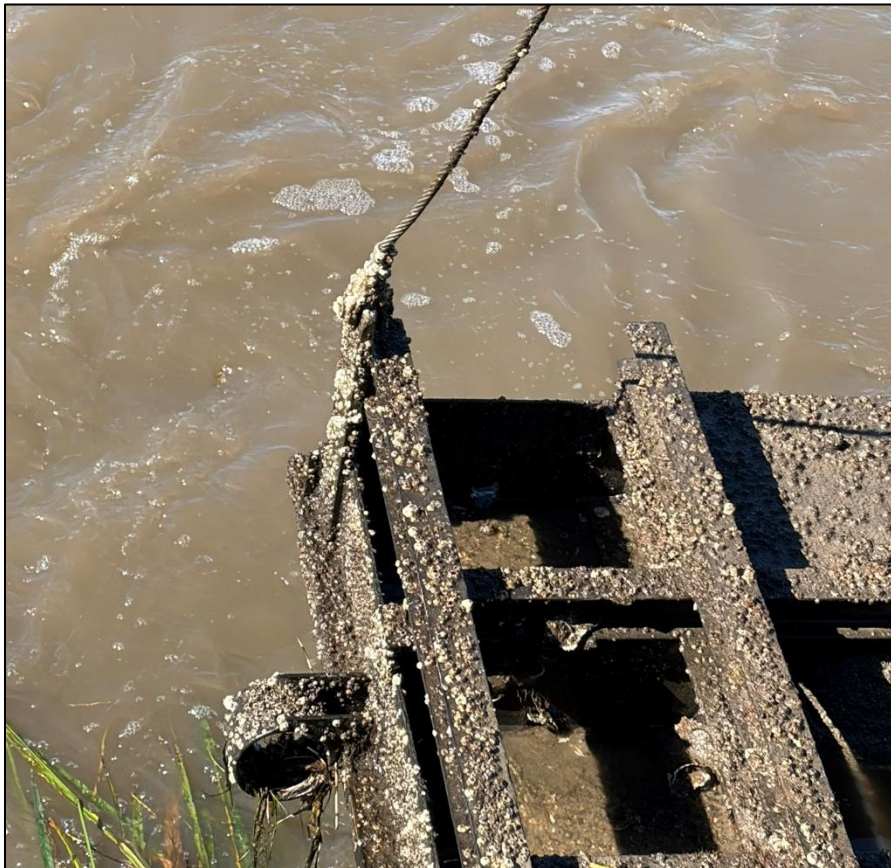
**7f. Gate No. 7 – Lifting eye, shackle and cable - South side of Gate**

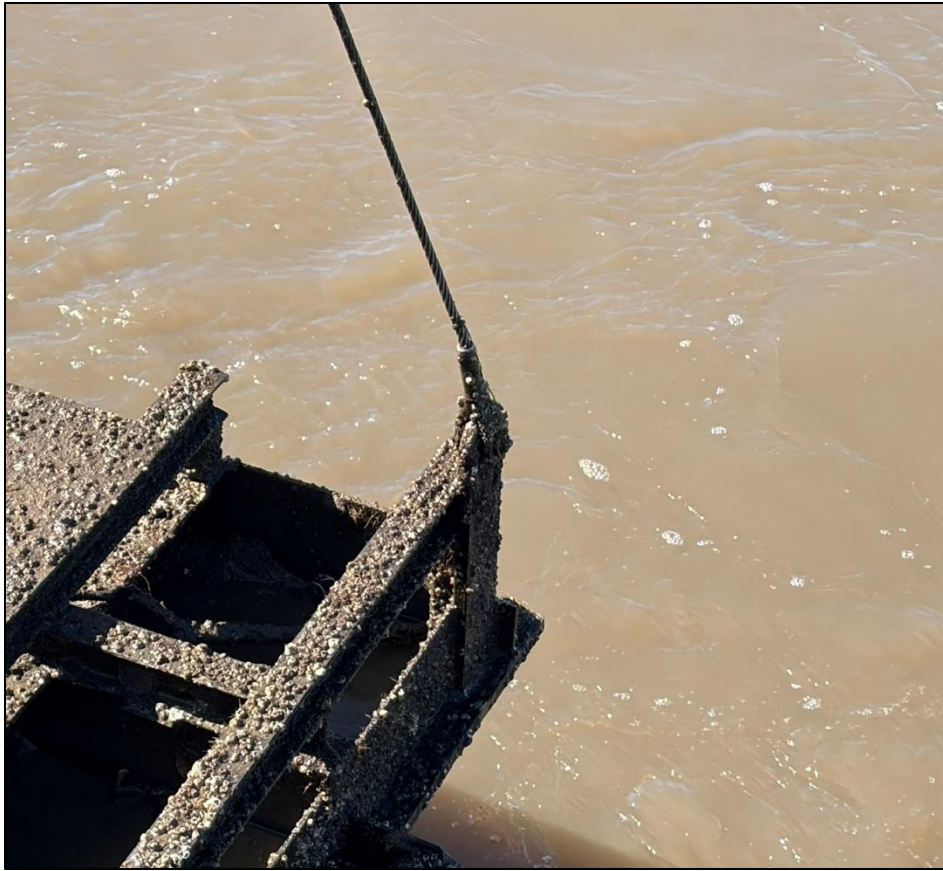
**8c. Gate No. 8 – Lifting eye, shackle and cable - North side of Gate.**

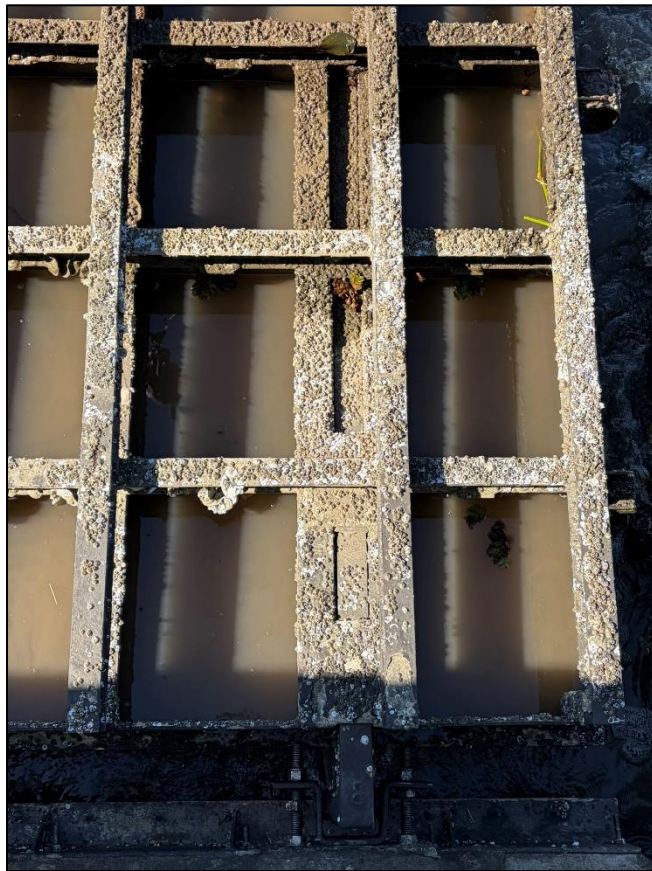
13	Aluminum Angle (Lt.)	X		
14	Aluminum Angle (Rt.)	X		
15	Stop Plate (Left)		X	Cracked weld
16	Stop Plate (Right)		X	Cracked weld
17	Lifting Cables	X		
<b>Additional Comments</b>				
A	Water levels in the channel did not allow for visual inspection of the locking rings attached to the gate frames.			
B	With all but one locking ring on the gate intact, barring issues with the rings on the receiver gate frame, there should be no problems locking the gate in the closed position. Repair/replacement is not recommended at this time.			
C	A new padlock was installed through the shackle of the lifting cables once the gate was lowered.			
D	Observed an increase in the growth of marine vegetation on the gate surface from that observed during last year's inspection.			
E				
F

**8f. Gate No. 8 – Hinge Assembly and Stop Plate – South Side**

**8g. Gate No. 8 – Hinge Assembly and Stop Plate – North Side**

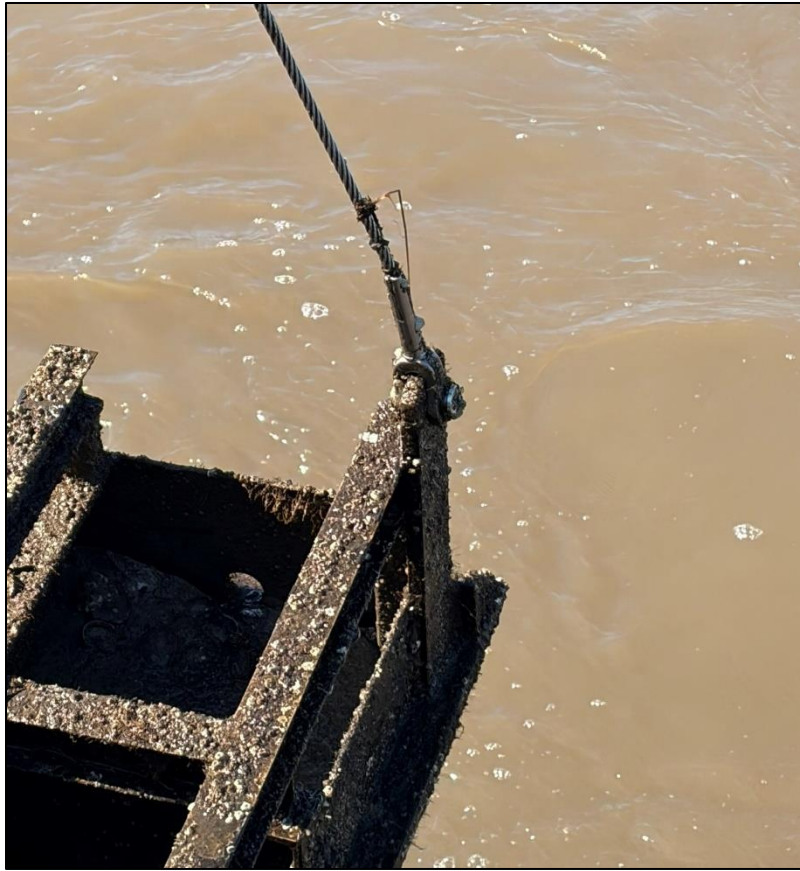
**9c. Gate No. 9 – Lifting eye, shackle and cable - North side of Gate.**

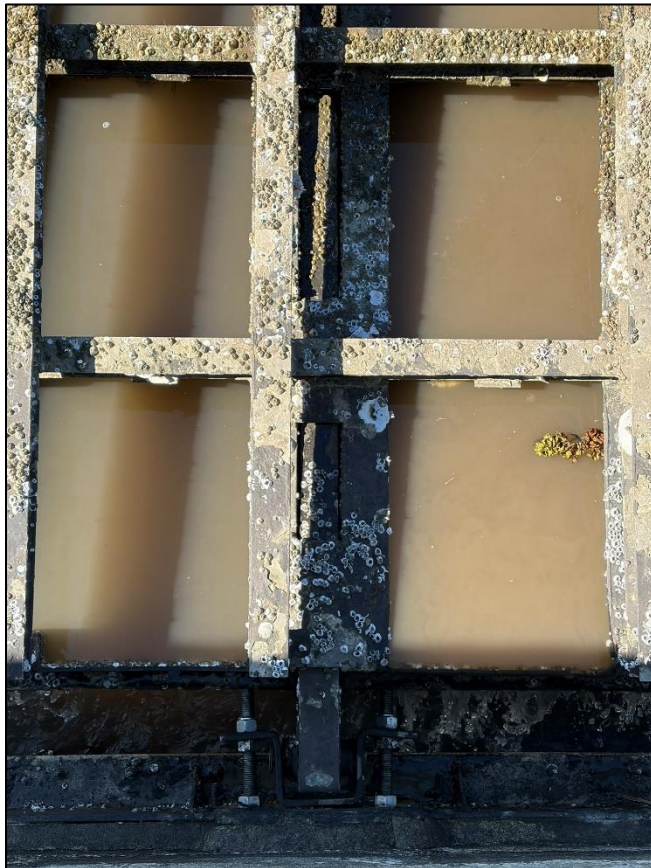
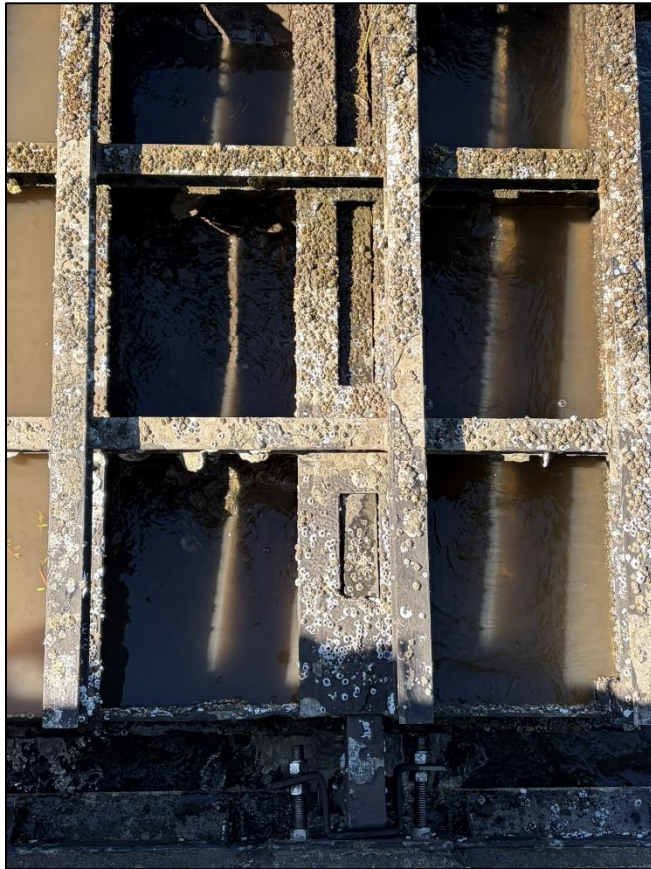
Feature No.	Description	Intact	Damaged	Comments
<b>Flap Gate Features</b>				
1	Hinge Assembly (Left)		X	Bent
2	Hinge Assembly (Right)	X		
3	Flap Gate Lock Ring, Upper (Rt.)	X		
4	Flap Gate Lock Ring, Middle(Rt.)	X		
5	Flap Gate Lock Ring, Lower (Rt.)	X		
6	Flap Gate Lock Ring, Lower (Lt.)	X		
7	Flap Gate Lock Ring, Middle (Lt.)	X		
8	Flap Gate Lock Ring, Upper (Lt.)	X		
9a	Aluminum Plate for Retaining Styrofoam Floatation Block	X		
9b	Styrofoam Floatation Block	X		
10a	Aluminum Plate for Retaining Styrofoam Floatation Block	X		
10b	Styrofoam Floatation Block	X		
11a	Aluminum Plate for Retaining Styrofoam Floatation Block	X		
11b	Styrofoam Floatation Block	X		
12a	Aluminum Plate for Retaining Styrofoam Floatation Block	X		
12b	Styrofoam Floatation Block	X		
13	Aluminum Angle (Lt.)	X		
14	Aluminum Angle (Rt.)	X		
15	Stop Plate (Left)	X		
16	Stop Plate (Right)	X		
17	Lifting Cables	X		
<b>Additional Comments</b>

**9f. Gate No. 9 – Hinge Assembly and Stop Plate – South Side**

**9g. Gate No. 9 – Hinge Assembly and Stop Plate – North Side**

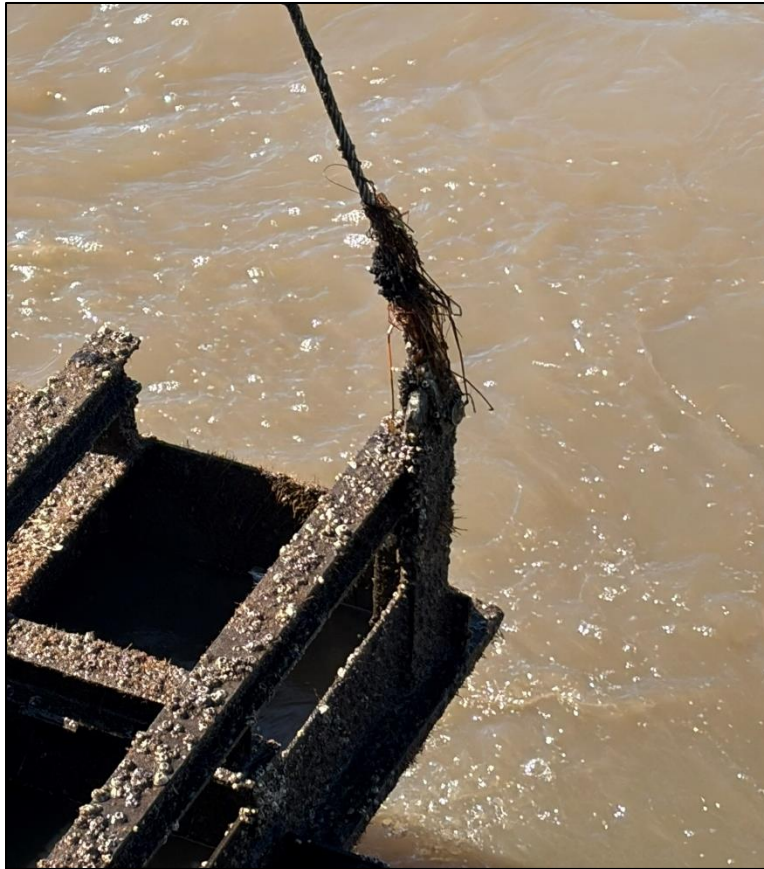
**10c. Gate No. 10 – Lifting eye, shackle and cable - North side of Gate.**

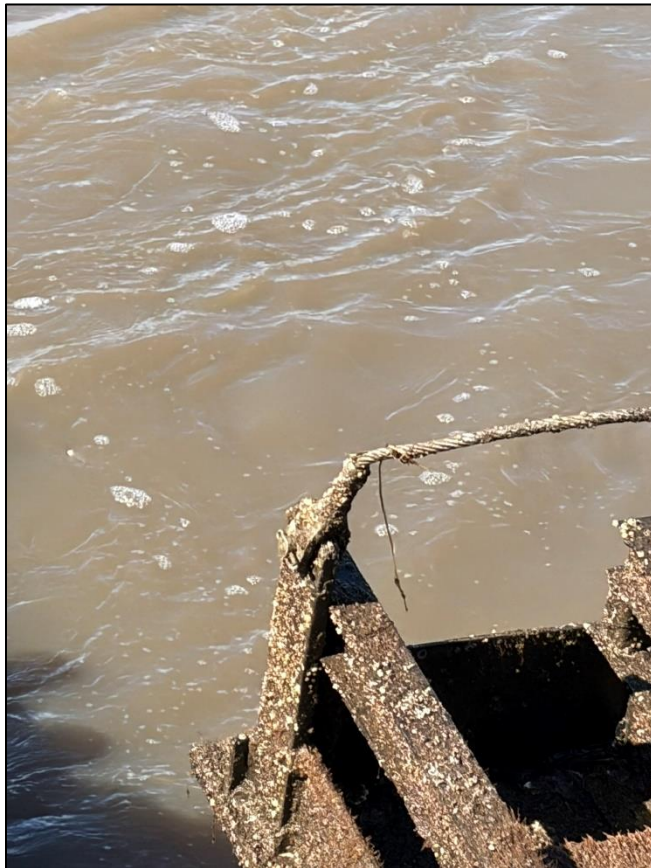
**10f. Gate No. 10 –South Side of Gate - New Pin**

During the inspection, the south lifting cable on Gate No. 6 and the north lifting cable on Gate No. 7 were replaced. In addition, the south lifting cable pin on Gate No. 10 was replaced.
