**2004 Operations, Maintenance,
and Monitoring Report**

**Boston Canal/ Vermilion Bay
Shoreline Stabilization**

State Project Number TV-09
Priority Project List 2

May 2004
Vermilion Parish

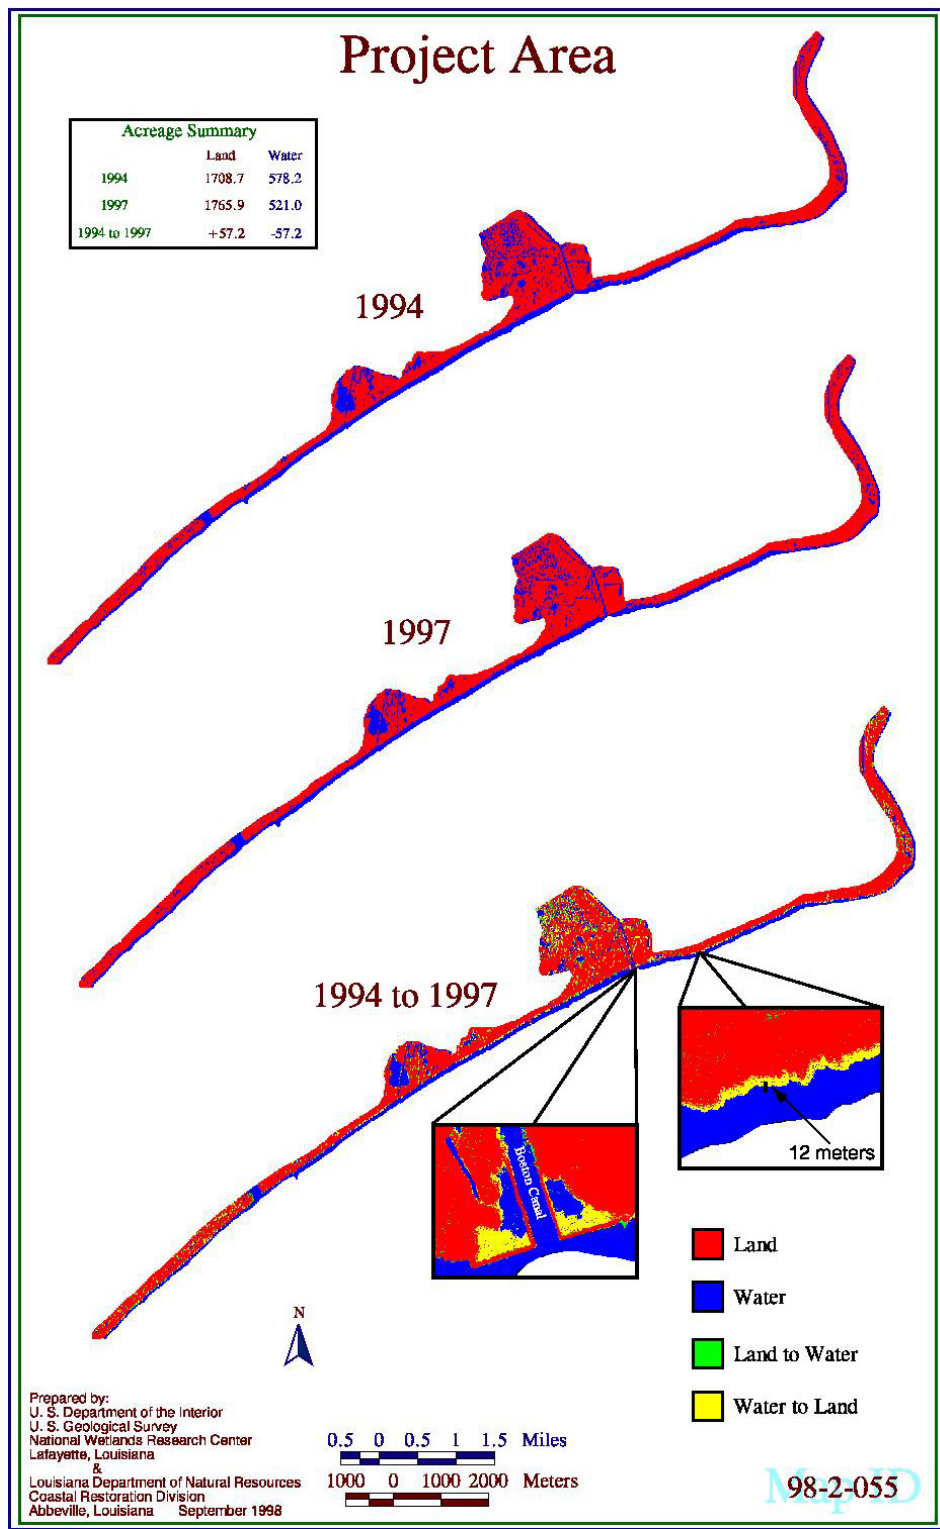
Figure 2. Boston Canal/Vermilion Bay Shoreline Stabilization (TV-09) GIS Land/Water analysis of project area.

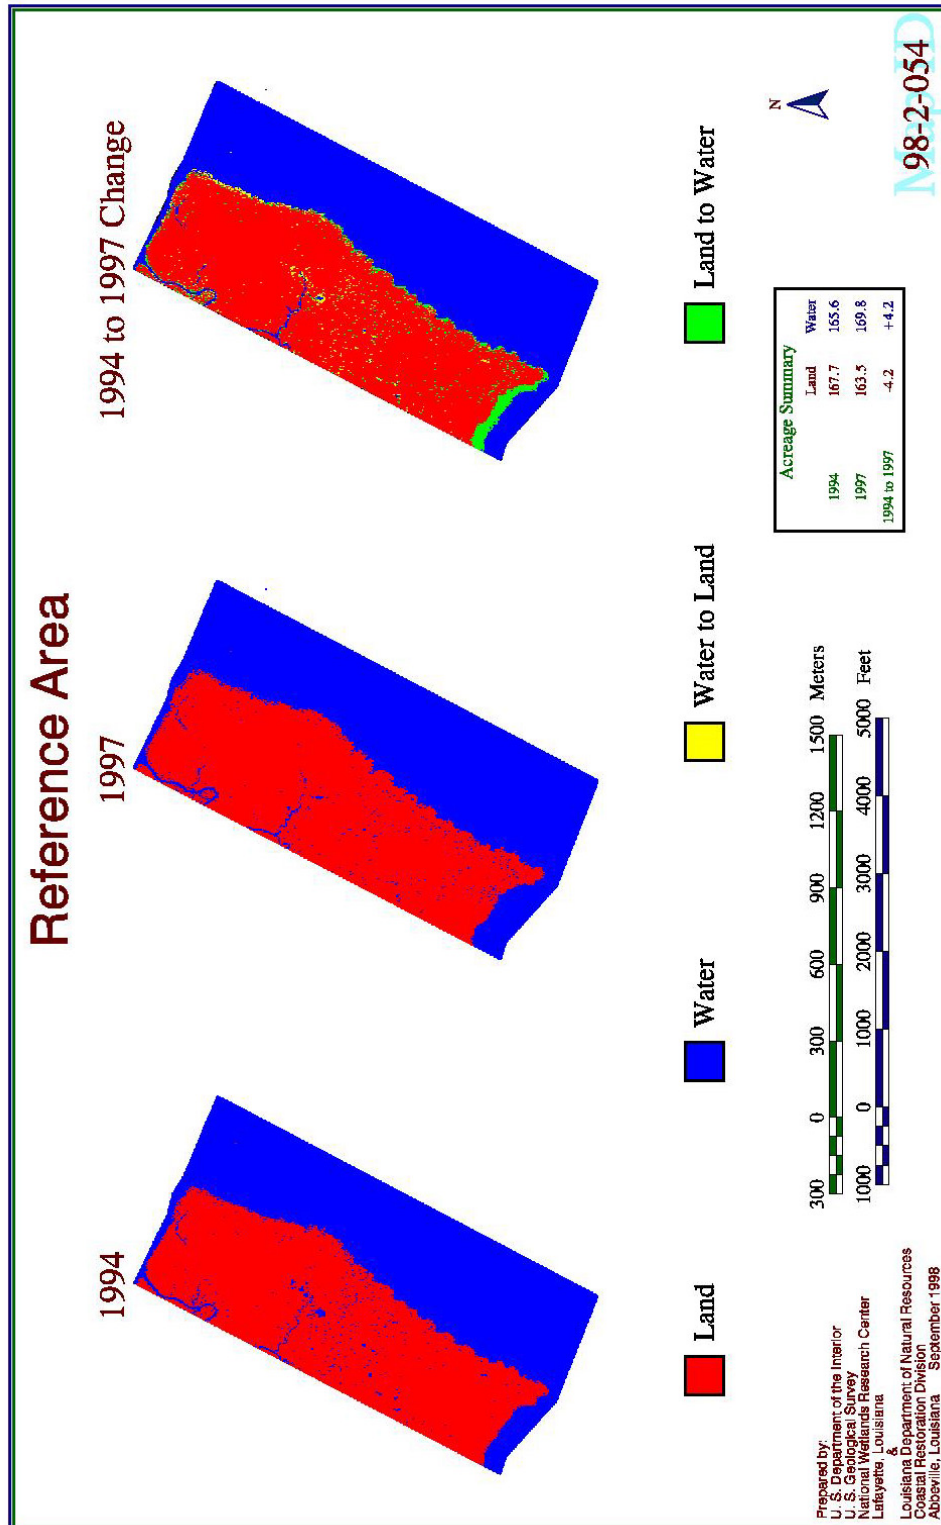
Figure 3. Boston Canal/Vermilion Bay Shoreline Stabilization (TV-09) GIS Land/Water analysis of the reference area.

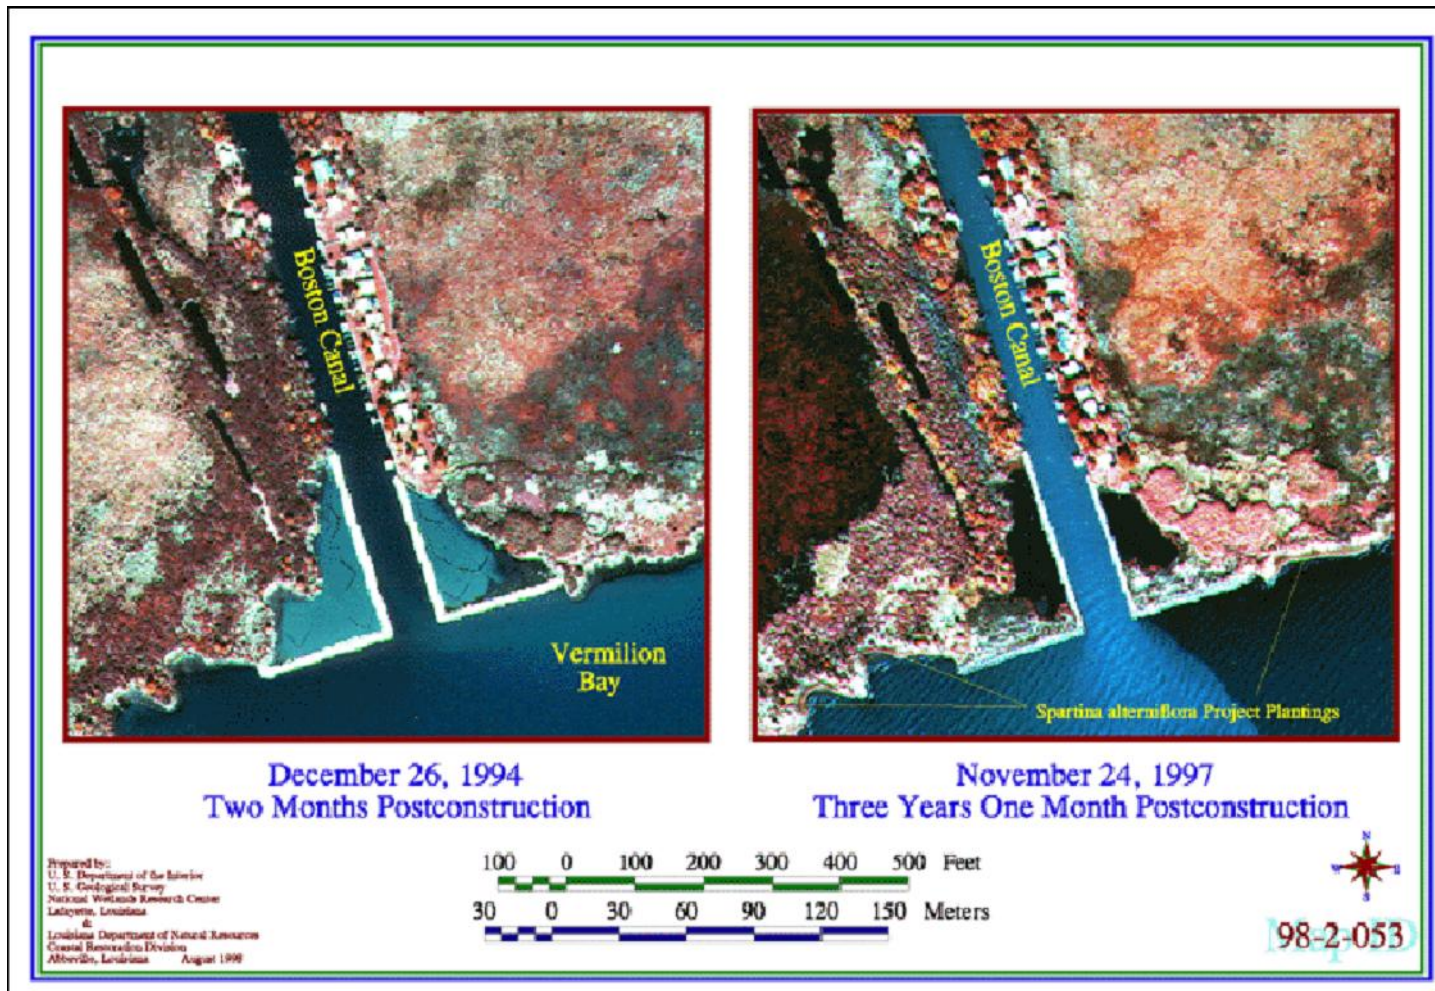
Figure 4. Aerial photography comparison of Boston Canal Shoreline Stabilization (TV-09) project at two month post construction (December 26, 1994) and three years one month post construction (November 24, 1997).

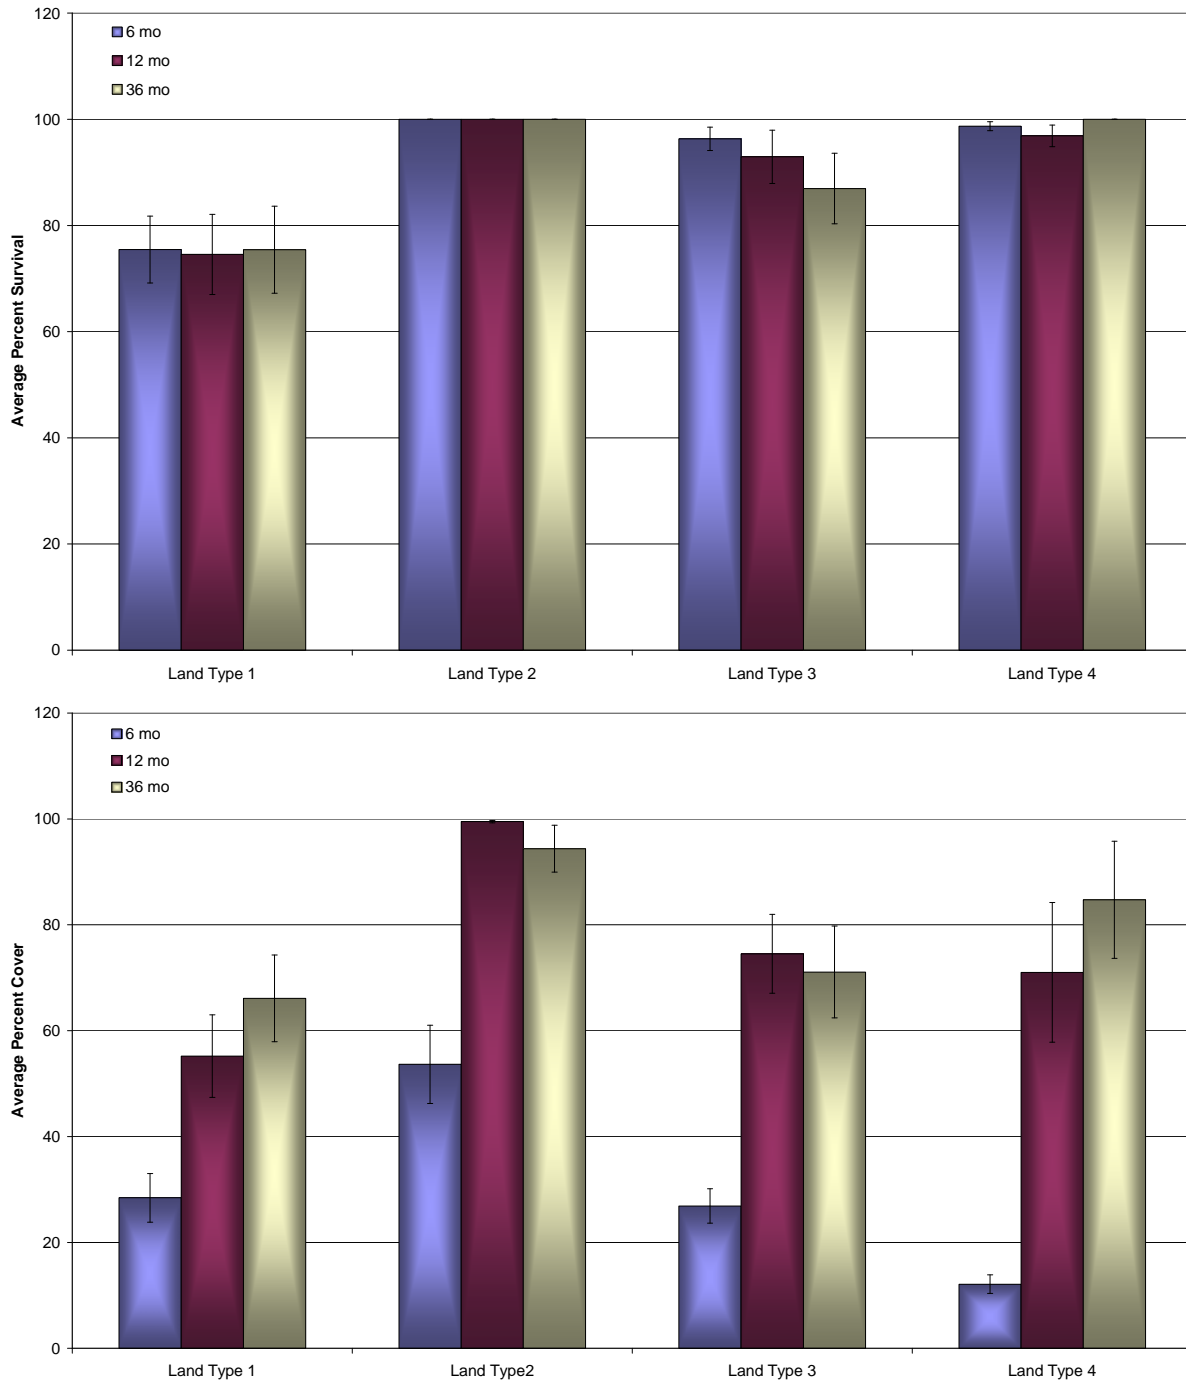
Although the plants were not closely inspected on this trip, according to Christine Thibodeaux, TV-09 Monitoring Manager, “the high average percent survival of *Spartina alterniflora* on the shoreline indicates that the plants have become established. The plants have become indistinguishable from one another and form a continuous vegetated layer along the shoreline and according to the monitoring plan, will no longer be monitored. Percent survival of *S. alterniflora* at the 36 month post-planting averaged 90.6 % among all land types. Percent survival of *S. alterniflora* at the 36 month post-planting in the high, medium and low *Phragmites australis* coverage was 12.5 %, 62.5 %, and 89.1 %, respectively. Percent cover of *S. alterniflora* at the 36 month post-planting in high, medium, and low *P. australis* coverage was 5.6 %, 56.9 %, and 75.9 %, respectively.”

Figure 5. Boston Canal/Vermilion Bay Shoreline Stabilization (TV-09) average percent survival (upper) and average percent cover (lower) of *Spartina alterniflora* plantings in land types 1-4 observed at 6, 12, and 36 months postplanting, 1995, 1996, and 1999 means \pm SE.

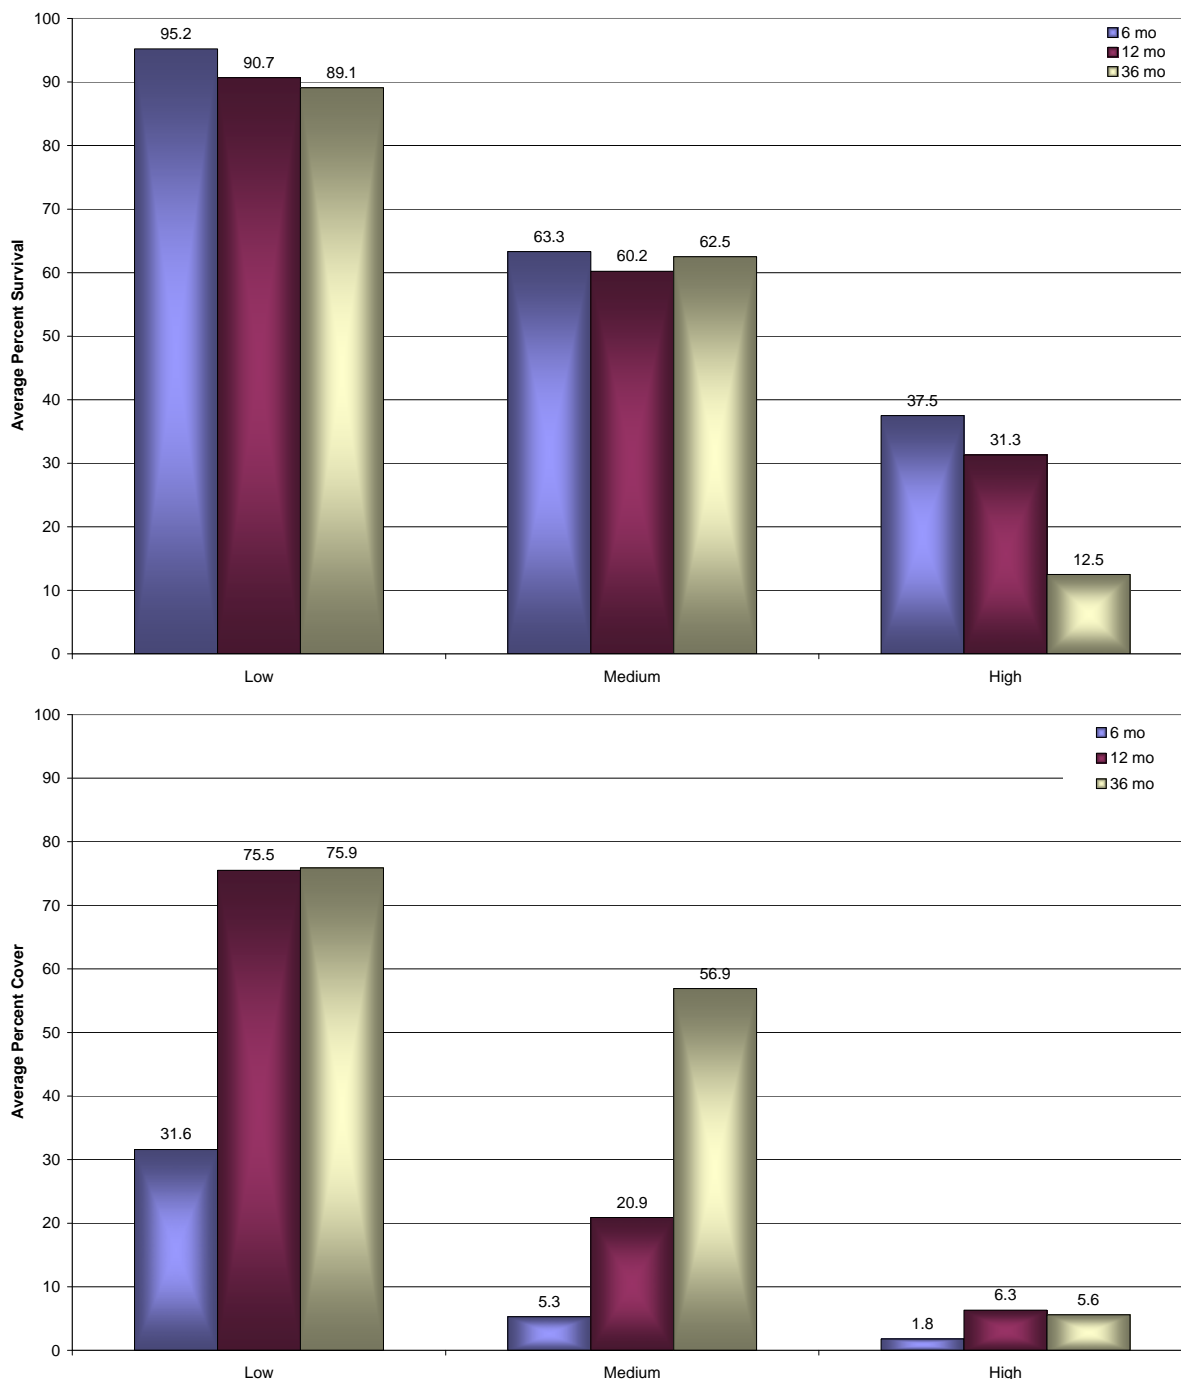
Figure 6. Boston Canal/Vermilion Bay Shoreline Stabilization (TV-09) average percent survival (upper) and average percent cover (lower) of *Spartina alterniflora* plantings at 6, 12, and 36 mo post-planting in low, medium, and high levels of *Phragmites australis* coverage.
