**State of Louisiana
Department of Natural Resources
Coastal Restoration Division and
Coastal Engineering Division**

**2004 Operations, Maintenance,
and Monitoring Report**

**Little Vermilion Bay Sediment
Trapping**

State Project Number TV-12
Priority Project List 5

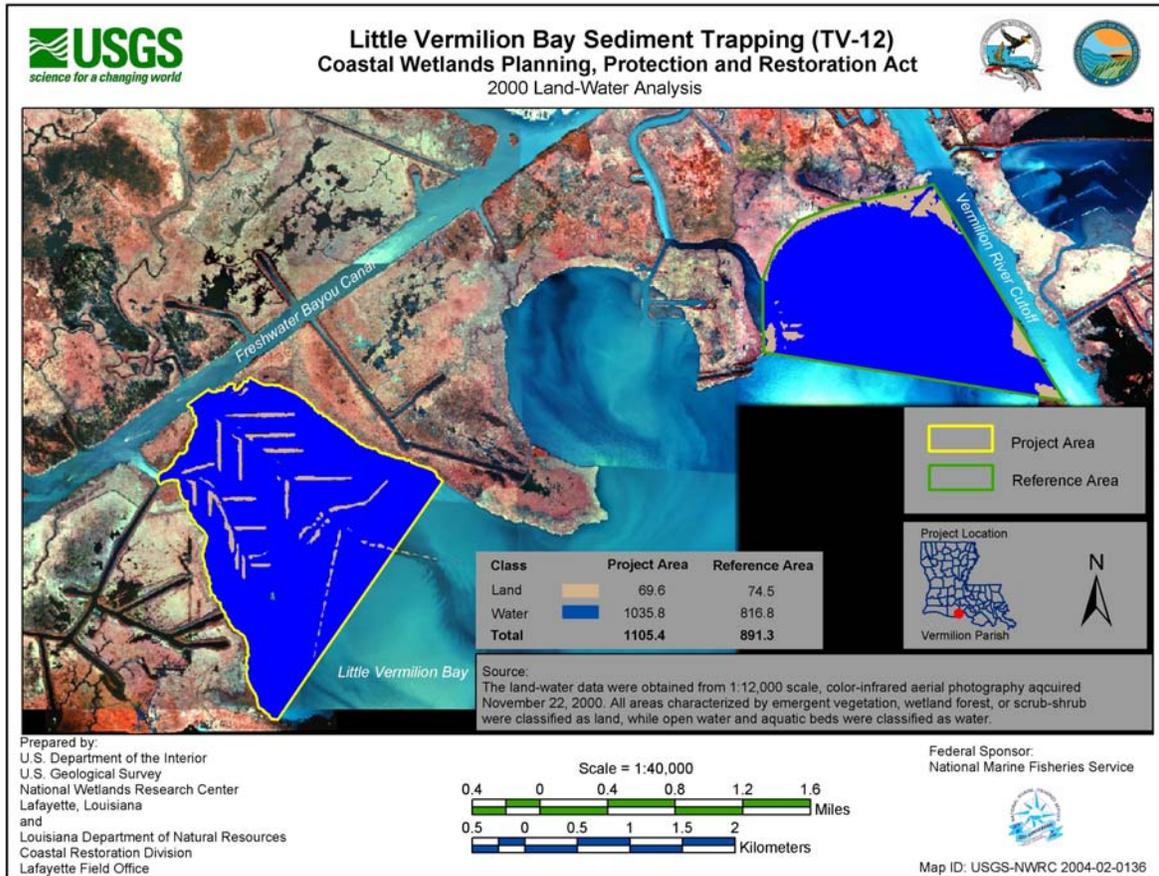
According to the year 2000 photography analysis, the project area consisted of 68 ac (27.5 ha) of land and the reference area had 74 ac (29.9 ha) (figure 4). Of the total land in the project area, 56.2 ac (22.7 ha) were constructed terraces (figure 5). The 2002 land-water analysis determined that the land portion of the project area consisted of 62.7 ac (25.4 ha) and the reference area had 73.5 ac (29.7 ha) of land (figure 6). The change from the 2000 amounts is a loss of 5.3 ac (2.1 ha) of land in the project area and a loss of 0.5 ac (0.2 ha) in the reference area. The project area was further analyzed to identify areas of loss and gain (figure 7). There was no pattern, but gains were limited to a few terraces, whereas losses were distributed among the edges of all terraces. In addition to the land and water classes, a mud flat class was added to describe areas of very shallow water mostly in between terraces and in some places in the reference area. In 2002, the project area had 199.5 ac (80.7 ha) of mud flat area and the reference area had 111.6 ac (45.1 ha) of mud flat. The periodically exposed mudflats are apparently building up from sediment deposition and may eventually become permanently subaerial and contribute to the land component of the analysis. It is interesting to note that mudflat developed around natural features in the reference area, yet in the project area, all sediment deposition appears to be near the project features, indicating the utility of the terraces.

Figure 4. TV-12 land / water analysis for the project and reference areas in 2000.

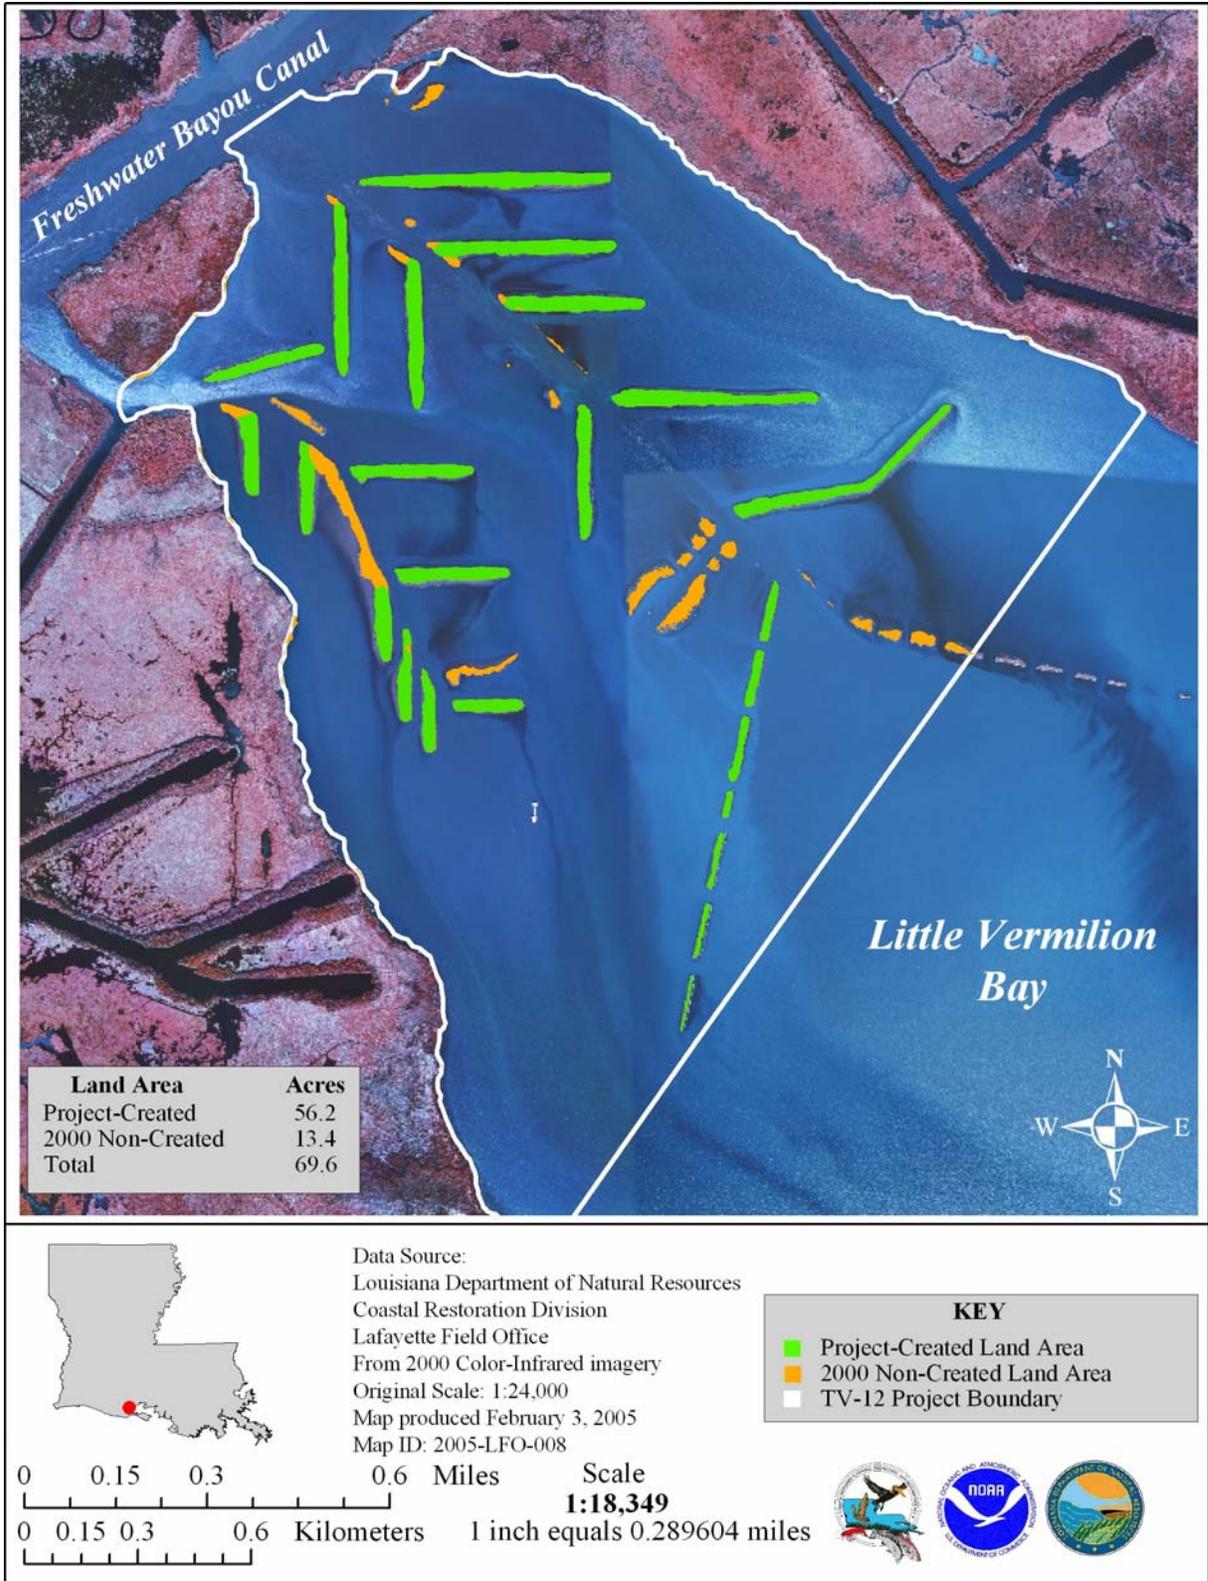
Figure 5. TV-12 project area with existing land and created terraces in 2000.

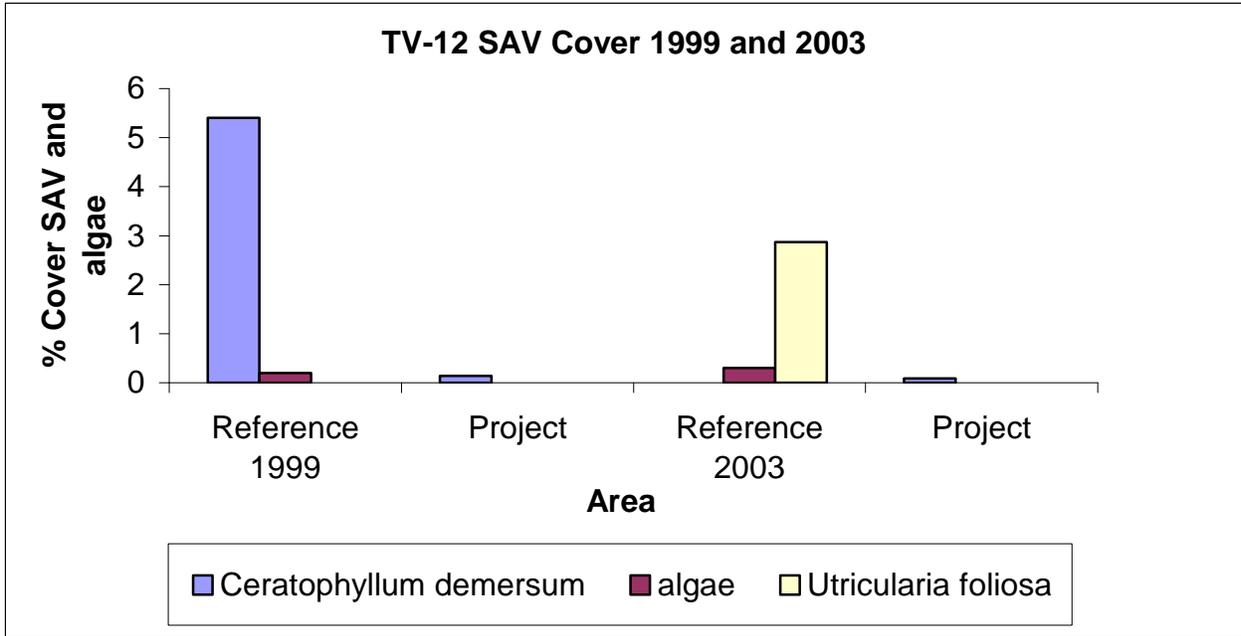
Significant amounts of SAV were not collected with rake samples at construction or nearly three years later (spring 2003). The mean % cover for all SAV in the reference area in 1999 was 5.4% and less than 1% in the project area (figure 13). In 2003, the mean % cover of SAV was less than 3% in the reference area and less than 1% in the project area. SAV is generally most abundant in late summer or fall; therefore it may have been underestimated in the 2003 spring

Figure 13. SAV cover in the TV-12 project and reference areas in 1999 and 2003.

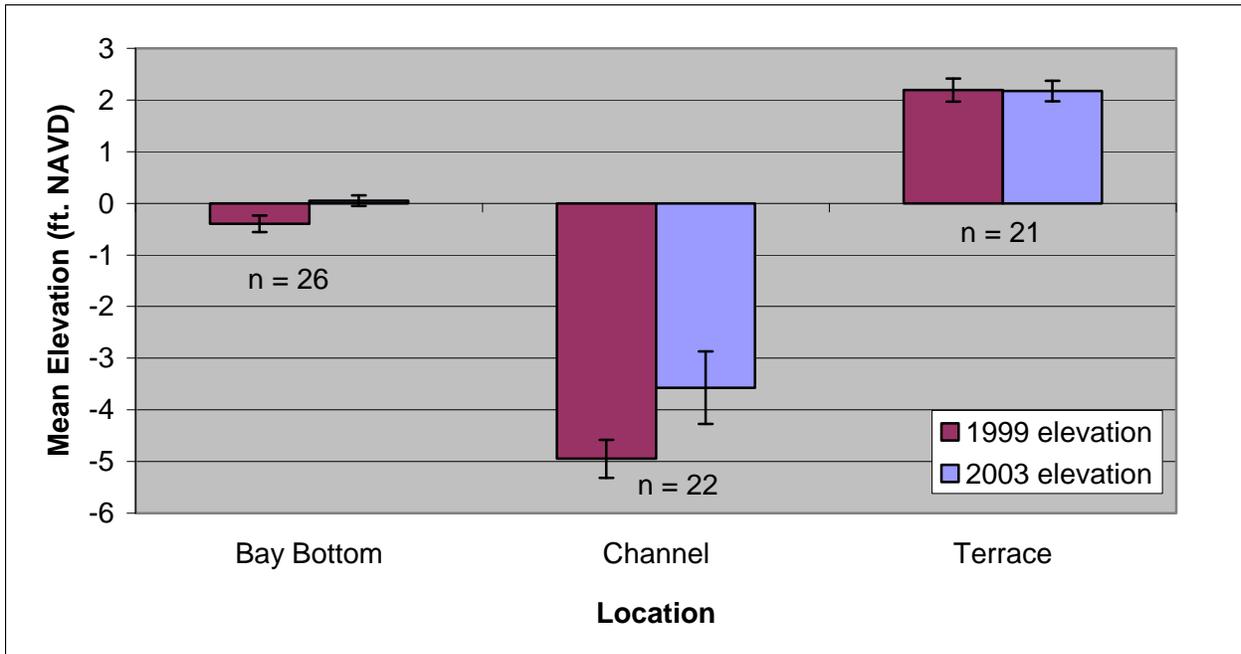
An elevation survey was conducted immediately after construction in September 1999. A postconstruction elevation survey of a subset of the original transects was completed in August 2003. It appears that there has been substantial sediment deposition. The mean channel bottom elevation in 2003 was 1.37 ft higher than in 1999 (figure 14). Bay bottom in the vicinity of the terraces, had a mean elevation increase of 0.5 ft. During the same period, the average terrace elevation loss was only 0.018 ft. All cross sections showed some elevation increases on bottoms or in channels (figures 15 – 20). Most channels filled in more by 2003, but a few apparently were scoured to a greater depth since 1999 (figures 15, 17, and 20).

Figure 14. Mean elevation of three major project area locations from the 1999 and 2003 elevation surveys. Each location mean was calculated from 21 to 26 points that were measured in the same place in both surveys.
