Freshwater Bayou Bank Stabilization Summary Data and Graphics

Freshwater Bayou Bank Stabilization (ME-13)

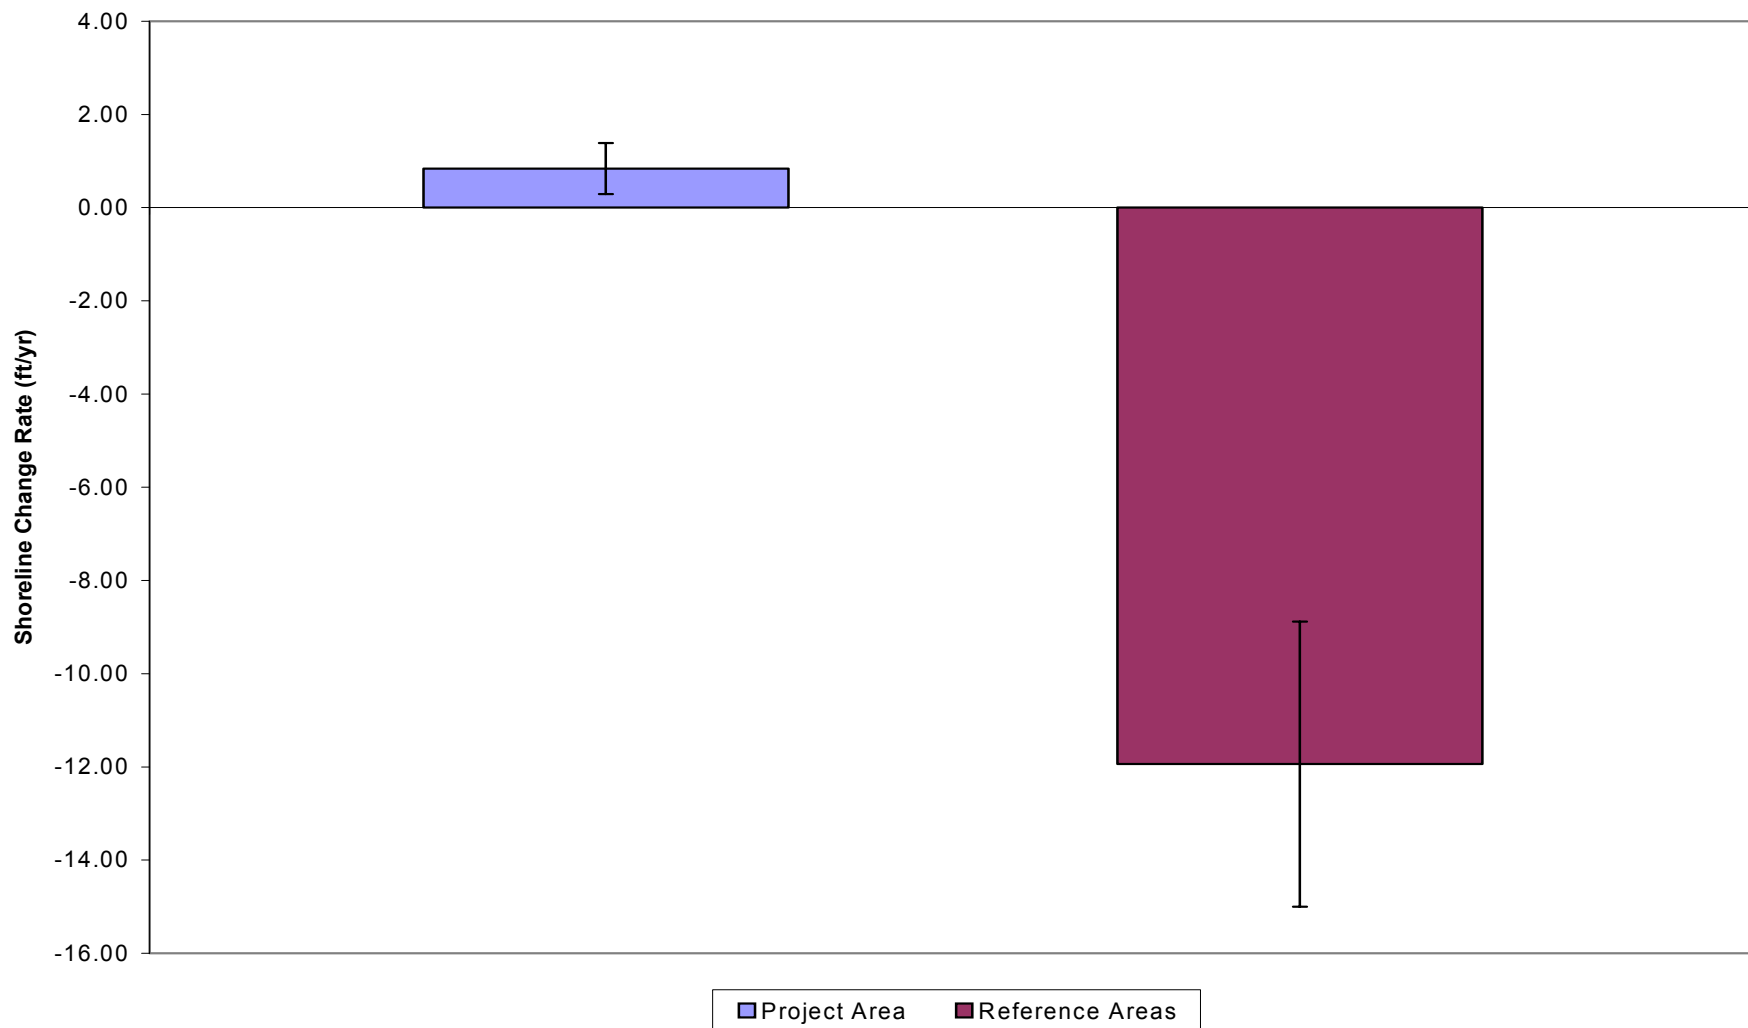
Figure 8. Mean shoreline change rate (ft/yr) along Freshwater Bayou Canal at the ME-13 project and reference area monitoring stations for the July 23, 1998 – July 21, 2003 time period. Error bars represent ± 1 standard error of the mean of all 24 project area and all 6 reference area stations, respectively.

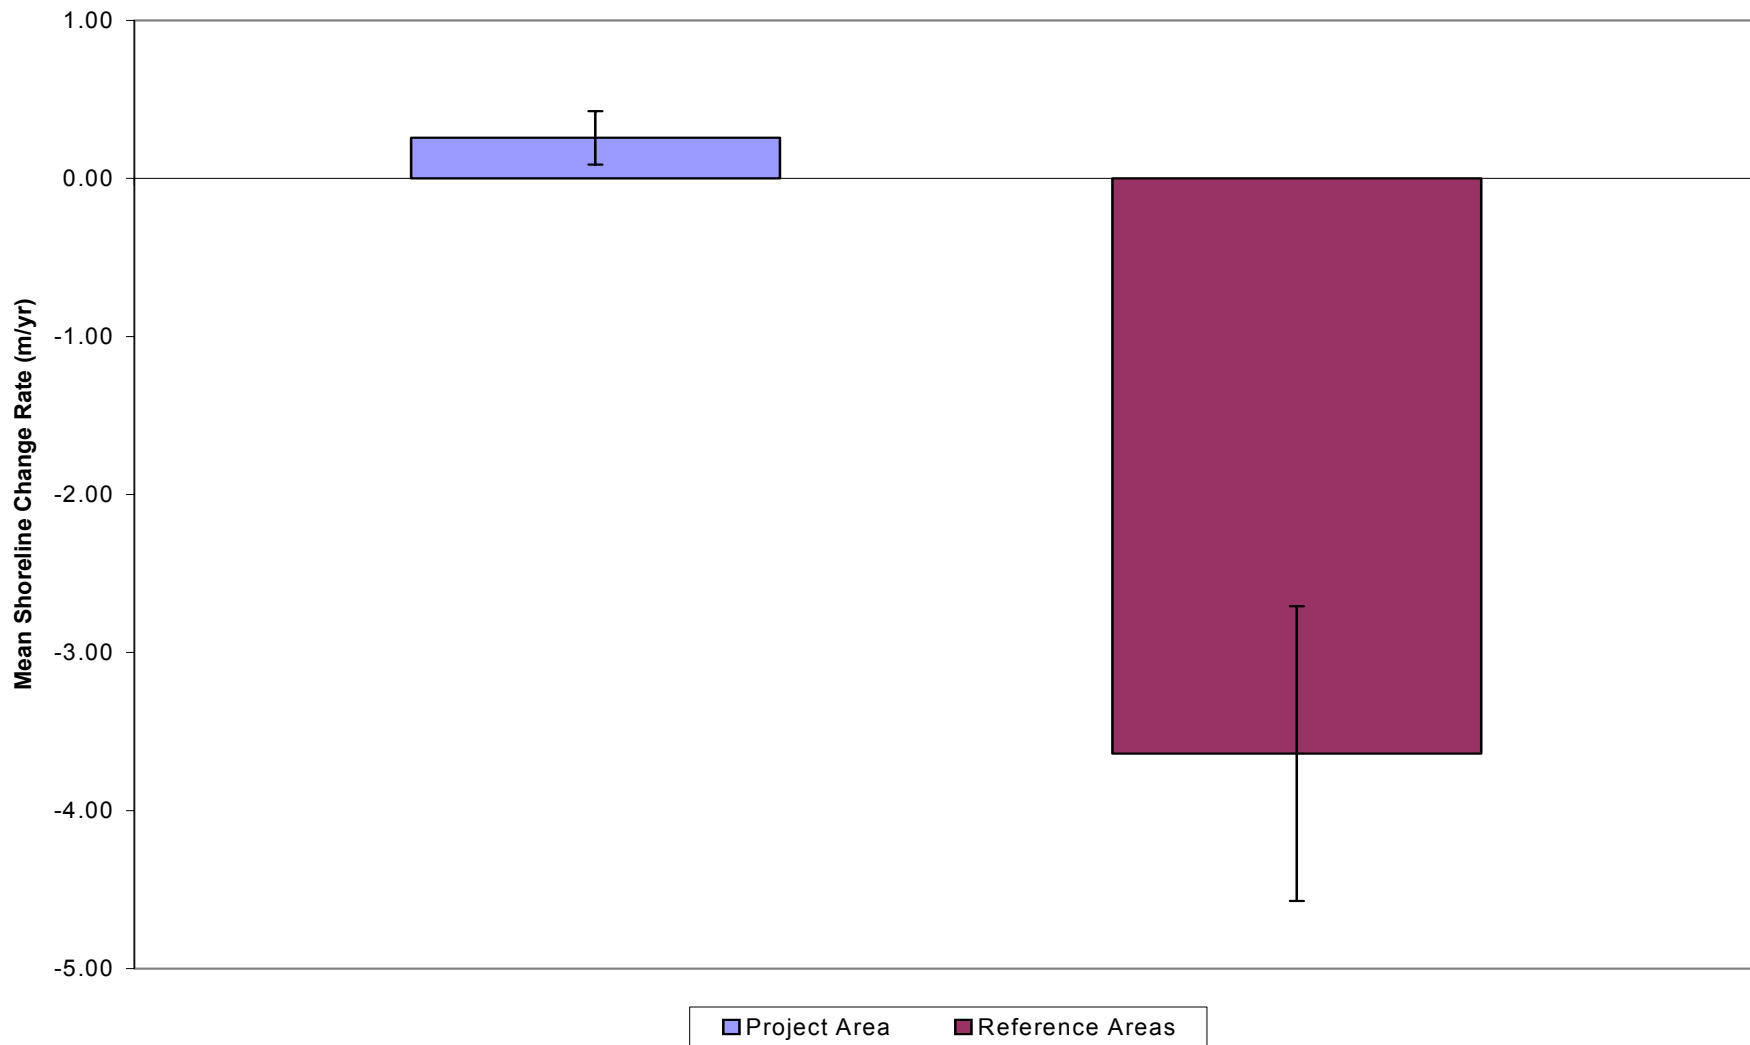
Figure 9. Mean shoreline change rate (m/yr) along Freshwater Bayou Canal at the ME-13 project and reference area monitoring stations for the July 23, 1998 – July 21, 2003 time period. Error bars represent ± 1 standard error of the mean of all 24 project area and all 6 reference area stations, respectively.

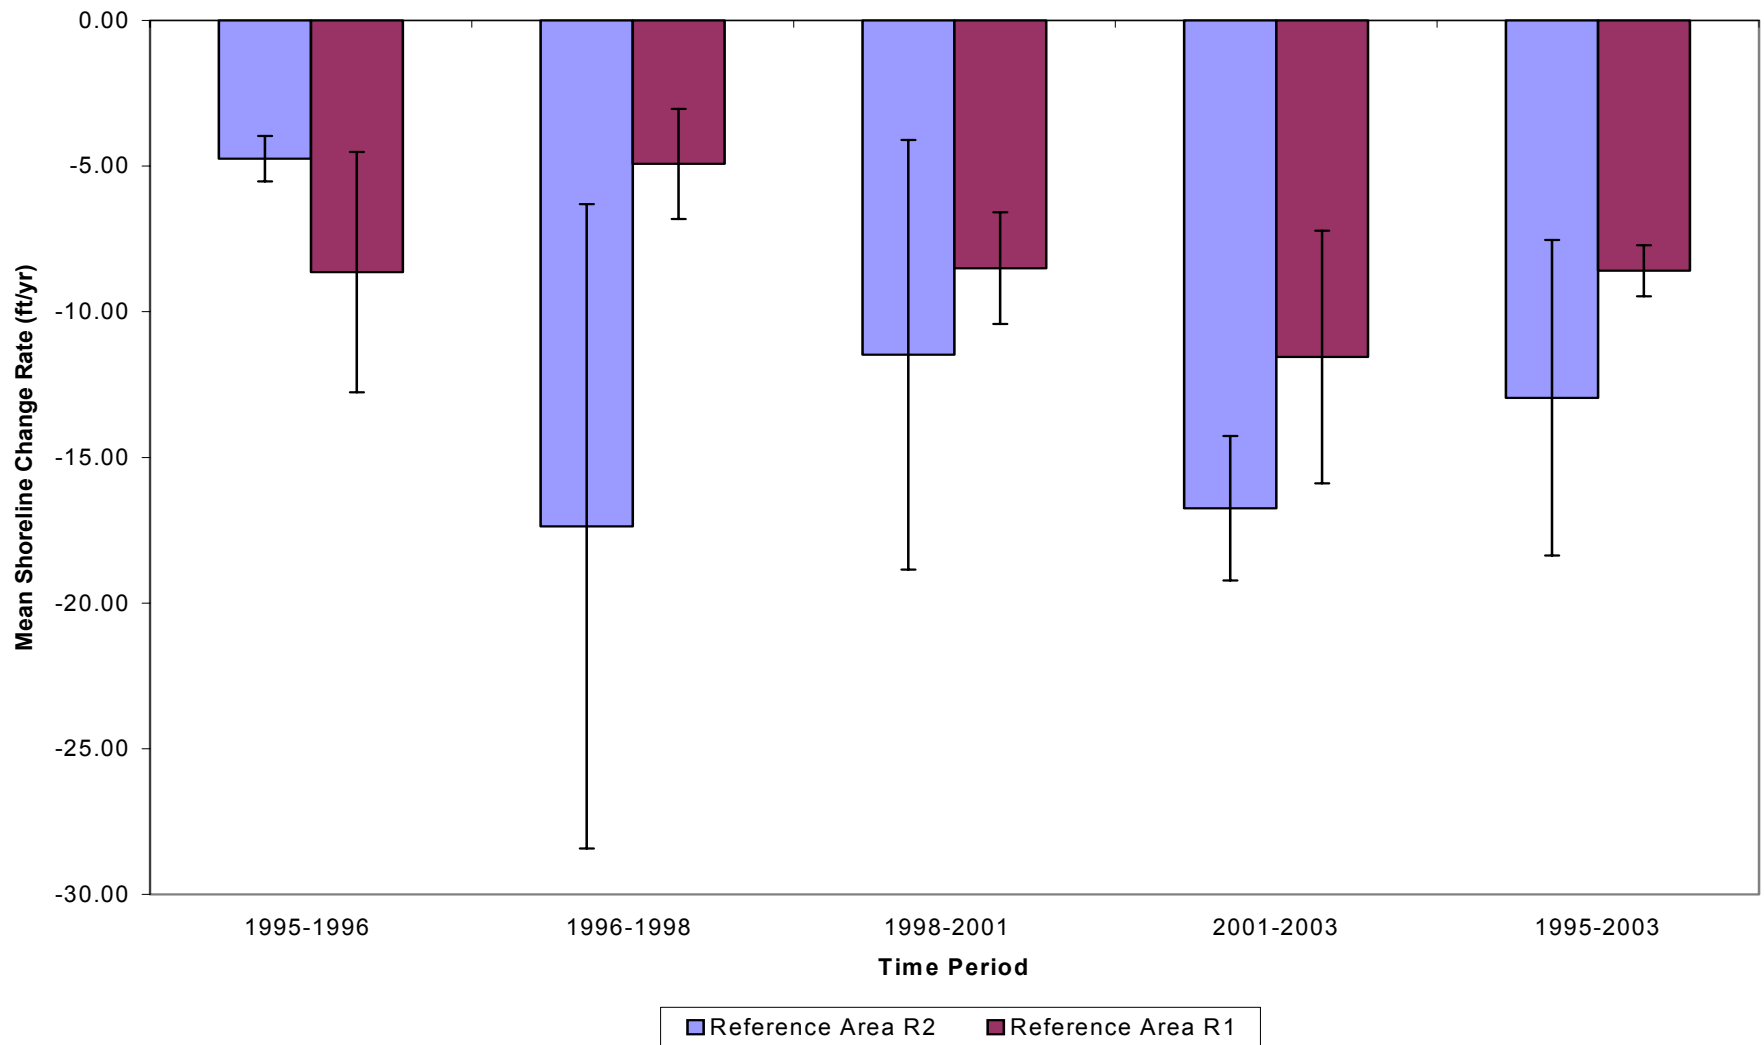
Figure 10. Comparison of mean shoreline change rates (ft/yr) along Freshwater Bayou Canal adjacent to the ME-04 and ME-13 reference areas R1 and R2 shoreline segments for 5 time periods between April 27, 1995 and July 21, 2003. Error bars represent ± 1 standard error of the mean for each reference area for each time period.

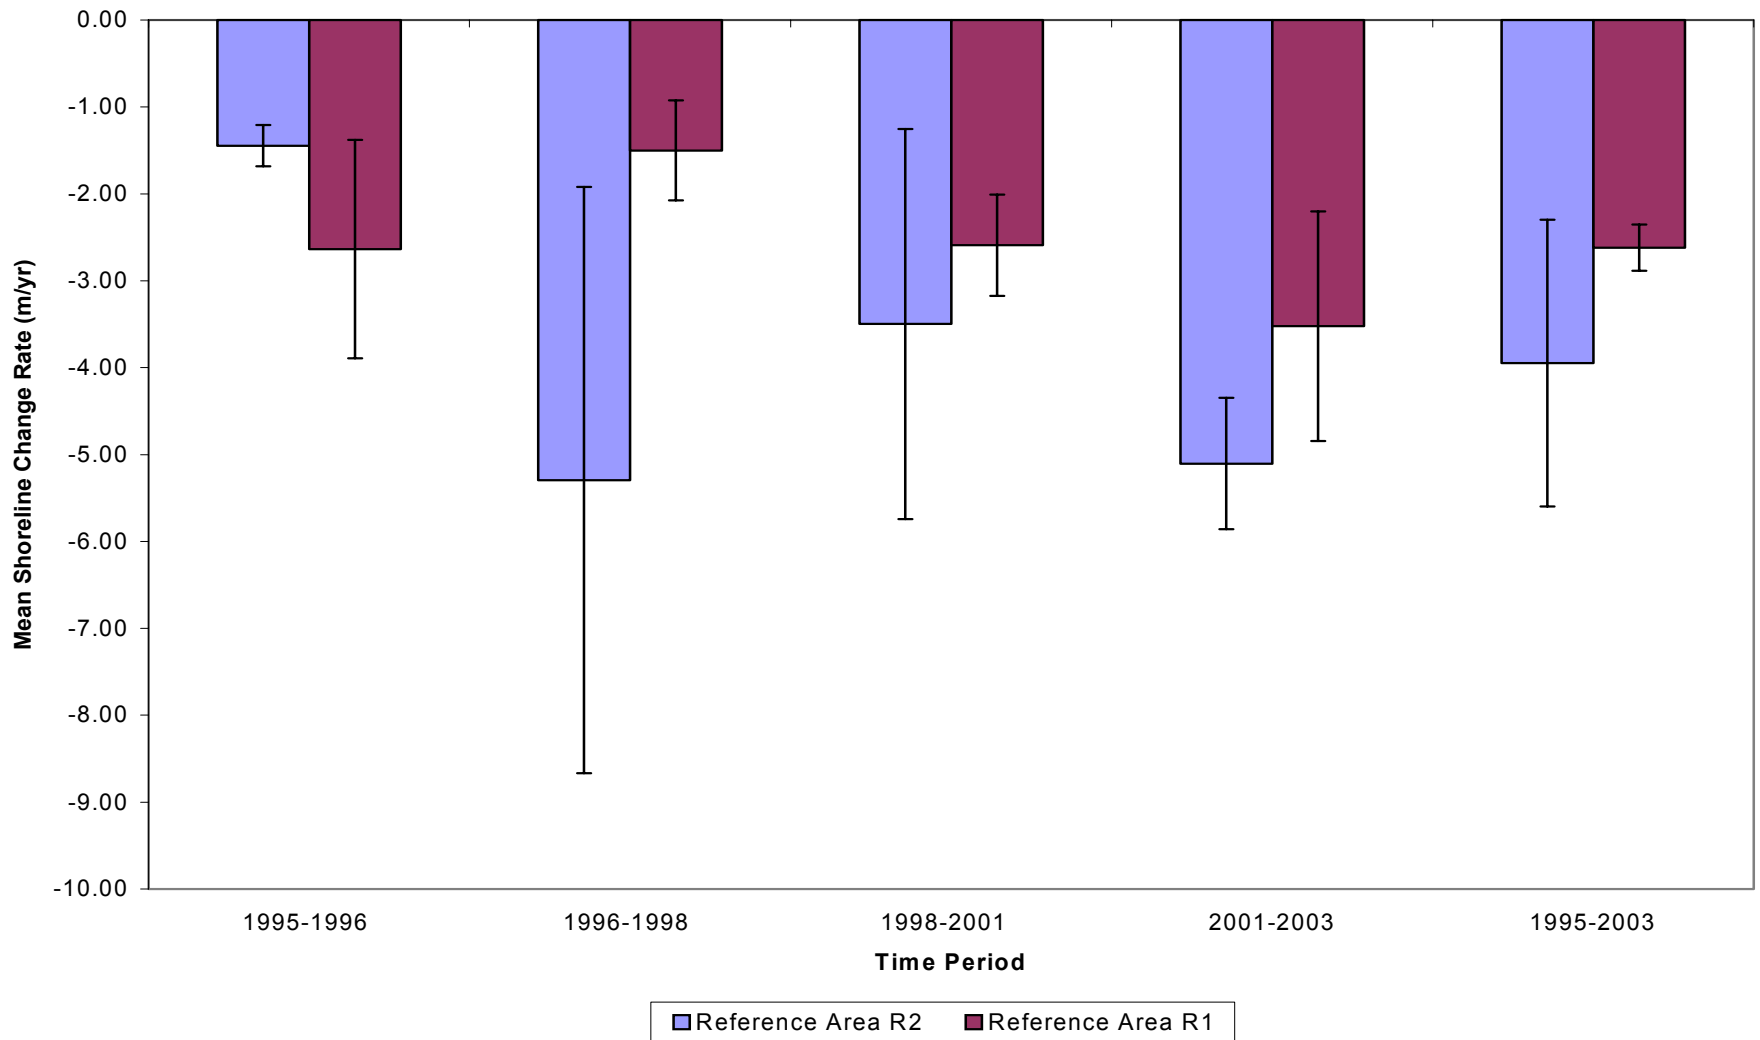
Figure 11. Comparison of mean shoreline change rates (m/yr) along Freshwater Bayou Canal adjacent to the ME-04 and ME-13 reference areas R1 and R2 shoreline segments for 5 time periods between April 27, 1995 and July 21, 2003. Error bars represent ± 1 standard error of the mean for each reference area for each time period.
