**2009 Operations, Maintenance, and
Monitoring Report**

**Boston Canal/Vermilion Bay Shoreline
Stabilization Project (TV-09)**

State Project Number TV-09
Priority Project List 2

June, 2009
Vermilion Parish

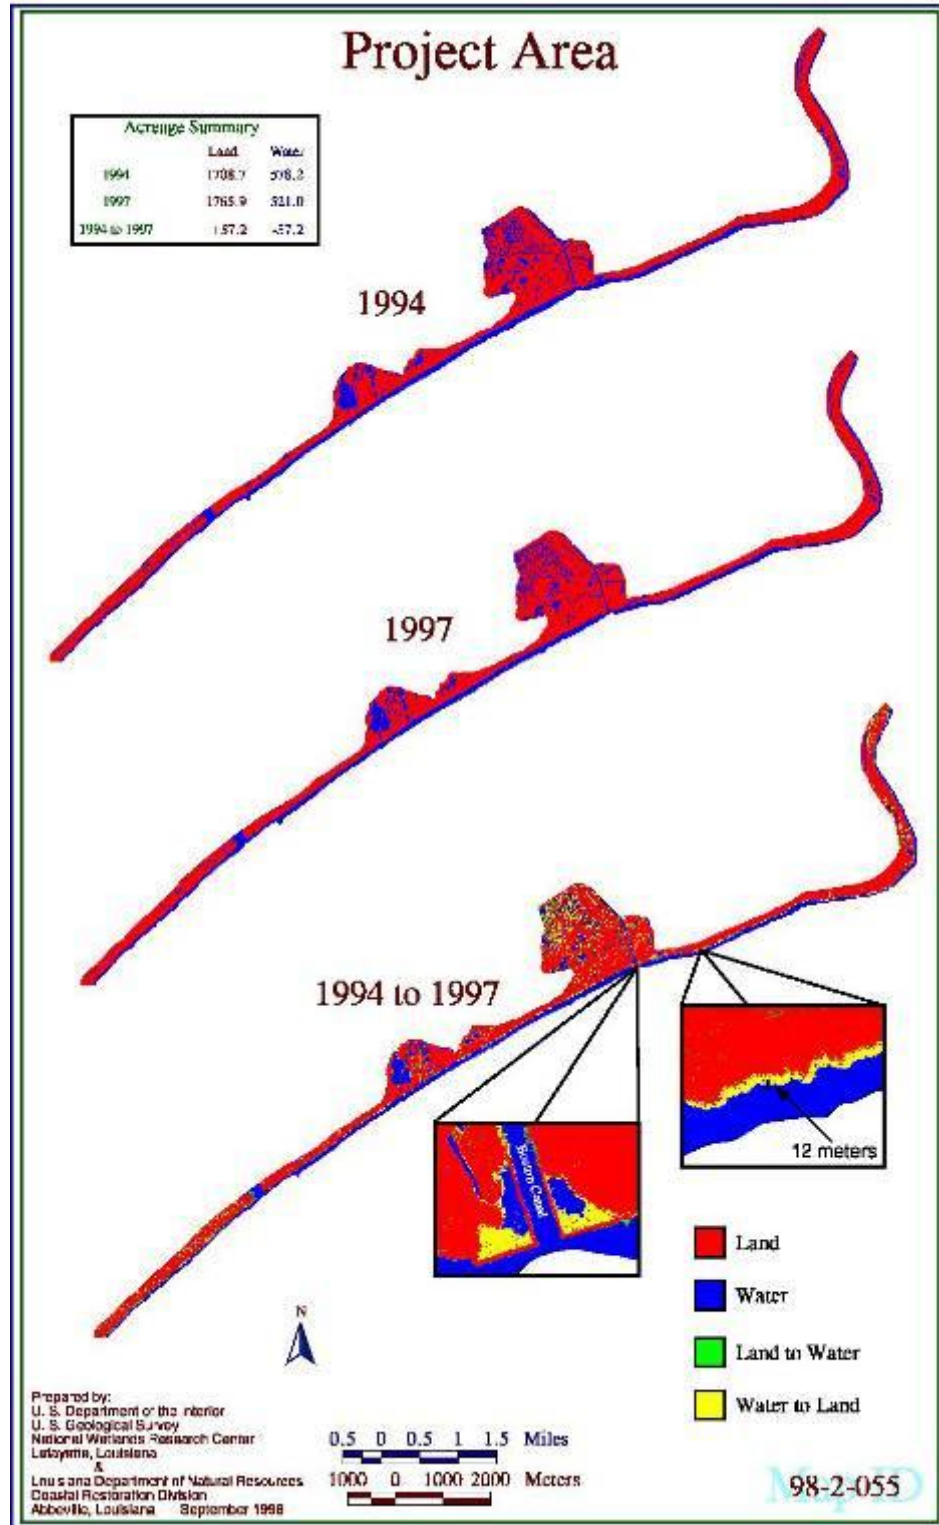
Figure 3. Boston Canal/Vermilion Bay Shoreline Stabilization (T/V-09) GIS Land/Water analysis of project area.

Land/Water analysis of the project area indicated an increase of 57.4 acres (23.2 ha) from 1994 to 1997 (figures 3 and 4). Some of the land gain is in the interior part of the project area, unrelated to project features; however, there were gains in the areas behind the rock dikes and among the plantings on the bay shoreline indicating effective protection and sediment trapping (figure 4). There were no breaches in the shoreline indicating that the interior marsh has remained protected from potential bay wave erosion.

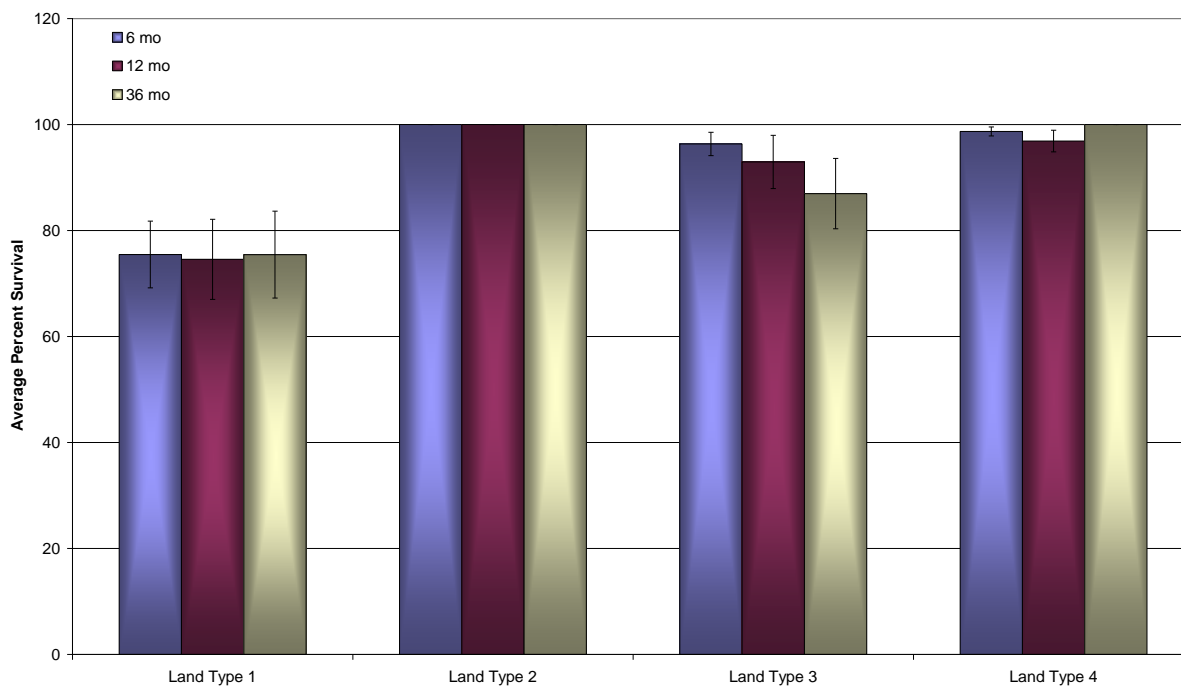
Figure 5. Average percent survival of *Spartina alterniflora* plantings in land types 1-4 observed at 6, 12, and 36 months post planting in 1995, 1996, and 1999 at TV-09 (means \pm SE).

Percent survival of *S. alterniflora* at the 36 month post-planting averaged 90.6 % among all land types (figure 5). The high average percent survival and percent cover of the *S. alterniflora* on the shoreline indicate that the plants have become established (figure 6). Percent survival of *S. alterniflora* at the 36 month post-planting in the high, medium and low *P. australis* coverage was 12.5 %, 62.5 %, and 89.1 %, respectively (figure 7). Percent cover of *S. alterniflora* at the 36 month post-planting in high, medium, and low *P. australis* coverage was 5.6 %, 56.9 %, and 75.9 %, respectively (figure 8). Survivorship and percent cover of *S. alterniflora* was lessened in established stands of *P. australis*. Data collection on vegetation is complete as per the 1999 vegetation survey because individual plants in the plots were indistinguishable. During the 2004 shoreline mapping the vegetation along some of the shoreline was photographed and appeared to be in good condition (figure 9 and 10).
