## **2005/2006 Annual Inspection Report**

### **GRAND-WHITE LAKES LANDBRIDGE PROTECTION PROJECT (ME-19)**

State Project Number ME-19  
Priority Project List 10

October 12, 2005  
Cameron Parish

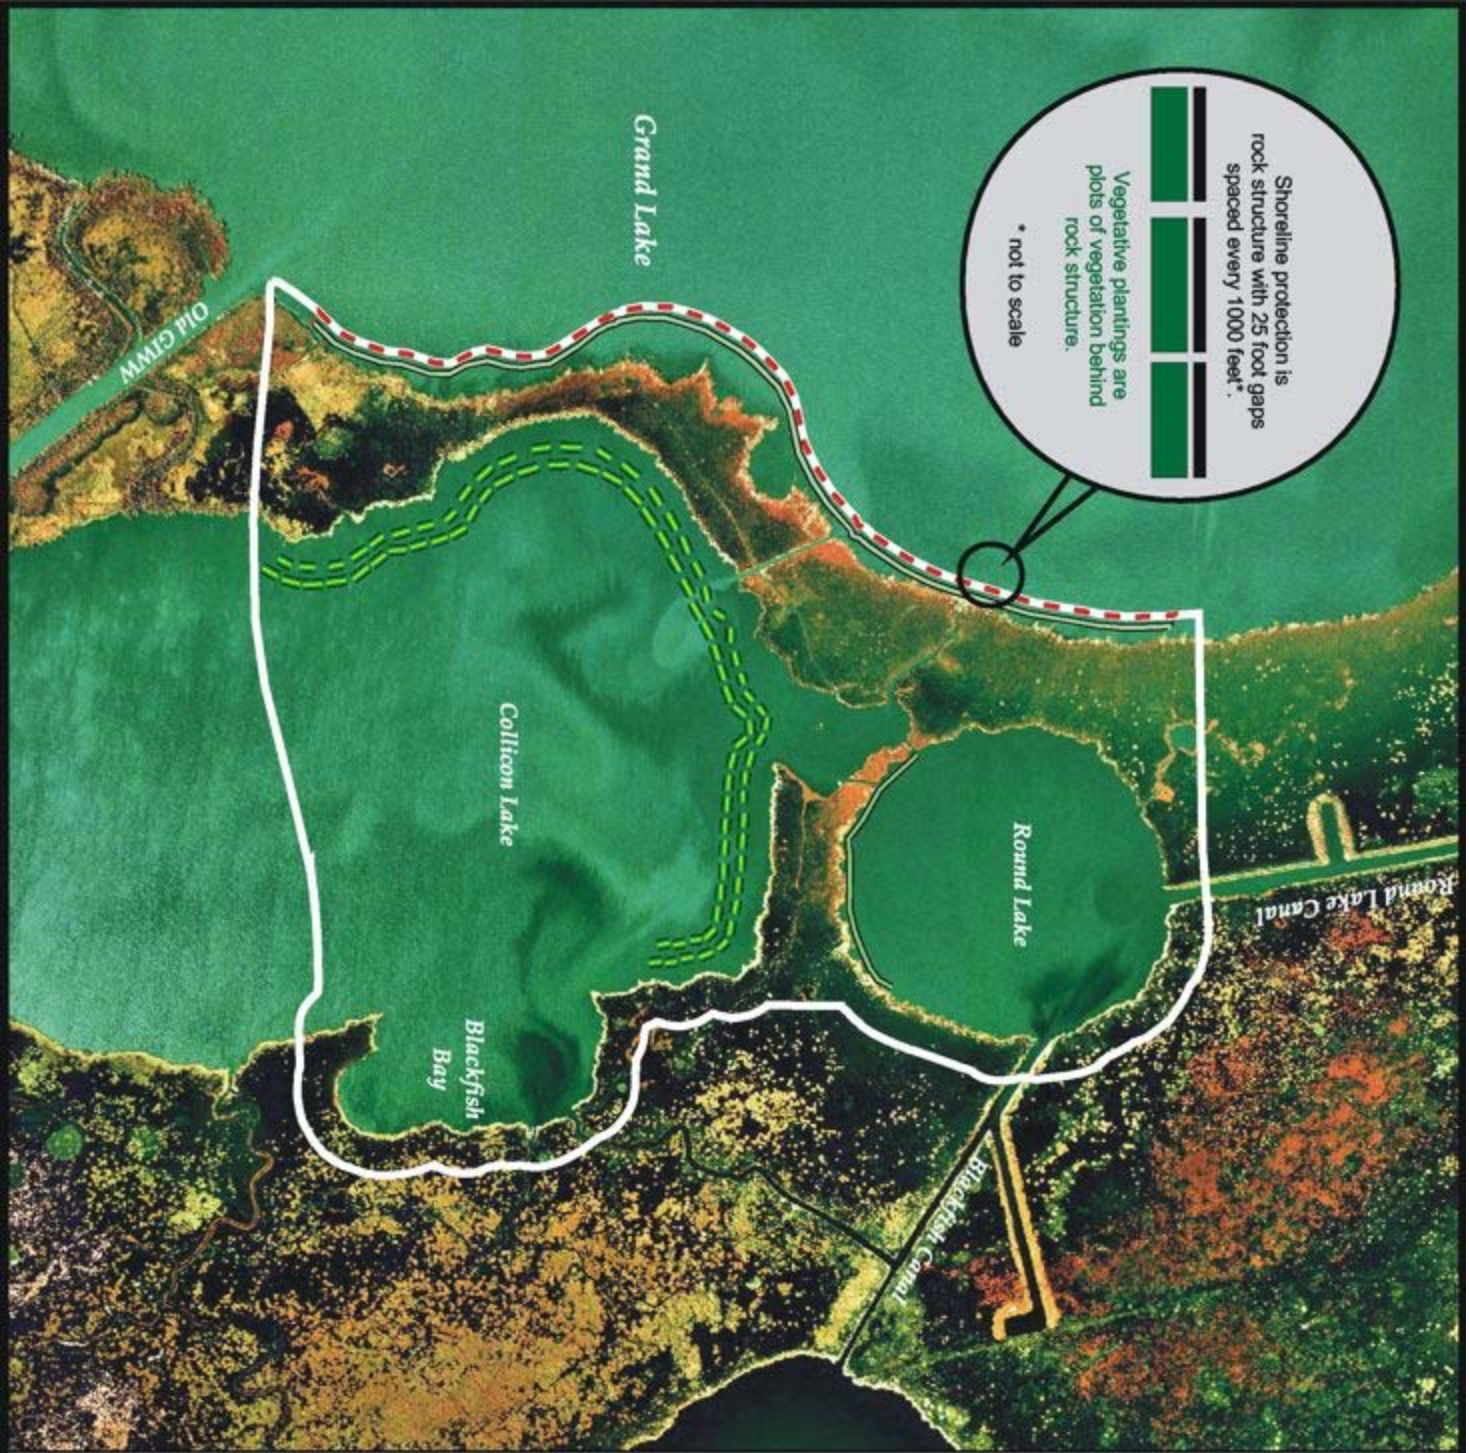
**Appendix A**  
**Project Features Map**

Shoreline protection is rock structure with 25 foot gaps spaced every 1000 feet\*.

Vegetative plantings are plots of vegetation behind rock structure.
