**State of Louisiana
Department of Natural Resources
Coastal Engineering Division**

**2005/2006 Annual Inspection
Report**

**LAKE CHAPEAU HYDROLOGIC
RESTORATION**

State Project Number TE-26
Priority Project List 2

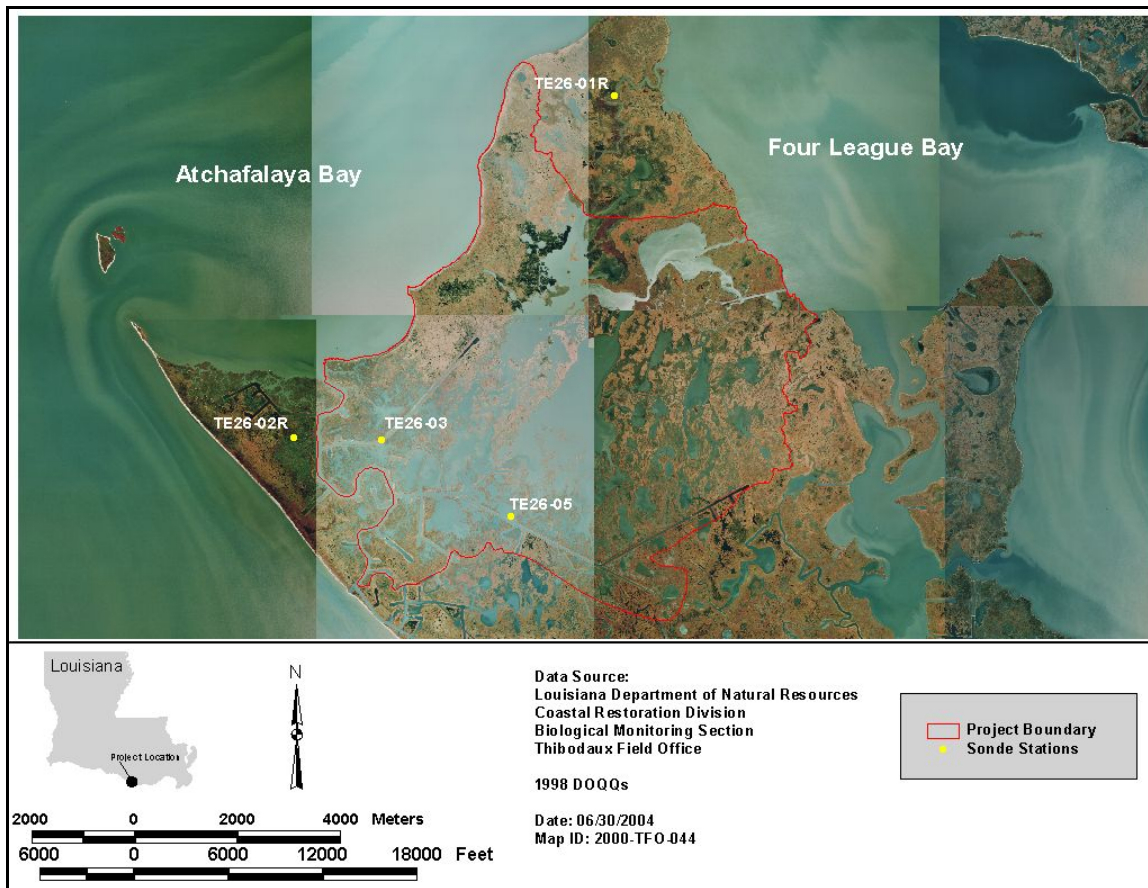
Figure 1: Continuous recorders location associated with the Lake Chapeau Marsh Creation and Hydrologic Restoration (TE-26) project.

During Hurricanes Katrina and Rita, four continuous recorders remained in place and captured the effects of the hurricanes with respect to the salinity and water levels. Figure 1 illustrates the location of the four continuous recorders. Figures 2 and 3 illustrate the salinity and water level response as a result of the passing of the hurricanes.
