**State of Louisiana
Department of Natural Resources
Coastal Restoration Division and
Coastal Engineering Division**

**2007 Operations, Maintenance,
and Monitoring Report**

Cameron Creole Plugs Project

State Project Number CS-17
Priority Project List 1

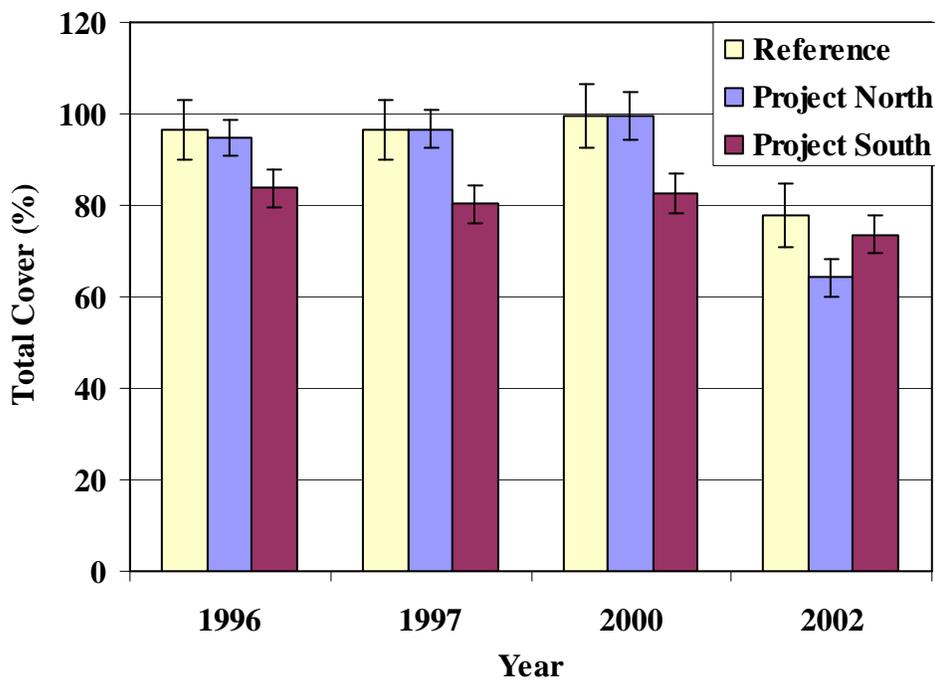
Emergent vegetation surveys were conducted in 1996 pre-construction, and in 1997, 2000, and 2002 post-construction. Species found each year and the frequency each species occurred each year can be found in table 3. Analysis of Variance (ANOVA) of total percent cover over years in the project and reference areas revealed that cover was lower in both the project and reference areas in 2002 than in the other three years (figure 8). Cover decreased in both the project and reference areas, which suggests that the reason for the decline was not the CS-17 project but rather some other factor. The most likely cause of that decrease is water level but it could be a combination of factors. Note that total cover is skewed and does not meet the assumptions of ANOVA.

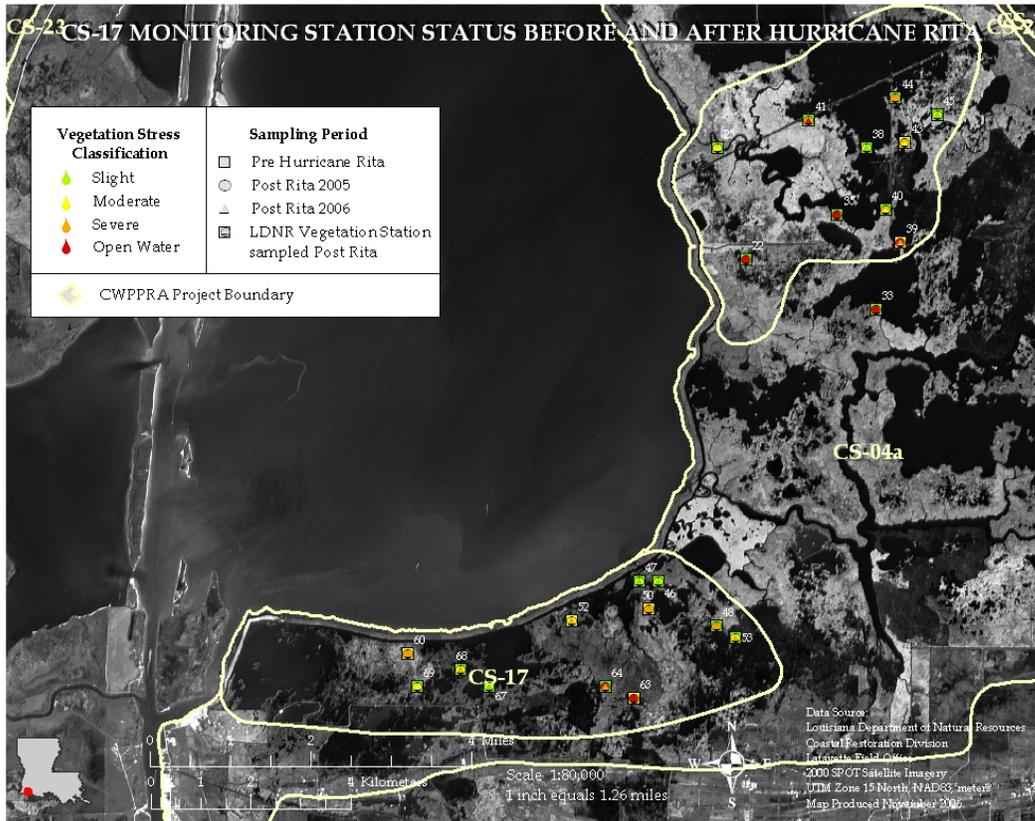
Figure 9. Location and status of CS-17 vegetation stations sampled after Hurricane Rita.

In the CS-17 project area, 24 stations were randomly chosen from the available stations, 12 in the northern project area and 12 from the southern project area (figure 9). In the last sampling before Rita (2002), the vegetation was broken but was not highly stressed (figure 10). In 2005, 60% of the stations had either turned to open water or were severely stressed. By 2006, the area had recovered slightly but 60% of the stations remained open water or severely stressed; 20% of the stations recovered to only slightly stressed. Total cover dropped to below 20% in 2005 and remained below 20% in 2006 (figure 11). Species richness recovered to pre-storm levels (about 2 species per plot) (figure 12).

The vegetation in the area remains highly stressed and the marsh is becoming more and more broken. The entire area may convert to open water if restoration attempts are not made. The levee south of Calcasieu Lake needs to be repaired and elevation needs to be restored. The area would make a good candidate for spray dredge applications.

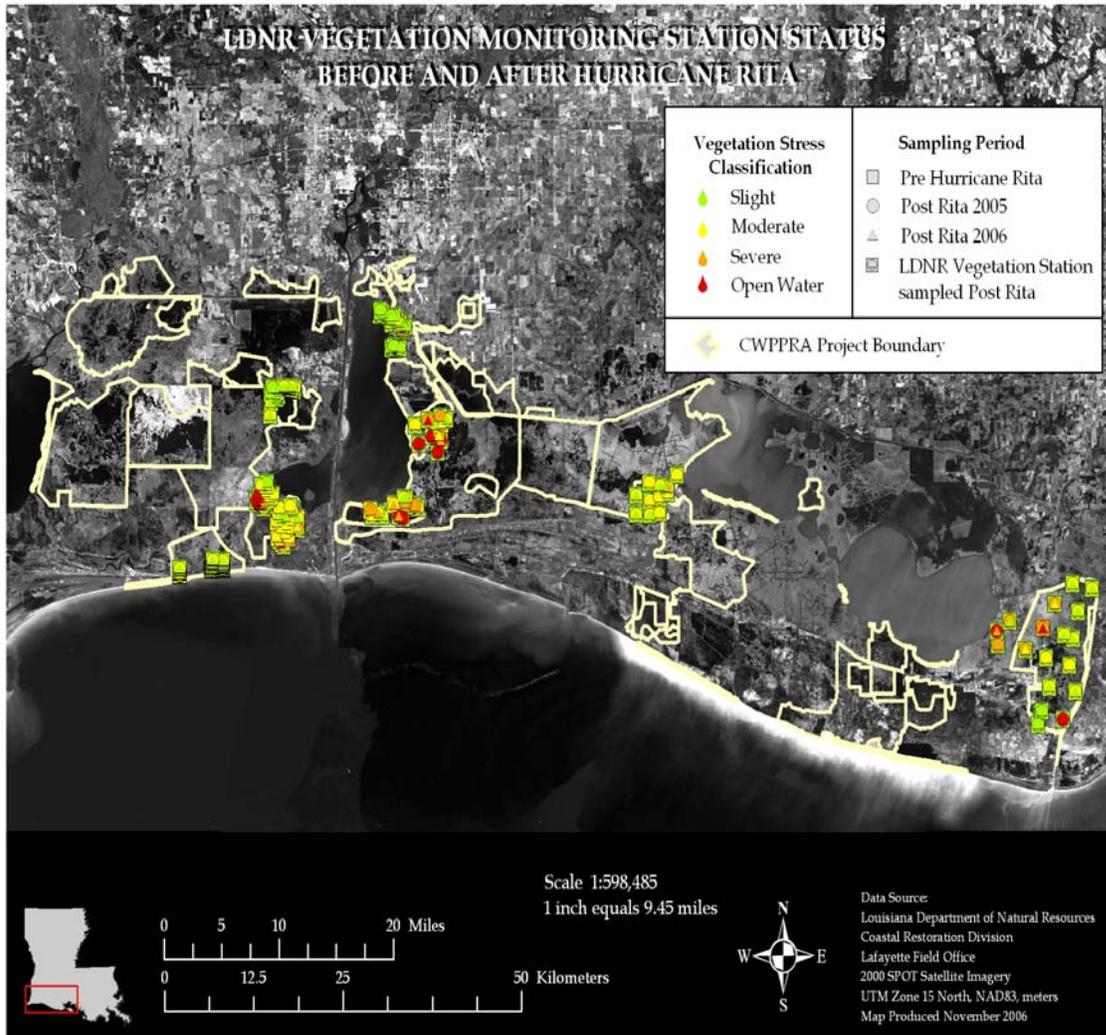
Figure 1. Location and status of LDNR vegetation stations sampled after Hurricane Rita. Stations were classified according to storm-induced stress as described in Table 1.

Prior to Hurricane Rita, most of the vegetation stations utilized for this survey were healthy and intact (>80%). Following the hurricane in 2005, most of the stations were stressed (67%) or worse (20%). A year later in 2006, over 50% of the stations were back to pre-storm stress levels. Severely stressed stations either converted to open water or recovered to a less stressed state. Most stations that had been converted to open water in 2005 did not recover (Figures 1 and 2).

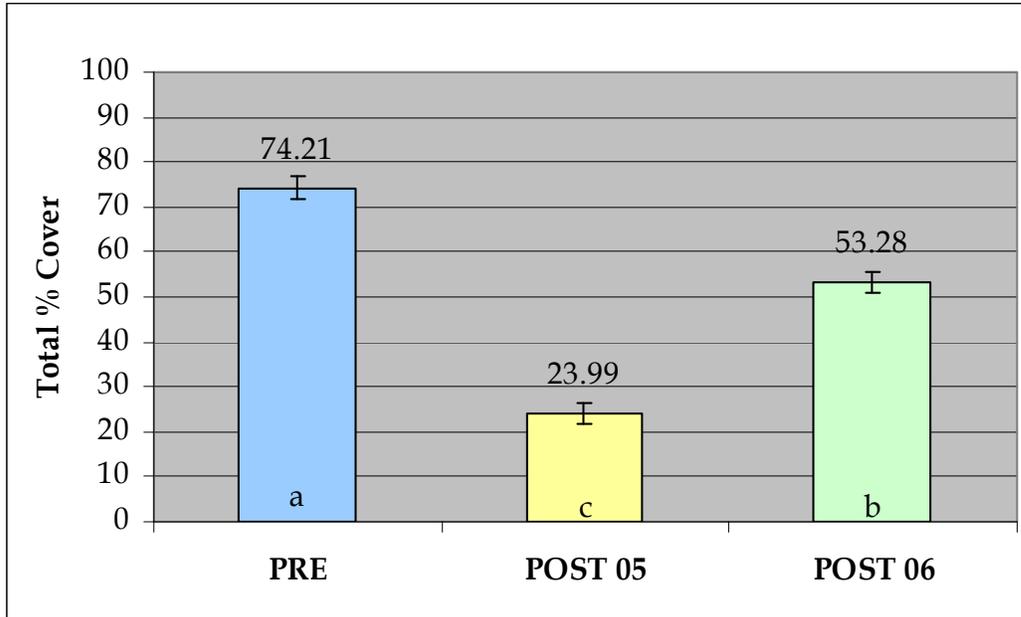
Figure 3. Total % Cover Pre- and Post-Hurricane Rita. LS Mean \pm SE, n=163 stations, $F_{2, 488}=109.7$, $p<0.0001$. Levels not connected by same letter are significantly different.

Total % Cover was significantly different over time (Figure 3). Post-ANOVA comparisons (Tukey's HSD) revealed that all three sampling periods were significantly different meaning Total % Cover for 2006 is still significantly lower than Pre-Rita levels. Species Richness was also significantly different over the three sampling periods (Figure 4). The number of species present before Rita and in 2006 were statistically the same.
