**2007 Operations, Maintenance,
and Monitoring Report**

**Humble Canal Hydrologic
Restoration**

State Project Number ME-11
Priority Project List 8

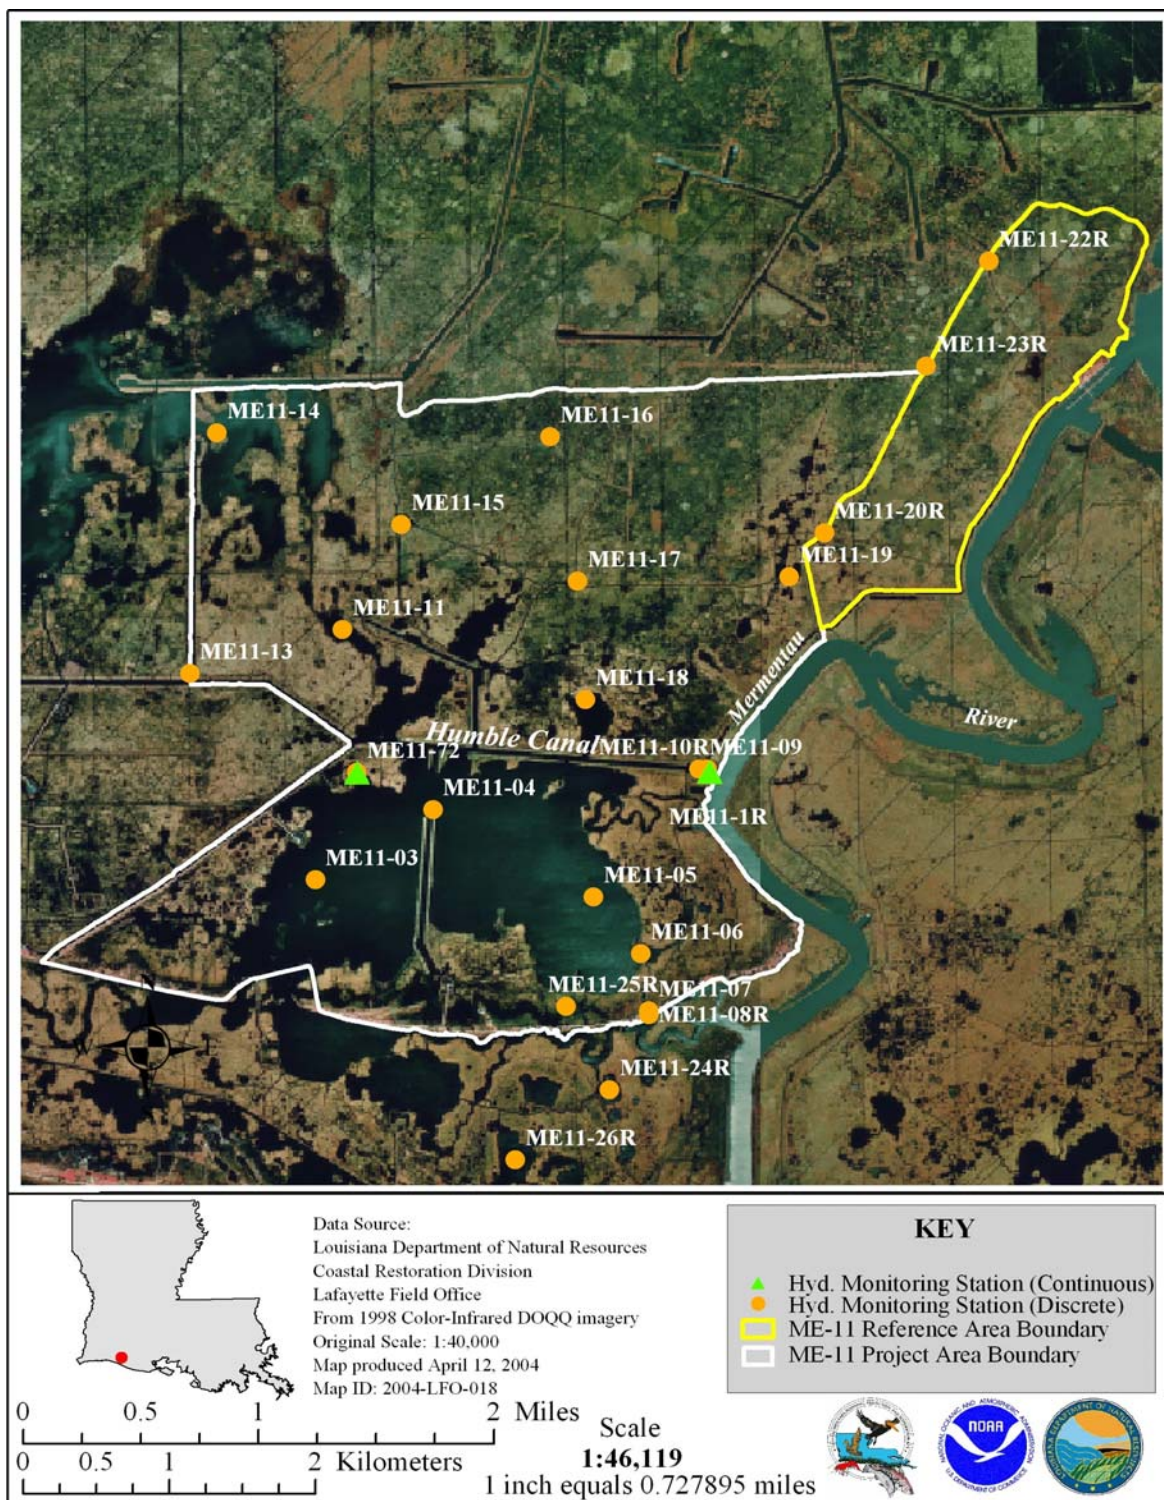
Figure 2. ME-11 project area with locations of continuous data recorders and discrete sampling stations.

To monitor water levels, continuous recorders and staff gauges were deployed in the project area and in the Mermentau River (figure 2). The project area recorder was removed in April 2004 and the reference recorder (ME11-01R) was maintained. Data from CRMS0624 is available in the project area and nearby CRMS0605 will be used as a reference. Water level relative to marsh will be used to assess the proportion of time water levels were within the target range.

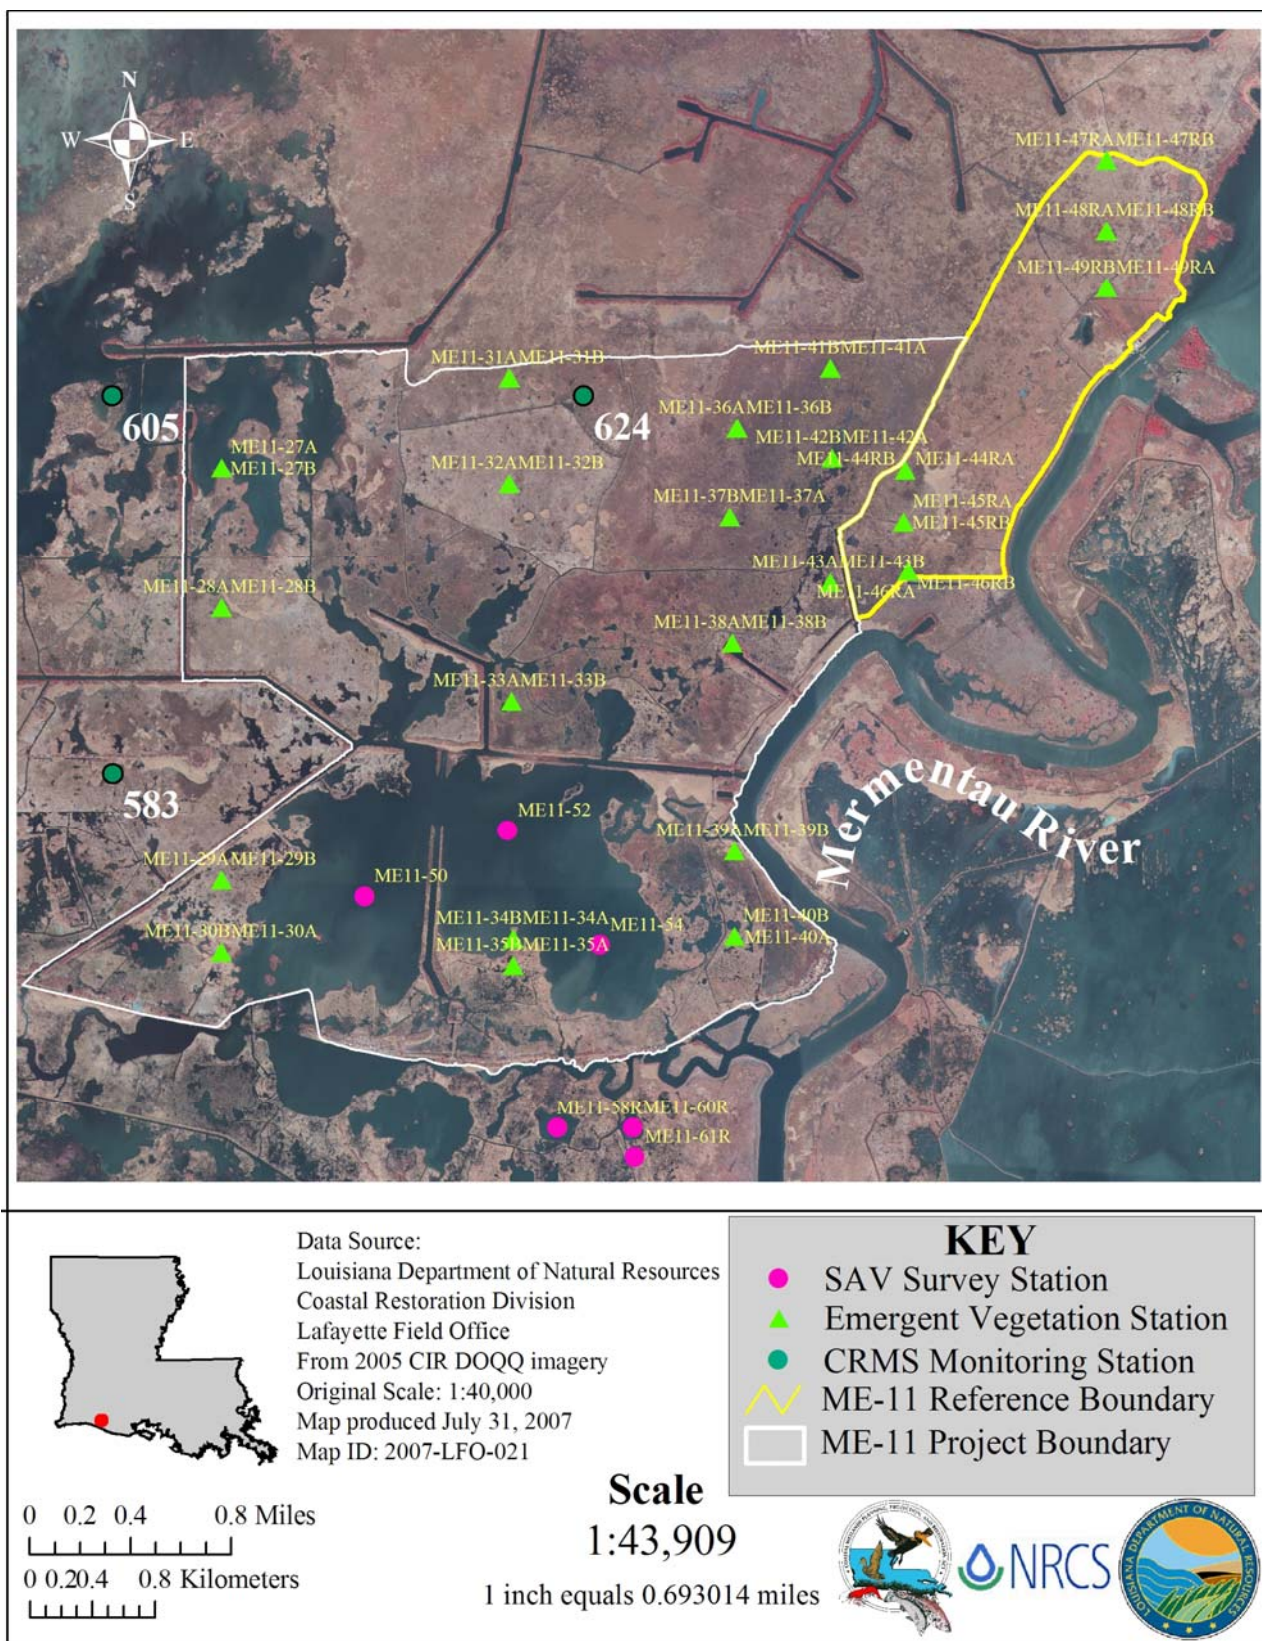
Figure 3. Location of emergent vegetation and SAV monitoring stations.

To document the condition of emergent vegetation in the project area over the duration of the project, vegetation was monitored at sampling stations (figure 3) established systematically in the project and reference area using a modified Braun-Blanquet sampling method as outlined in Steyer et al. (1995). Four north-south transects were established uniformly across the project area and sampling stations were established uniformly along each transect line to obtain an even distribution throughout the project area. Two north-south transects were delineated across reference area # 1 to establish the sampling stations. Percent cover, dominant plant height, and species composition were documented in 4 m² sampling plots marked with two corner poles to allow for revisiting the sites over time. Vegetation was evaluated at the sampling sites in the fall of 2000 (pre-construction) and in the fall of 2003 (post-construction). Future vegetation sampling will be conducted through CRMS-*Wetlands*.

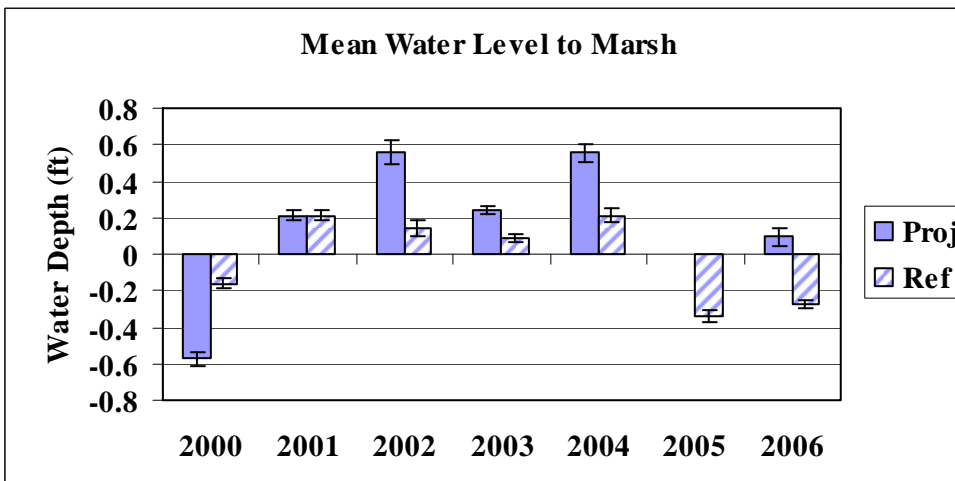
Figure 8. Mean daily water depth relative to marsh surface by year in the ME-11 project and reference areas.

It should be noted that the pre-construction period was six months in 2000 (May through October), which was during an extreme drought. It is not surprising that water levels were rarely $> 6''$ above the marsh and were often $> 2''$ below the marsh pre-construction (figure 8). It is difficult to definitively assess project effectiveness under these conditions.

The project appears to be maintaining (but not increasing) the land water ratio and the cover of emergent marsh vegetation. The goal of maintaining salinities within the target range for fresh emergent marsh vegetation was attained; however, mean water levels in the project area were above the target range more often after construction compared to the reference area (figure 8). The frequency of occurrence of SAV increased in both the project and reference areas.

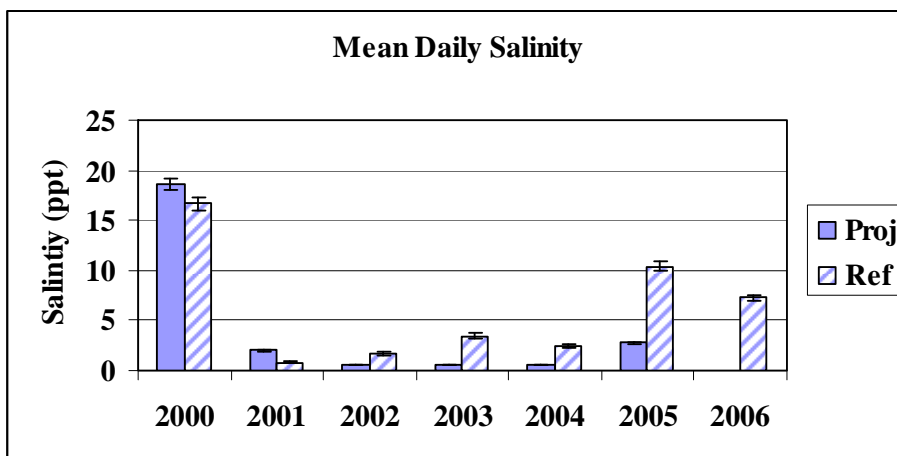
Figure 12. Mean daily salinity by year in the ME-11 project and reference areas.

In addition to the target range analyses, daily mean salinity was compared pre- and post-construction in the project and reference areas using ANOVA. The model included sampling area, time, stations nested within sampling area, and the interaction between sampling area and time. The overall model was significant but more importantly, the interaction between area and time was significant (figure 11). Salinity pre-construction was around 18 ppt in both the project and reference area (due to the drought). Mean daily salinities post-construction were 1.2 ppt in the project area and 4.7 ppt in the reference area. Salinities remained low post-construction until 2005 and 2006, when they increased in the reference area but not the project area (figure 12).

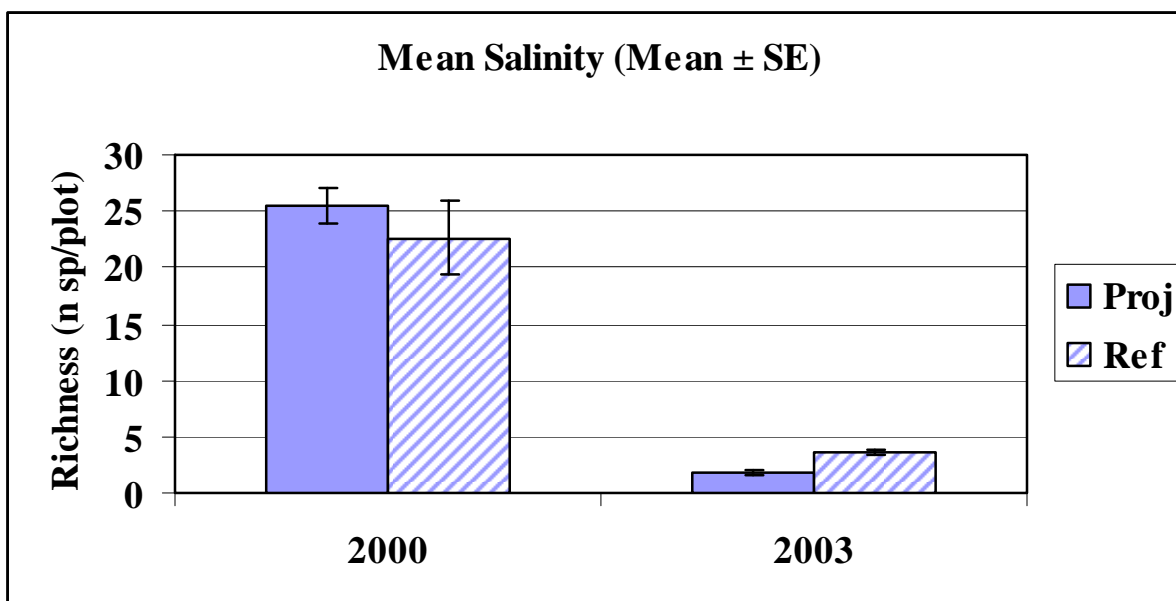
Figure 16. Mean salinity during SAV sampling in the project and reference area.

Mean salinities recorded during SAV sampling in both the project and reference areas were greater than 20 ppt in 2000 but did not exceed 5 ppt in 2003 (figure 16). In the reference area, the salt-tolerant *Ruppia maritima* (widgeon grass) comprised approximately 70% of the cover in 2000 and was absent in 2003. The fresh-to-intermediate species *Potamogeton pusillus* (baby pondweed) comprised 70% of the cover in 2003.

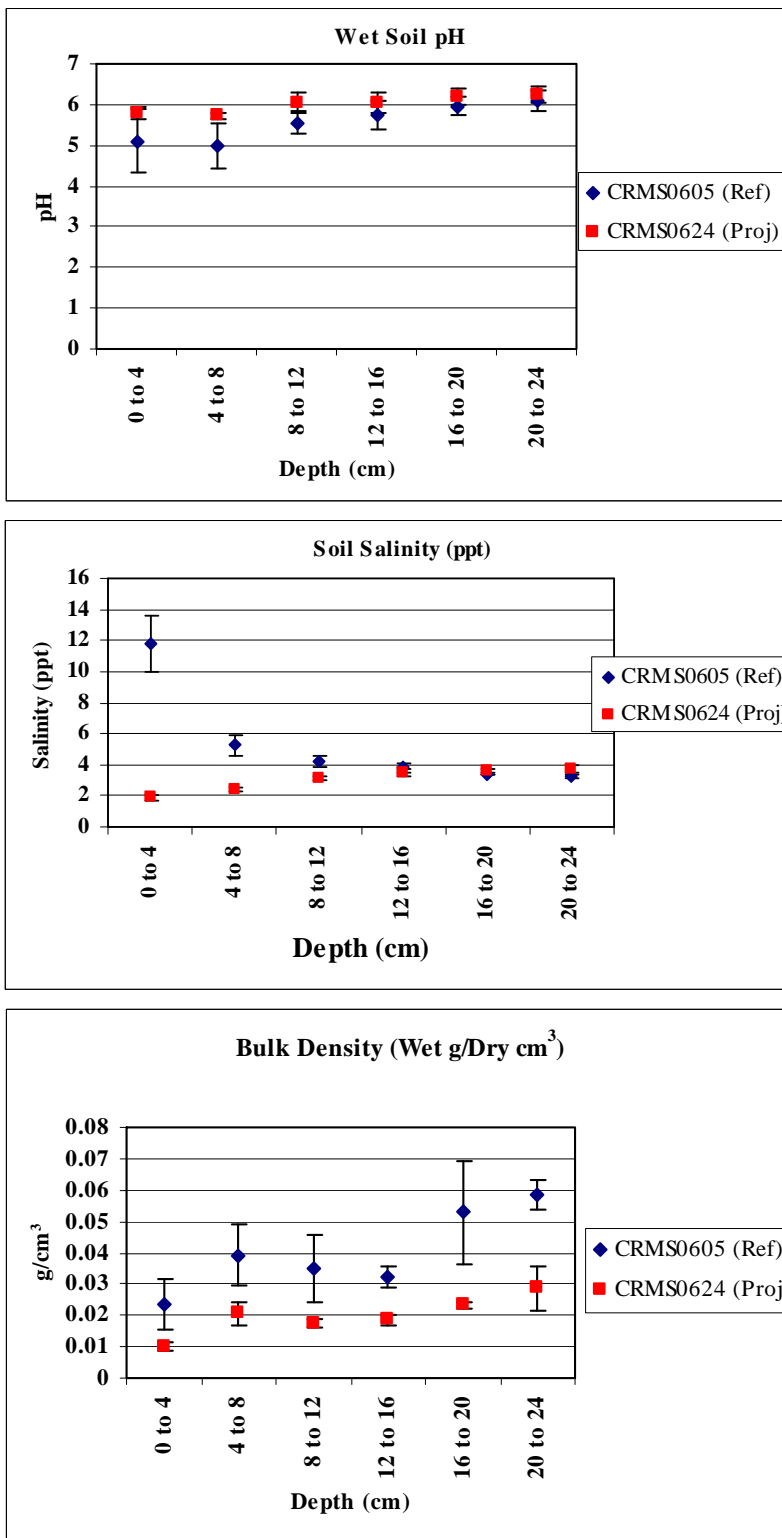
Figure 17. Soil Bulk pH, salinity, and bulk density at CRMS0605 and 0624.

Soil core data from the project site CRMS0624 and the reference site CRMS0605 were collected in November and May of 2006, respectively. The three cores collected from each site were summarized for pH, soil salinity, and bulk density by depth (figure 17). Both sites were acidic with soil pH from 5 to 6. Soil salinity at the reference site was higher in the surface sections than in the deeper sections. Both sites are organic down to 24 cm though the reference site is slightly more mineral than the reference site.

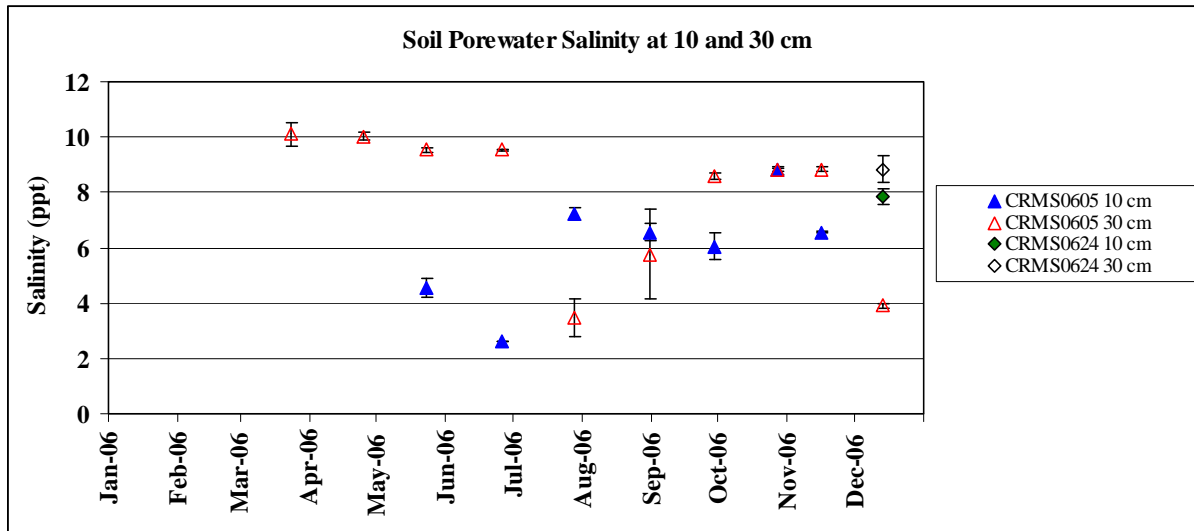
Figure 18. Porewater salinities at 10 and 30 cm at CRMS0624 and CRMS0605.

Porewater salinities are available from CRMS0624 and 605. CRMS0605 is available from May to December 2006 and CRMS0624 is available from December 2006. Salinities at 30 cm are almost always several ppt higher than salinities at 10 cm (figure 18).

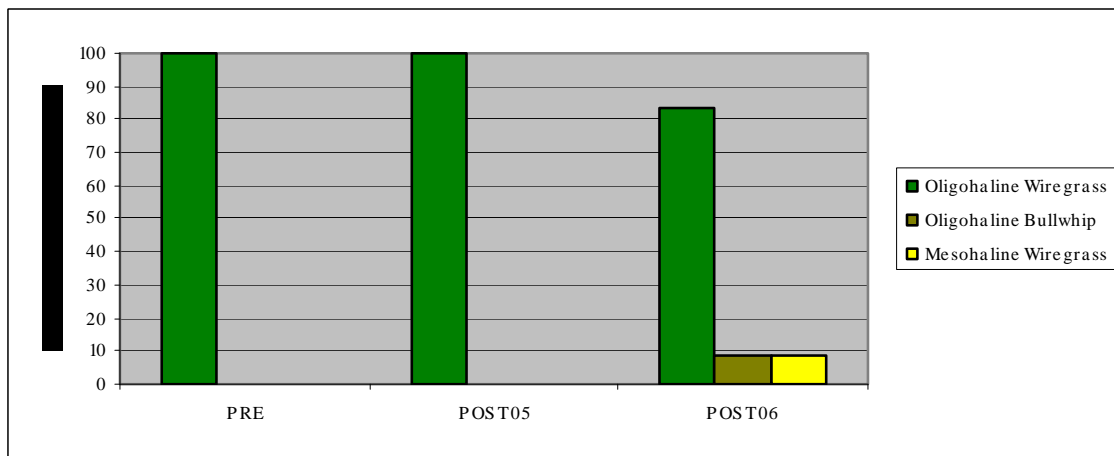
Figure 22. Percent of ME-11 vegetation stations in each Visser vegetation type before and after Hurricane Rita (n=23).

The subset of stations were also classified according to their Visser vegetation type (Visser et al. 2000) of which three were used to classify vegetation in the ME-11 Project area; Oligohaline Wiregrass, which is dominated by *Spartina patens*, Oligohaline Bullwhip, which is dominated by *Schoenoplectus californicus*, and Mesohaline Wiregrass, which is co-dominated by *Spartina patens* and *Schoenoplectus americanus*. In 2003 and 2005, all of the stations were classified as Oligohaline Wiregrass. In 2006, Oligohaline Bullwhip and Mesohaline Wiregrass had appeared (figure 22).

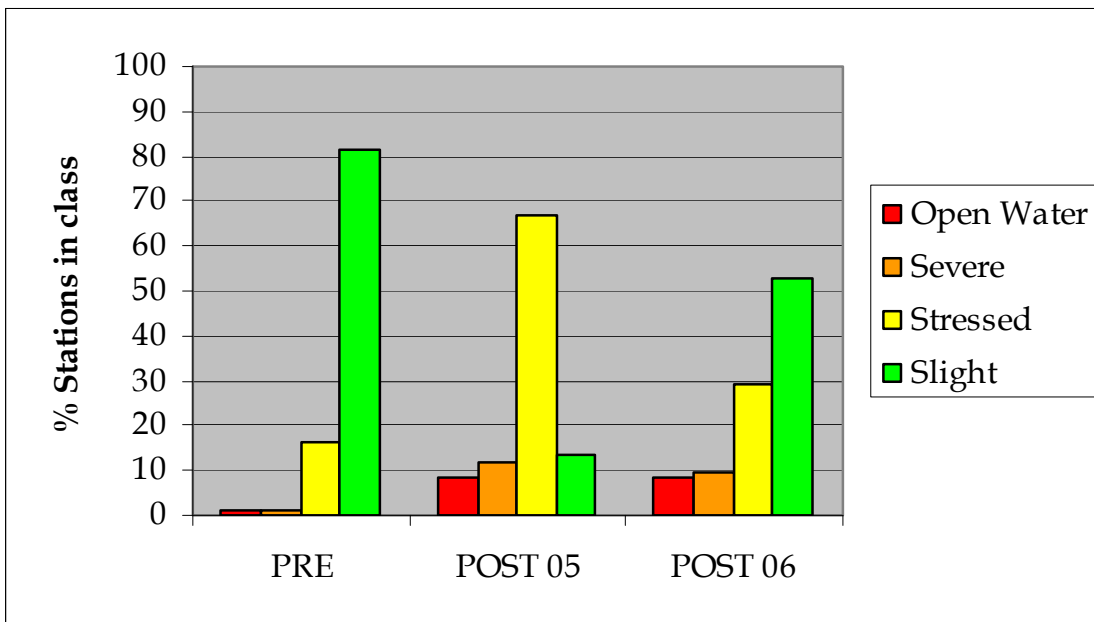
Figure 2. Percent of LDNR vegetation stations in each stress class before and after Hurricane Rita (n=163).

Prior to Hurricane Rita, most of the vegetation stations utilized for this survey were healthy and intact (>80%). Following the hurricane in 2005, most of the stations were stressed (67%) or worse (20%). A year later in 2006, over 50% of the stations were back to pre storm stress levels. Severely stressed stations either converted to open water or recovered to a less stressed state. Most stations that had been converted to open water in 2005 did not recover (Figures 1 and 2).

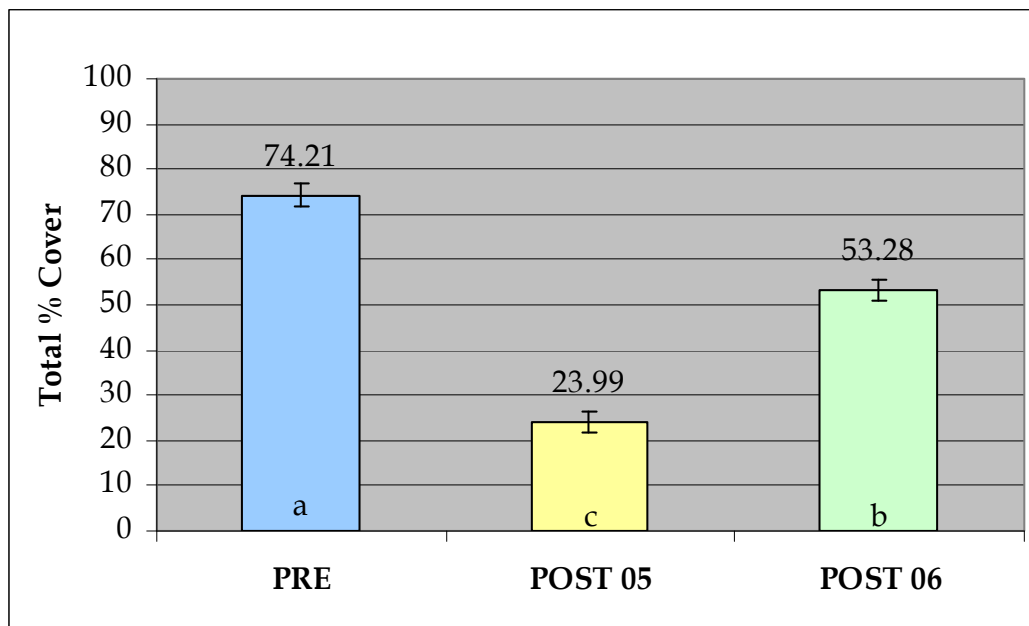
Figure 3. Total % Cover pre- and post-Hurricane Rita. LS Mean \pm SE, n=163 stations, $F_{2, 488}=109.7$, $p<0.0001$. Levels not connected by same letter are significantly different.

Total % Cover was significantly different over time (Figure 3). Post-ANOVA comparisons (Tukey's HSD) revealed that all three sampling periods were significantly different meaning Total % Cover for 2006 is still significantly lower than Pre-Rita levels. Species Richness was also significantly different over the three sampling periods (Figure 4). The number of species present before Rita and in 2006 were statistically the same.

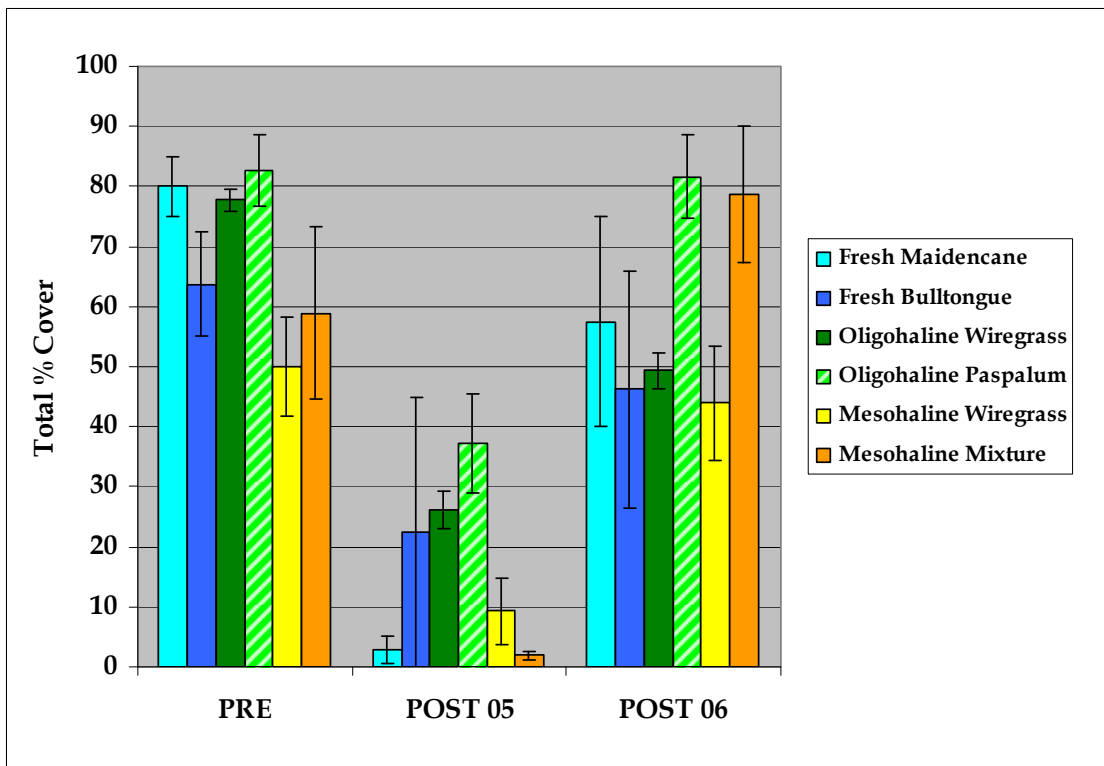
Figure 5. Total % Cover by Visser Vegetation Type. LS Mean \pm SE, n=163 stations, $F_{17, 488}=17.0$, $p<0.0001$.

Visser Type was added to the overall model and the interaction between Visser Type and time was analyzed. Both models had significant differences in Visser Type over time (Figures 5 and 6). Post-ANOVA contrasts of Cover and Richness Pre-Rita and Post 06 for each Visser Type revealed that all Visser Types were the same in Total Cover (had recovered to pre-storm levels) and in Richness except Fresh Bulltongue (mostly in the ME-04 project area) which

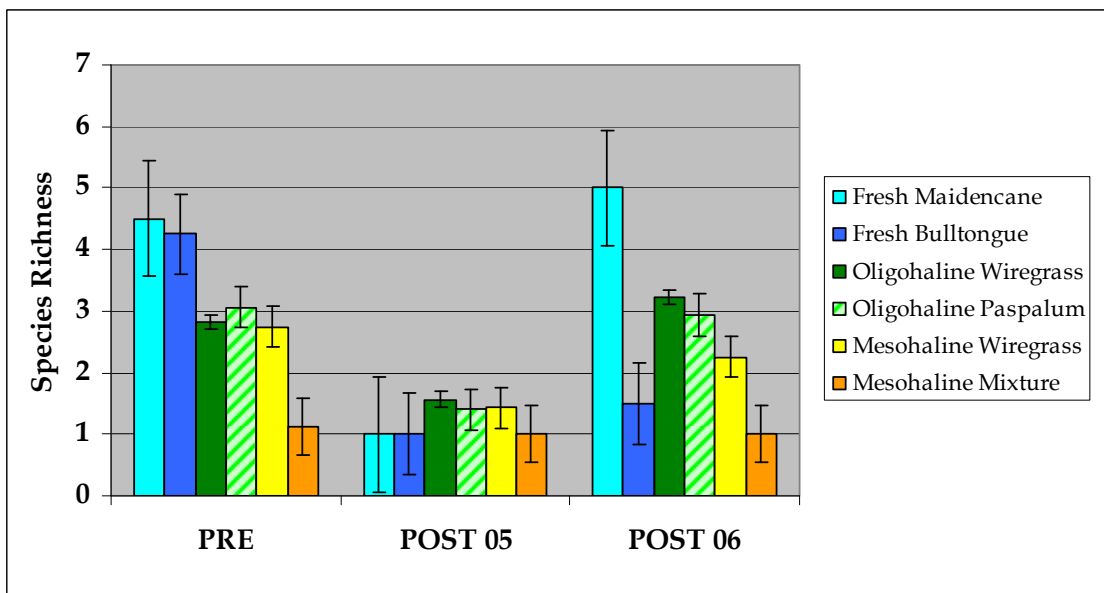
Figure 6. Species Richness by Visser Vegetation Type. LS Mean \pm SE, n=163 stations, $F_{17, 488}=10.9$, $p<0.0001$.

had not recovered and in Oligohaline Wiregrass which had significantly more species per plot post Rita than before (up from 2.83 to 3.22 species).
