**2007 Operations, Maintenance,  
and Monitoring Report**

**Grand-White Lakes Landbridge  
Protection**

State Project Number ME-19  
Priority Project List 10

August 2007  
Vermilion Parish

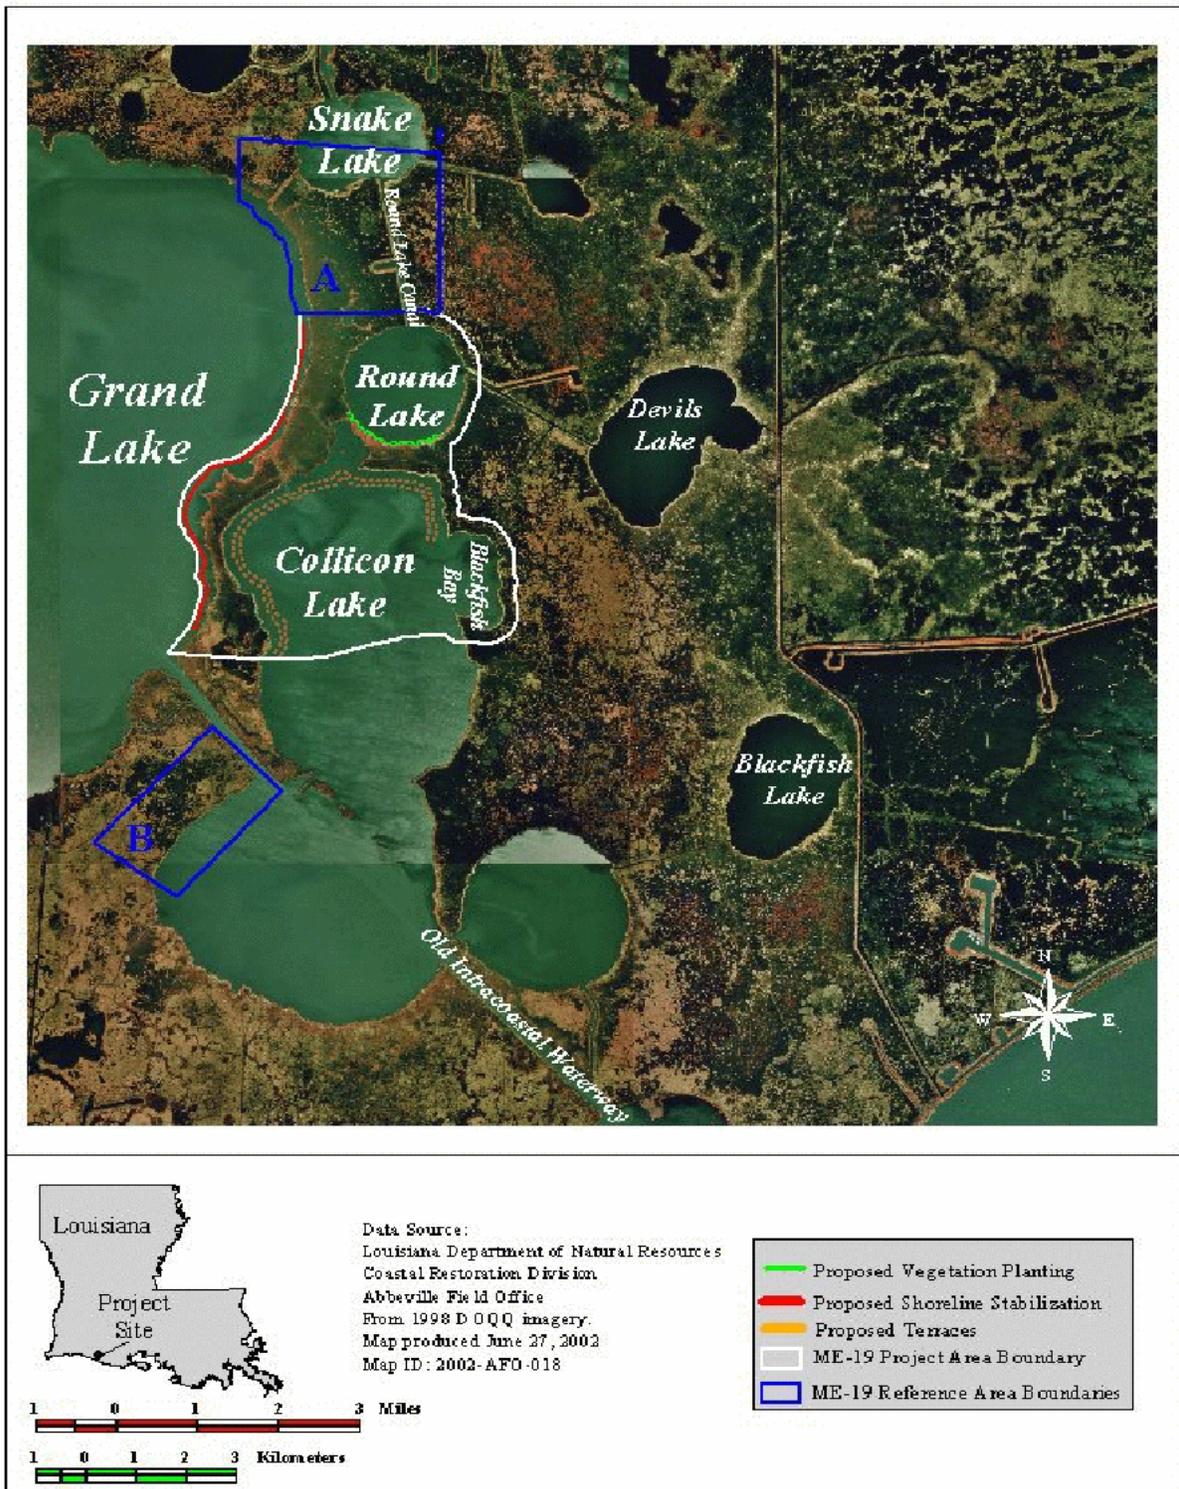
Figure 1. Grand-White Lakes Landbridge Protection Project (ME-19/PME-18) project and reference area showing shoreline planting, shoreline stabilization, and terrace locations.

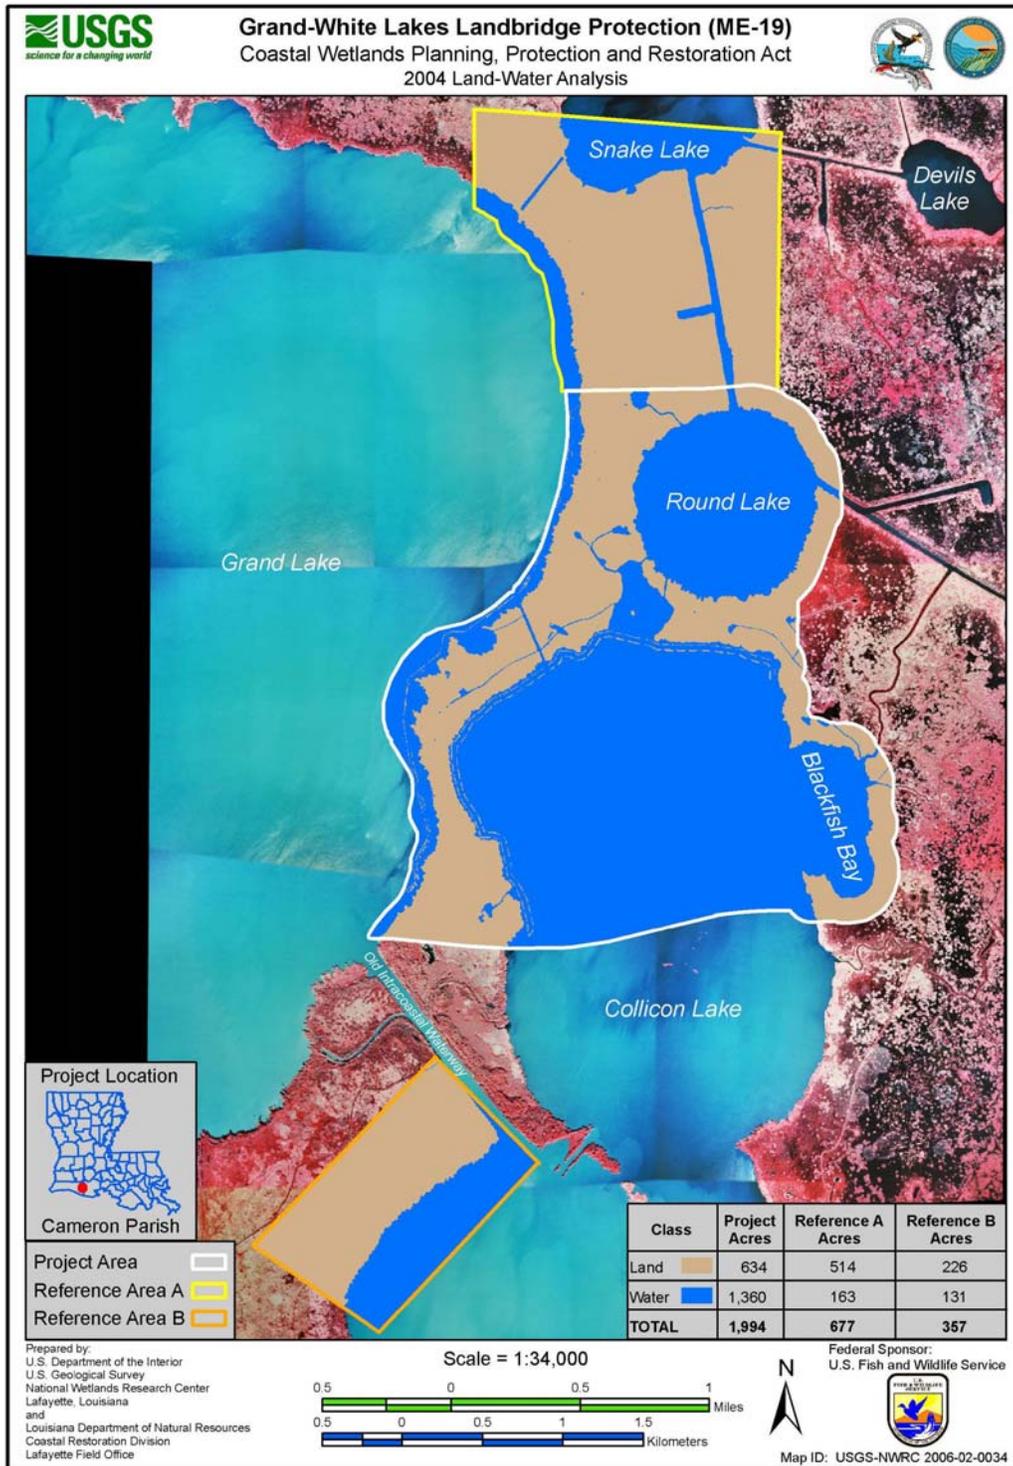
Figure 2. Land to water analysis for Grand-White Lakes Landbridge Protection Project (ME-19), flown November 24, 2004, following completion of construction.

Aerial photography for the project area was flown on November 25, 2004. The results of the 2004 aerial photography shows the total project area consisted of 1,994 ac (806.9 ha) with 634 ac (256.6 ha) of land and 1,360 ac (550.3 ha) of water (figure 2). The reference for the project is divided into two sections, one to evaluate the shoreline behind rock foreshore dike and the other to evaluate the shoreline behind the terraces over time. The reference area for the foreshore dike total was 677 ac (273.9 ha) with 514 ac (208 ha) of land and 163 ac (66 ha) of water. The reference area for the terraces total was 357 ac (144.5 ha) with 226 ac (91.5 ha) of land and 131 ac (ha) of water. Evaluation of project area and reference areas for marsh creation and erosion will be determined after the post-construction photographs are obtained in 2013.

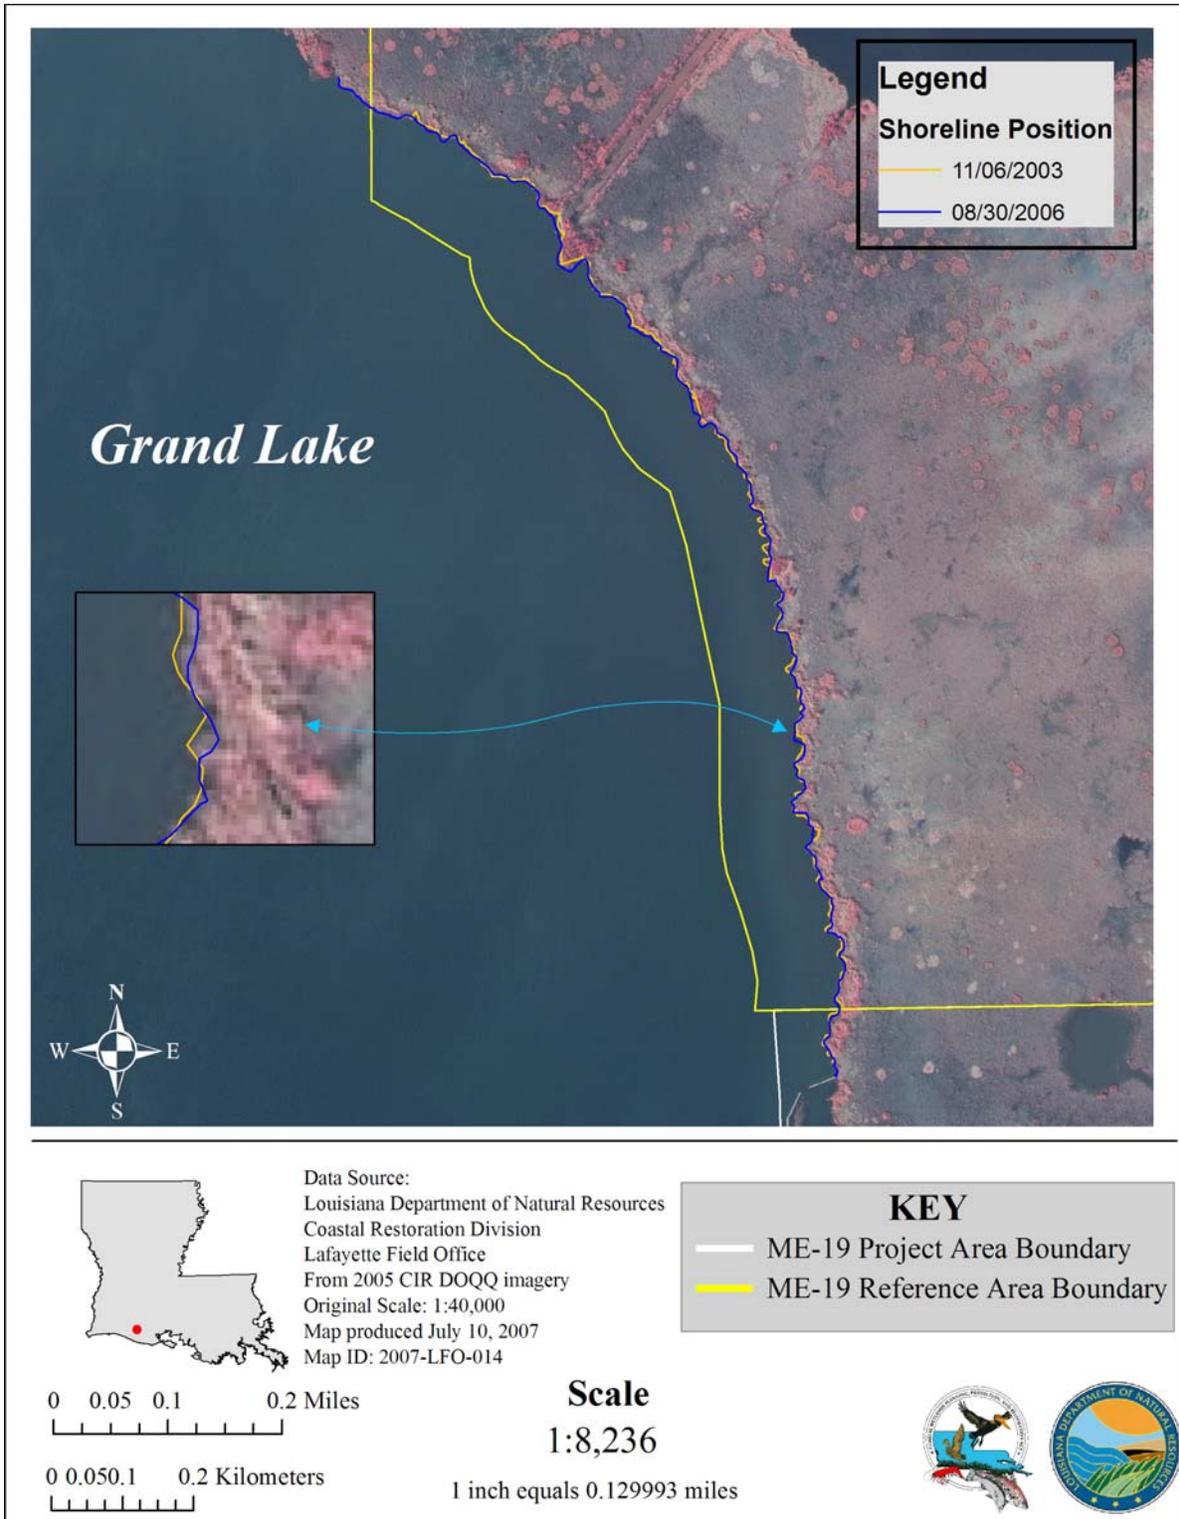
**Figure 4.** Shoreline change map of the Grand-White Lakes Landbridge Protection (ME-19) reference area for the period of record of November 11, 2003, to August 30, 2006.

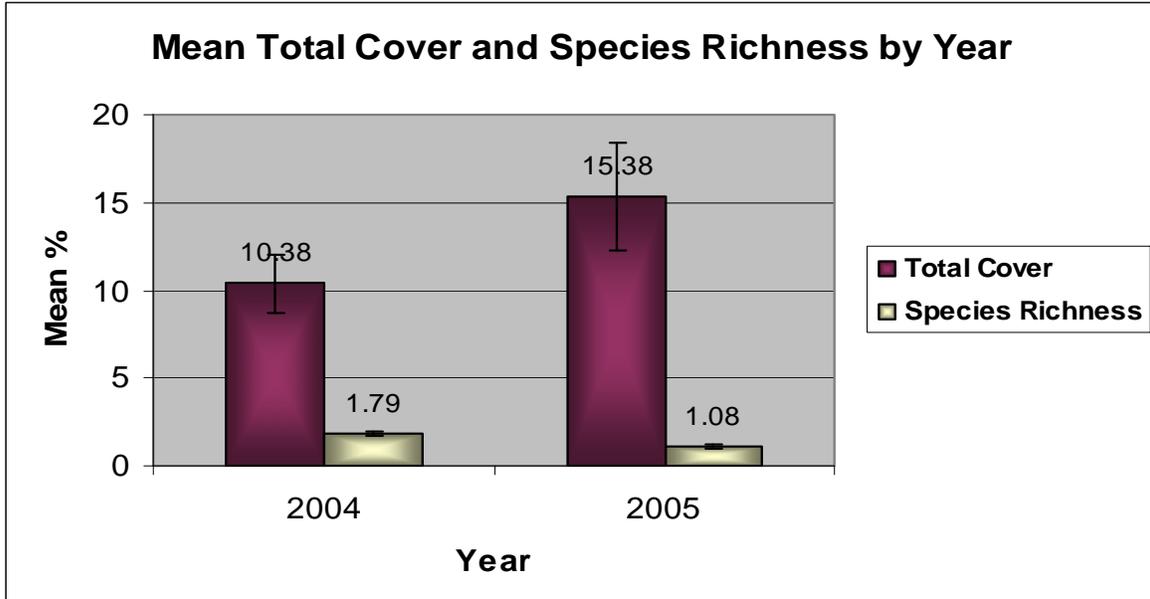
**Figure 5.** Mean total % cover and mean % richness of sampled vegetation for the period of record of November 4, 2004, to October 31, 2005. LS Mean  $\pm$  SE, n=96 stations,  $F_{1,94}=14.22$ ;  $p=0.0003$ .

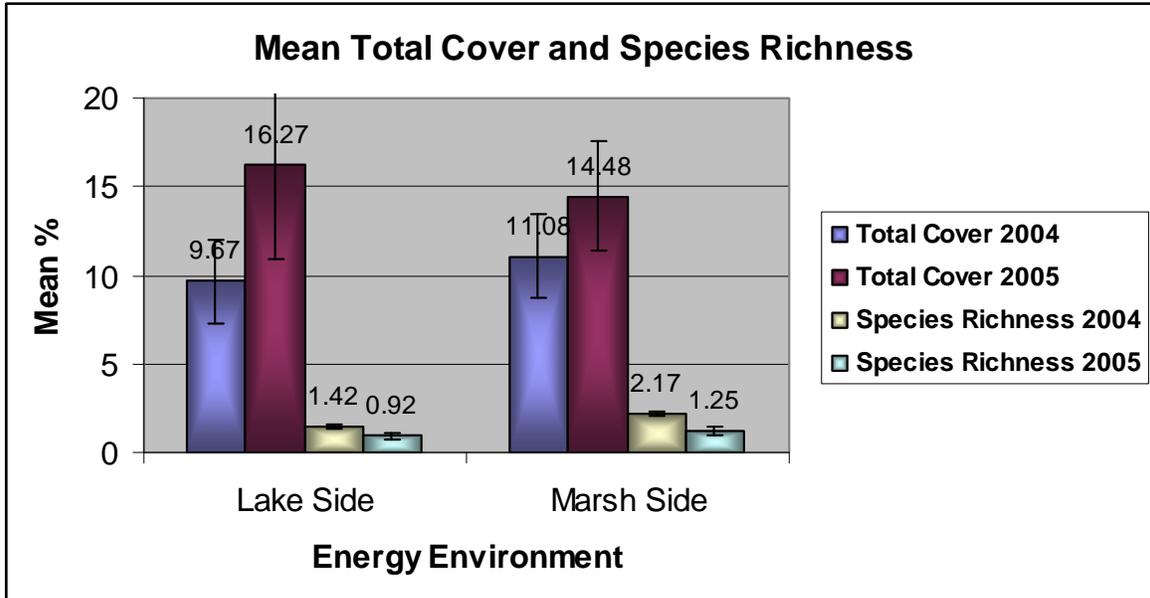
**Figure 6.** Mean total % cover and mean % richness of sampled vegetation over time and between the high energy environment of the lake terraces and the low energy environment of the marsh terraces.

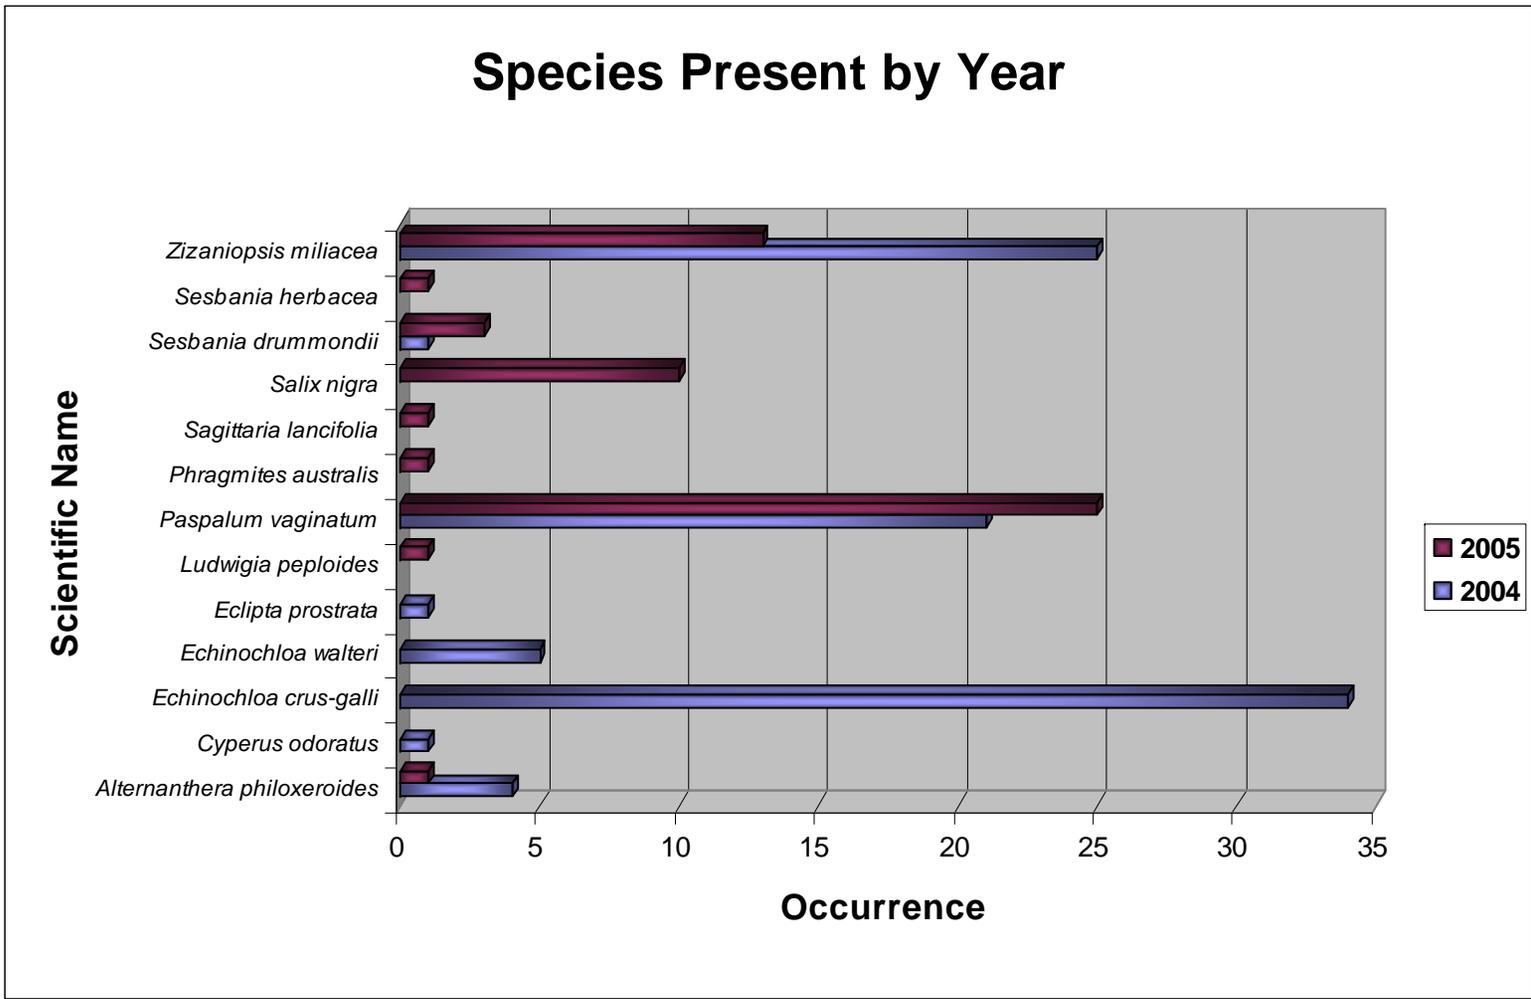
Species occurrence on terraces between years were plotted in figure 7. *Zizaniopsis miliacea*, which was planted on the terrace slopes, decreased in occurrence from 2004 to 2005. *Paspalum vaginatum*, which was planted on the terrace crowns, increased in occurrence over time. Weifenbach and Sharp (2006) reported an increase in *Paspalum* species in all marsh types in southwestern Louisiana post-Hurricane Rita. *Echinochloa crus-galli*, which had been seeded on the crown, did not occur in the 2005 sampling. The overall appearance and health of all species present at the 2005 sampling were considered to be stressed and adversely affected by Hurricane Rita (figures 8 and 9).

**Figure 7.** Species occurrence on terraces. Planted species were *Zizaniopsis miliacea* on terrace slopes and *Paspalum vaginatum* on crowns. *Echinochloa crus-galli* was seeded on crowns.

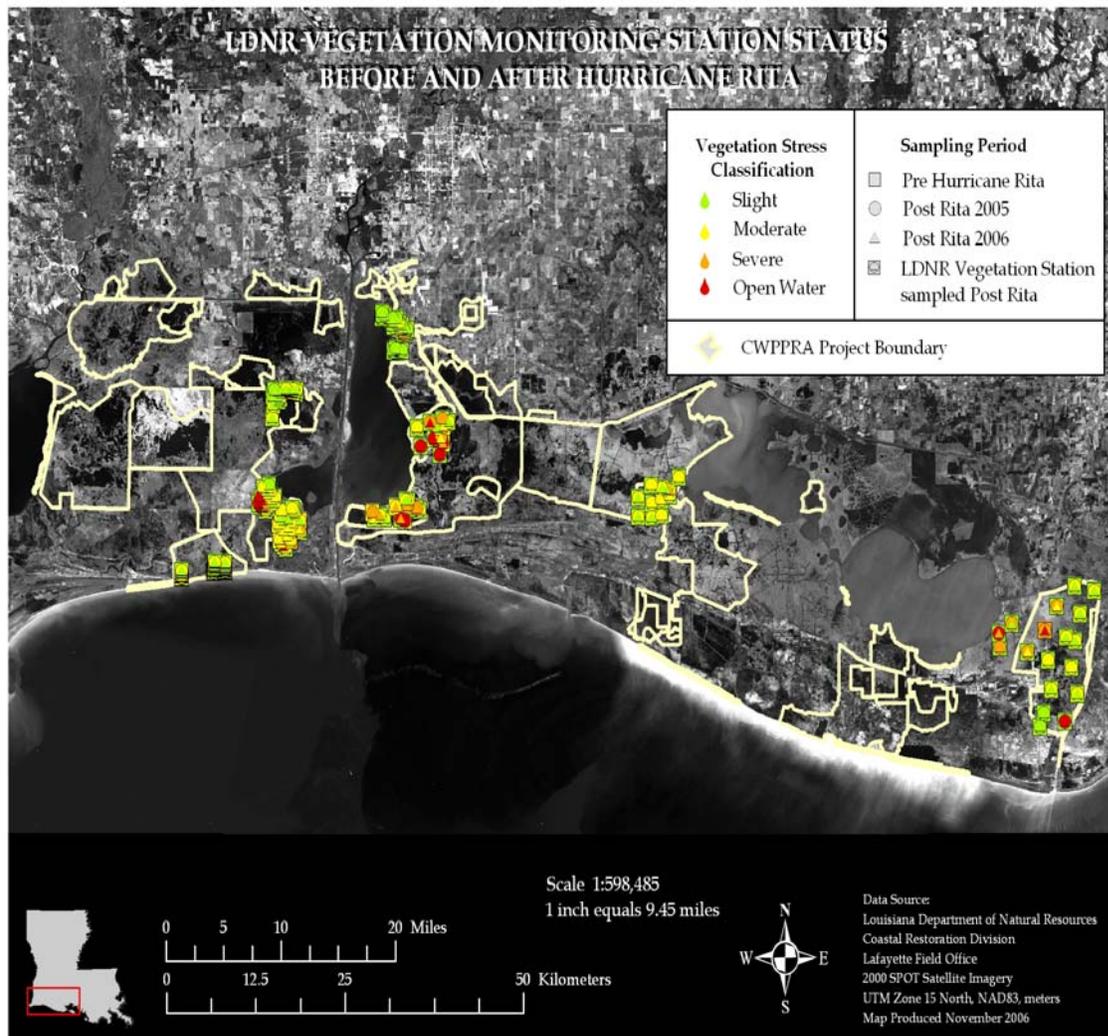
Prior to Hurricane Rita, most of the vegetation stations utilized for this survey were healthy and intact (>80%). Following the hurricane in 2005, most of the stations were stressed (67%) or worse (20%). A year later in 2006, over 50% of the stations were back to pre-storm stress levels. Severely stressed stations either converted to open water or recovered to a less stressed state. Most stations that had been converted to open water in 2005 did not recover (figures 1 and 2).

**Figure 1.** Location and status of LDNR vegetation stations sampled after Hurricane Rita. Stations were classified according to storm induced stress as described in Table 1.

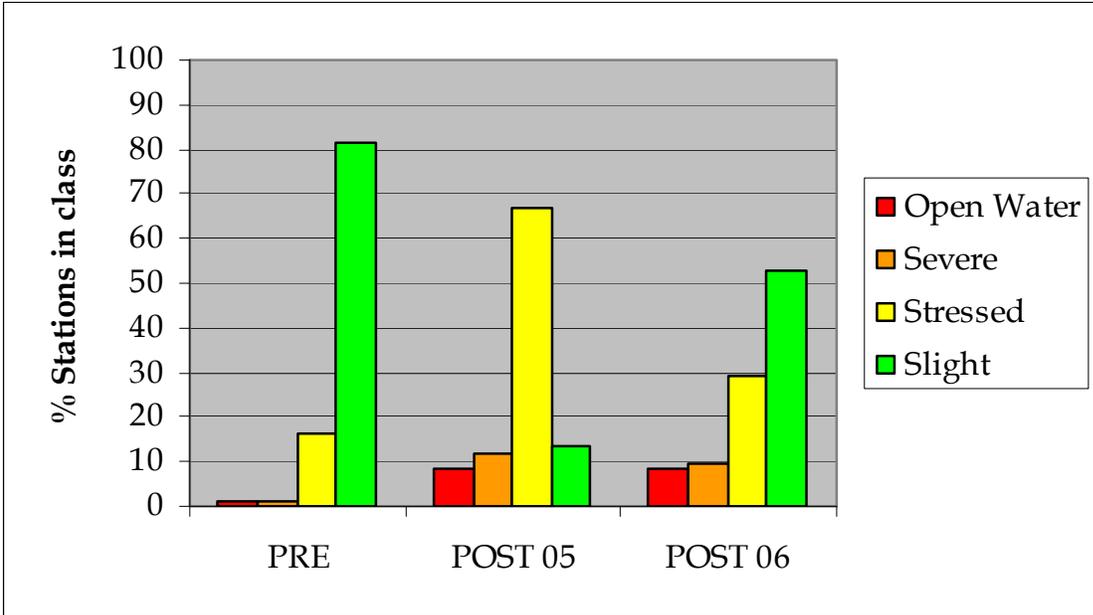
**Figure 2.** Percent of LDNR vegetation stations in each stress class before and after Hurricane Rita (n=163).

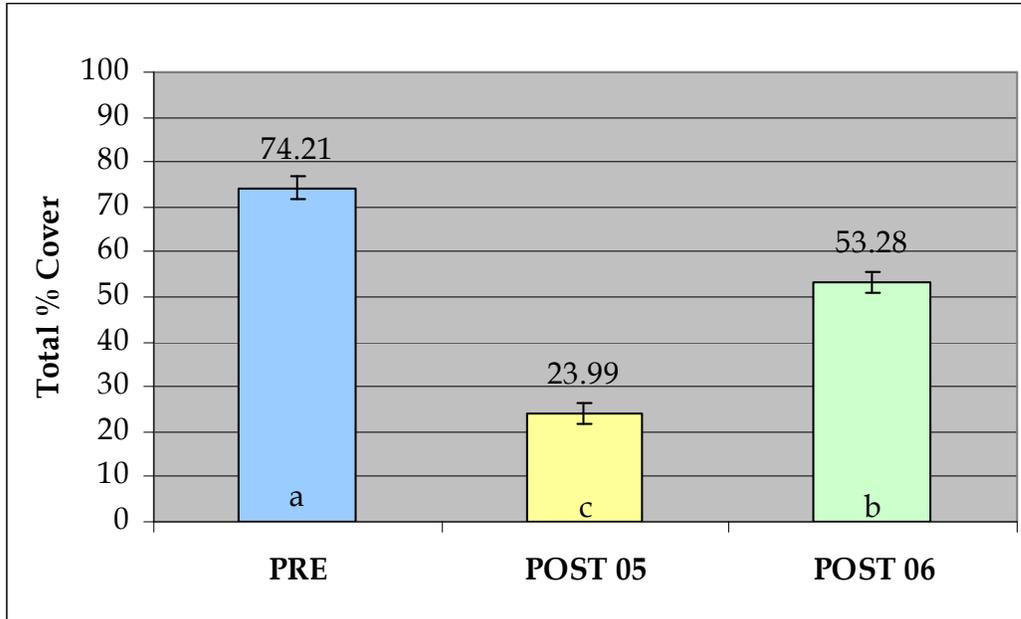
Total % Cover was significantly different over time (figure 3). Post-ANOVA comparisons (Tukey's HSD) revealed that all three sampling periods were significantly different, meaning Total % Cover for 2006 is still significantly lower than Pre-Rita levels. Species Richness was also significantly different over the three sampling periods (figure 4). The number of species present before Rita and in 2006 were statistically the same.

**Figure 3.** Total % Cover pre- and post-Hurricane Rita. LS Mean  $\pm$  SE, n=163 stations,  $F_{2, 488}=109.7$ ,  $p<0.0001$ . Levels not connected by same letter are significantly different.

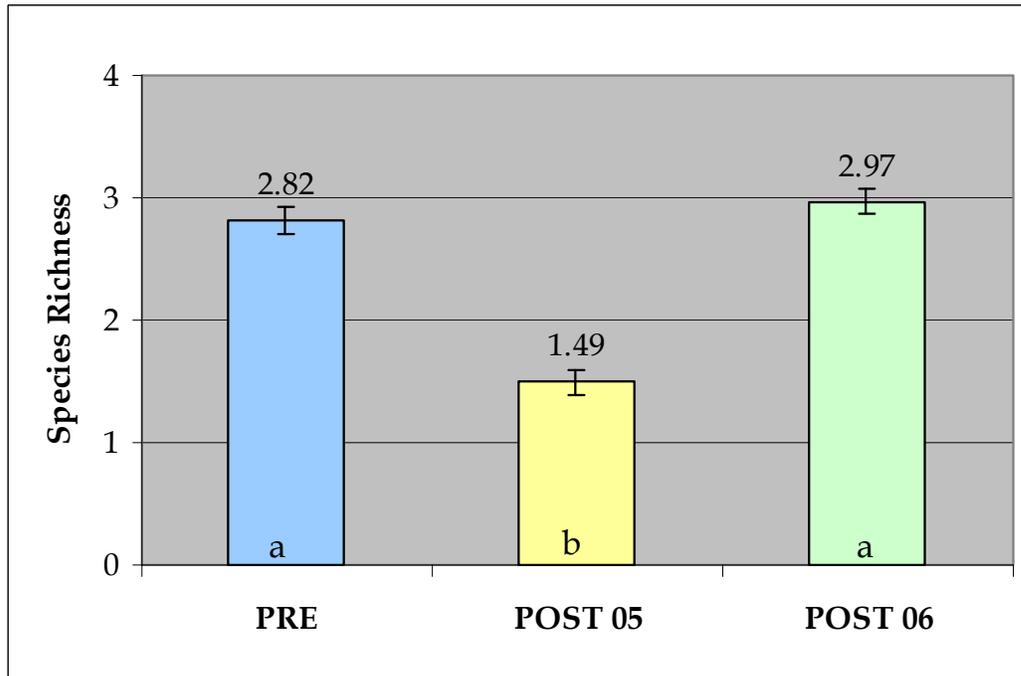
**Figure 4.** Species Richness pre- and post-Rita. LS Mean  $\pm$  SE, n=163 stations,  $F_{2, 488}=56.8$ ,  $p<0.0001$ . Levels not connected by same letter are significantly different.

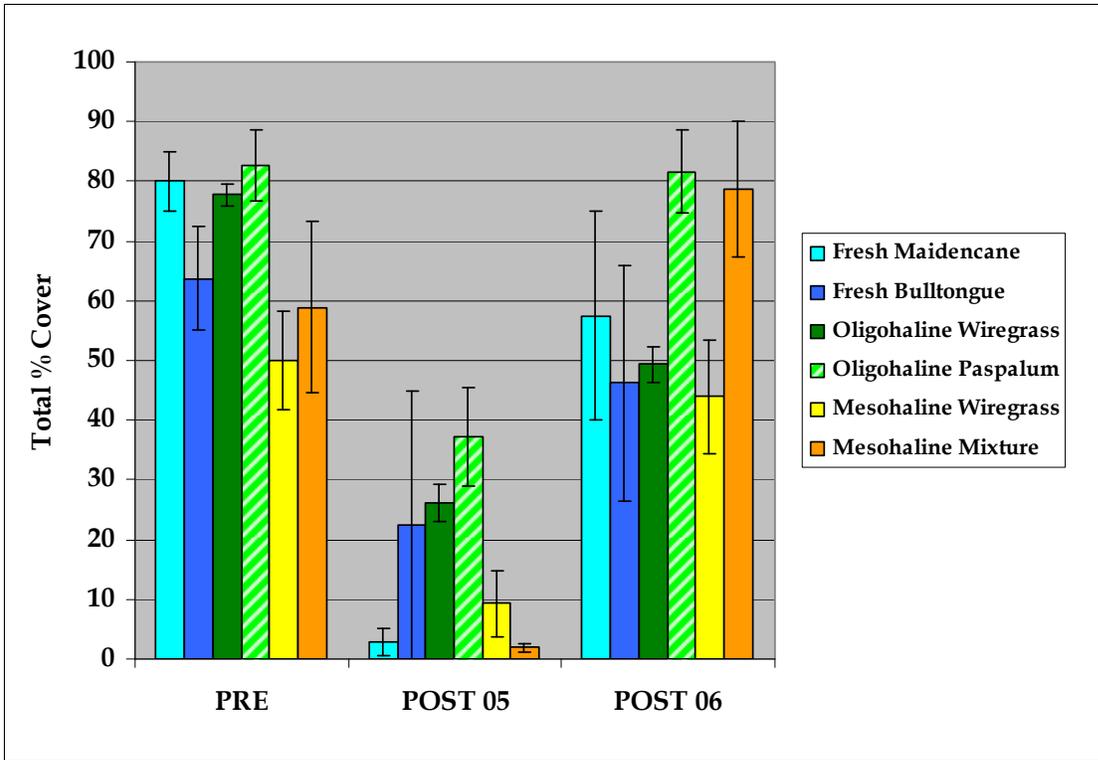
Visser Type was added to the overall model and the interaction between Visser Type and time was analyzed. Both models had significant differences in Visser Type over time (figures 5 and 6). Post-ANOVA contrasts of Cover and Richness Pre-Rita and Post-06 for each Visser Type revealed that all Visser Types were the same in Total Cover (had recovered to pre-storm

**Figure 5.** Total % Cover by Visser Vegetation Type. LS Mean  $\pm$  SE, n=163 stations,  $F_{17, 488}=17.0$ ,  $p<0.0001$ .

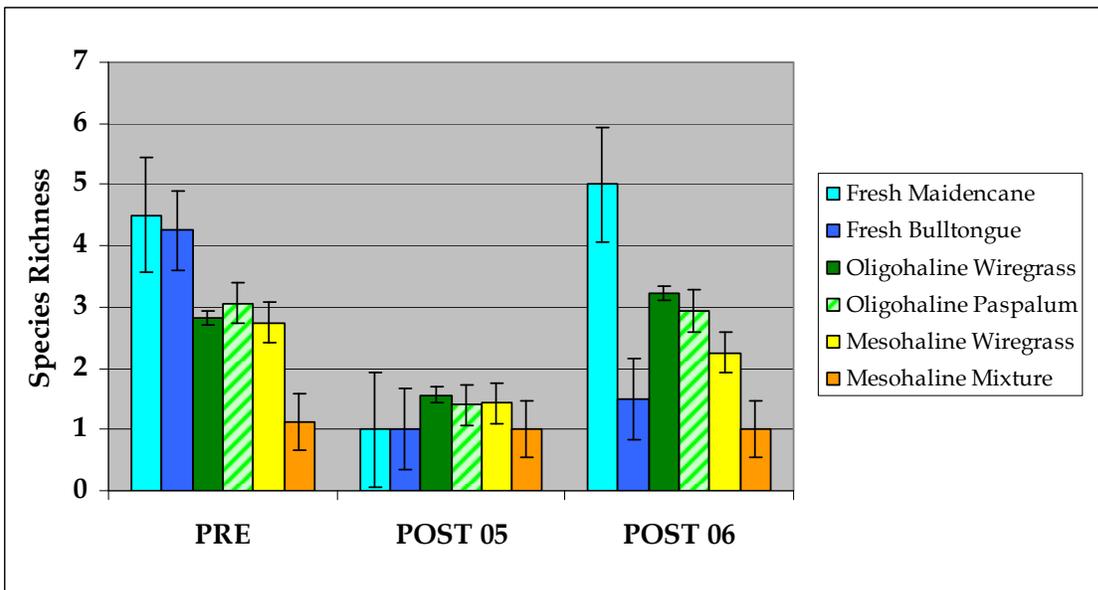
levels) and in Richness except Fresh Bulltongue (mostly in the ME-04 project area), which had not recovered, and in Oligohaline Wiregrass, which had significantly more species per plot post-Rita than before (up from 2.83 to 3.22 species).

**Figure 6.** Species Richness by Visser Vegetation Type. LS Mean  $\pm$  SE, n=163 stations,  $F_{17, 488}=10.9$ ,  $p<0.0001$ .
