**2007 Operations, Maintenance,
and Monitoring Report**

**Marsh Island Hydrologic
Restoration**

State Project Number TV-14
Priority Project List 6

August 2007
Iberia Parish

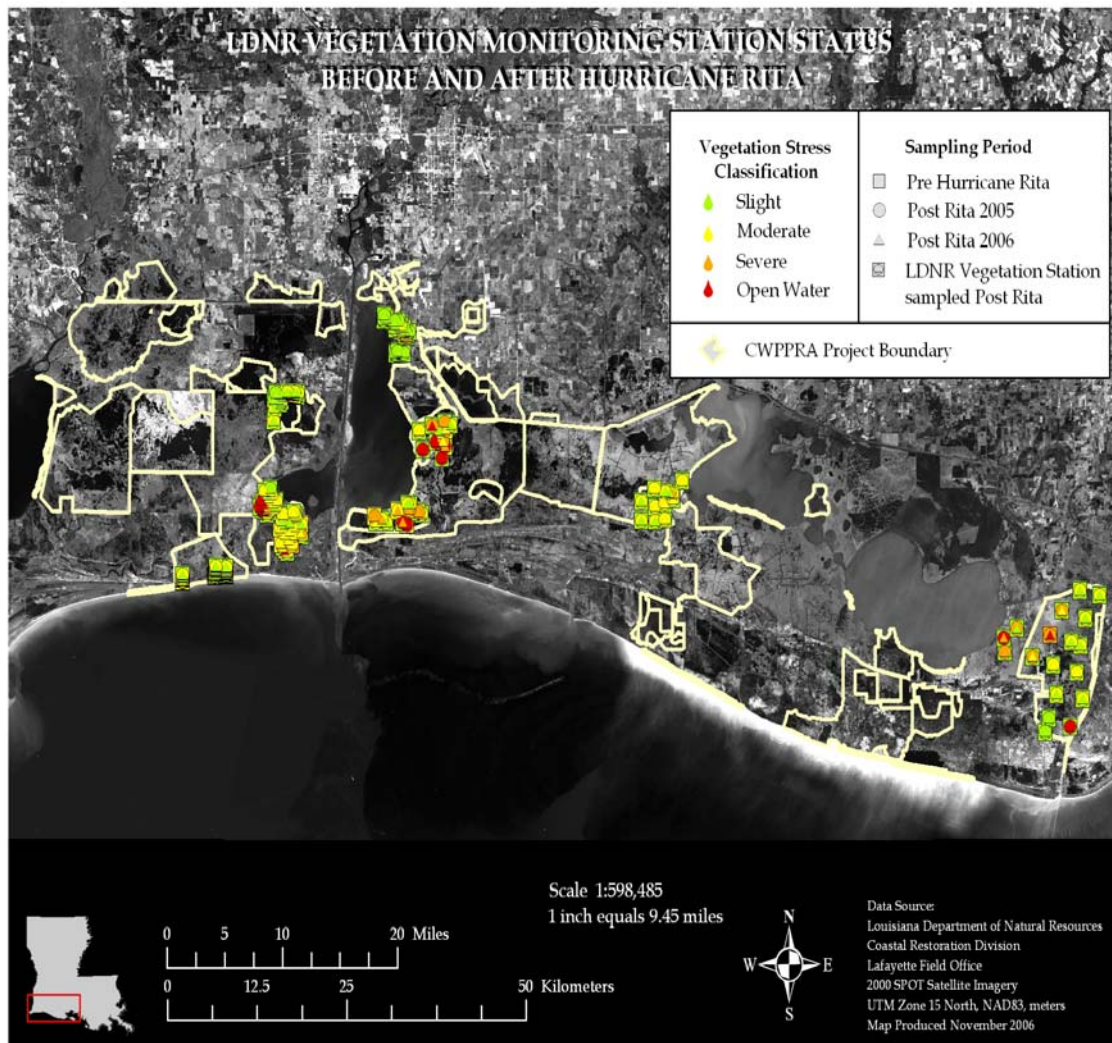
Figure 1. Location and status of LDNR vegetation stations sampled after Hurricane Rita. Stations were classified according to storm-induced stress as described in Table 1.

Prior to Hurricane Rita, most of the vegetation stations utilized for this survey were healthy and intact (>80%). Following the hurricane in 2005, most of the stations were stressed (67%) or worse (20%). A year later in 2006, over 50% of the stations were back to pre-storm stress levels. Severely stressed stations either converted to open water or recovered to a less stressed state. Most stations that had been converted to open water in 2005 did not recover (figures 1 and 2).

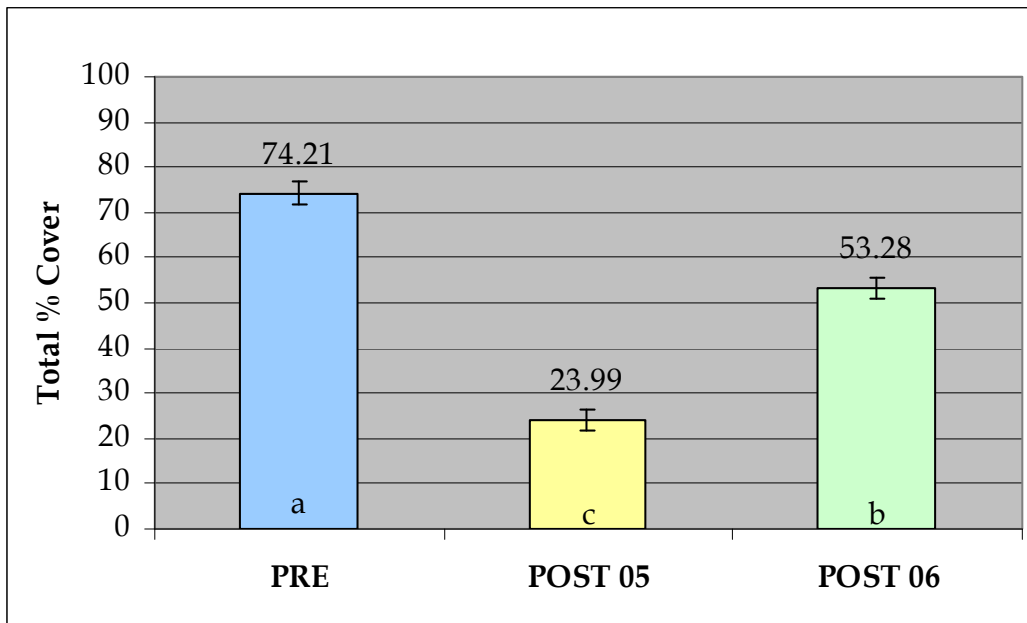
Figure 3. Total % Cover pre- and post-Hurricane Rita. LS Mean \pm SE, n=163 stations, $F_{2, 488}=109.7$, $p<0.0001$. Levels not connected by same letter are significantly different.

Total % Cover was significantly different over time (figure 3). Post-ANOVA comparisons (Tukey's HSD) revealed that all three sampling periods were significantly different, meaning Total % Cover for 2006 is still significantly lower than pre-Hurricane Rita levels. Species Richness was also significantly different over the three sampling periods (figure 4). The number of species present before Rita and in 2006 were statistically the same.
