**State of Louisiana
Office of Coastal Protection and
Restoration**

2009 Annual Inspection Report

**GIWW/ CLOVELLY HYDROLOGIC
RESTORATION**

State Project Number BA-02
Priority Project List 1

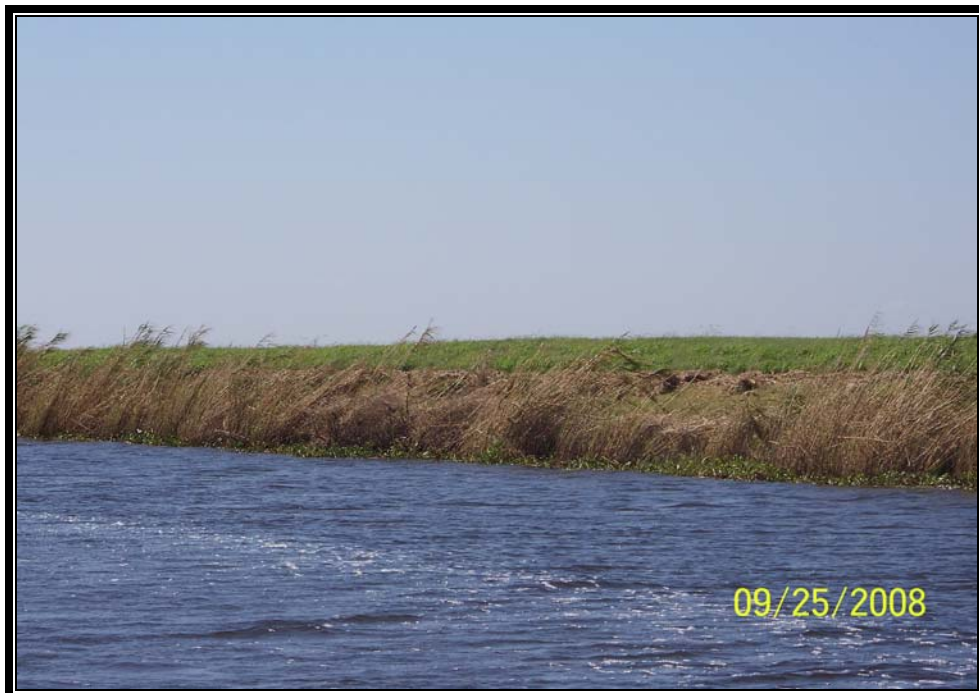
Photo No. 50 – view of the wrack line on the Lafourche Parish protection levee along the eastern boundary of the project.

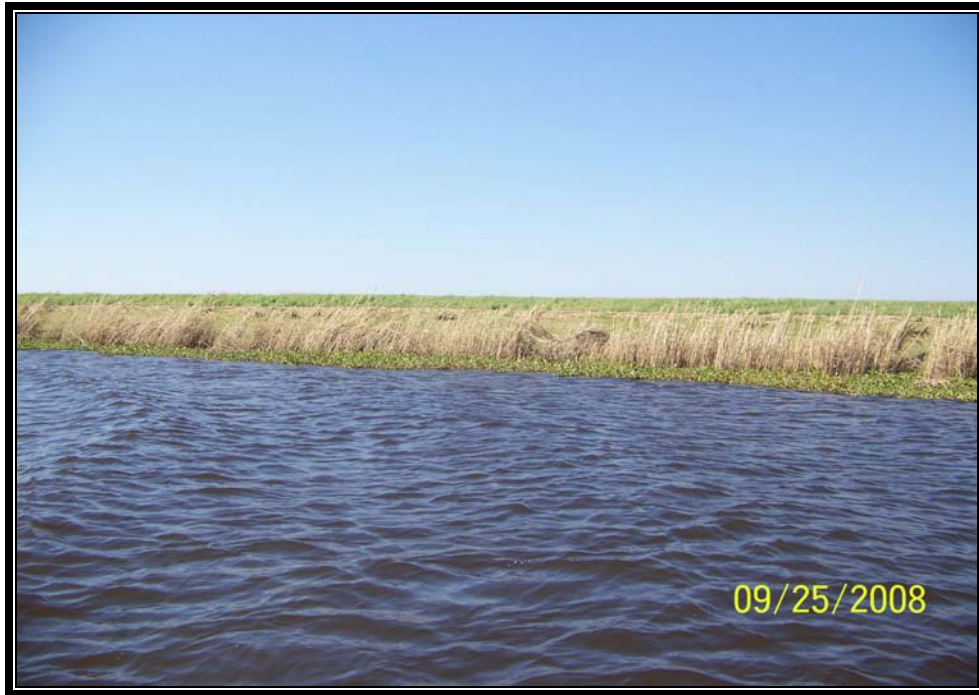
Photo No. 51 -view of the wrack line on the Lafourche Parish protection levee along the eastern boundary of the GIWW to Clovelly project.
