TIMBALIER ISLAND PLANTINGS (TE-18)

TE-18-MSPR-0697-4

PROGRESS REPORT NO. 4

December 9, 1996 to June 8, 1997

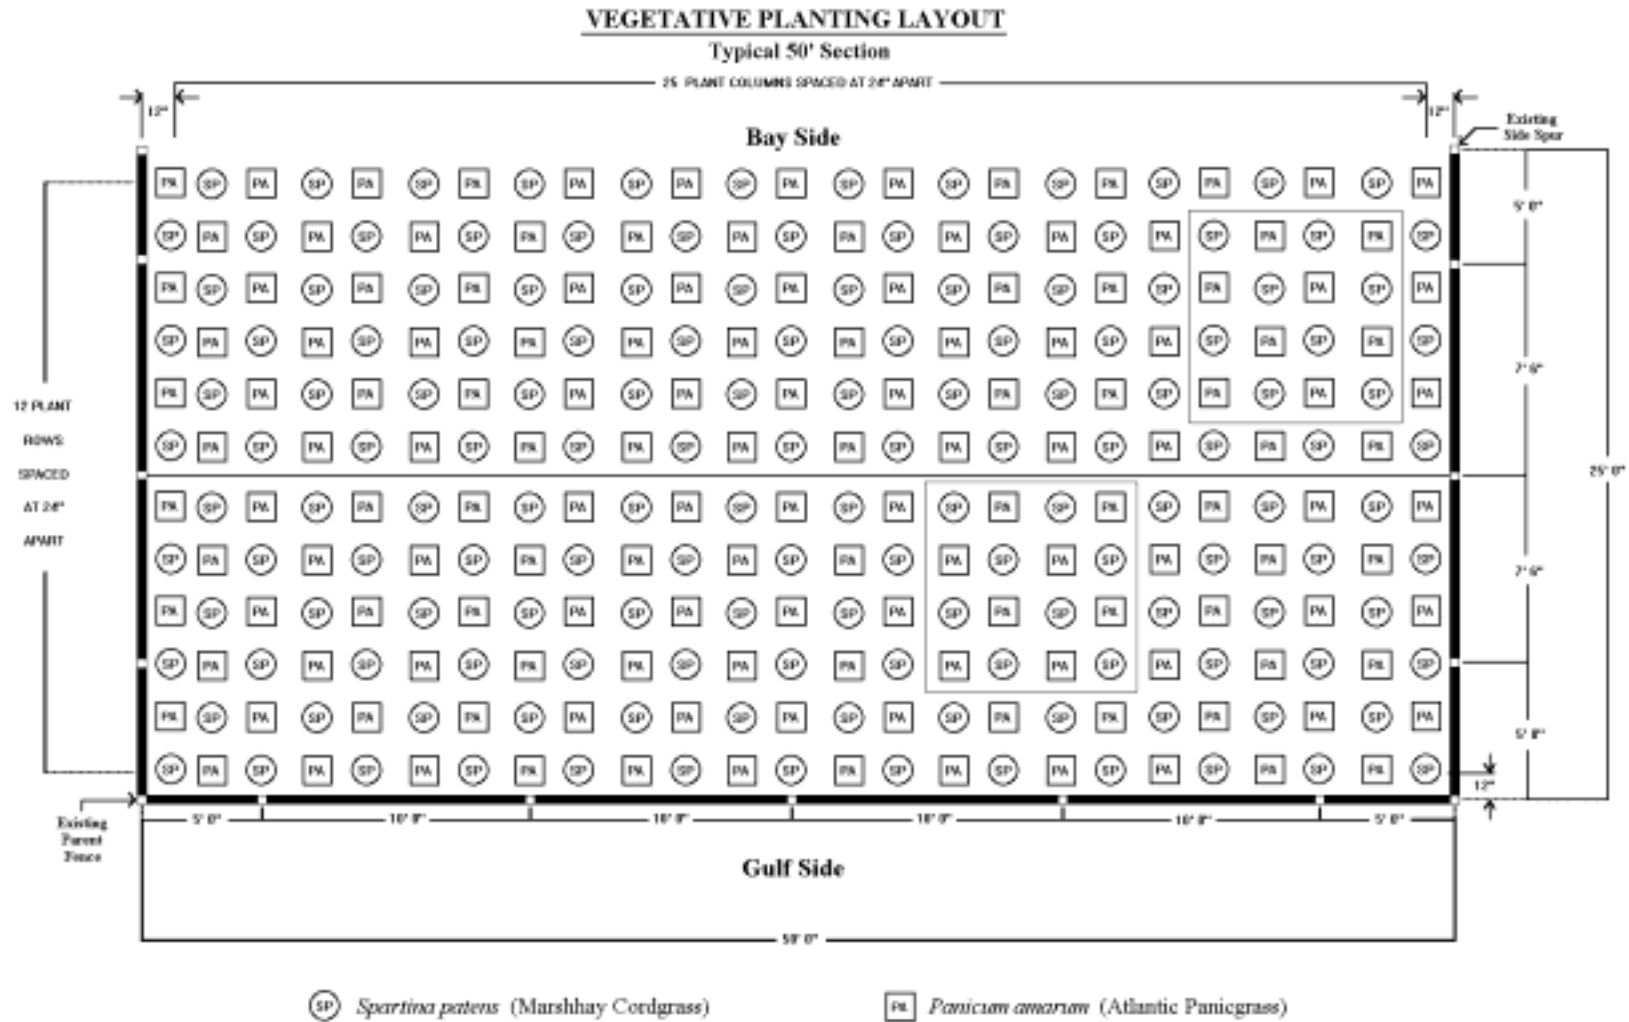
plants are indistinguishable. Planted segments will be analyzed as “bayside” and “gulfside,” based on the location of the plants with respect to center line and the Gulf of Mexico (figure 2). In both the bayside and gulfside of all segments where vegetation was planted (A, B, I-1, I-2), percent survival of planted individuals, percent cover of plants, and plant species composition will be determined within a permanent 4-m² quadrat. In addition, two plants within each quadrat will be randomly selected to determine tiller number and tiller length. Due to the extreme length of segment B, it will be divided and sampled in two sections, the east end, BE, and the west end, BW.

Figure 2. Timbalier Island Plantings (TE-18) project proposed layout for vegetation plantings, typical 50' section.
