**State of Louisiana  
Department of Natural Resources  
Coastal Restoration Division and  
Coastal Engineering Division**

**2005 Operations, Maintenance,  
and Monitoring Report**

**Marsh Island Hydrologic  
Restoration**

State Project Number TV-14  
Priority Project List 6

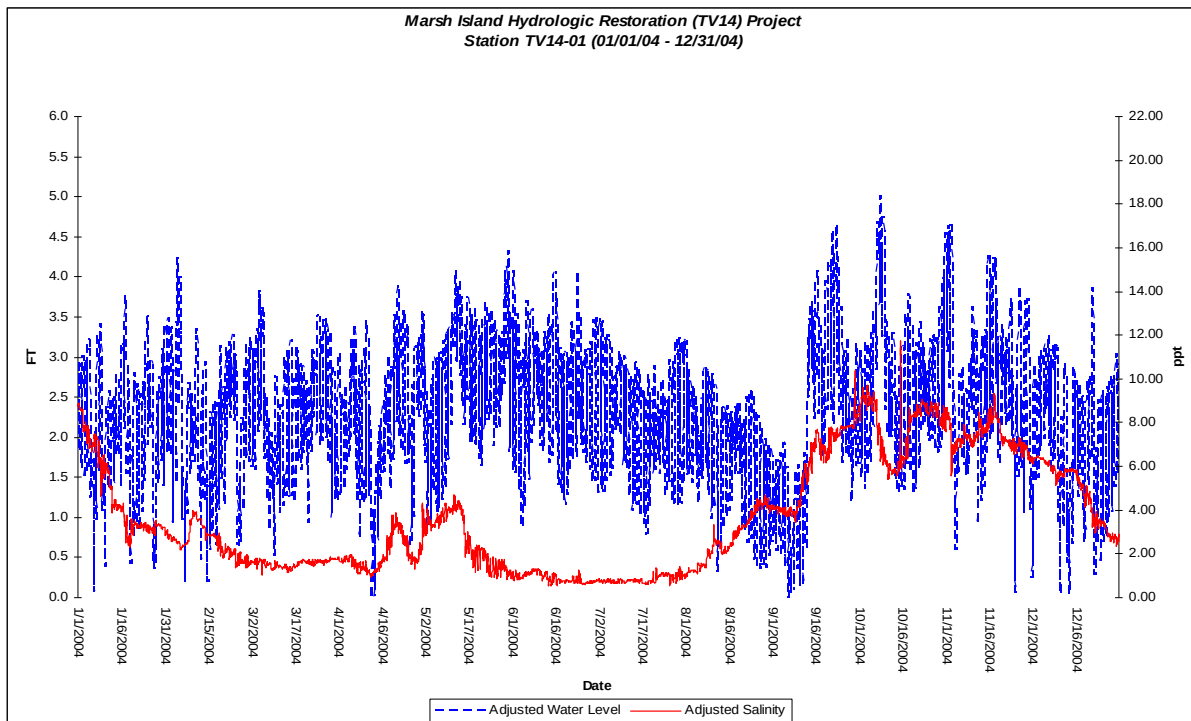
**Figure 9.** Salinity and relative water level data from 2004 for TV-14 project Station 1, in feet.

Hourly salinity and relative water level data for the two project and two reference stations for 2004 are presented in figures 9–12. Minimum, maximum, and mean water levels within the project area were all significantly lower ( $P < 0.0001$ ) than in R1 during the year (figure 13). Daily water level variability was significantly lower (0.13 ft [0.04 m]) within the project area than in R1 during 2003 (figure 14). As this decrease in water level variability was relatively small, the biological significance of this change could not be determined without more detailed vegetation sampling and analysis.

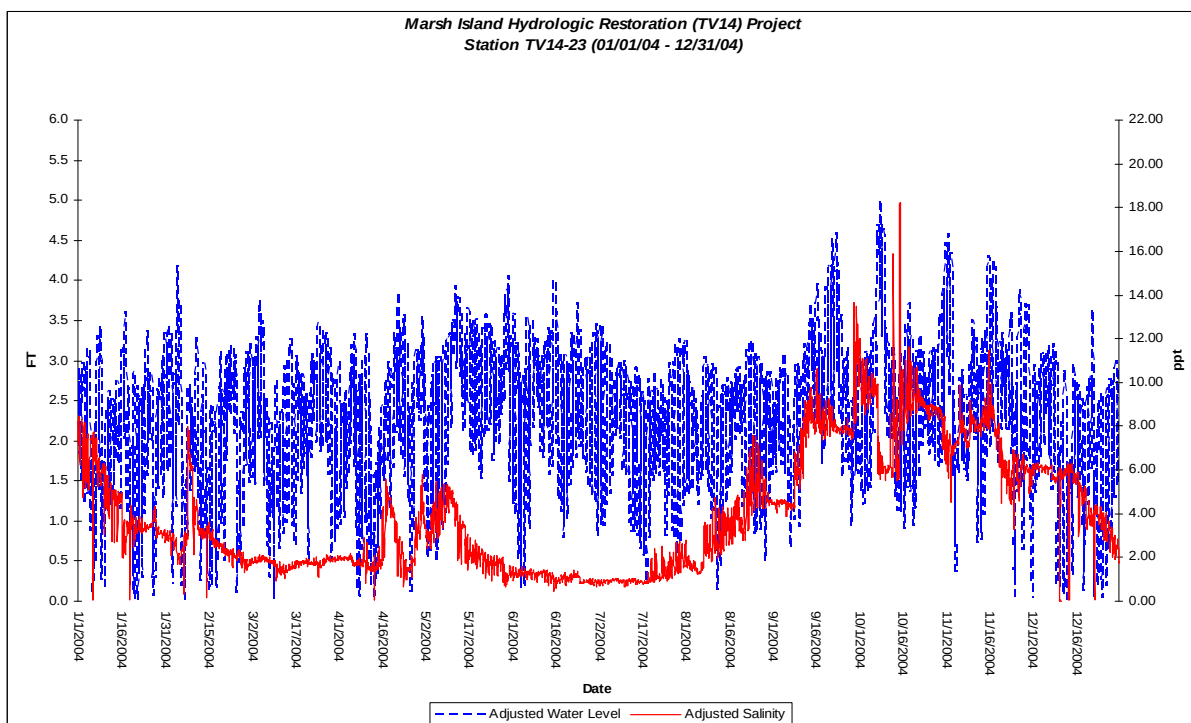
**Figure 10.** Salinity and relative water level data from 2004 for TV-14 project Station 23, in feet.

\*The continuous recorder at TV14-02 was removed because of access problems following project construction. The replacement station, TV14-23, was installed closer to Bayou Blanc, a more accessible location.
