**2004 Operations, Maintenance,  
and Monitoring Report**

**Black Bayou Hydrologic Restoration**

State Project Number CS-27  
Priority Project List 2

May 2004  
Calcasieu and Cameron Parishes

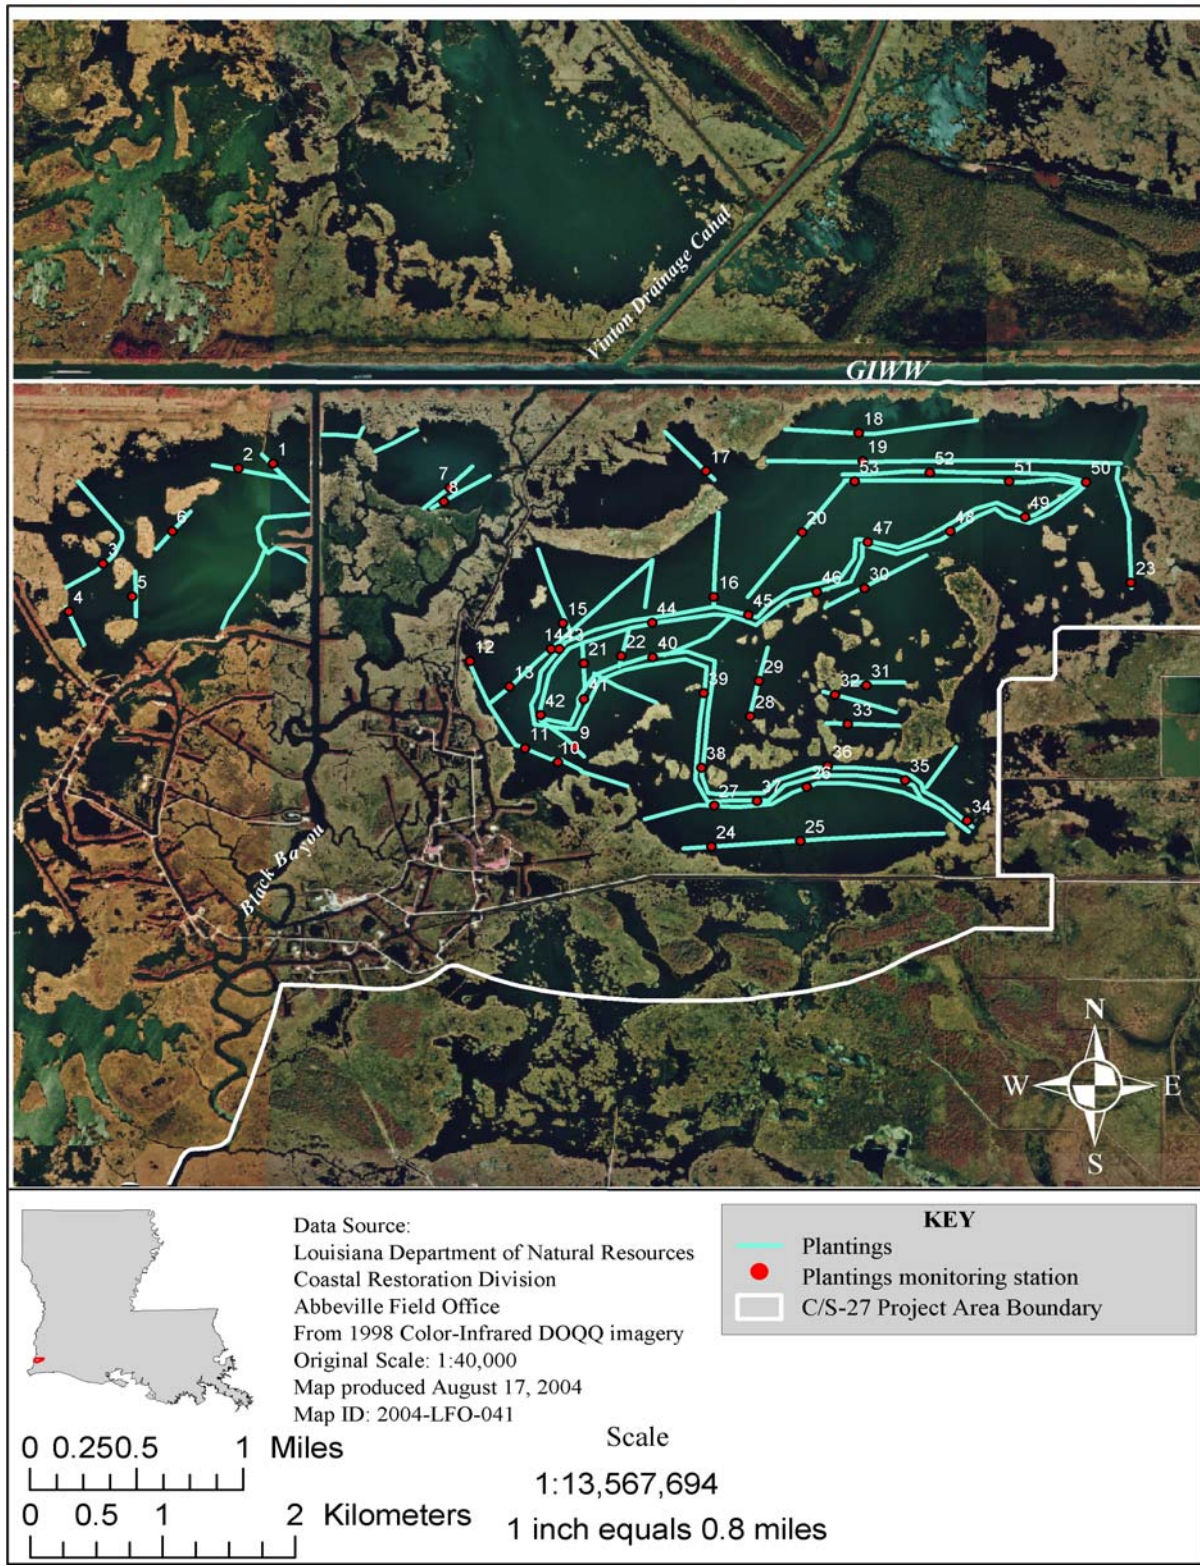
**Figure 3.** Black Bayou (CS-27) planting locations with monitoring sample locations.

*Schoenoplectus californicus* (bullwhip) plantings were installed in 2002. Monitoring was conducted in September approximately 1 year after planting. Sample plots had varying survival success. Individuals were recorded as alive, absent, or dead. Except for a few, most plants counted as absent or dead were absent. A total of 53 plots containing 848 plants were sampled. The mean percentage found alive was 68%, the maximum was 100%, and the least amount found alive in a plot was 6%. Some plots had robust, healthy plants almost indistinguishable, whereas, other plots had plants with few stems in deteriorated condition (figures 9 and 10).

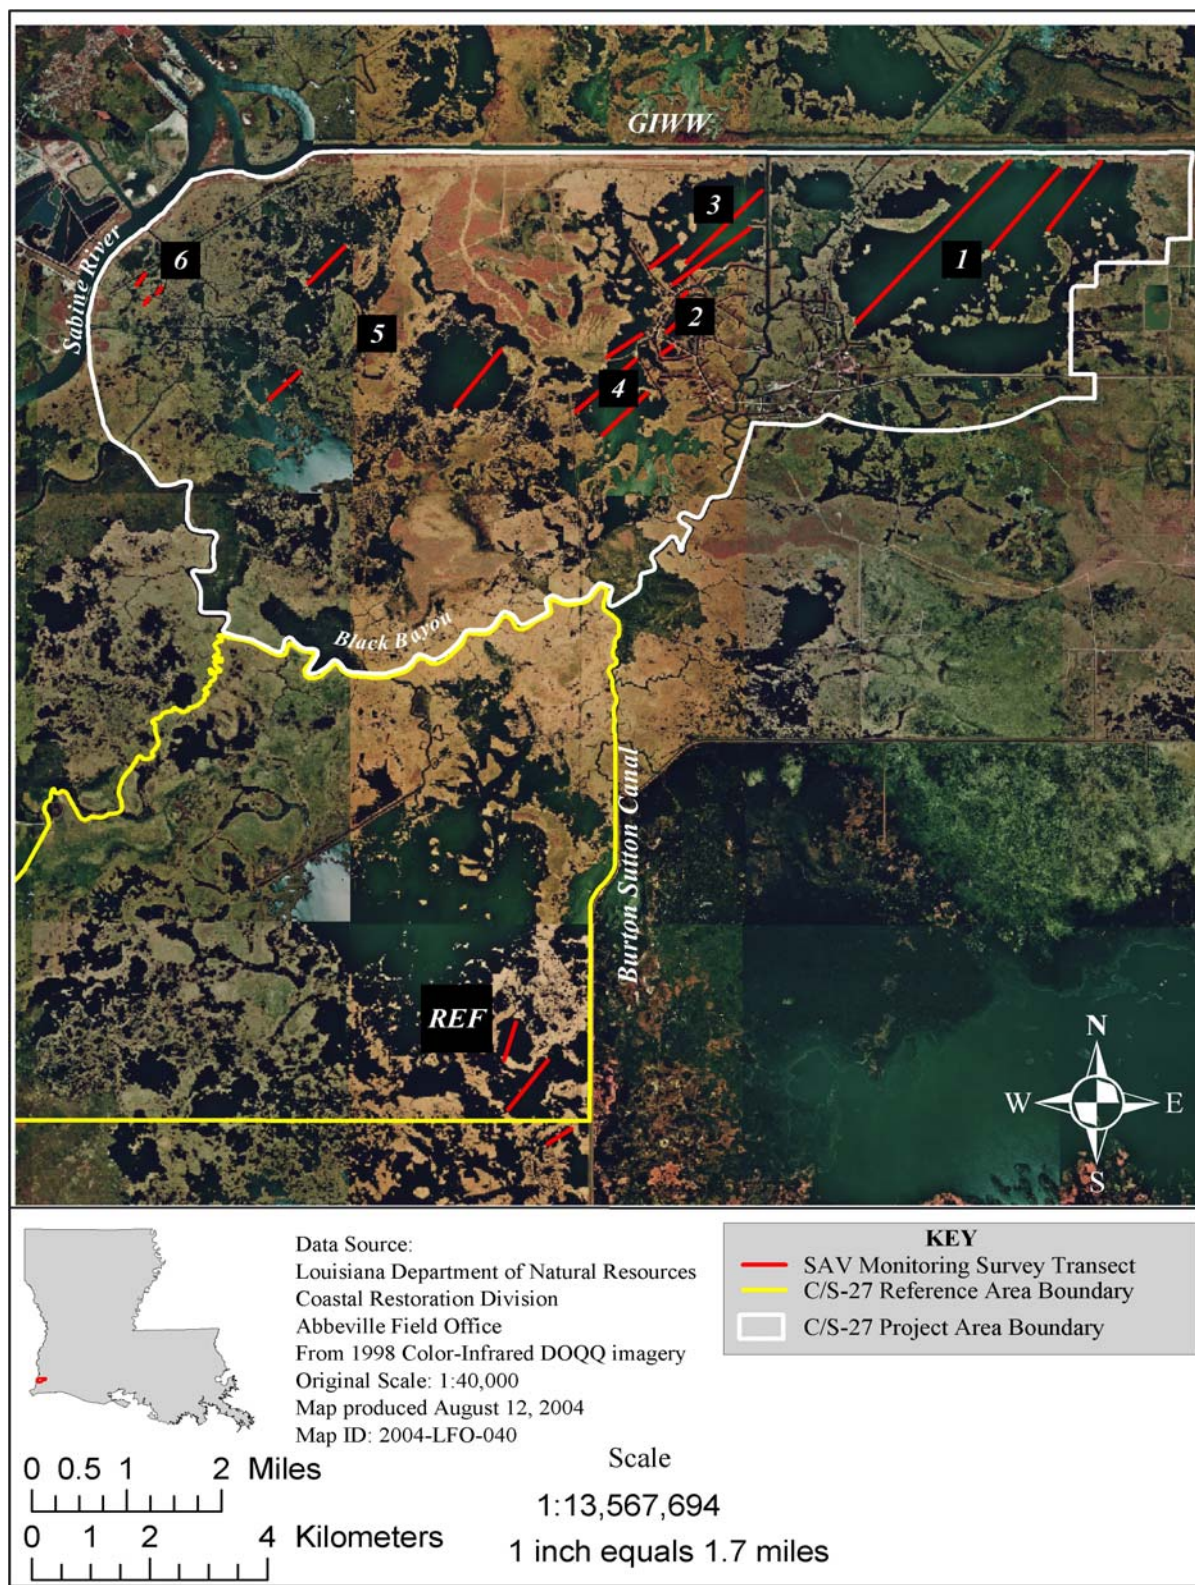
**Figure 5.** Location of SAV sampling in the project and reference areas.

SAV was sampled in many open water areas throughout the project and reference areas (figure 5). Total SAV coverage was very high in most of the ponds sampled preconstruction in 1999 (100% in three areas) and has remained high in the years between sampling (Castellanos, per. obs.) (figure 11). In 2003, when the first postconstruction monitoring was conducted, average percent cover was about 90% for nearly all areas (figure 11). The species collected at both sampling times were very similar, but the percent cover of each did change in some areas over time (figures 12 and 13). Overall, there was a decrease in *Myriophyllum spicatum*, *Ruppia maritima*, and *Najas guadalupensis*, with the notable exception of increase of *M. spicatum* in areas 1 and reference. We also documented *Chara sp.*, *Nymphaea odorata*, and *Ottelia alismoides* for the first time in 2003.

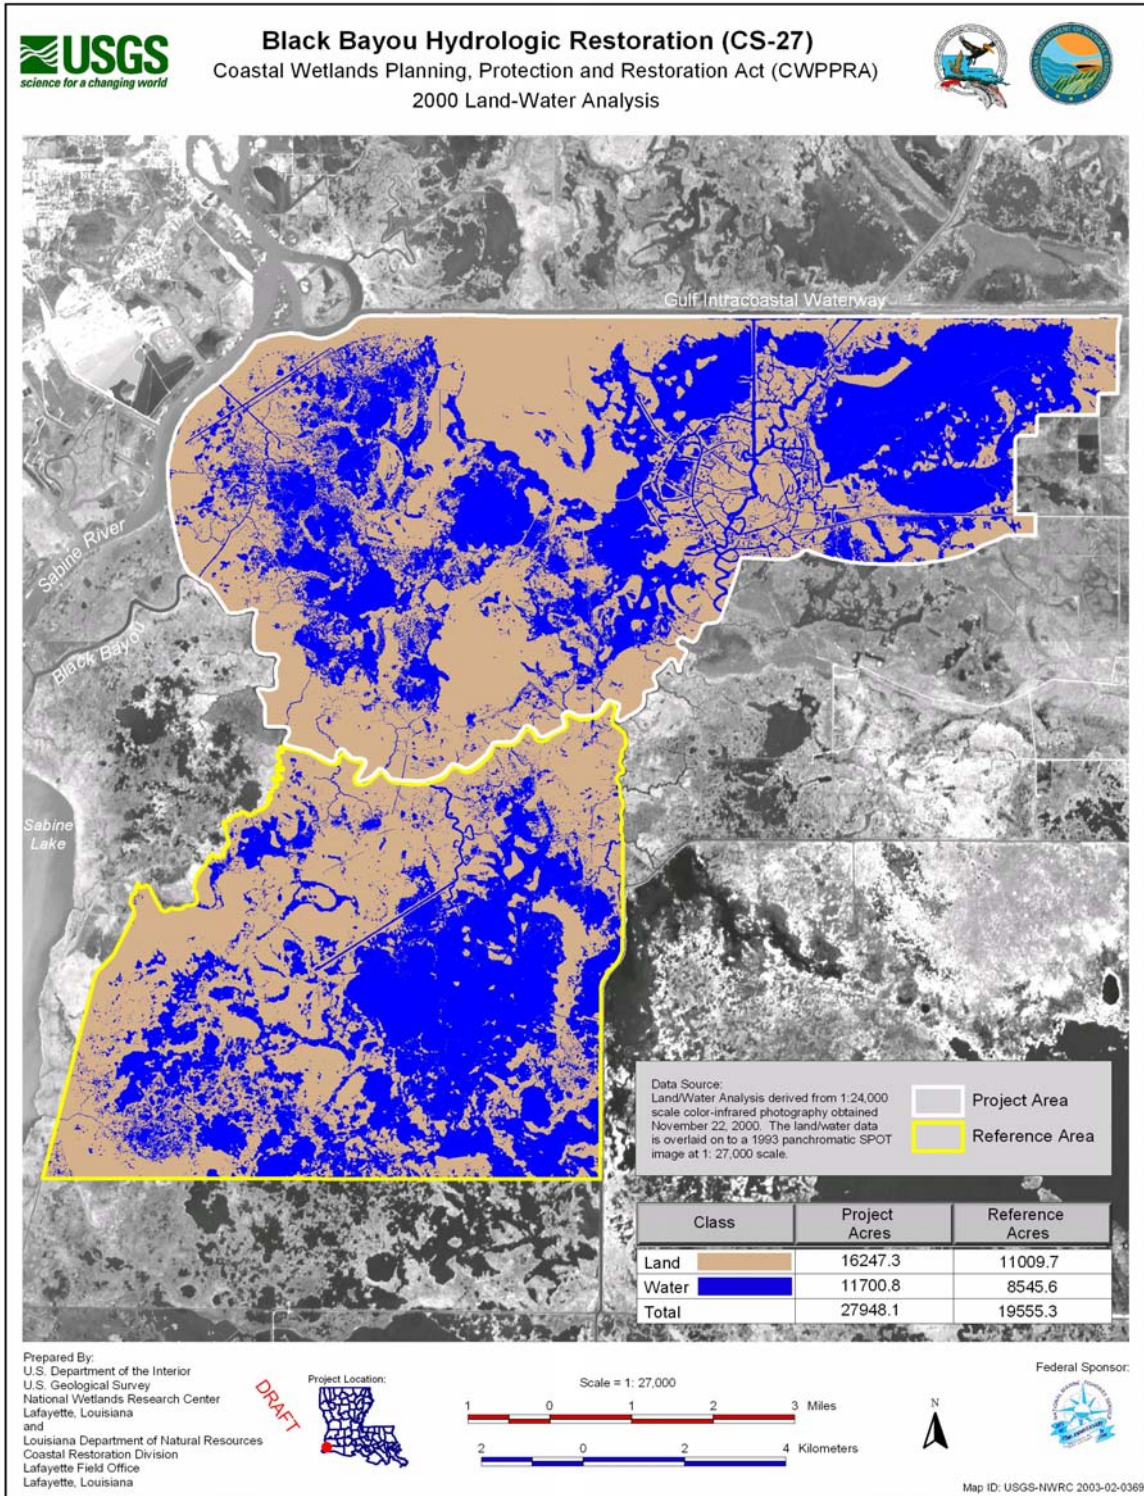
**Figure 6.** Preconstruction land / water analysis of project and reference areas from photography taken November 20, 2000.

Aerial photography was acquired before construction in November 2000, and the area will be photographed again in 2004. The available photography and land water analysis is a preconstruction baseline for year 2000 (figure 6). The project area was 58 % land and 42 % water, and the reference area was 56 % land and 44 % water. Later photography, beginning in 2004 will be compared to the 2000 data to determine land loss or gain.

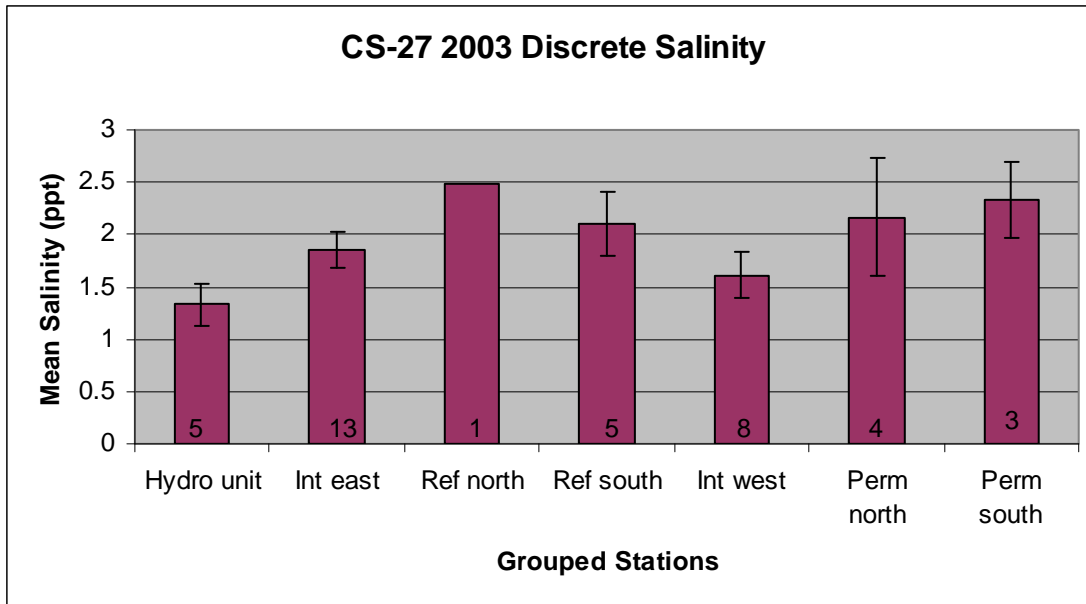
Discrete data show that salinities across the area are very similar with the lowest values in the impounded hydrologic unit (figure 7). The other areas that include stations that are actually within the project structures (Int east, Int west) also had a lower average salinity. The greatest difference was about 1ppt. Inference from this small and inconsistent data set however, should be conservative. Despite some missing data due to equipment malfunctions, continuous recorder data does provide some information. Salinities at station CS27-25, located within the impounded unit behind the self regulated tide gate track those at CS27-22, but high salinities spikes appear muted (figures 8a and b). In February, May, and July, salinity spike maximums are up to 1ppt lower at CS27-25 than CS27-22. Incidences of higher salinity values in August (10 ppt) and September (13 ppt) at CS27-22 occurred during a period of missing data at CS27-25 and no comparison can be made. The salinity charts in the 2002 summary data and graphics report also show a difference during high salinity events. Salinity in the rest of the project area that is not impounded is not measured with continuous recorders and thus comparison to the two other continuous data sets was not meaningful. Salinity means were not calculated because the periods of missing data are at different times for each station and the results would not be representative or comparable. Water levels were typically lower in the hydrologic unit compared to those at CS27-22 at the GIWW / Black Bayou Cutoff intersection (figures 8a and b).
