# **LAKE CHAPEAU SEDIMENT INPUT AND HYDROLOGIC RESTORATION (TE-26)**

## **I. INTRODUCTION**

### **I.1. Project Description**

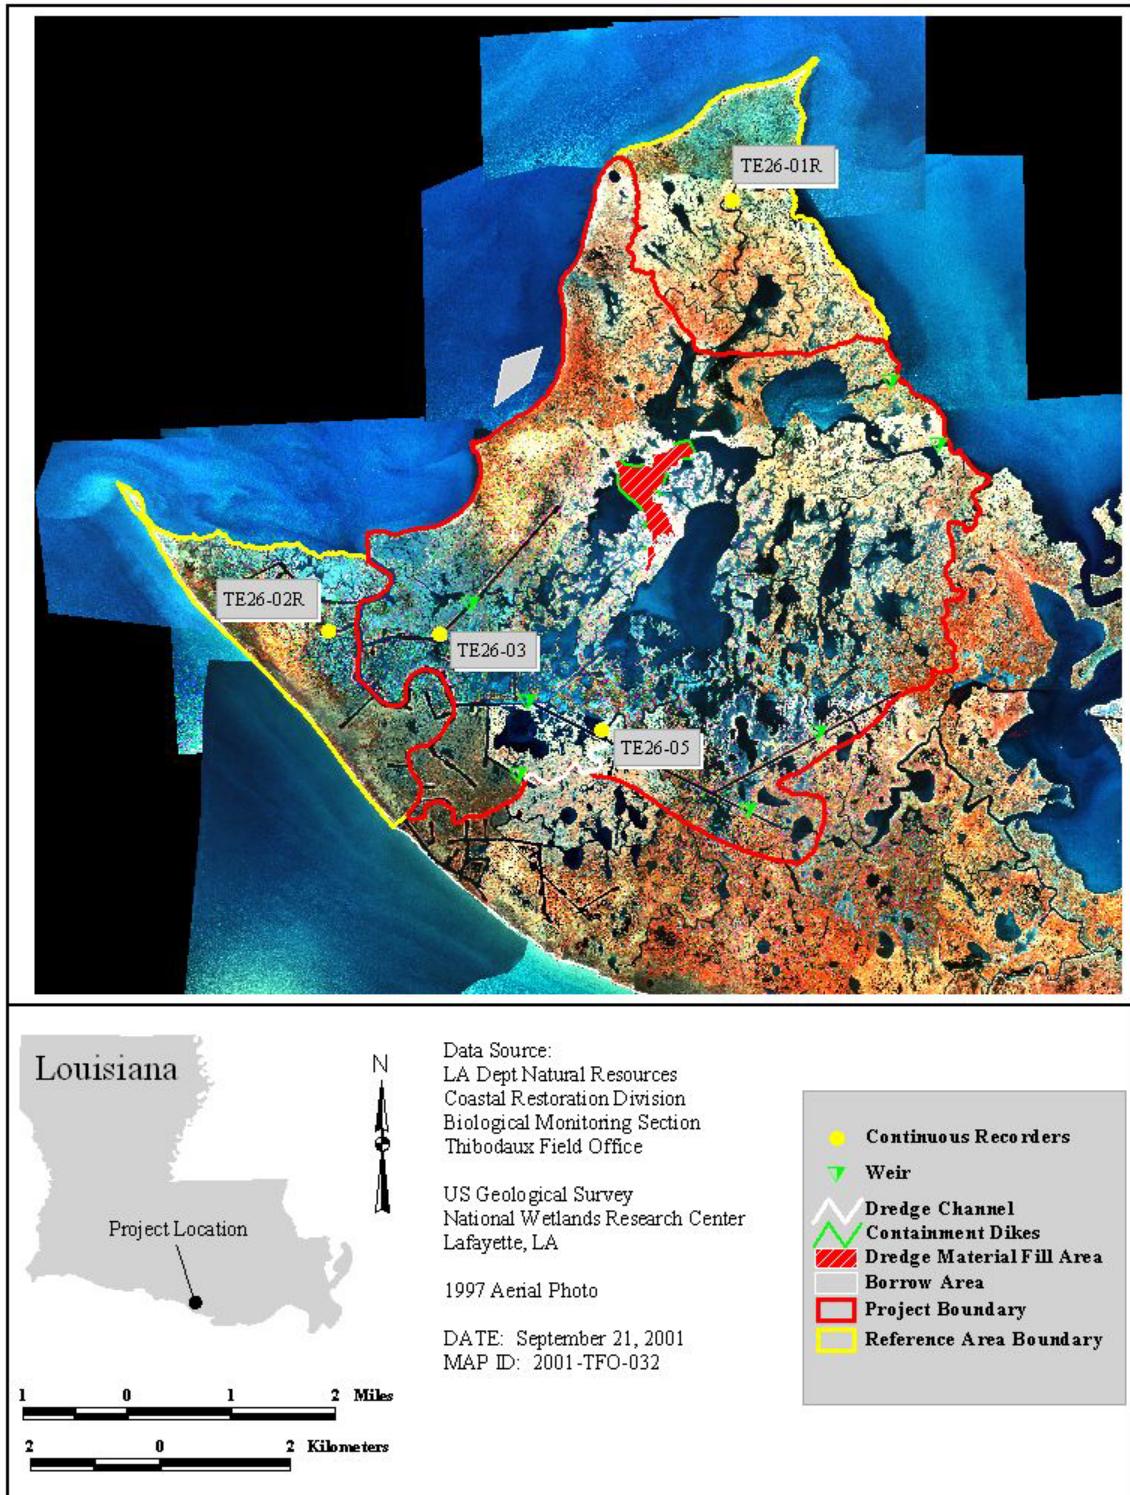
Figure 1. Lake Chapeau Sediment Input and Hydrologic Restoration Project Location and Features (TE-26)

- Sediment hydrologically dredged from Atchafalaya Bay, 300 yards (274 m) off the west central shoreline of Point au Fer Island, was to be pumped over the broken marsh west of Lake Chapeau creating approximately 260 ac (105 ha) of marsh at a mean elevation 1.0 ft (0.3 m) NGVD (figure 1).
- Eight earthen plugs were to be constructed in canals around the fringes of the project area (figure 1).
