## **2011 Operations, Maintenance, and Monitoring Closeout Report.**

### **SWEET LAKE/WILLOW LAKE HYDROLOGIC RESTORATION**

State Project Number CS-11B  
Priority Project List 5

June 2011  
Cameron Parish

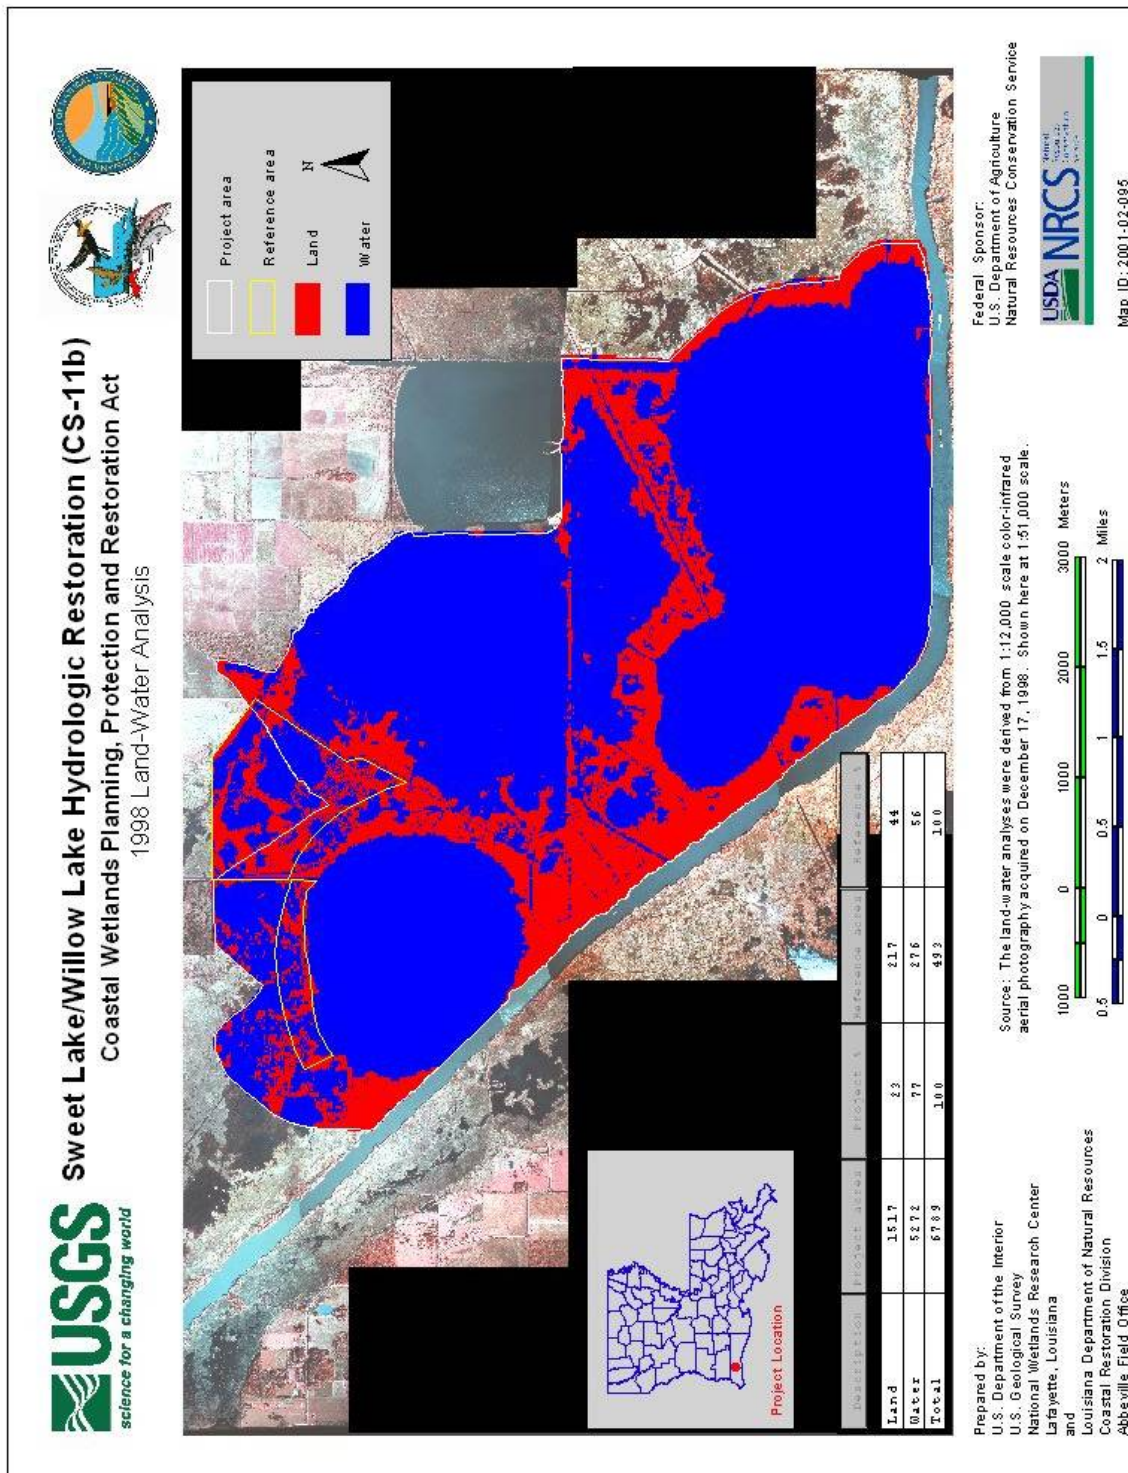
**Figure 4. .** Land to Water analysis of the Sweet/Willow Lake Hydrologic Restoration (CS-11b) project area from photography obtained December 17, 1998.

Land to water analysis for pre-construction photography, collected on December 17, 1998 indicated 23.0% land and 77.0% water within the project area versus 44.0% land and 56.0% water within reference area (figure 4). Due to project ineffectiveness and budgetary constraints post construction land to water analysis was eliminated.

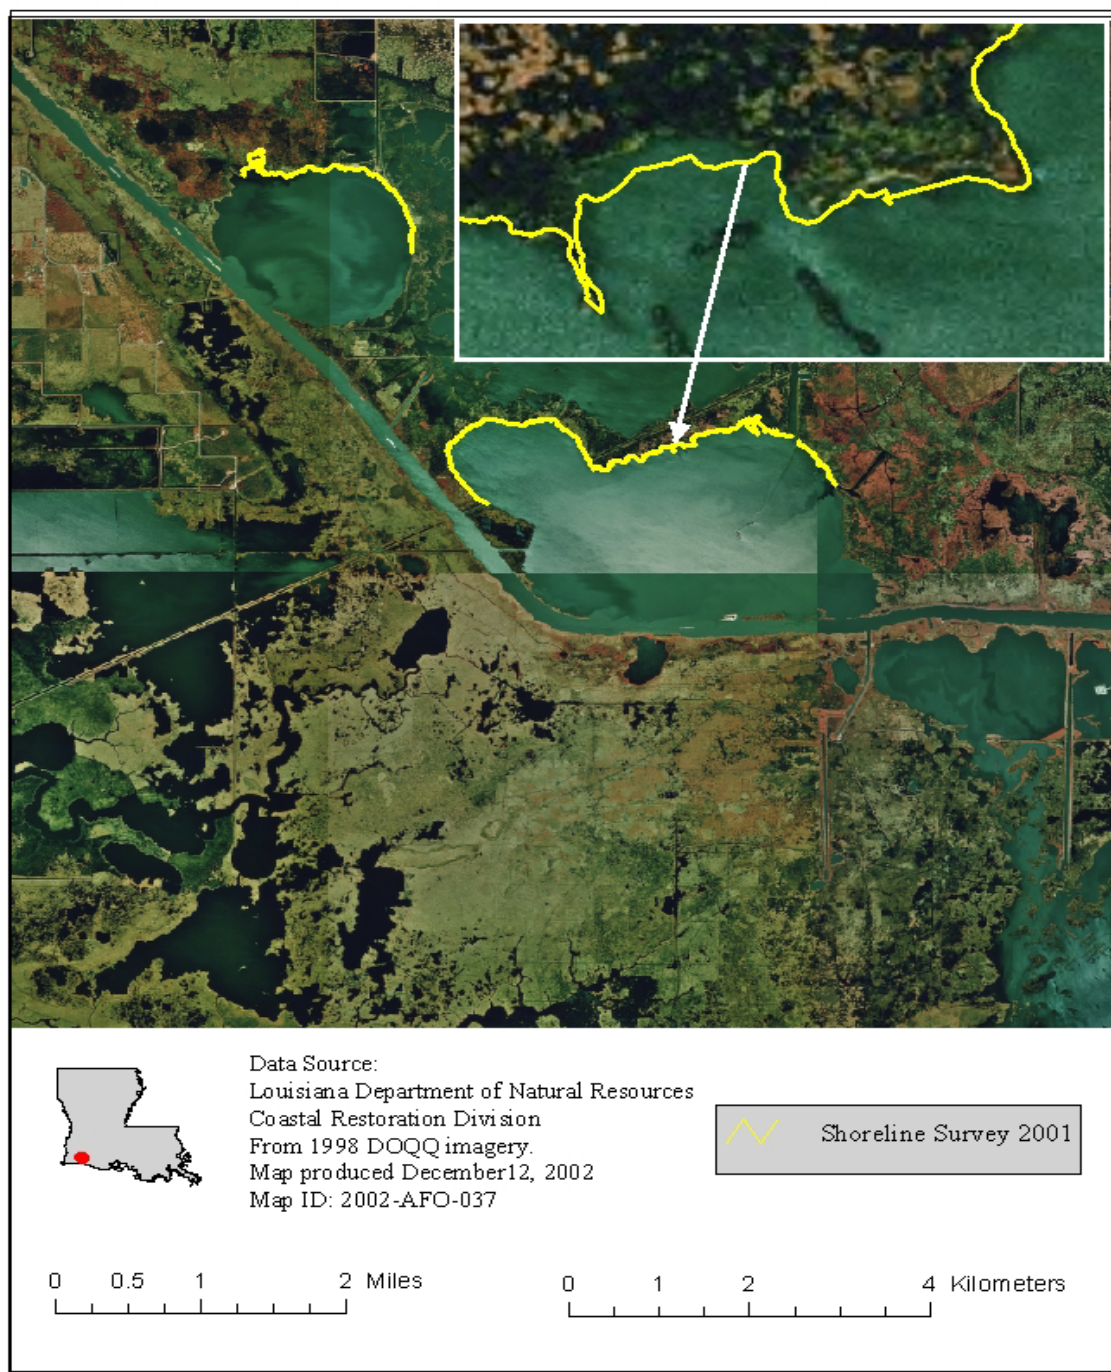
**Figure 5.** Baseline shoreline position survey of the Sweet/Willow Lake Hydrologic Restoration (CS-11b) project area from data obtained August 2001.

DGPS readings to document shoreline position were collected in August 2001 (pre-construction) as baseline data (figure 5). Due to elevated water levels and constant wave poundings, a rapid deterioration of the terraces occurred within the first year. The shoreline

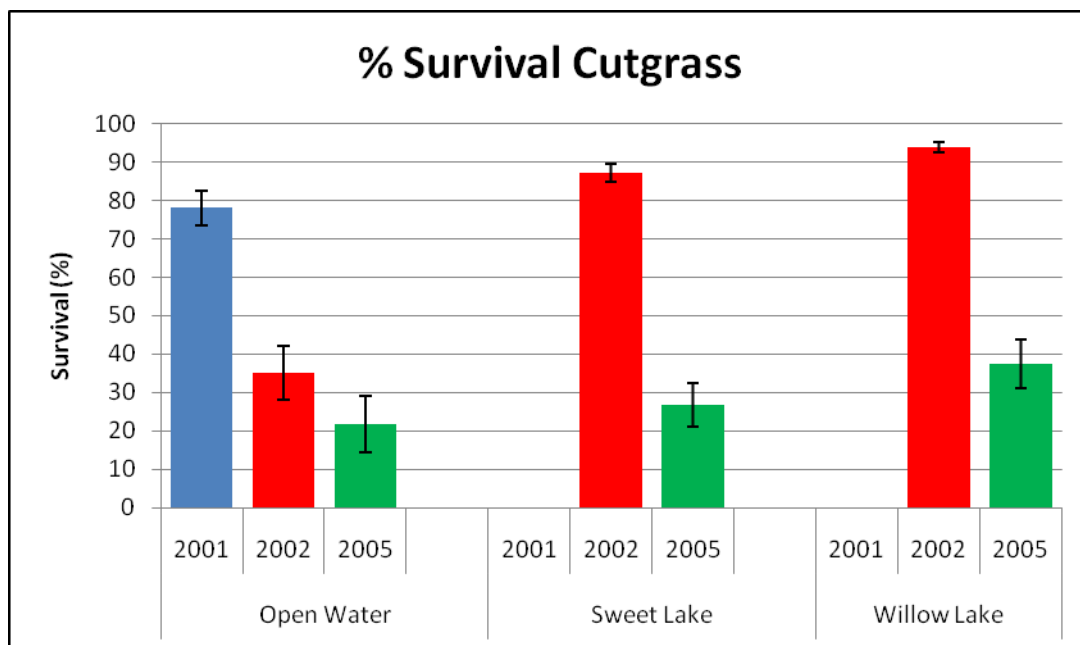
**Figure 6.** Mean Percent survival of cutgrass (*Zizaniopsis miliacea*) plantings on the Open Water, Sweet Lake and Willow Lake terraces for 2001, 2002 and 2005 sampling periods. (Mean Survival = # alive / # planted x 100)

Mean % survival of *Z. miliacea* plantings on the open water terraces from 1 month post planting in 2001, 1 year post planting in 2002 and 3 year post planting in 2005 decreased from 78.1 %, 35.0 % to 21.7 % respectively (figure 6). Mean % survival of *Z. miliacea* plantings on the Sweet Lake and Willow Lake terraces from 1 month post planting in 2002 and 3 year post planting in 2005 decreased from 87.2 %, to 26.7 % and 94.0 % to 37.5 % respectively (figure 6). The decrease in % survival was attributed to elevated water levels, poor soils, and constant wave poundings, causing the terraces to deteriorate rapidly and the plantings to be washed away. Vegetative sampling was discontinued after the 2005 sampling period.

Due to elevated water levels, constant wave poundings, and rapid deterioration of the terraces, most of the plantings were washed away within the first year. The large open water fetches across Sweet Lake and Willow Lake caused the terraces and plantings to be ineffective at meeting the goals of reducing shoreline erosion and decreasing marsh loss within the project area.

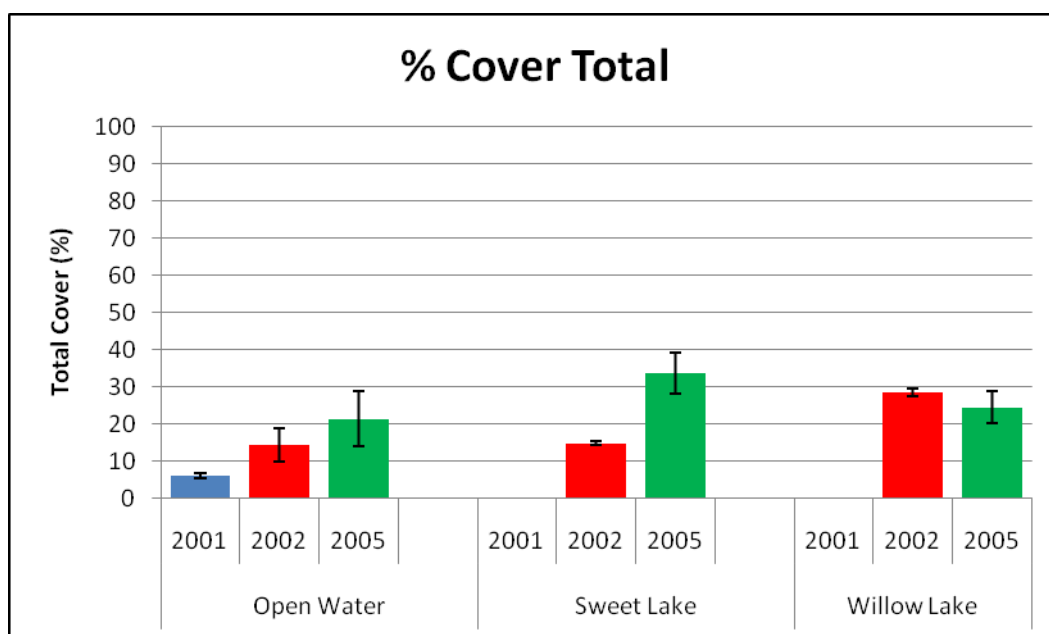
**Figure 7.** Mean Percent Total Cover of cutgrass (*Zizaniopsis miliacea*) plantings on the Open Water, Sweet Lake and Willow Lake terraces for 2001, 2002 and 2005 sampling periods.

Mean % cover on the open water terraces in 2001, 2002 and 2005 increased from 6.15 %, 14.3 % to 21.3% (figure 7). Mean % cover on the Sweet Lake terraces in 2002 and 205 increased from 14.9 % to 33.7 % while the Willow Lake terraces showed a slight decrease of 28.6 % to 24.5 % (figure 7)

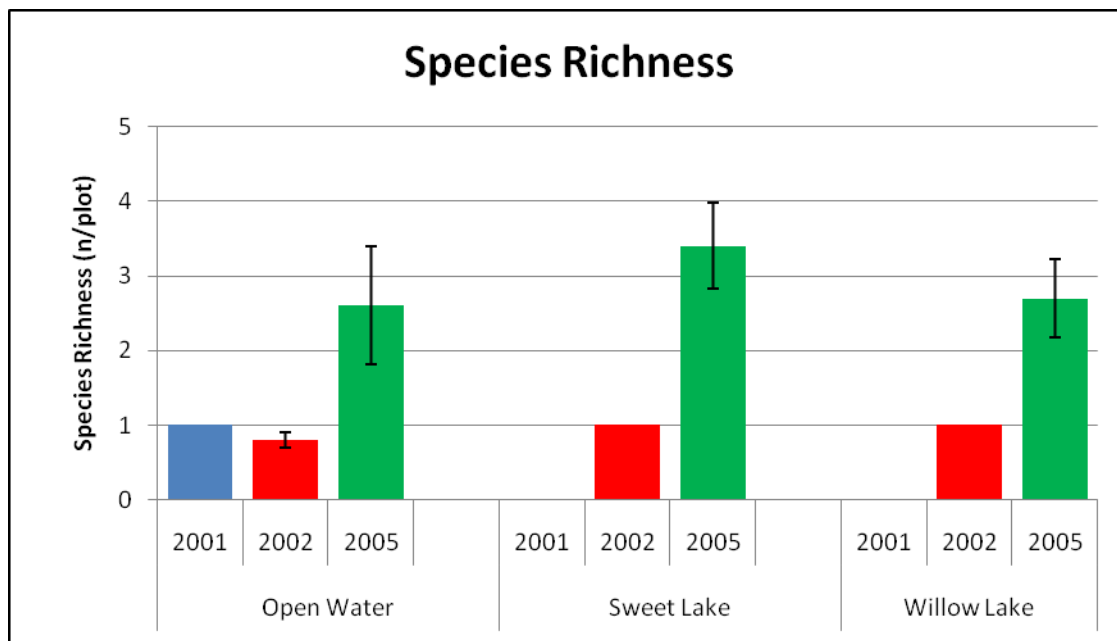
**Figure 8.** Species Richness of vegetation occurring within the Open Water, Sweet Lake and Willow Lake terraces for 2001, 2002 and 2005 sampling periods.

The species richness on the open water terraces in 2001, 2002 and 2005 increased slightly from 1.0%, 0.8% to 2.6% respectively (figure 8). The Sweet Lake and Willow Lake terraces showed an increase in richness of 1.0 % to 3.4% and 1.0% to 2.7 % respectively (figure 8). The increase in % cover and species richness was attributed to the growth of less desirable species occurring within the sampling plots after the *Z. miliacea* plantings were washed away.

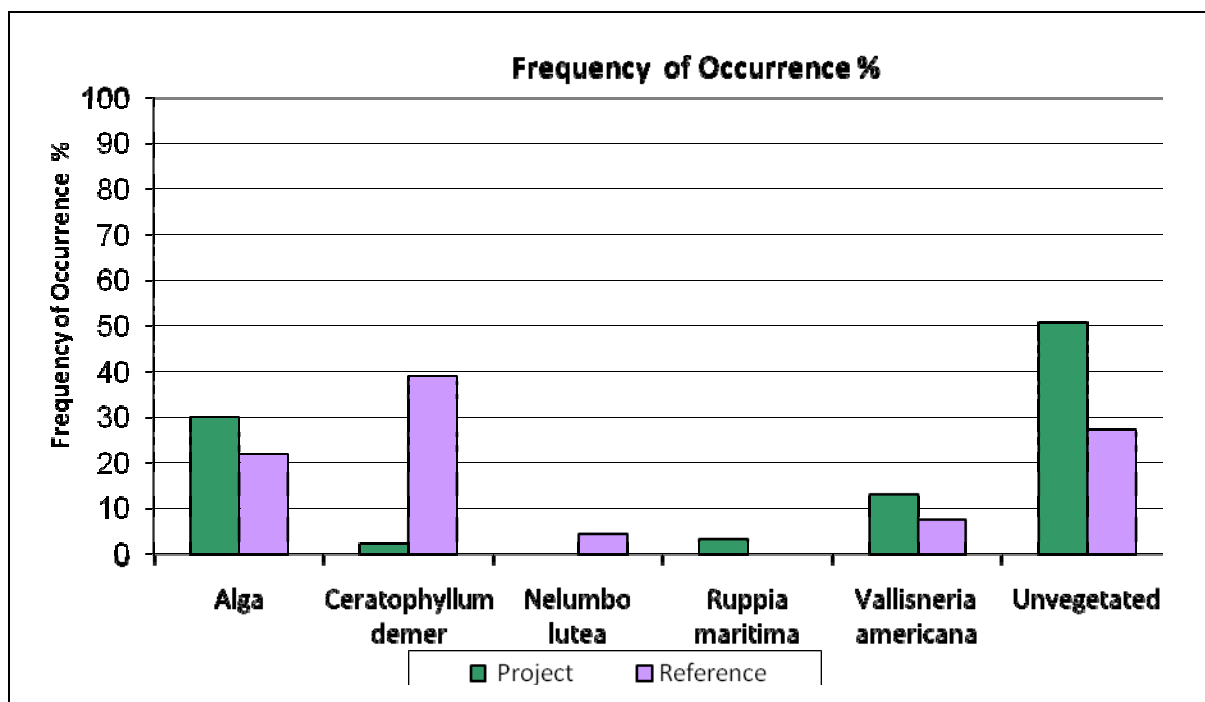
**Figure 9.** 2000 preconstruction data for frequency of occurrence % of submerged aquatic vegetation within the Sweet/Willow Lake Hydrologic Restoration (CS-11b) project and reference areas. (% Occurrence = number of occurrences/number of samples taken x 100).

Data collected pre-construction in May 2000 indicated unvegetated areas within the project and reference areas were 50.9 % and 27.2 %, respectively (figure 9). *Ruppia maritima* (widgeon grass) was found only in the project area while *Nelumbo lutea* (water lily) was found only in the reference area. Species present in both the project and reference area included *Vallisneria americana* (water celery), *Ceratophyllum demersum* (coontail) and an unidentified green alga (figure 9). Based on recommendations from the CRMS review, SAV sampling originally scheduled for 2004, 2009, and 2016 was cancelled. Due to the limited data set and rapid deterioration of the terraces within the first year it is assumed that the project did not meet its goal of increasing SAV.
