**2011 Operations, Maintenance, and
Monitoring Report**

**Grand-White Lake Land Bridge
Protection**

State Project Number ME-19
Priority Project List 10

May 2011
Cameron Parish

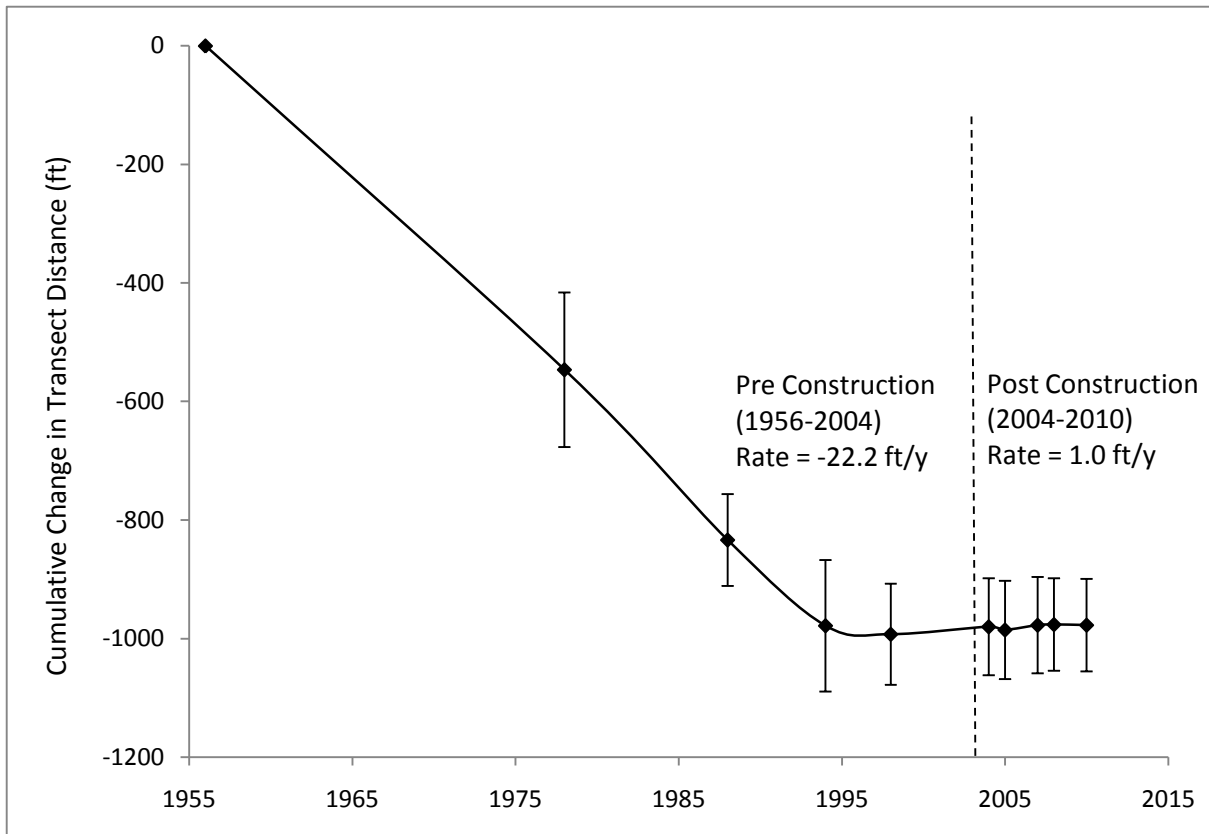
In a historical perspective within the project area, the rate of change in the land-bridge width differed significantly as the land bridge quickly narrowed during pre-construction (1956-2004: -22.2 ft/y [6.6 m/y]) and slowly broadened during post-construction (2004-2010: 1.0 ft/y [0.3 m/y]) periods ($F_1=101.1$; $p<0.0001$). An example of this is at the narrowest width of the land bridge (Transect 9) which shrunk from 1405 ft (428 m) in 1956 to 422 ft (129 m) in 1998 then broadened to 456 ft (139 m) in 2010. Graphically, two trends are predominant; the land bridge sharply narrowed 25.9 ft/y (7.9 m/y) from 1956-1994 while it slightly broadened by 0.5 ft/y (0.15 m/y) from 1994-2010 (figure 4). During the recent time period, the project area held steady during the pre-construction period (1994-2004: 0 ft/y [0 m/y]) and has slowly broadened since construction (2004-2010: 1.0 ft/y [0.3 m/y]).

Figure 4. Historical and post construction change in land bridge width over time (1959-2010) in the ME-19 project area. The values are the means (± 1 SE) for cumulative change in distance of transects ($t_i - t_0$) since 1959 ($n=10$).

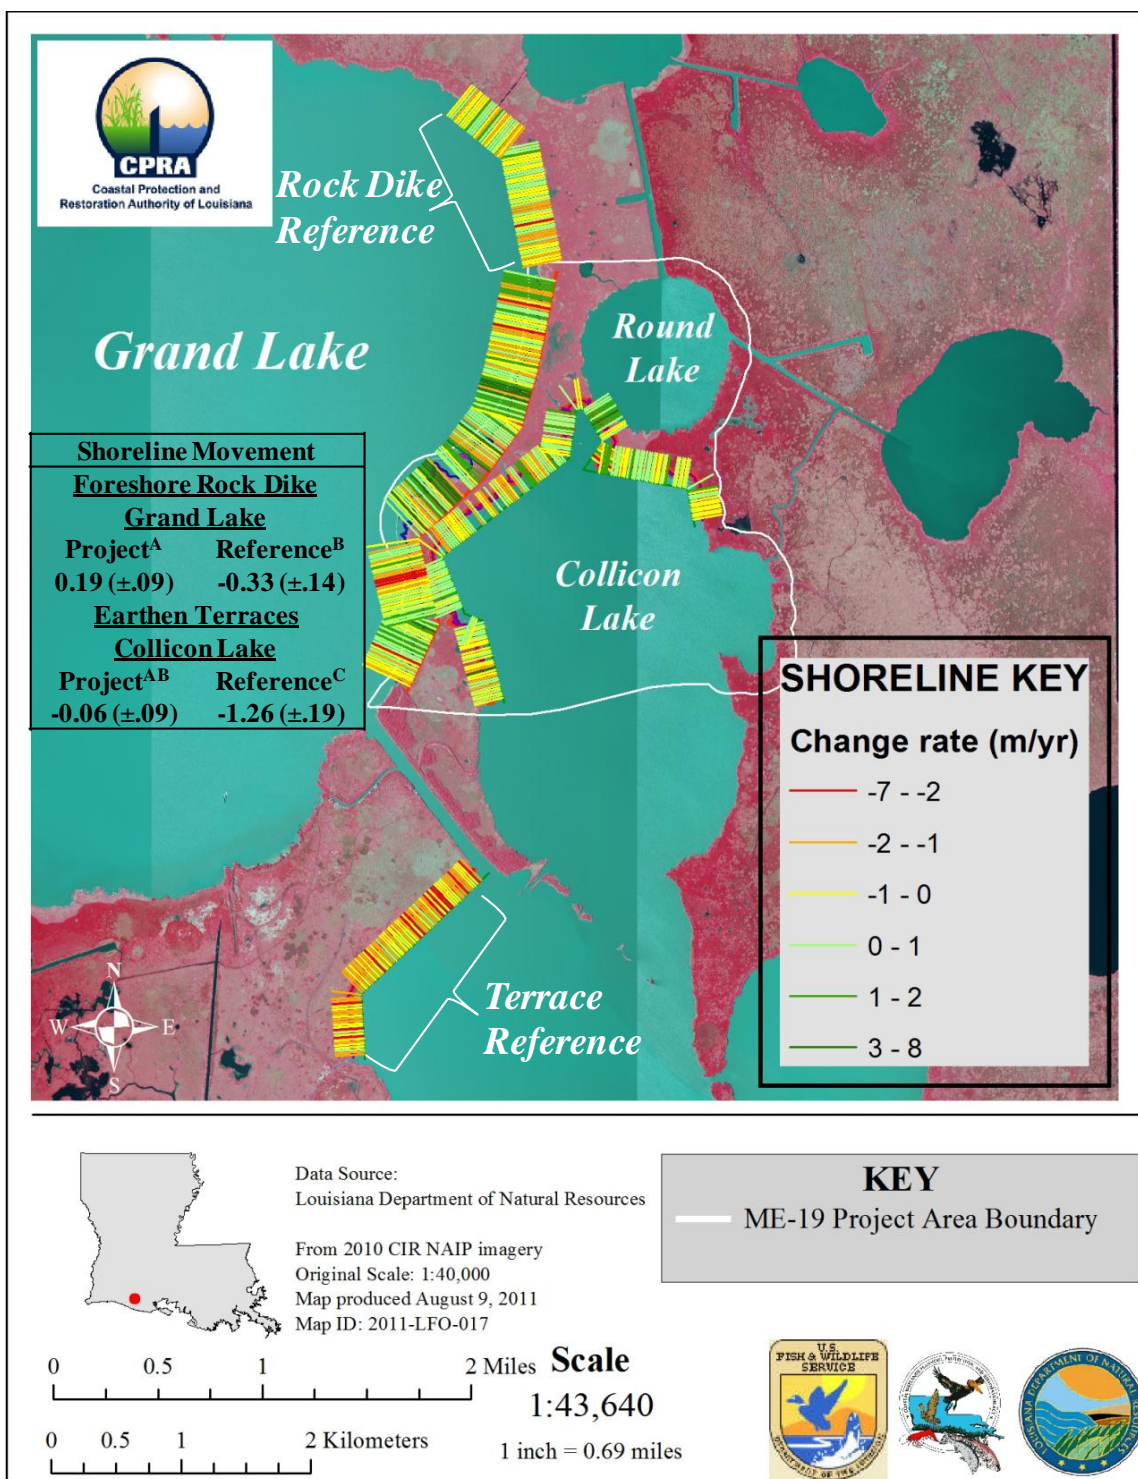
Overall, shoreline change rates from construction to 2008 among the areas were statistically different ($F_3=31.1$, $p<0.0001$, figure 5). The shoreline behind the foreshore dike along Grand Lake was the only shoreline to gain land since construction, and its rate was significantly greater than the reference area to the north (figure 5). The shoreline behind the earthen terraces along Collicon Lake slightly receded overall since construction, and it eroded at a significantly lesser rate than the reference area to the south which experienced the greatest erosion of the areas (figure 5). Although the shoreline advanced behind the foreshore dike along Grand Lake and slightly receded behind the terraces along Collicon Lake, the terraces (1.2 m/y less loss than its reference) reduced shoreline loss about twice as much as the foreshore dike (0.52 m/y less loss than its reference) relative to their references as shoreline erosion was greatest along the Collicon Lake reference area (figure 5, note inset table). Shorelines where terrace and land bridge vegetation merged (Roseau cane and alligator weed; picture 1) were not included in the analysis because the vegetation was floating on the water and not emergent; however, they will be included if the vegetation roots into the underlying sediment and converts from floating into emergent land.

Figure 5. Shoreline mapping was conducted behind project structures (foreshore rock dike along Grand Lake and terraces along Collicon Lake) and corresponding reference areas of the ME-19 project area soon after construction (foreshore rock dike, November 2003; terraces, October 2004) and in October 2008. Shoreline movement rates (mean±SE m/y) were calculated from 20 m spaced transects along Grand Lake and Collicon Lake; negative change rates indicate loss while positive change rates indicate gains. Different letters in inset table indicate significantly different rates among areas (Tukey's Honest Significant Difference post-test; $\alpha = 0.05$).

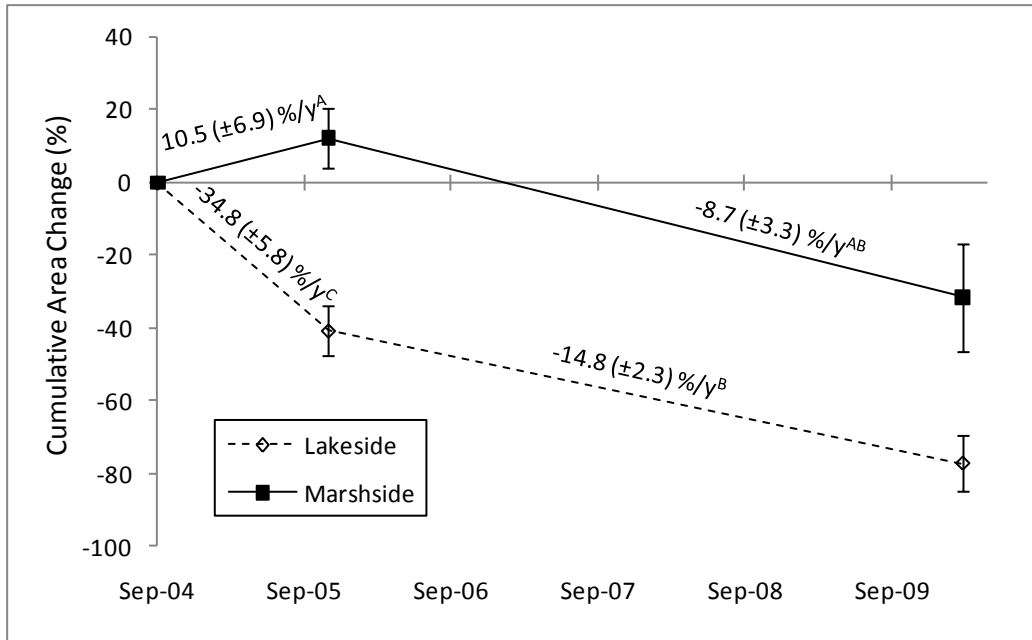
Of the twelve terraces selected for vegetative evaluation (6 lakeside and 6 marshside), erosion was much greater from lakeside (14 %/y) than marshside (6 %/y) terraces from construction to March 2010 ($r^2=0.43$; $F_{1,1}=7.65$; $p=0.0199$). Percent change in terrace area was different between the terrace locations (lakeside and marshside) over the time intervals (2004-2005 and 2005-2010) ($r^2=0.64$; $F_{1,1}=15.94$; $p=0.0007$; figures 6 and 7). Initially after construction (2004-2005), % terrace area diverged as the sacrificial lakeside terraces sharply eroded (picture 2) while the buffered, marshside terraces expanded (figure 6). Assessment of the high rate of lakeside terrace loss (2004-2005) is confounded by immaturity of the plantings in a highly exposed environment and the effects of Hurricane Rita. The initial and continued (although significantly reduced) loss of the lakeside terrace area decreased the protection of the marshside terraces as they eroded from 2005-2010 (figures 6 and 7).

Figure 6. Terrace areas were determined for the Collicon Lake terraces for September 2004 (as-built), November 2005, and March 2010. Cumulative percent change in area since construction was calculated and plotted (means±SE). Rates of percent change (values over lines) interactions were compared for terrace location (lakeside and marshside) by time intervals (2004-2005 and 2005-2010); exclusively different superscript letters indicate significant difference.

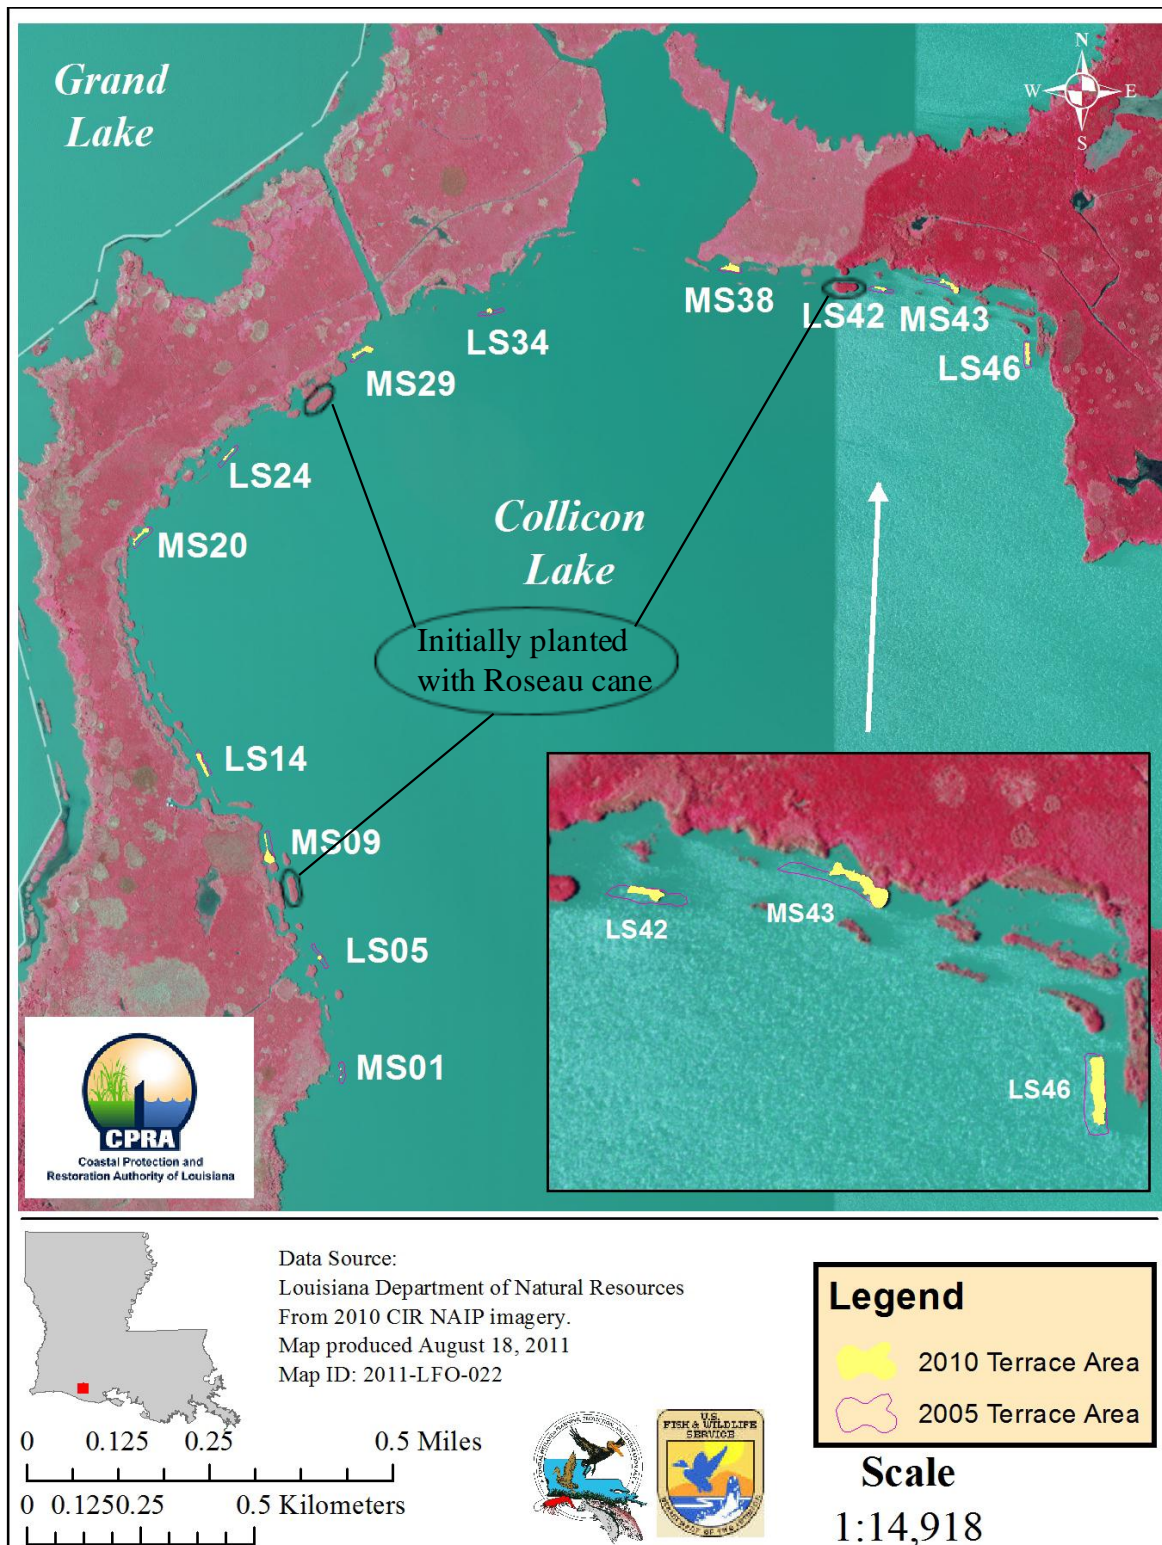
Figure 7. 2005-2010 land change analysis of ME-19 terraces along Collicon Lake used for vegetation analysis indicates that marshside (MS, 9 %/y) and lakeside (LS, 15 %/y) terraces have lost area. From construction (September 2004) to 2010, MS terrace area decreased by 32% while lakeside LS terrace area decreased by 77%.

Although the lakeside terraces were initially effective at buffering the marshside terraces, the high rate of lakeside terrace loss has made the marshside terraces vulnerable. The wind fetch across Collicon Lake from all directions is large enough to allow for the sizeable wave generation that has degraded the earthen terraces. In terms of vegetation used as armor, *Phragmites australis* (Roseau cane) has been effective in maintaining terraces thus far; however, high water-levels will not allow for a successful planting event.

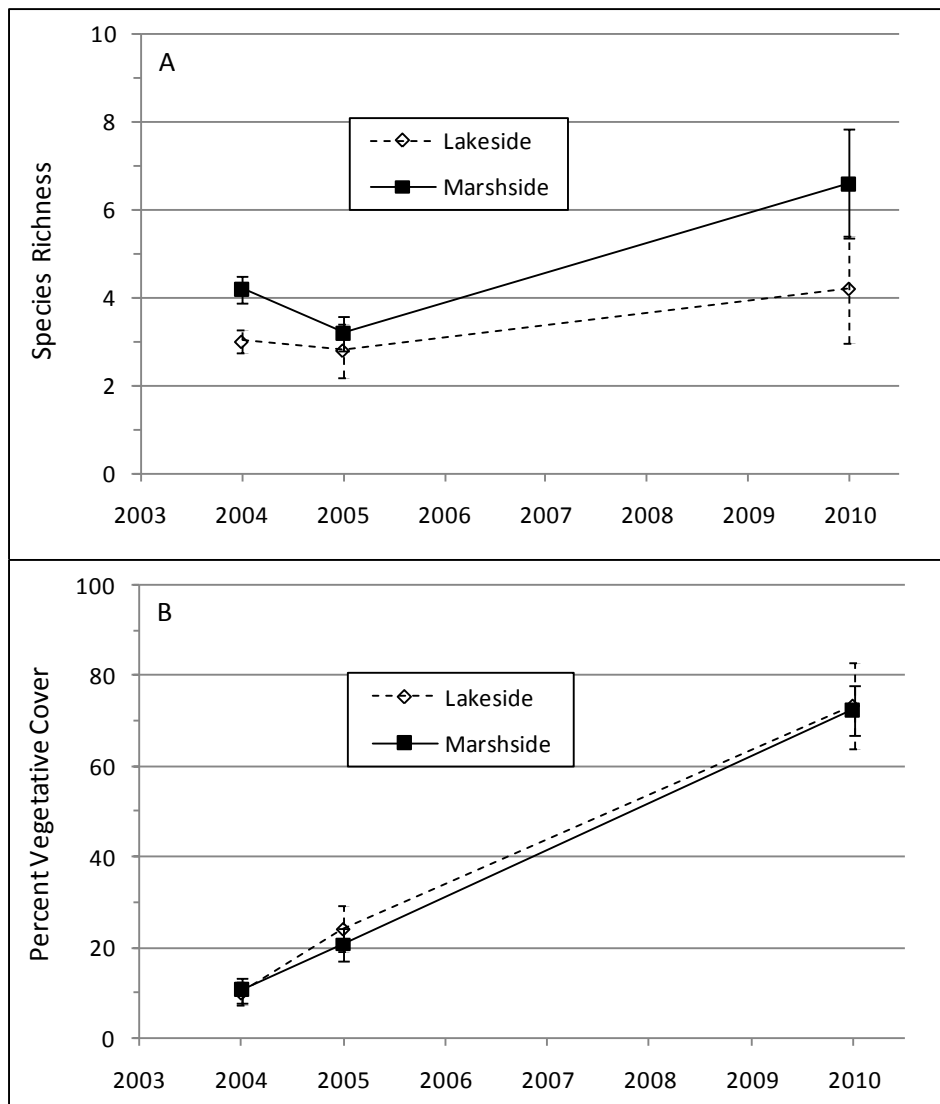
Vegetation has matured over time on the remaining terrace area as both species richness and percent vegetative cover increased since construction (Table 1; figure 8). Species richness was greater on the marshside terraces which are closer to the marsh and buffered from wave energy by the lakeside terraces. Species richness increased over time after an initial dip in 2005 caused by Hurricane Rita (Thibodeaux and Guidry 2007). Since construction (2004) and Hurricane Rita (2005), the percent vegetative cover of the remaining terrace area increased by 3.5 times as of 2010.

Figure 8. Species richness (A) and percent vegetative cover (B) over time collected on terraces along Lake Collicon in ME-19. Values are means and standard errors of 6 terraces.
