**2007 Operations, Maintenance,
and Monitoring Report**

**LAKE CHAPEAU SEDIMENT
INPUT AND HYDROLOGIC
RESTORATION, POINT AU FER
ISLAND**

State Project Number TE-26
Priority Project List 3

June 15, 2007
Terrebonne Parish

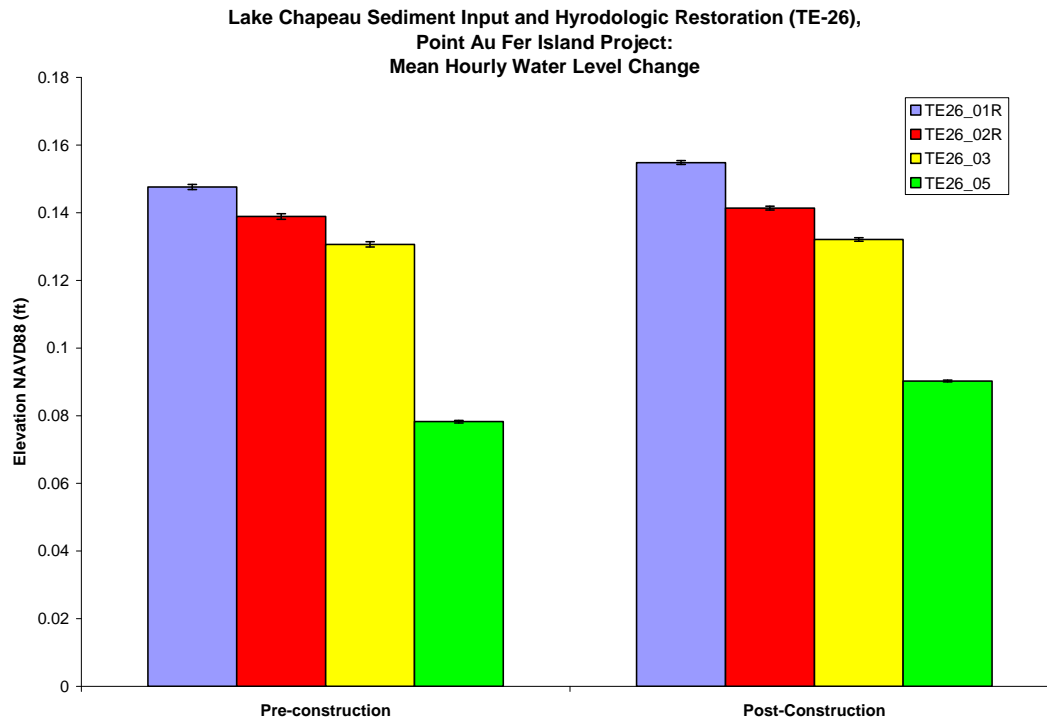
Results for the individual stations separated by pre- and post-construction data showed a significant difference ($p < 0.0001$) for stations TE26-01R and TE26-05. Figure 12 illustrates the mean hourly water level change along with the standard deviation. When the data were analyzed using project and reference areas, i.e., TE26-01R and TE26-02R combined and TE26-03 and TE26-05 combined, the results showed a significant difference ($P < 0.0001$). However, the mean hourly change only increased by 0.0058 feet. As with the station data the difference was less than 0.1 feet. These results may be statistically different, but ecologically the difference is not significant at this time.

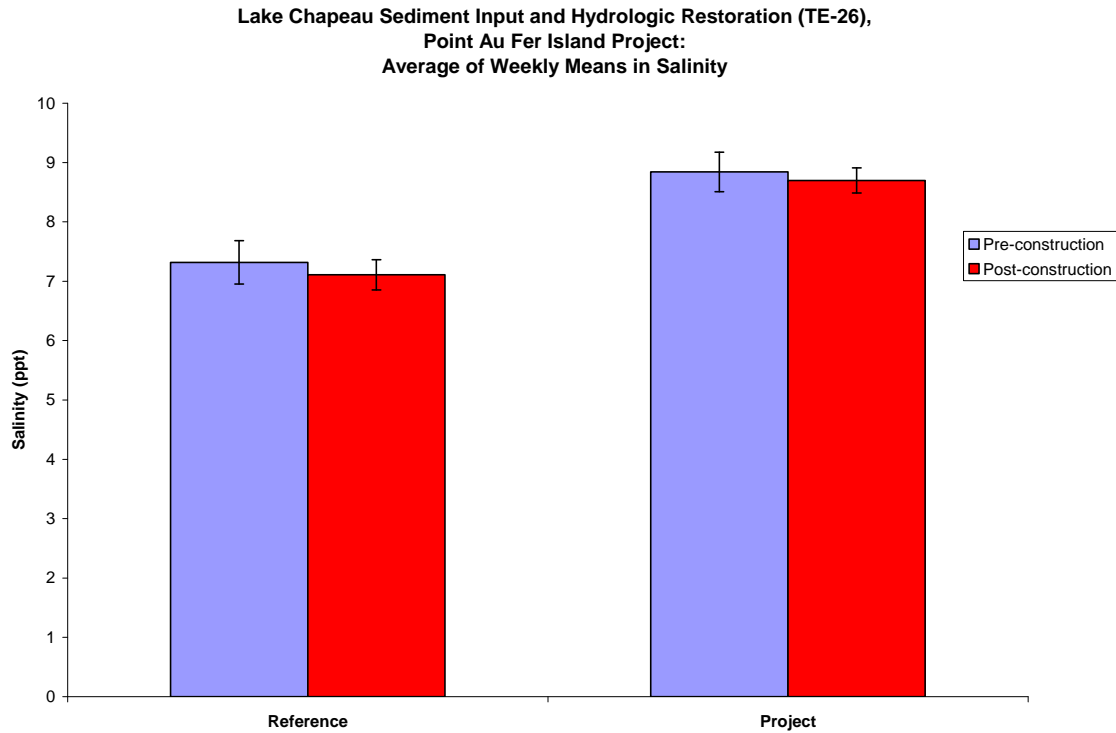
Analysis of the salinity was also conducted using average weekly means to reduce the effects of diurnal tides. However, these differed from the water levels in that while the project and reference were significantly different from each other ($P < 0.0001$) the project had no effect on salinity (figure 13). Analysis by station showed no significant changes in any individual stations pre- to post-construction (table 4; figure 14). The average weekly mean salinity for both project and reference stations trended either slightly higher or lower.

This indicates that while there may be some project effect on average weekly water levels it is not enough to affect salinity.

As indicated in figure 13, the lower mean readings for salinity for the reference area may be attributed to the location of the TE26-01R station. It is approximately 5.5 miles northeast of TE26-02R and more influenced by the Atchafalya river stages, while the stations on the southern end are more influenced by the gulf waters because of their proximity. Figure 14 shows the 5-6 ppt difference in weekly means as compared to the other stations.

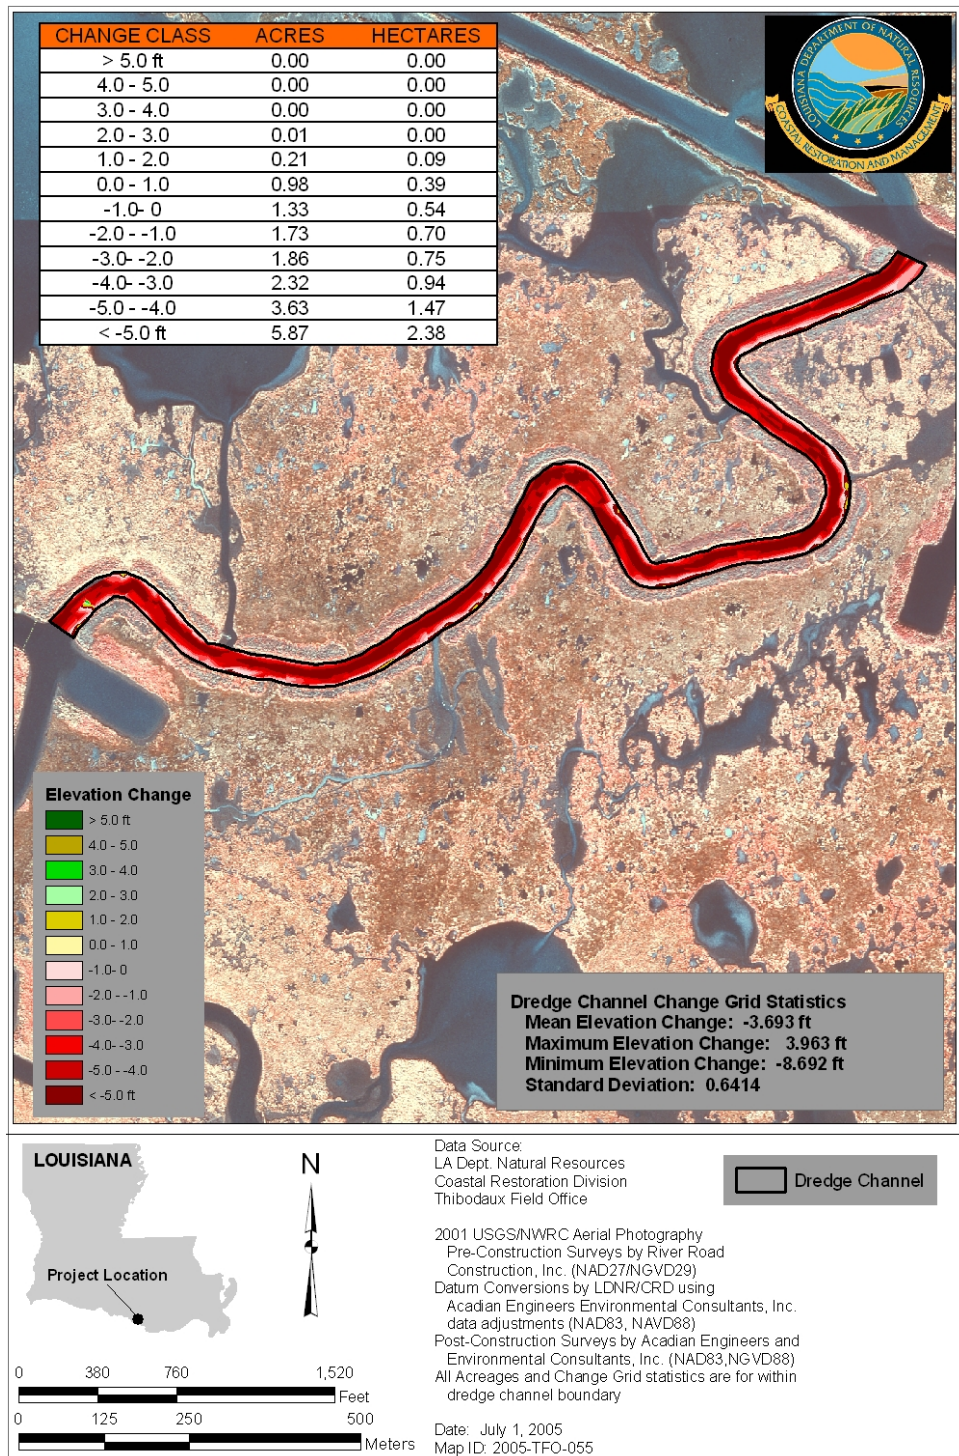
Figure 19. Change class acreages for the pre-construction (1999) versus post-construction (2004) elevation surveys of the Locust Bayou dredge channel for the Lake Chapeau Sediment Input and Hydrologic Restoration, Point Au Fer Island (TE-26) project.

Dredging of the Locust Bayou channel created an overall mean elevation change of -3.693 ft between pre-construction and post-construction (figure 19). Change analysis indicates that the channel continued to deepen after the dredge event, though the mean elevation change (-0.924 ft) was not as pronounced between the as-built and post-construction surveys (figure 18) as the mean elevation change (-2.777 ft) between the pre-construction and as-built surveys (figure 17). Also, it appears from the analysis in figure 18 that once the dredge material was placed along the bank lines, some material sloughed off into the channel and was transported by the current and re-deposited in curves along the bayou, while the channel continued to deepen. Since the change analysis is limited to an area inside the channel fixed by the extent of where the three surveys overlap, it does not capture all of what is going on adjacent to the channel. The continued deepening of the channel five years after the dredge event may be the result of an increased flow of water from the north as a result of the marsh creation (fill area). Water from the northern portion of the project is now focused to Lake Chapeau and through Locust Bayou, having a

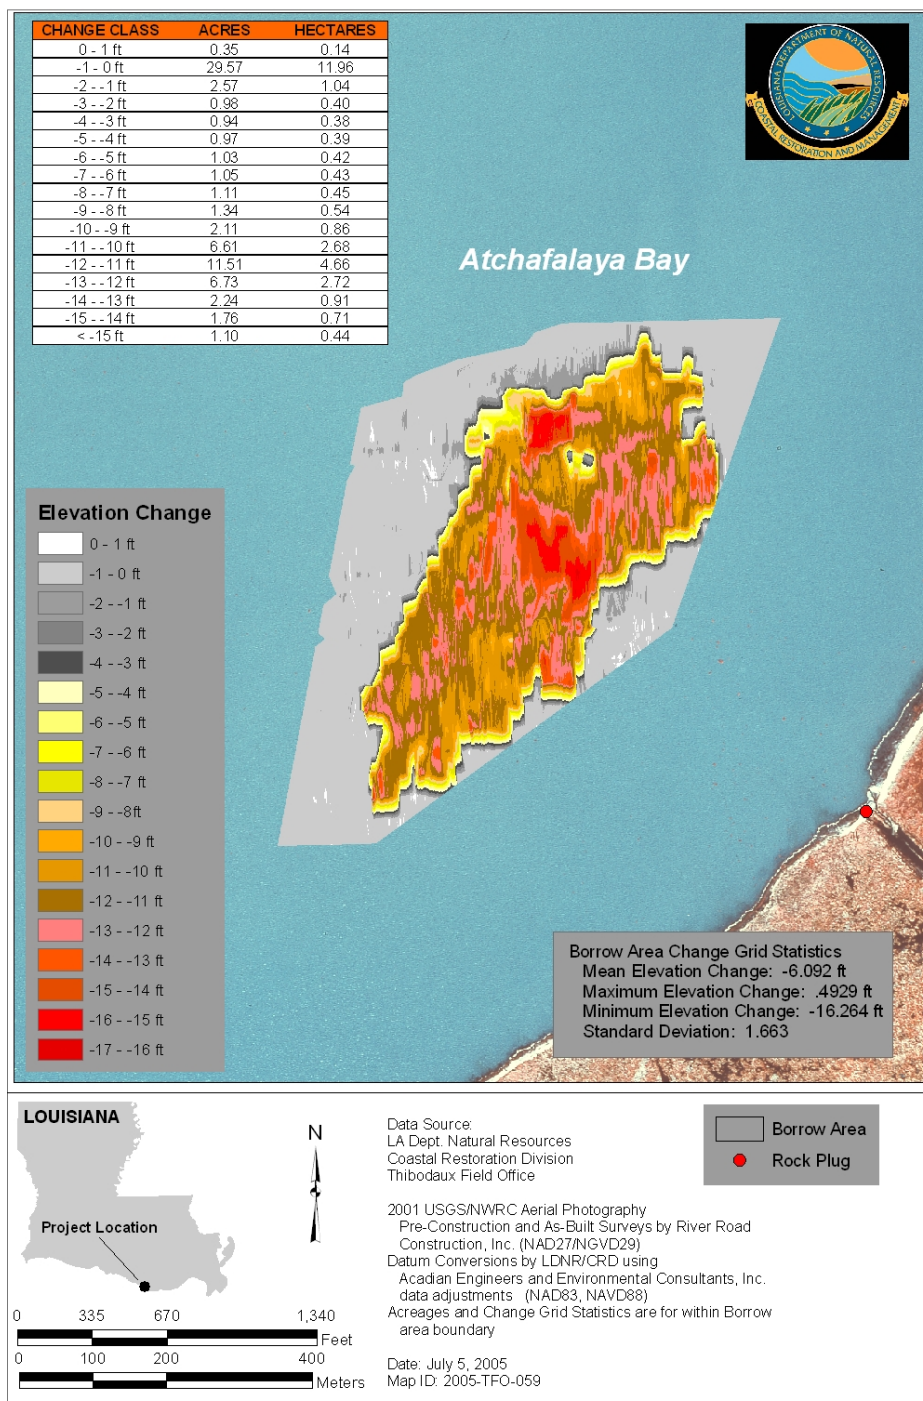
Figure 23. Change class acreages for the pre-construction (1999) versus as-built (1999) elevation surveys of the borrow area for the Lake Chapeau Sediment Input and Hydrologic Restoration, Point Au Fer Island (TE-26) project.

From pre-construction to post-construction the overall mean elevation change was -0.3618 ft, with most of the change (51.91 ac) occurring in the -1 – 0 change class range (figure 25). The greatest mean elevation change of -6.092 ft occurred between the pre-construction and as-built surveys (figure 23), and is attributed to the dredging of the borrow area. Conversely, an almost equal mean elevation change (5.696 ft) occurred between the as-built and post-construction surveys, but in the positive range. It appears that the borrow area has filled in only five years after construction. The mean elevation change from pre-construction to post-construction was minimal and it appears the borrow area served as a natural sink where sediment is trapped. This has made it possible for the borrow area to be used again for future dredge events, depending on the fill material composition.

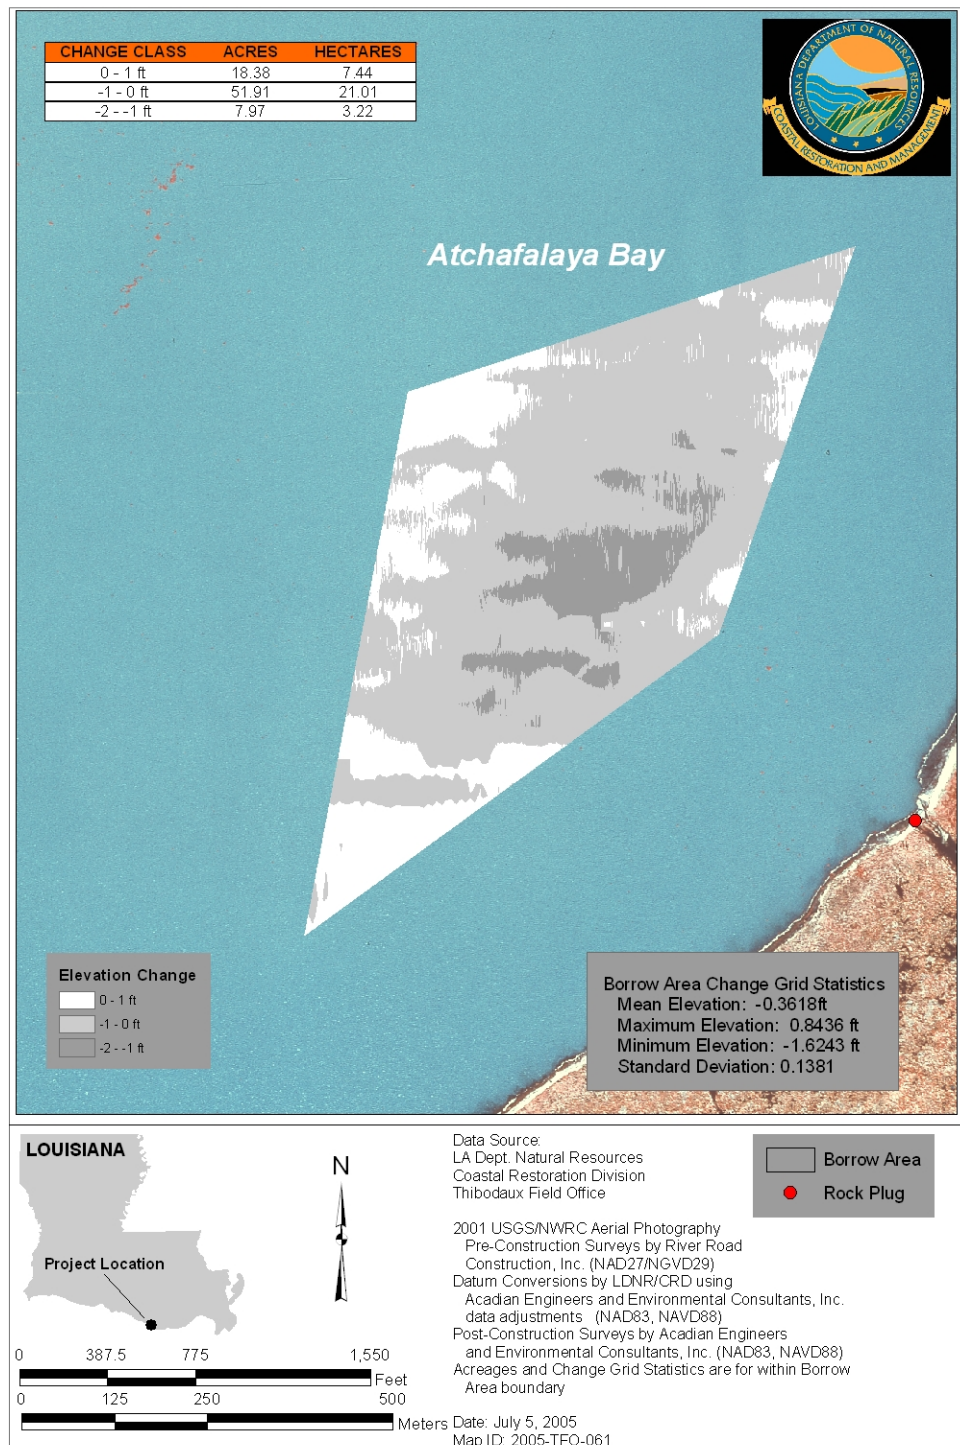
Figure 25. Change class acreages for the post-construction (2004) versus pre-construction (1999) elevation surveys of the borrow area for the Lake Chaupeau Sediment Input and Hydrologic Restoration, Point Au Fer Island (TE-26) project.
