## 2011 Operations, Maintenance, and Monitoring Report

### Lake Chapeau Sediment Input and Hydrologic Restoration, Point Au Fer Island (TE-26)

State Project Number TE-26  
Priority Project List 3

August 2011  
Terrebonne Parish

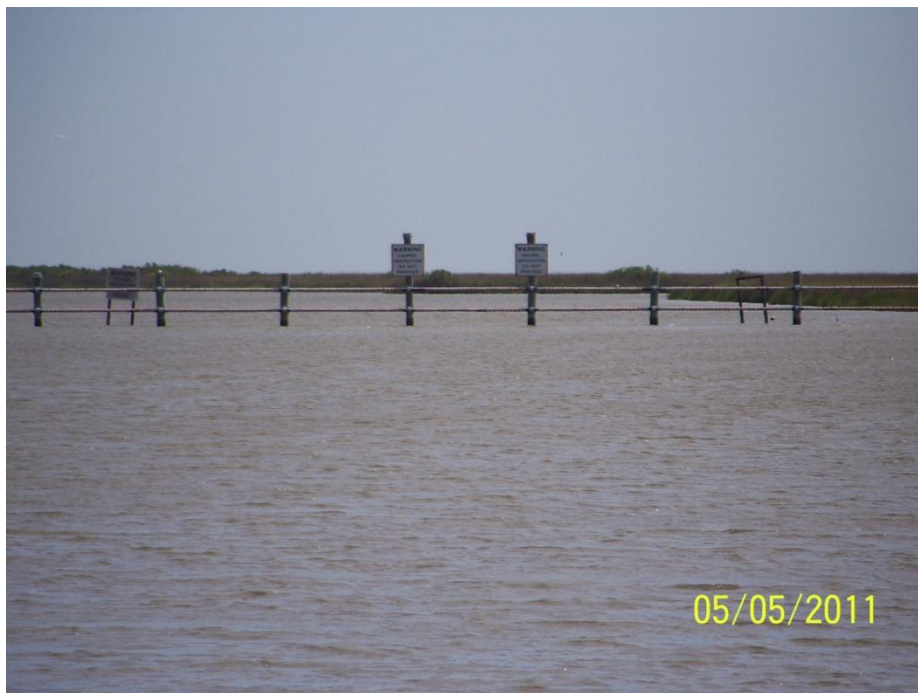
A close inspection of Site No.1 was not possible due to a floating gate located approximately 500' southwest of the rock weir, preventing access to the canal. The rock weir appeared to be in good overall condition. There are no visible signs of erosion or breaching around the embankment tie-ins. The timber barricade system and warning signs also appeared to be in good overall condition. Two (2) timber piles were identified in the 2009 Annual Inspection to be missing their protective galvanized cap. Due to the floating gate, we were unable to get close enough to the structure to determine if these timber piles have experienced any deterioration due to weathering. The latest elevation data available from the 2004 survey profile of the structure indicates that the crest of the rock weir has settled approximately 1.39' since 1999. The newly set TE26-07 data recorder station, located approximately 600' from the structure, was reading a tide level of 1.0' NAVD88 at 10:25 AM, the time of the inspection of Site No. 1. (Appendix A, Photos 1 - 6)

Photo #4: View of Site No. 1 in oil field access canal off of Locust Bayou, looking northeast

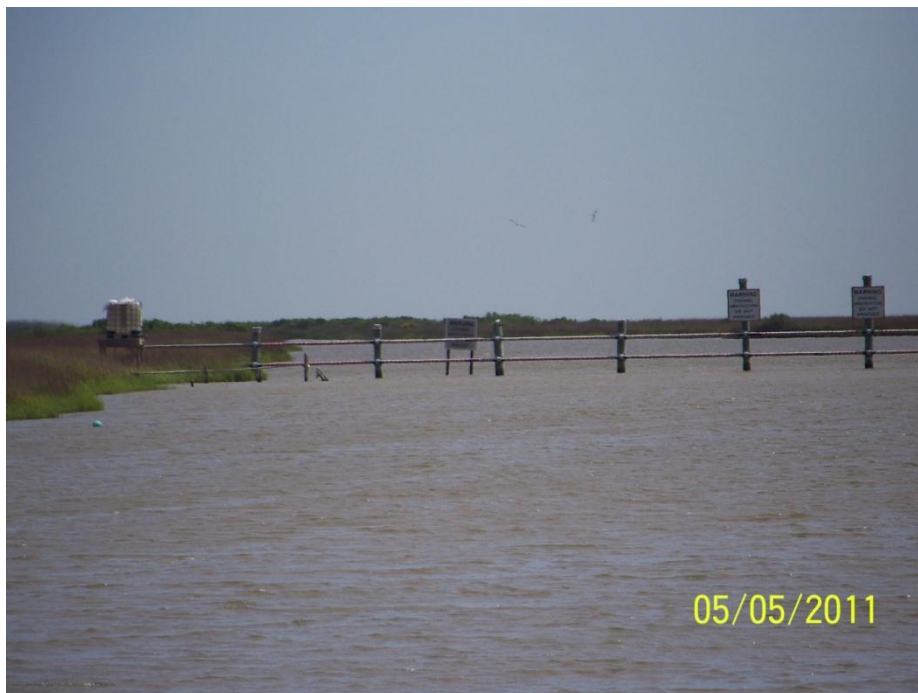
Photo #6: View of Site No. 1 embankment tie-in on northwest side of structure, looking northeast

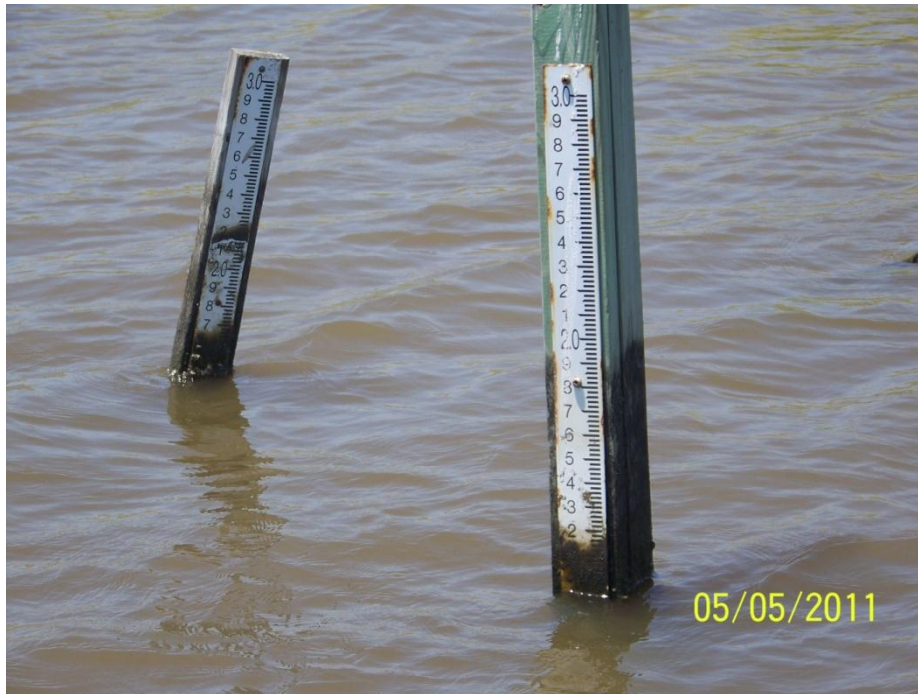
Photo #17: Staff gauge TE26-05 located near Site No.6 used to determine water level during inspection

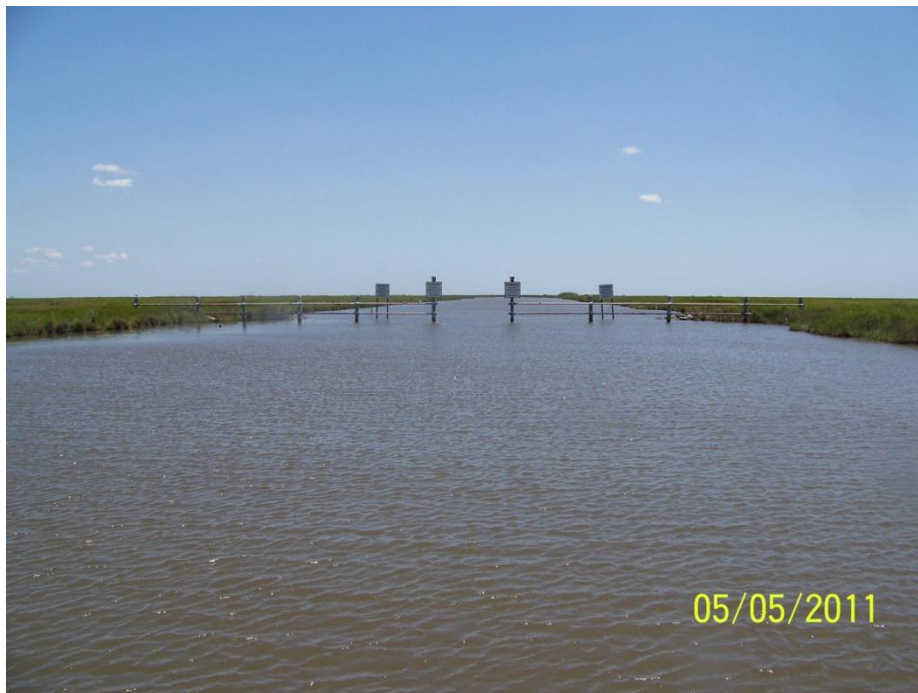
It was discovered during the 2008 Annual Inspection that the timber barricade system in front of the structure had been vandalized. Large sections (approximately 10 feet) on both of the steel pipe cross members had been cut with a torch and are missing. It remains our opinion that an attempt to repair the damage would be unsuccessful; therefore there are no recommendations for corrective actions at this time. Other than the cut sections, the barricade systems is in good condition with no signs of damage or corrosion. The rock weir appeared to be in good overall condition with no signs of erosion or breaching around the embankment tie-ins. The warning signs and supports are also in very good condition. From the 2004 profile survey of the structure, it was determined that the rock weir had settled an average of approximately 1.1 ft. (Appendix B, Photos 18 - 21)

Photo #18: Overall view of Site No.6 rock weir and barricade system, looking east

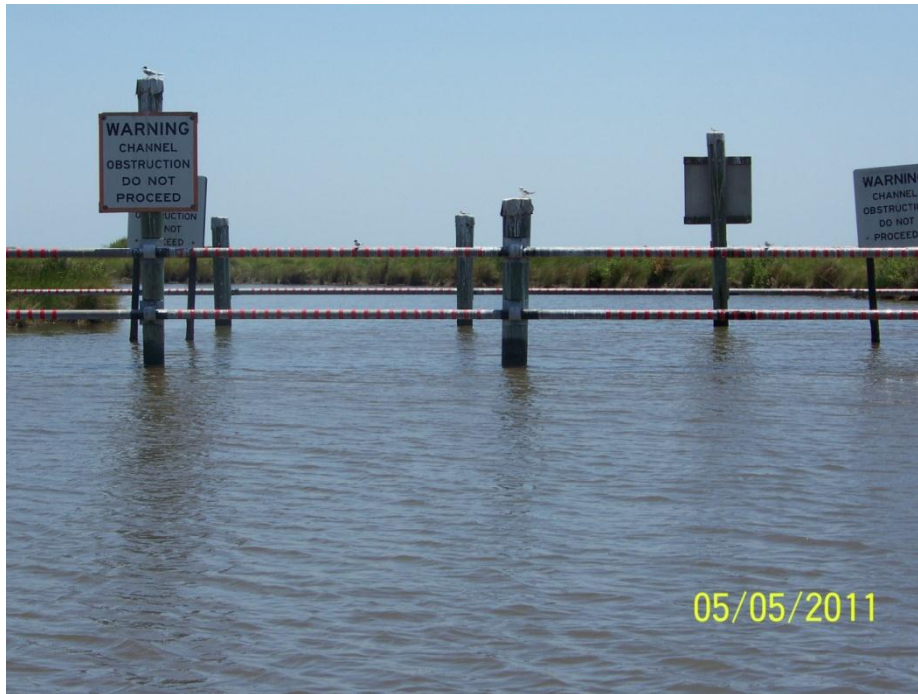
Site No.5 rock weir is in good overall condition. The embankment tie-ins showed no signs of marsh erosion or breaching. The barricade system and timber piles show no sign of damage or corrosion. The warning signs and supports are also in good condition. The latest elevation data from the 2004 survey profile of Structure No.5 indicates that the structure has settled on average of 0.14' from the designed elevation. (Appendix A, Photos 22 - 25)

Photo #23: Close up view of Site No.5 rock weir in oil field access canal, looking east

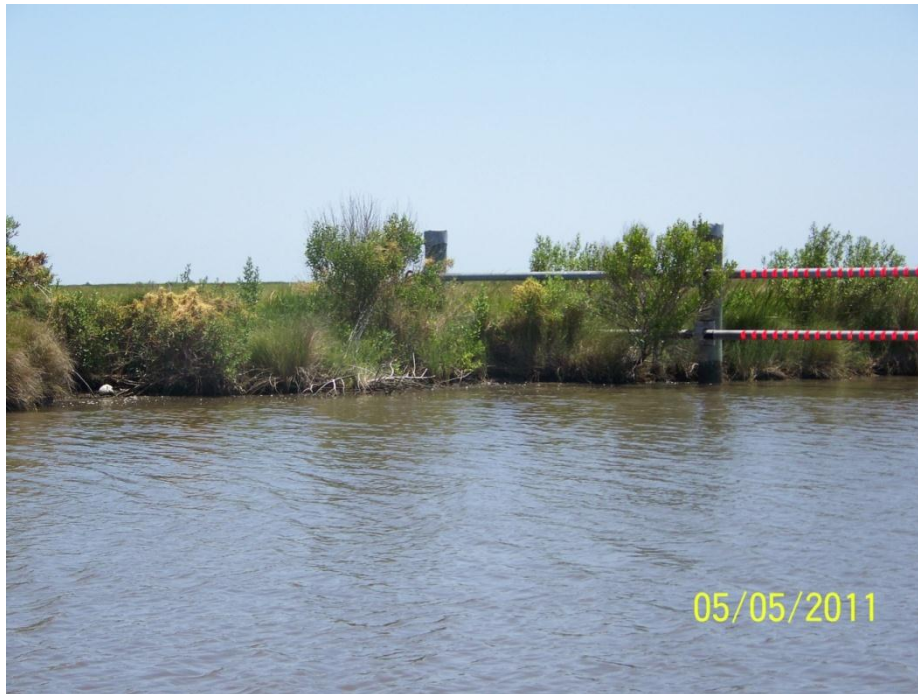
Photo #25: View of embankment tie-in on the north side of Site No.5, looking northeast

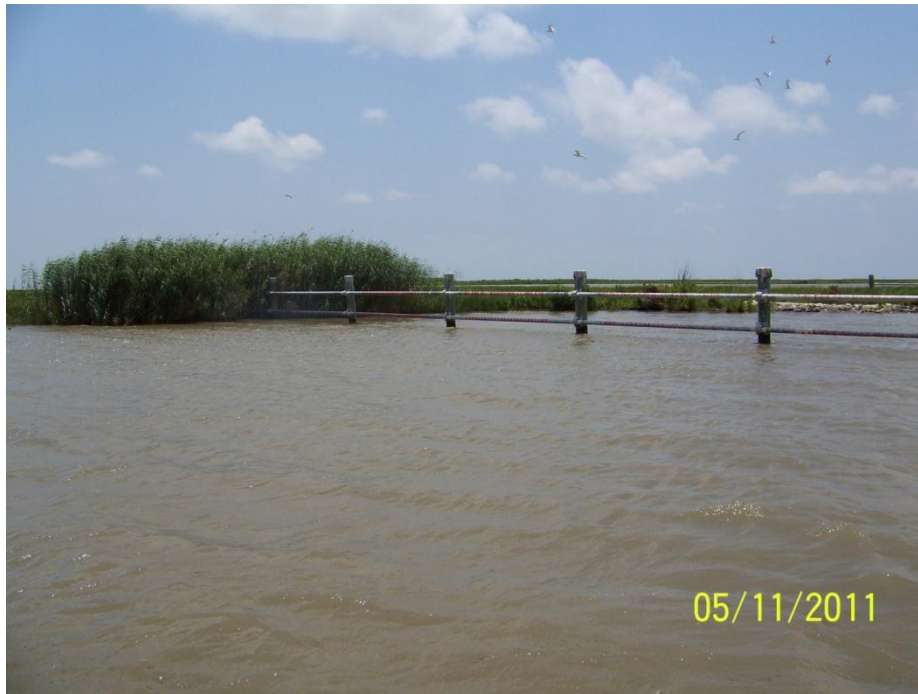
The rock weir appeared to be in good condition with no breaching around the ends. As in previous inspections, we found that the existing marsh connecting the structure to land on the south side of the weir was thin. However it didn't seem that there was any significant erosion since the last inspection. The timber barricade system appears to be in good condition. As previously reported, the two (2) center pilings are slightly unstable thought to be due to inadequate embedment and poor soil conditions. Also, a 10' section of pipe was cut by vandals on the northwest side of the structure. We do not believe the instability or cut section will have a detrimental effect to the structure, therefore there will be no recommendations for repair at this time, but will continue to monitor the situation on future inspections. (Appendix A, Photos 26 - 30)

Photo #27: View of embankment tie-in on south side of Site No.4, looking southwest

Site No.4 rock weir appears to be in overall good condition. By comparing the current and past assessments, there seems to be no noticeable erosion along the shoreline. Based on the current short-term shoreline erosion rates, there is a chance Site No.4 will remain intact for the remainder of the project life, barring any extreme storm events. Based on these observations there are no recommendations for corrective actions at this time, but we will continue to monitor the condition of the marsh surrounding Site No.4 to determine the extent of the shoreline degradation.

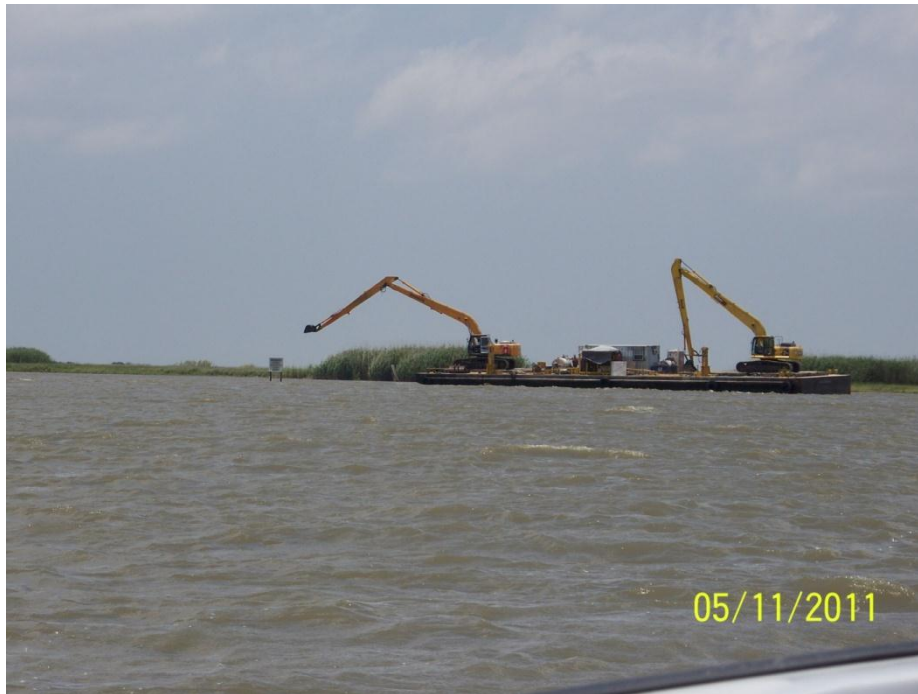
As previously reported, there was a significant breach at the north embankment tie-in and a small breach developing on the southern embankment tie-in. It was determined this structure should not be repaired due to the excessive land loss occurring along the shoreline; with erosion rates exceeding 60 ft/year, it is no longer feasible to maintain the structure. It was decided to degrade the structure to an -8.0' NAVD88 elevation to remove the navigation hazard posed by the rock weir. At the time of the 2011 annual inspection, the degrading of the

Photo #31: View of Site No. 3 Weir Removal in progress at time of inspection

rock weir was in progress and subsequently completed at the completion of this report. (Appendix A, Photos 31 - 34)

At the time of the 2011 inspection, the degrading of Site No.3 rock weir was in progress. This structure was deemed ineffective due to the extreme erosion around the north end of the rock weir. It was decided the best course of action was to degrade the weir to a -8.0' NAVD88 so that it is no longer a navigational hazard. The degrading of the structure has been completed at the time of this report and Site No.3 will no longer be monitored or maintained as part of project TE-26.

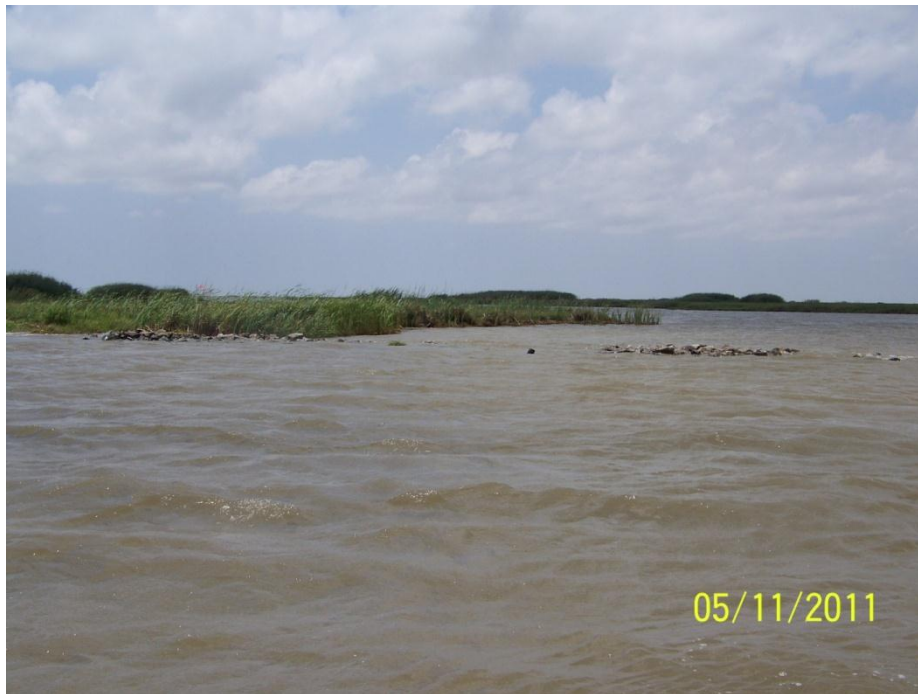
Photo #32: View of Site No. 3 Weir Removal in progress at time of inspection
