**State of Louisiana
Coastal Protection and Restoration Authority
Office of Coastal Protection and Restoration**

2011 Operations, Maintenance, and Monitoring Report

Timbalier Island Dune/Marsh Restoration (TE-40) Project

State Project Number TE-40
Priority Project List 10

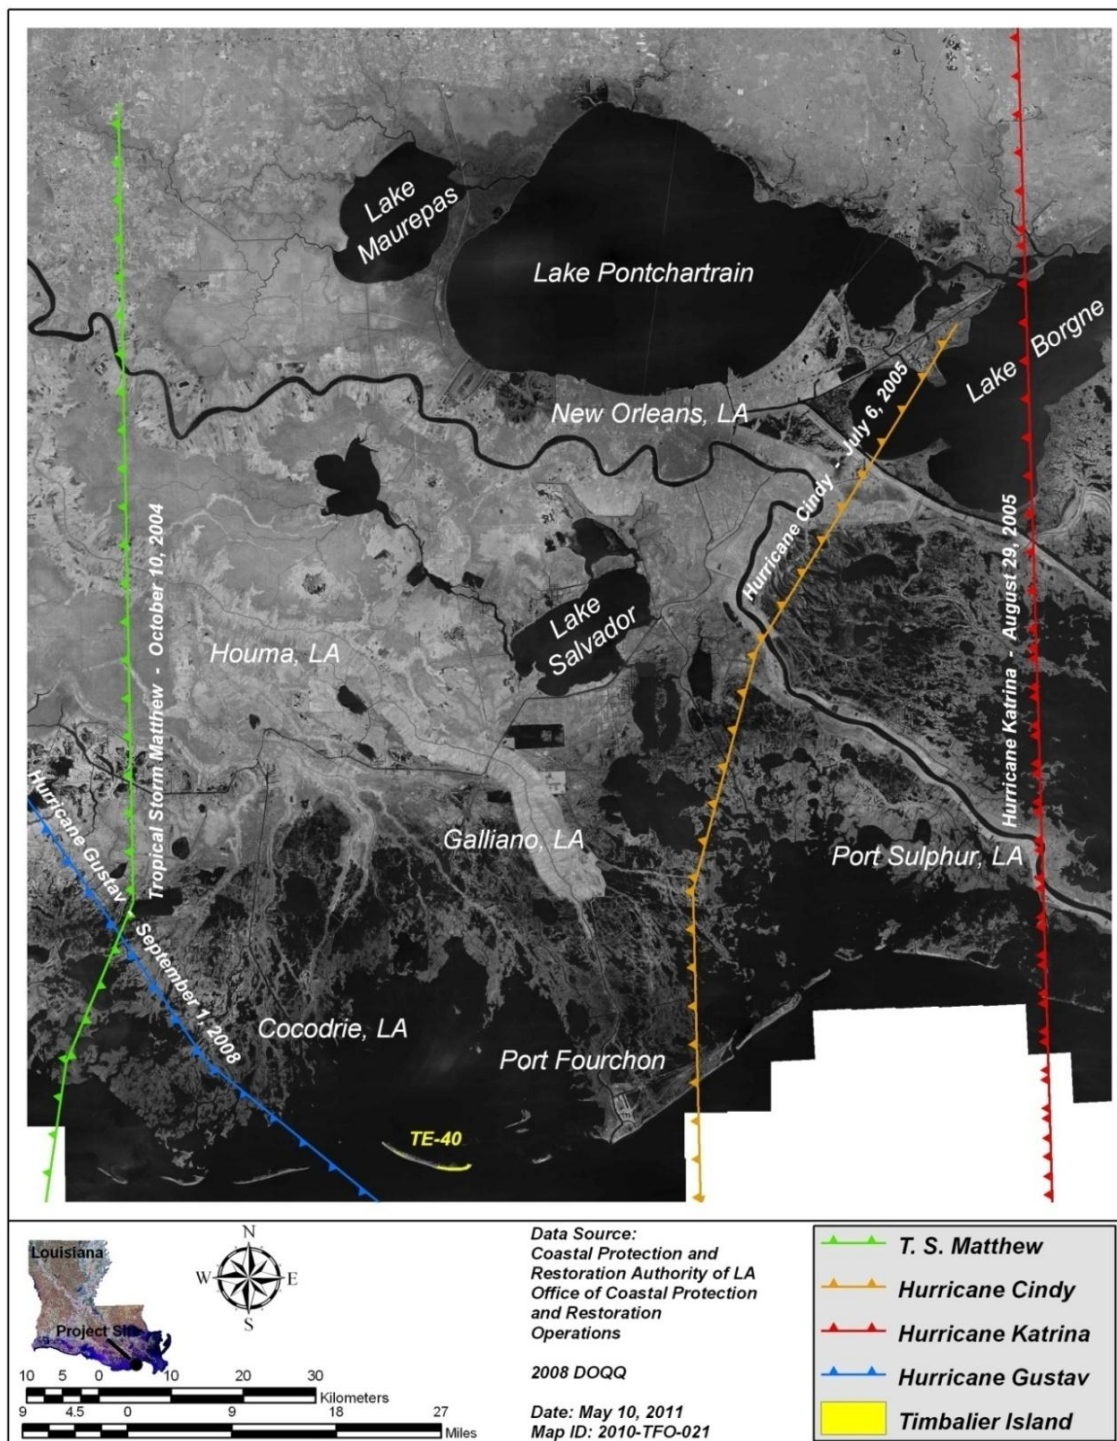
Figure 4. Pre-construction (2004) and post-construction (2005 and 2008) tropical storms impacting the Timbalier Island Dune/Marsh Restoration (TE-40) project area shoreline. Hurricanes Ivan (2004), Rita (2005), and Ike (2008) are not shown because the eye wall of these storms traveled further to the south (off the map).

Overall the fill area continues to show erosion, particularly on the east end due to long-shore transport, pass migration, and tropical cyclone impacts. The fill area has had impacts from at least 5 hurricanes since construction (figure 4), and this year Tropical Storm Lee in September 2011 made landfall on the Louisiana shoreline west of Timbalier Island, placing the project area on the worst side of the storm.

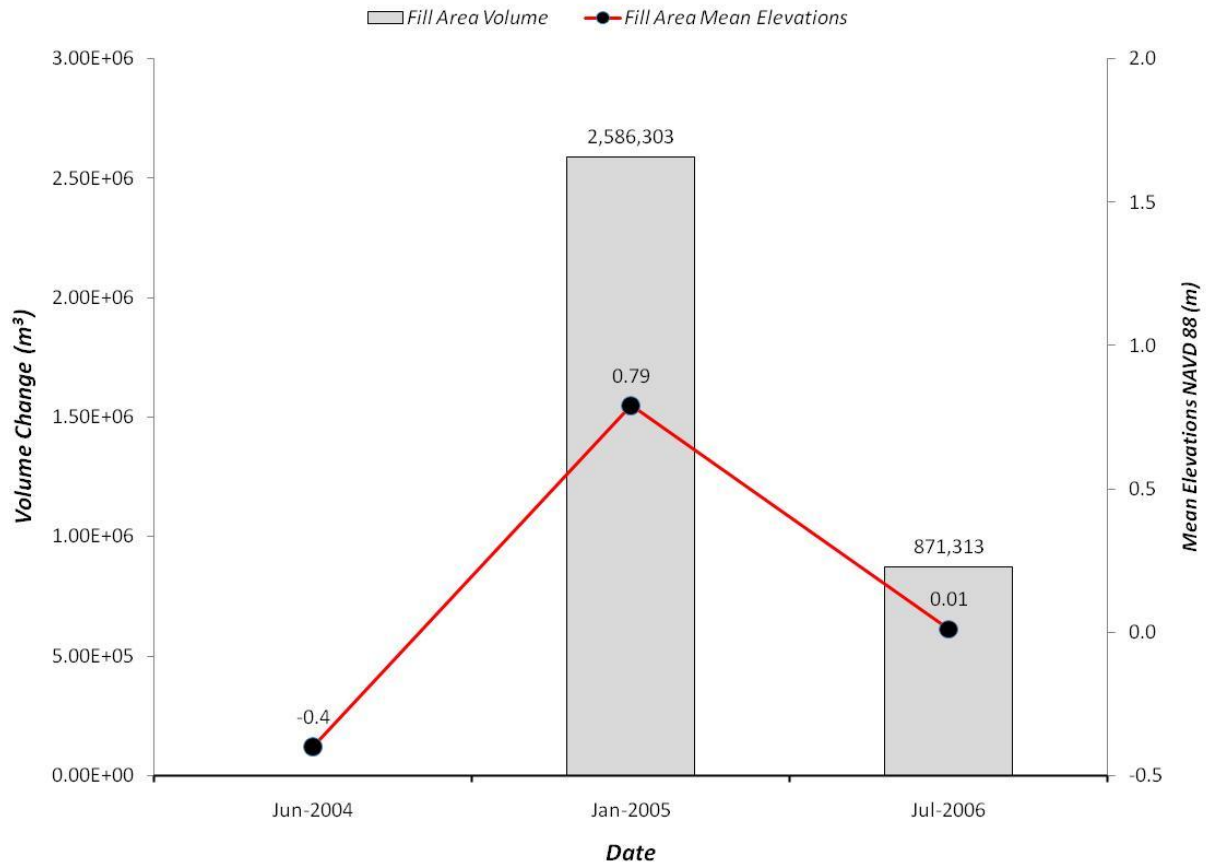
Figure 8. Sediment volumes and mean elevations over time inside the Timbalier Island Dune/Marsh Restoration (TE-40) fill area.

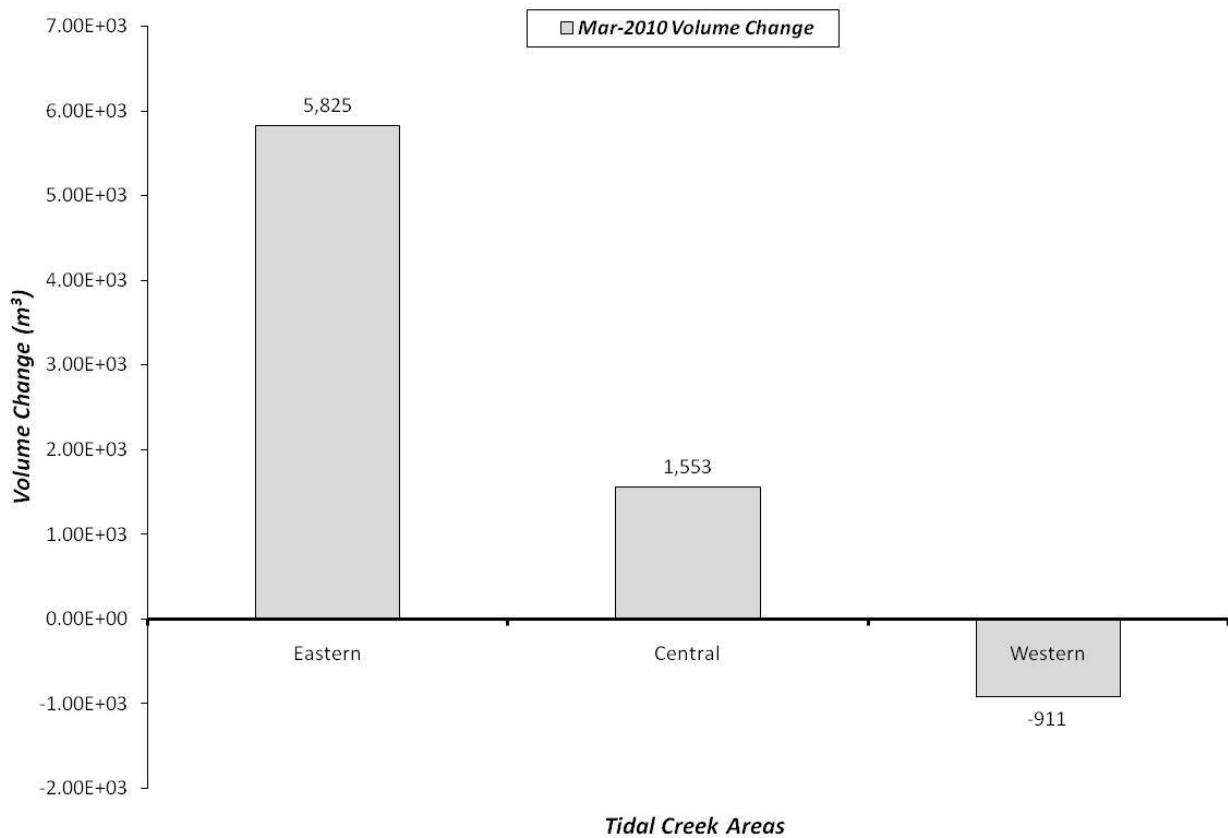
The Timbalier Island Dune/Marsh Restoration (TE-40) tidal creek areas have incurred varied sedimentation responses from 2008 to 2010. Elevation and volume changes for the tidal creek areas are delineated in figures 9 and 10. Elevation grid models for the April 2008 and March 2010 surveys are also provided in appendix C. The eastern and central tidal creek areas gained sediment volume while the western tidal creek area displayed volume losses during the study period (figures 9 and 10). Therefore, it seems that the cross-shore transport processes are greatest on the eastern side of the island and progressively decline in the western direction. The tidal creek surveys did not provide evidence supporting tidal creek formation and evolution but did show that cross-shore transport of sediment is occurring within the TE-40 fill area.

Figure 10. Sediment volume change inside the Timbalier Island Dune/Marsh Restoration (TE-40) tidal creek areas.

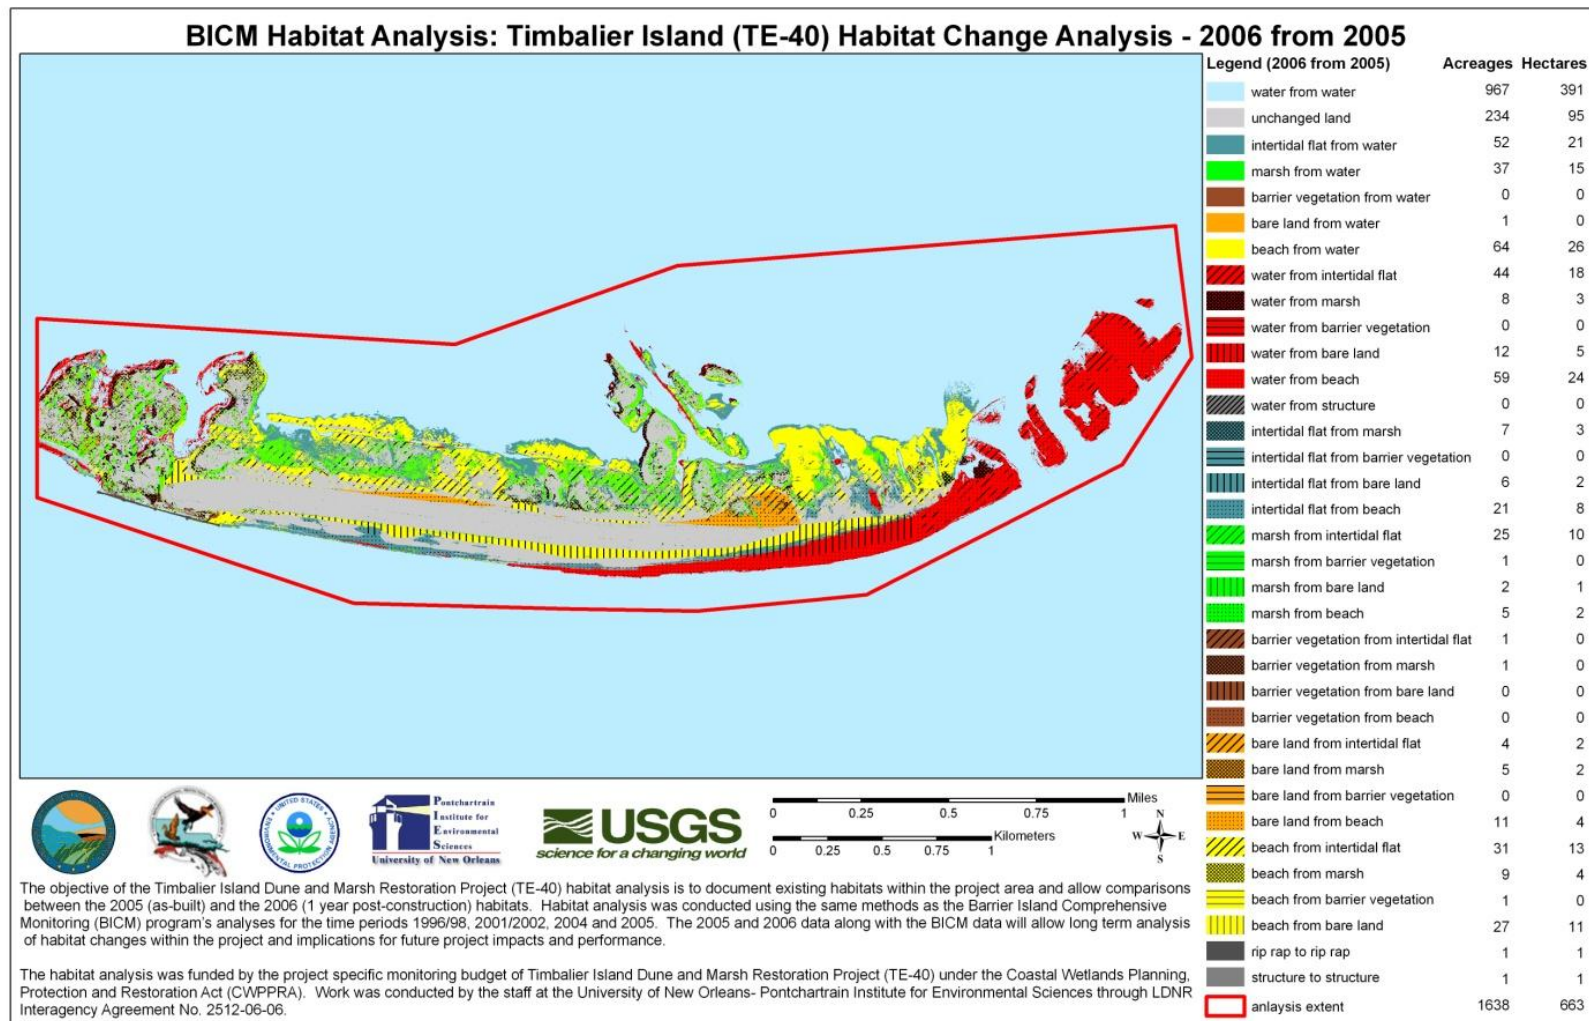
The Timbalier Island Dune/Marsh Restoration (TE-40) fill area habitats were reshaped during the first two post-construction years. The change in habitats from January 2005 to November 2006 is shown in figure 11 and table 3. Habitat maps for the January 2005 and November 2006 periods are also presented in appendix D. Approximately, 15 ha (37 acres) of beach and 16 ha (40 acres) of marsh habitat were created from 2005 to 2006 while acreages of bare land (dune) -11 ha (-26 acres), intertidal flat -8 ha (-20 acres), and water -12 ha (-30 acres) habitats declined. During this interval, the width of the TE-40 fill area expanded and the length diminished. Moreover, the shoreline transgressed considerably to the west leaving the eastern tip of Timbalier Island (outside of the fill area) and bare land (dune), beach, and intertidal habitats within the TE-40 fill area subaqueous (figure 11). The width of the TE-40 fill area seems to have increased through cross-shore transport of sediments from the shoreface, beach, and dune (bare land) infilling intertidal flat and shallow open water areas on the bay side of the fill area (figure 11). The 2005 hurricanes (Cindy, Katrina, and Rita) are probably the primary cause forcing the redistribution and loss of sediments in the fill area and on the eastern edge of Timbalier Island for the 2005-2006 period (figure 4). Furthermore, East Isle Dernieres and Whiskey Island also exhibited considerable shoreline transgressions and land loss on the eastern edge of their shorelines following the 2005 hurricanes (Barras 2006; Rodrigue et al. 2008a; and Rodrigue et al. 2008b; Fearnley et al. 2009; Martinez et al. 2009). Longshore transport processes also probably induced some of the shoreline losses because the eastern shorelines of Timbalier Island have historically been erosional (Peyronnin 1962; Stone and Zhang 2001; Georgiou et al. 2005; Martinez et al. 2009).

Figure 11. Habitat change analysis of Timbalier Dune/Marsh Restoration (TE-40) project from Jan 2005 to Nov 2006.

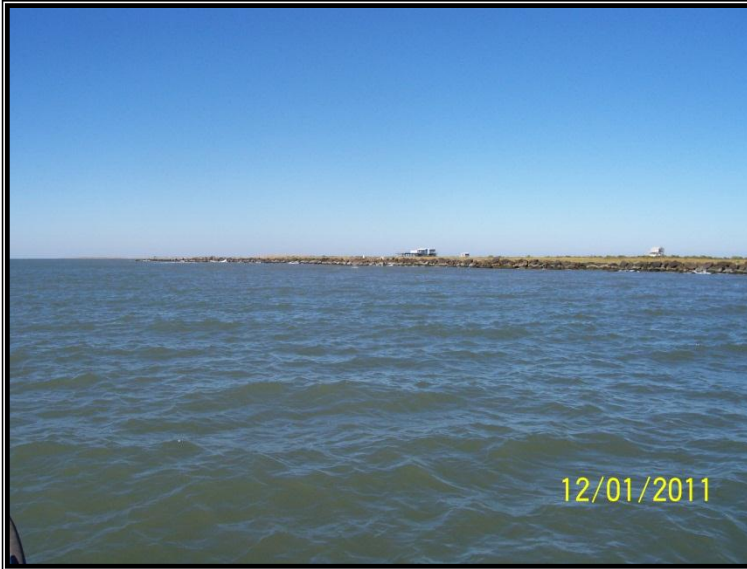
Photo 25. Site #6 near station 97+00 looking northwest at west end of Canal 19 rocks.

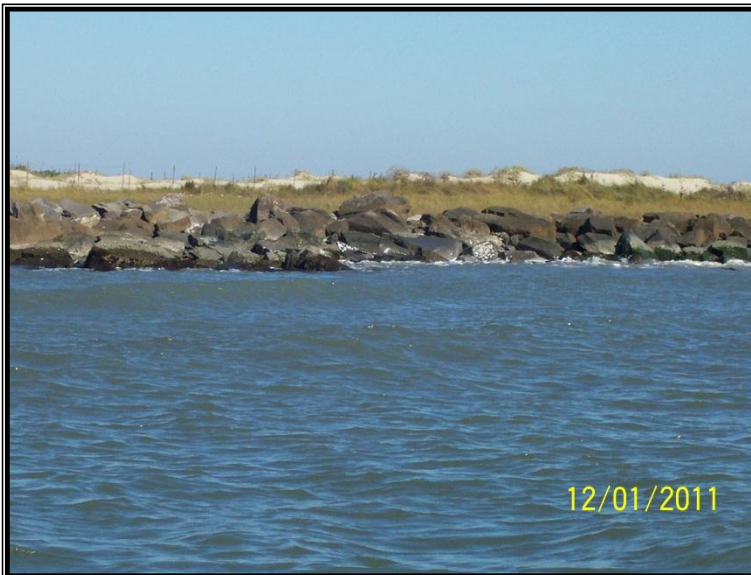
Photo 26. Site #6 near station 97+00 looking north at Canal 19 rocks and west end of dune feature.
