2012 Operations, Maintenance, and Monitoring Report

East Sabine Lake Hydrologic Restoration (CS-32)

State Project Number CS-32
Priority Project List 10

July 2012
Cameron Parish

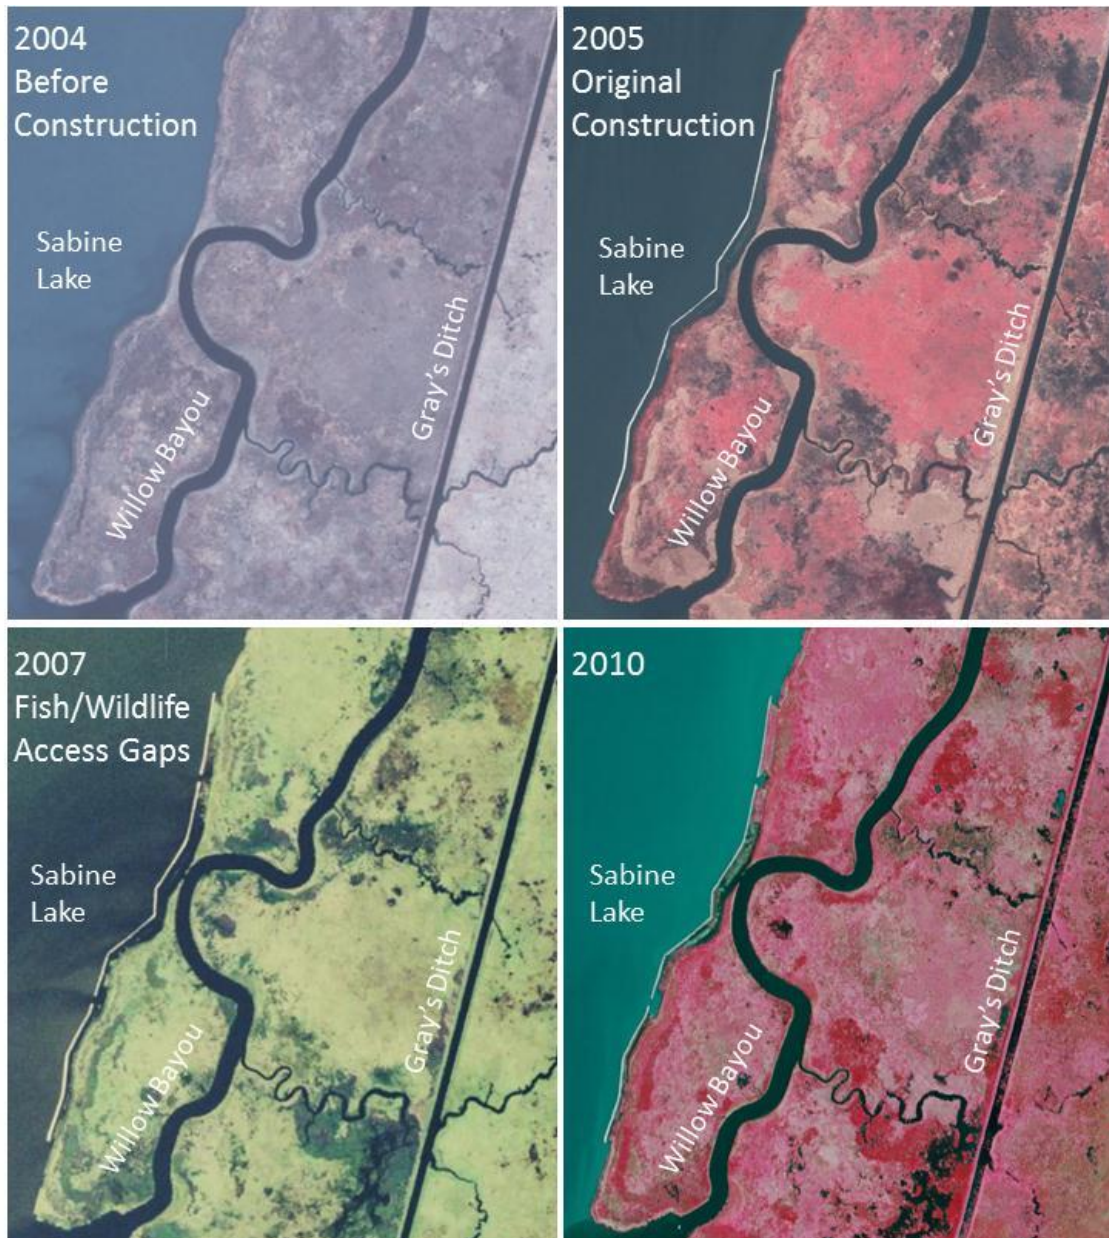
Land expansion in the Sabine Lake Rock Dike area (Area 5) will be limited by the rock dike. Much of the area had converted from open water to land between construction in 2005 and the 2008 photography for the land-water classification. Mud flats have formed and vegetation has established behind the rock dike except for areas behind the gaps in the rock dike (both ends and two in the middle) which allow for fish and estuarine organisms access to the shoreline (figure 5). The rock dike did not prevent the breaching of Sabine Lake and Willow Bayou; however, subsequent mud flat formation and vegetation in the vicinity of the breach behind the rock dike is expected to diminish hydrologic exchange between the two water bodies.

Figure 5. Sabine Lake rock dike near Willow Bayou before construction in 2004 and after construction in 2005 (full rock dike), 2007 (gapped rock dike), and 2010 (vegetation and mud flat expansion). Note thin strip of land between Sabine Lake and Willow Bayou in 2004 and 2005 and subsequent breach in 2007 and 2010. Also note the conversion of open water to land over time.

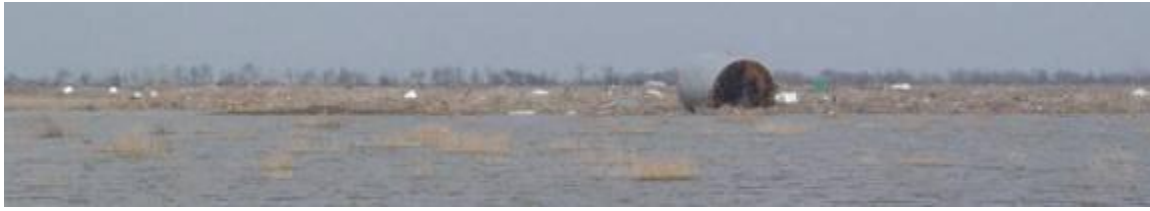
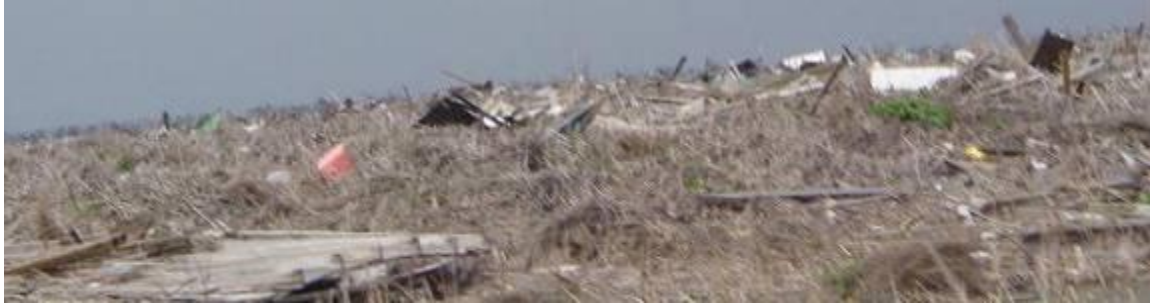
On the October 2005 trip, the investigating party traveled west by airboat, from near USFWS Sabine Refuge Headquarters on Hwy 27, across Refuge marshes to the project area. Huge swaths of wrack, composed of vegetative and anthropogenic material (tanks, lumber, 18-wheeler trailers, etc.), had been deposited on top of the marshes. All emergent marsh vegetation that could be seen was completely brown and much of it was covered with what appeared to be fine-grained sediment and precipitated salt (below).

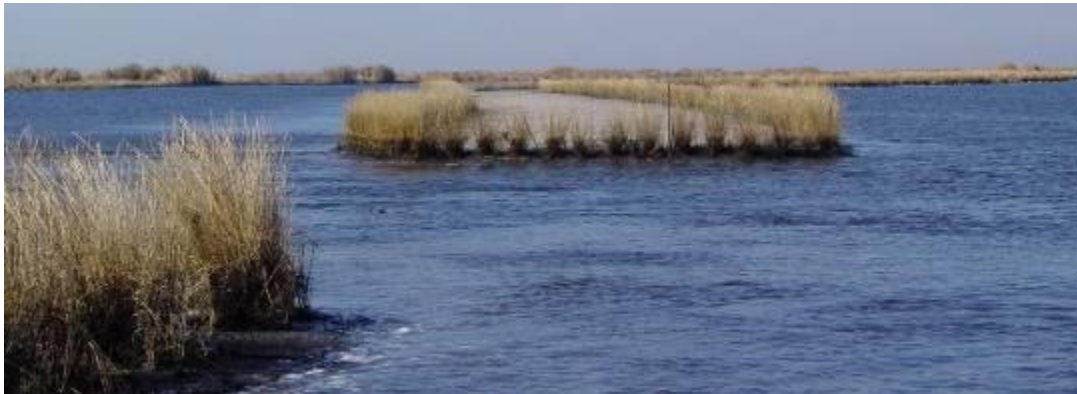
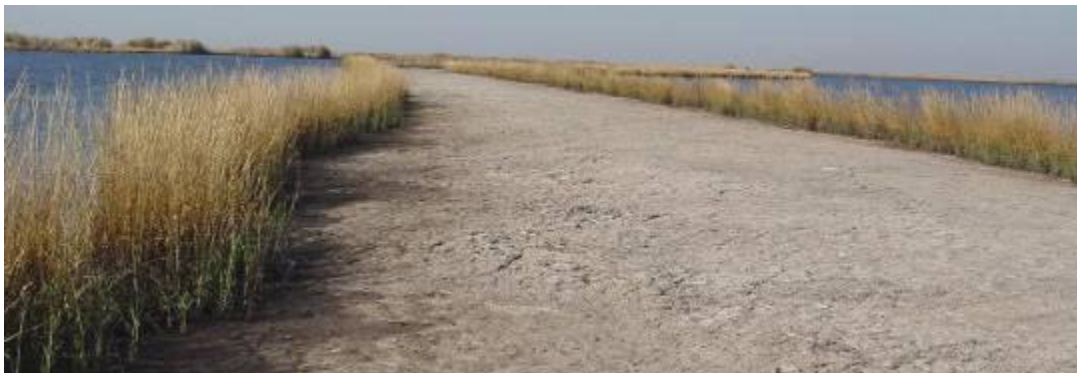
At the project area, although the plants on the southernmost terrace rows appeared to have produced significant growth and spread prior to the storm and the plants' physical structure was mostly intact, we found that all contract plantings on all of the terraces were considerably browned (below).

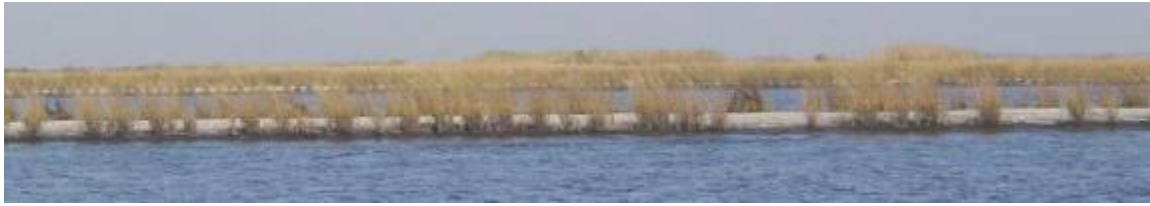
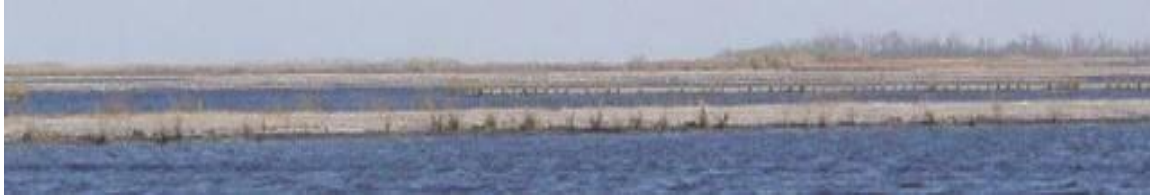
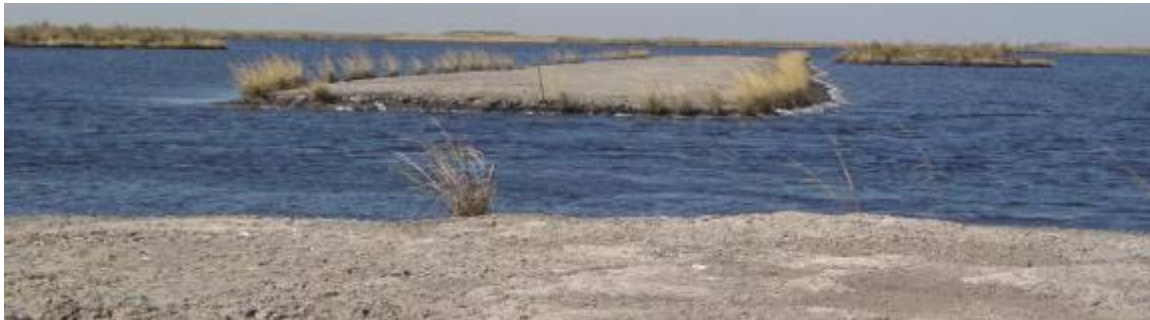
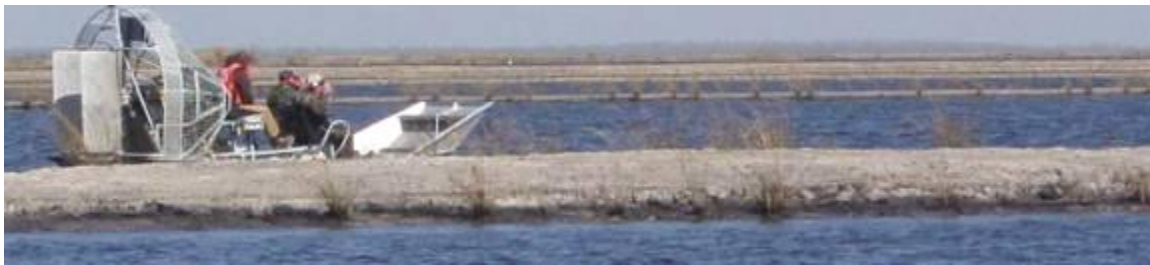
Proceeding northward, we began to note gaps in the planted rows and the number of plants missing on each terrace segment progressively increased.

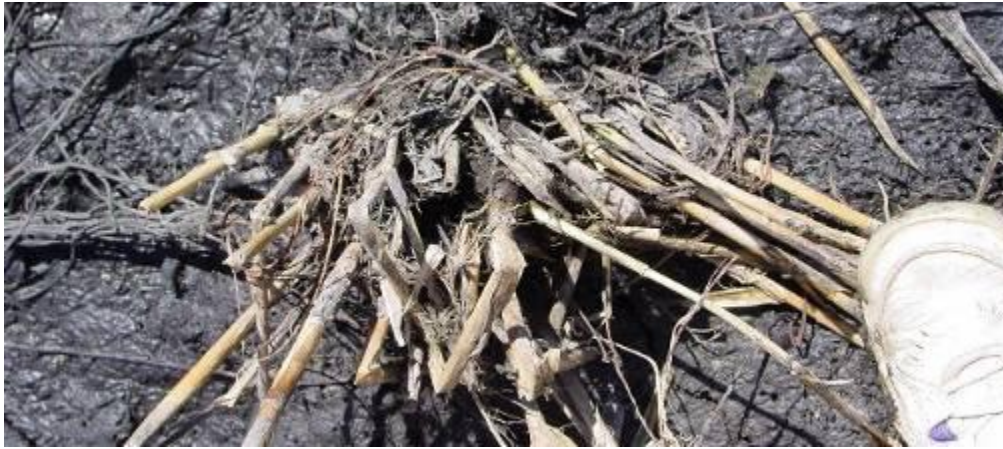
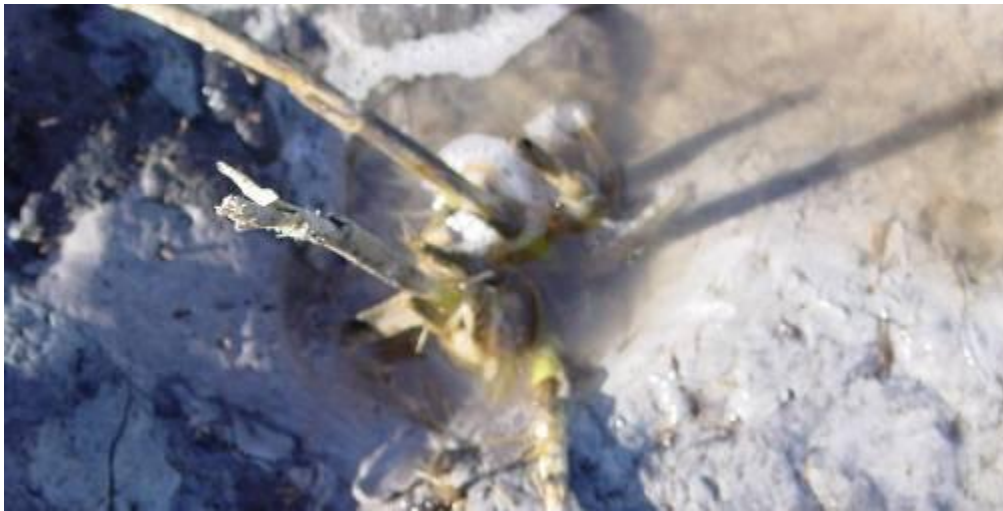
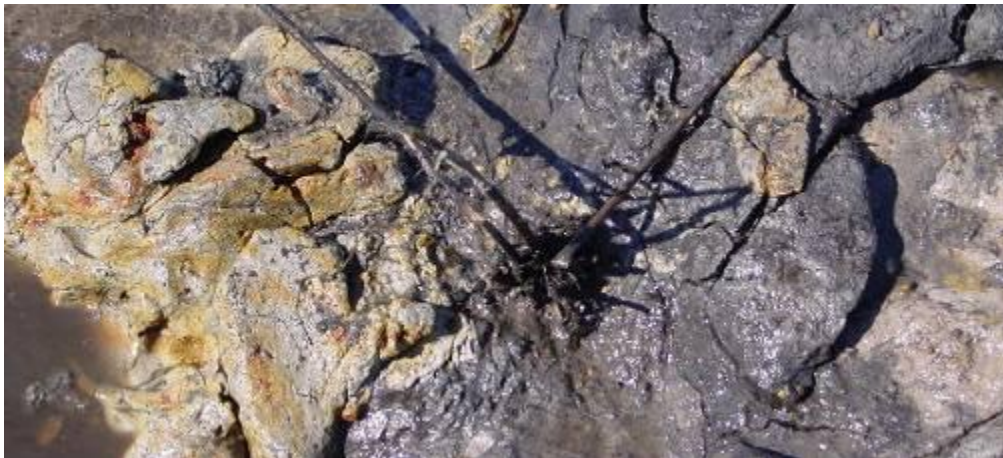
In addition, the younger a transplant was, the less old and new growth was present. From oldest to youngest, mortality increased, and the base of the plant stems ranged in color from pale yellow/green to brown/black and rotten at the base.

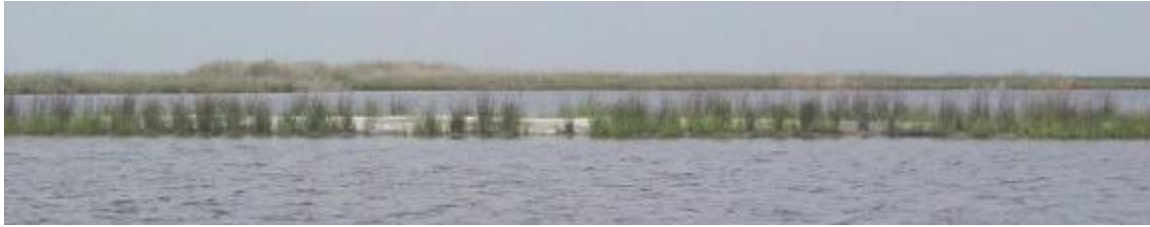
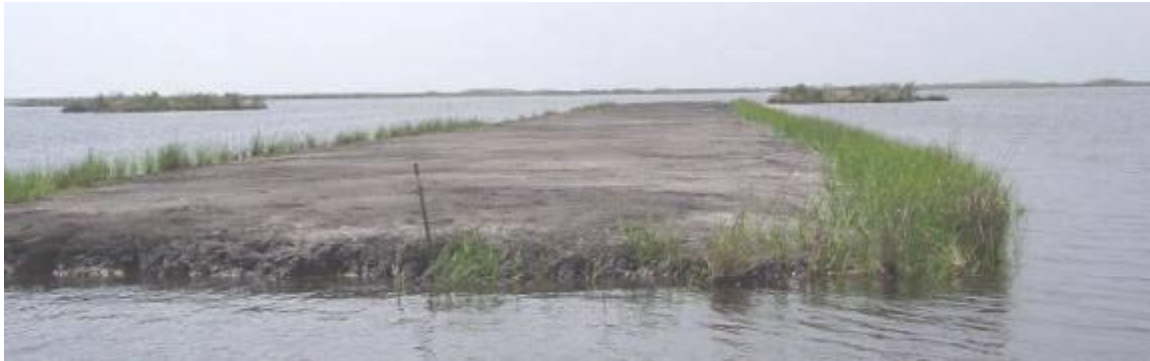
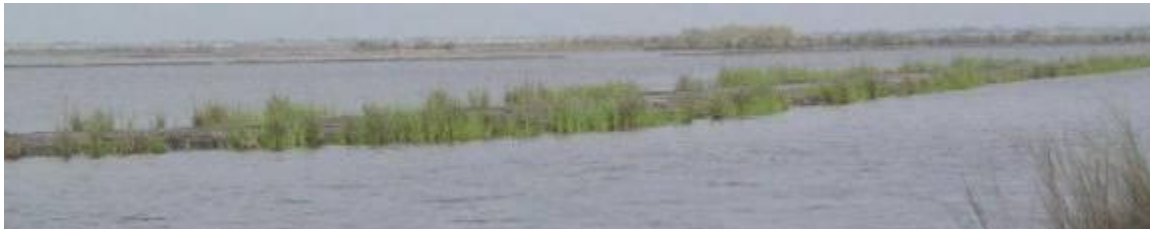
However, moving northward, we found that as age of the plantings decreased, mortality increased, until the plantings no longer formed a continuous vegetative hedge at the toe of the terrace segments. On the newest terrace segments, remaining plants formed very sparsely

distributed live clumps, or single plants with a couple of stems each. There was no longer difficulty in calculating the plant mortality.

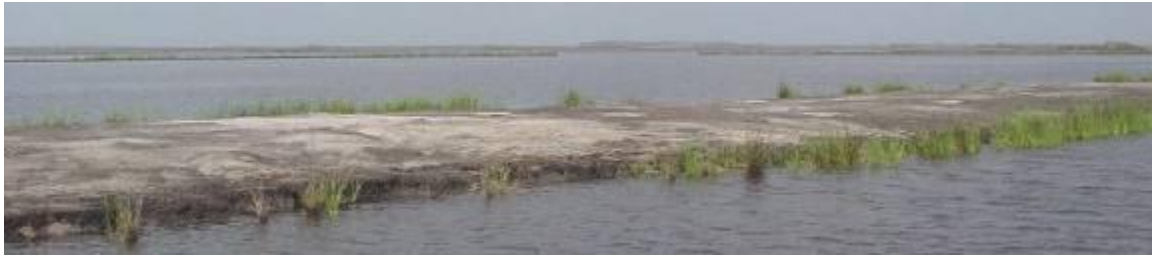
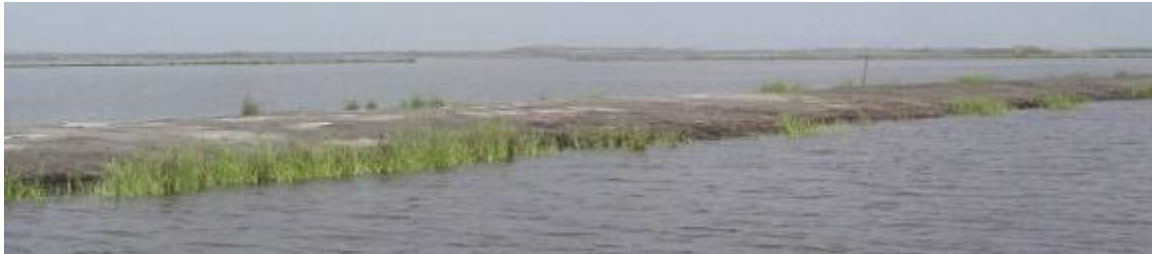
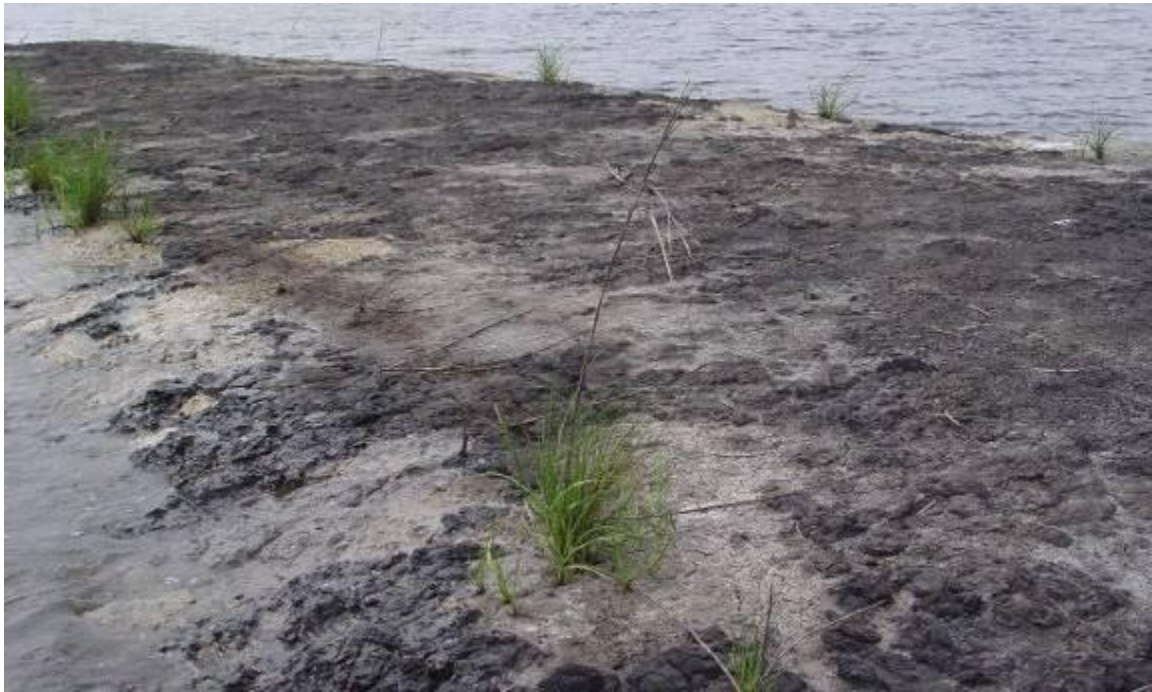
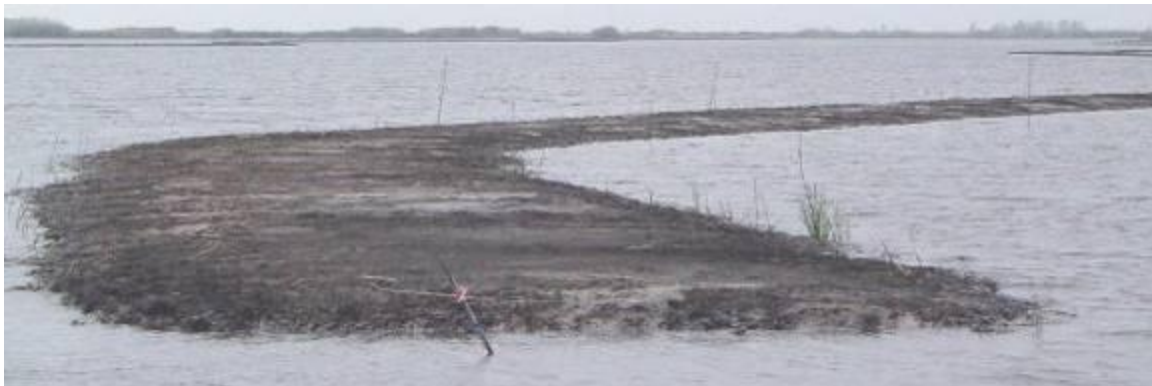
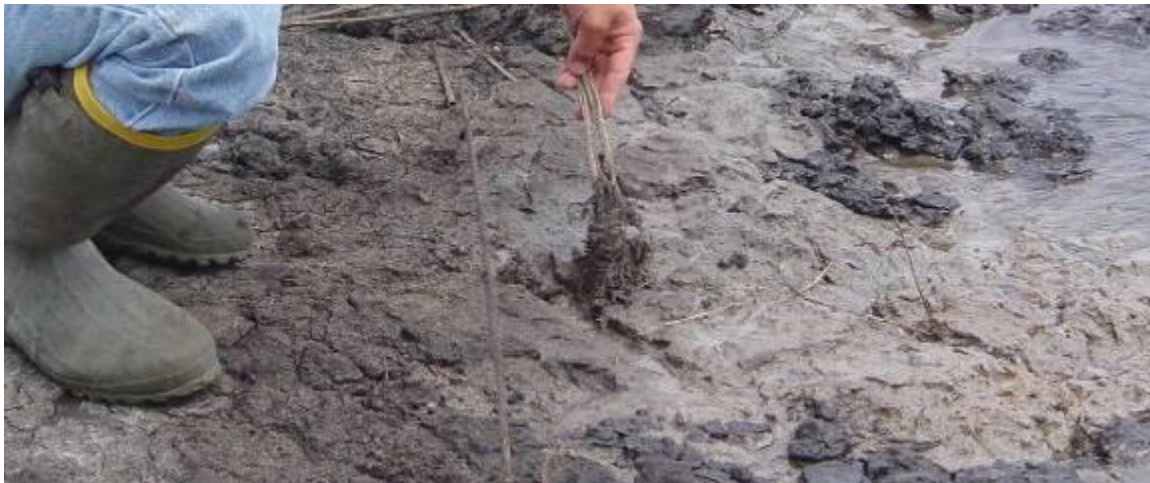
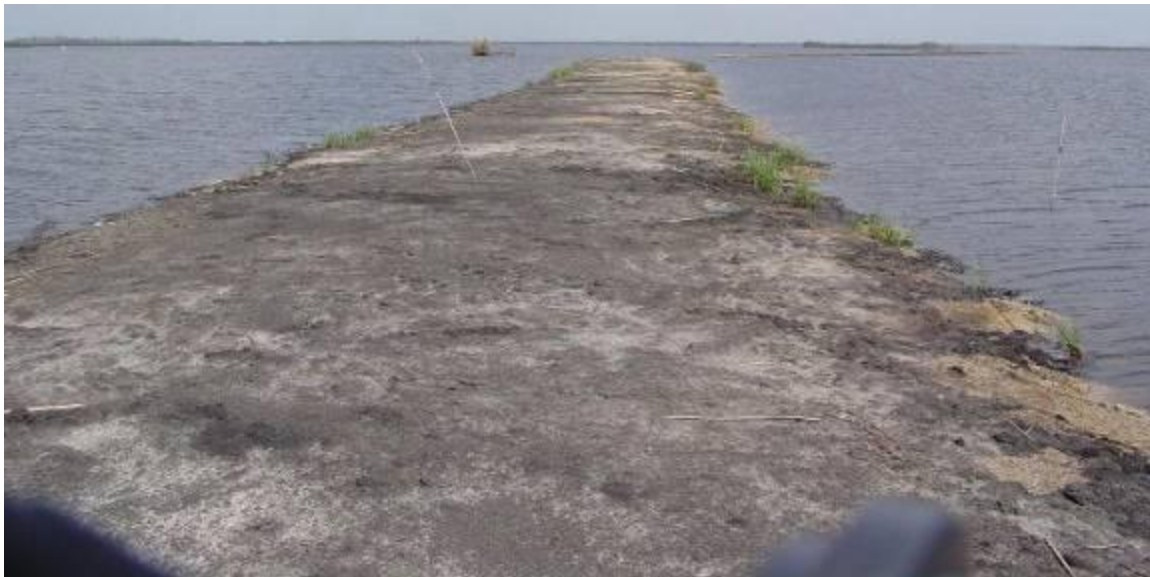
Plant mortality was estimated for each row of constructed terrace segments, and ranged from zero to 92%. All mortality was found to have occurred within the plantings on terrace rows 6 through 15. The plantings on rows 16 through 25 had 100% survival and were producing new growth. Based on the known constructed lengths of each terrace segment within the rows, the total linear footage of terrace edge that will require replanting was calculated by row and totals 103,022 linear feet. To replace the destroyed plantings on the 2.5 foot center spacing, per the contract specifications, will require 41,209 plants. To allow for changes in field conditions, a three percent allowance should be added for a total of 42,500 plants to be replaced. The original government cost estimate for the contract planting component was approximately three dollars per plant installed plus mobilization and demobilization. Based on recent successful bids for post-hurricane vegetative planting contracts, increases in local labor and fuel costs, and damages reported by Louisiana wetland plant nurseries, the government cost estimate for the replacement planting would be \$3.50 per plant installed for a total of \$148,750 plus mobilization and demobilization.

It is recommended that the destroyed plantings be replaced as soon as possible, in order to achieve the necessary stabilizing vegetative cover on the exposed tops and edges of the earthen terraces, particularly now that the start of hurricane season is days away. Please contact me and the LDNR and USFWS project and O&M managers to discuss how, and how soon, this can be accomplished.

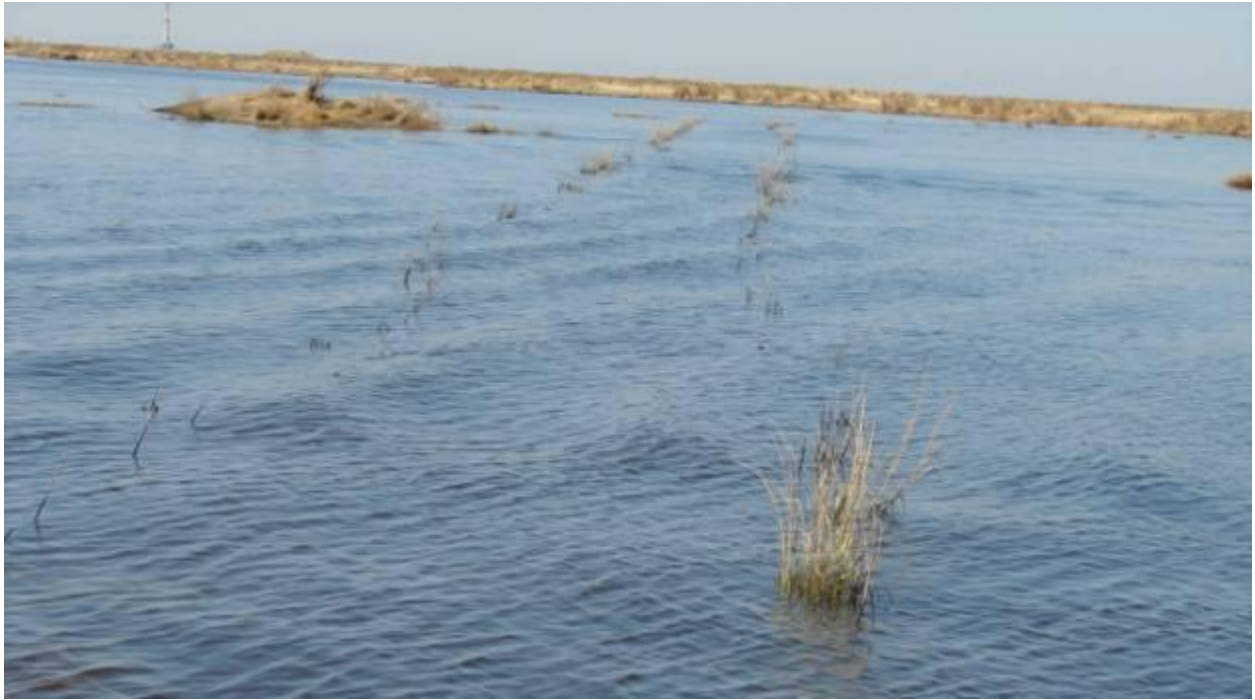
Figure 4. Project terraces remained flooded one month following Hurricane Ike landfall.

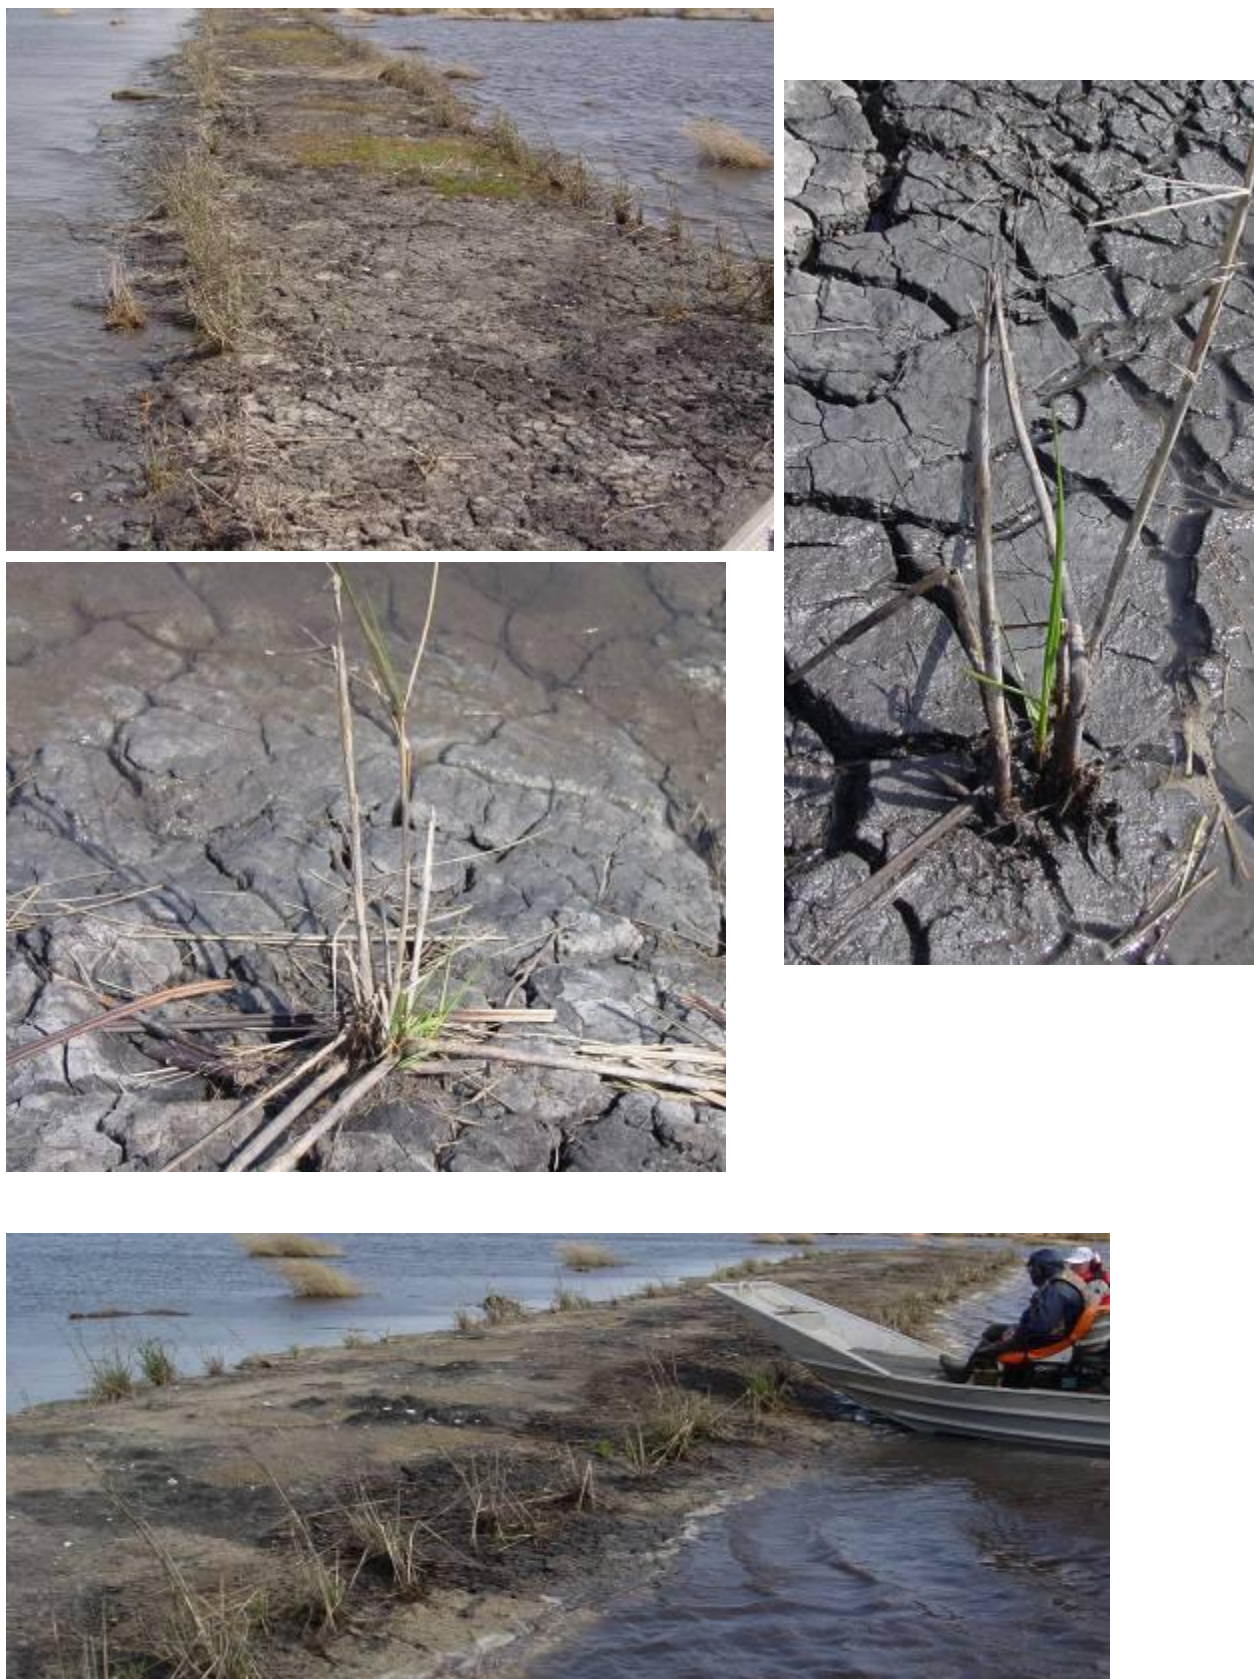
Figure 7. Composite of typical examples of surviving plants.

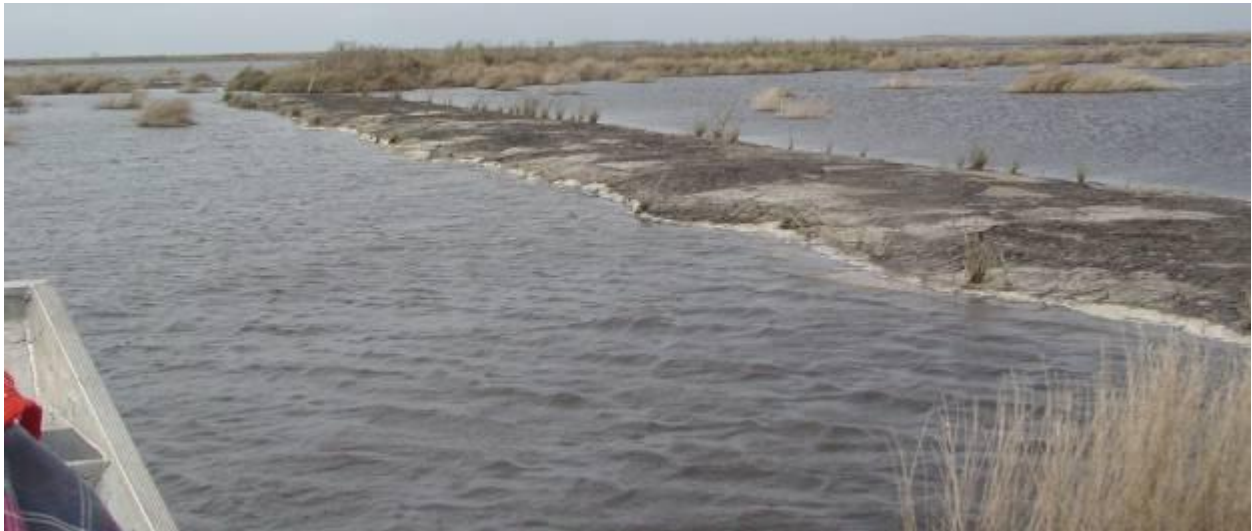
Plant mortality and loss appeared to generally follow three patterns: One, over all rows, mortality or loss was the greatest on those terrace segments that were exposed to open water with longer fetch lengths, especially to the south (i.e., Row 10) (Figure 8). Plantings seemed to fare better when there was at least some emergent marsh adjacent to the terrace segment, even when the marsh consisted of very small fragments (Figure 9). Two, within each row, plantings on the north sides of the rows/segments fared better than on the south sides (Figure 10). Three, over all rows, mortality appears to increase as the age of the plantings decrease (Figure 11).

Figure 8. Greater mortality and loss seen where exposed to open water with longer fetch.

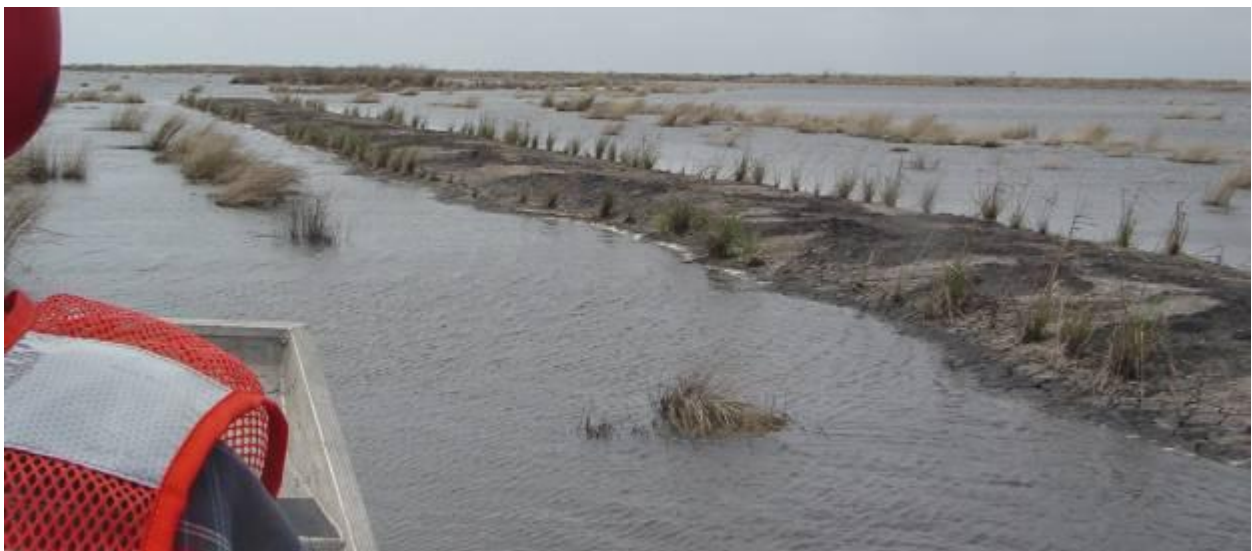
Figure 9. Survival tended to be greater on terrace segments where there was some adjacent fragmented marsh.

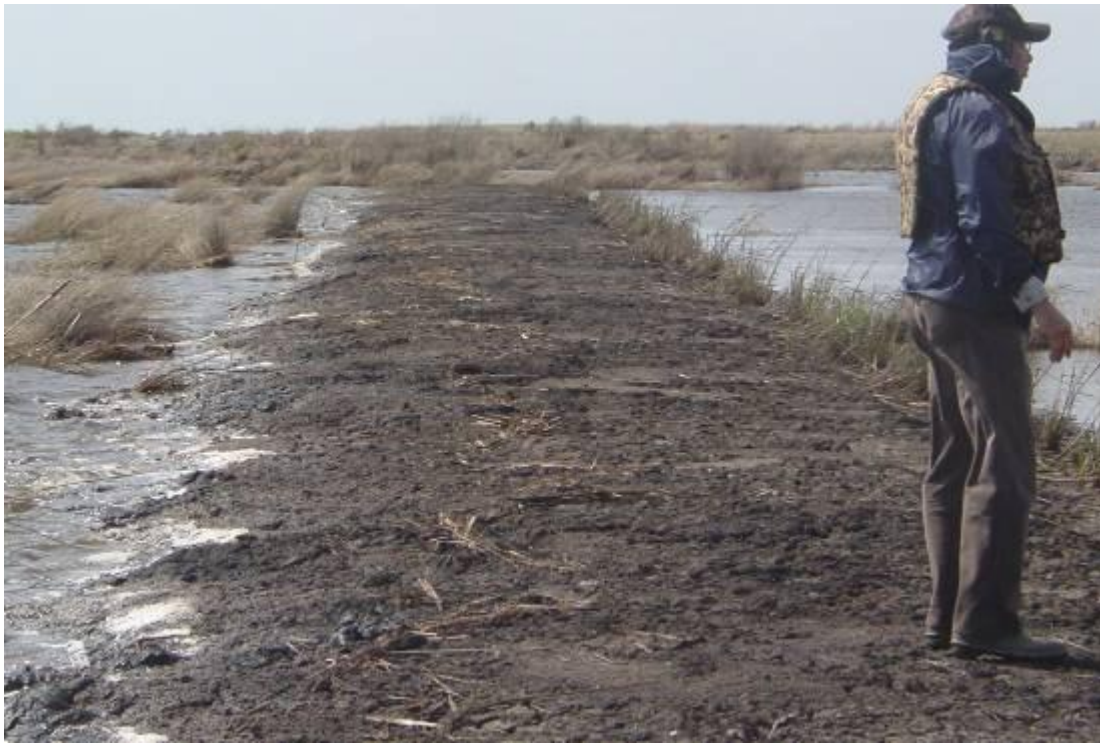
Figure 10. Comparison of mortality and loss on a terrace segment's south (left) side vs. the north (right) side.

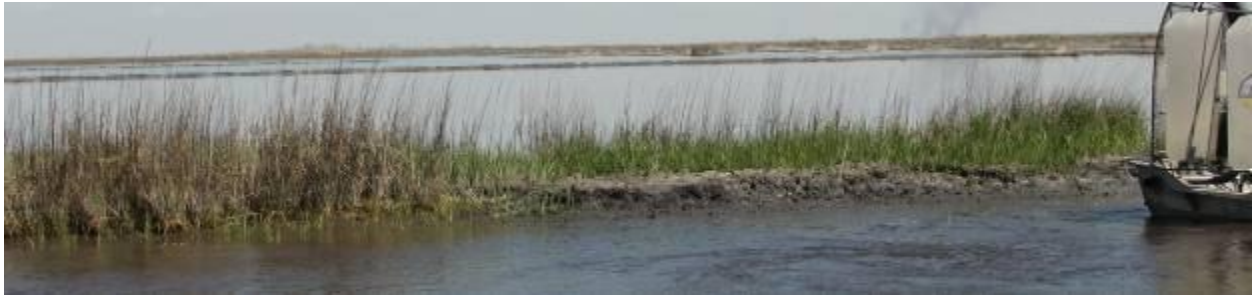
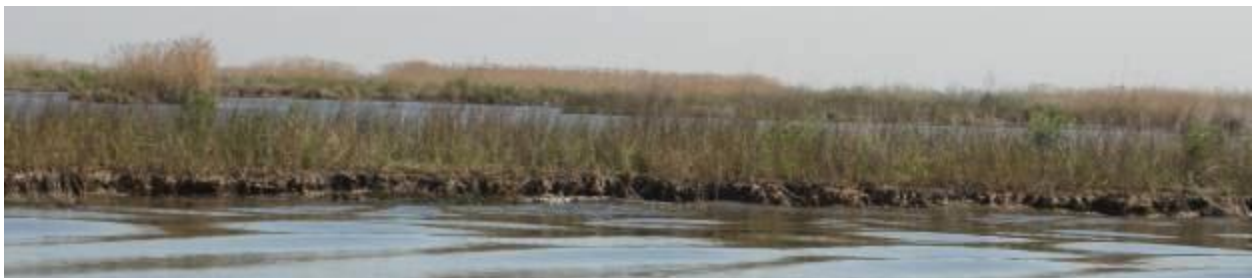
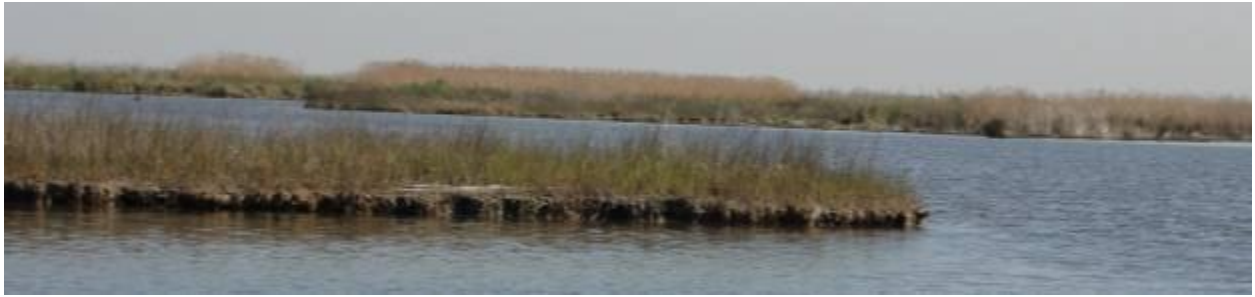
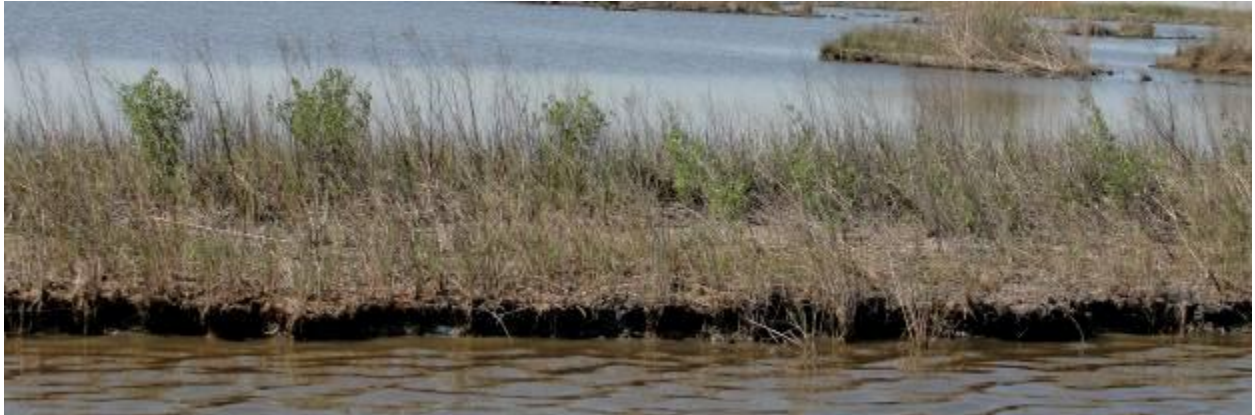
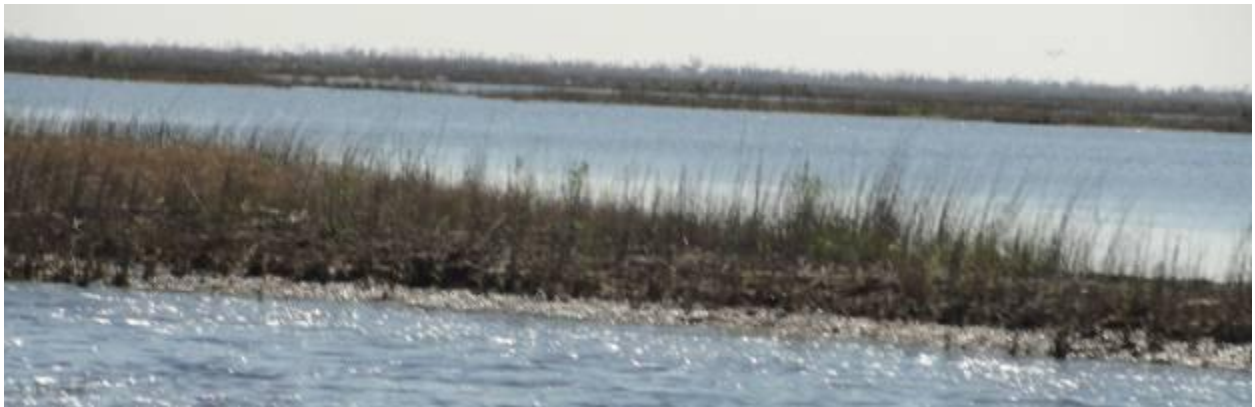
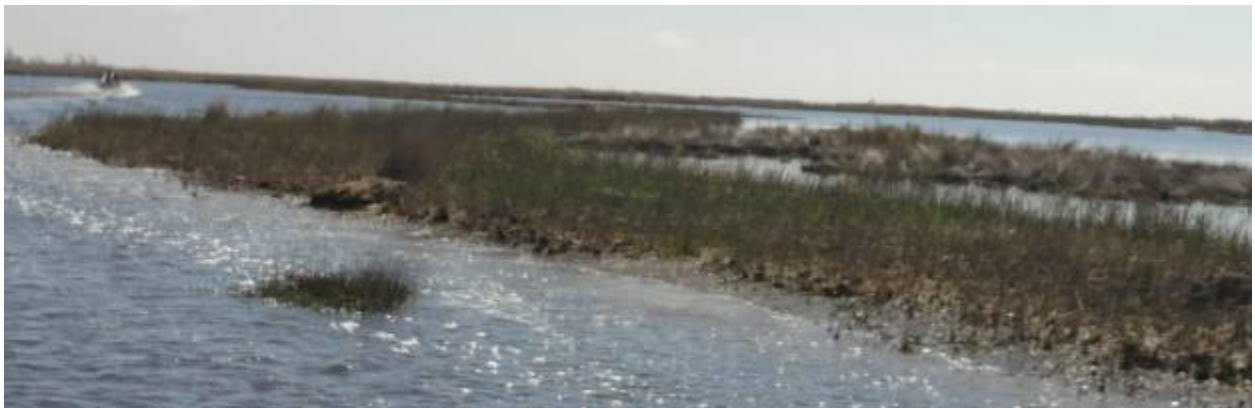
Contrast above with the appearance of the condition of those older plantings in March 2010:

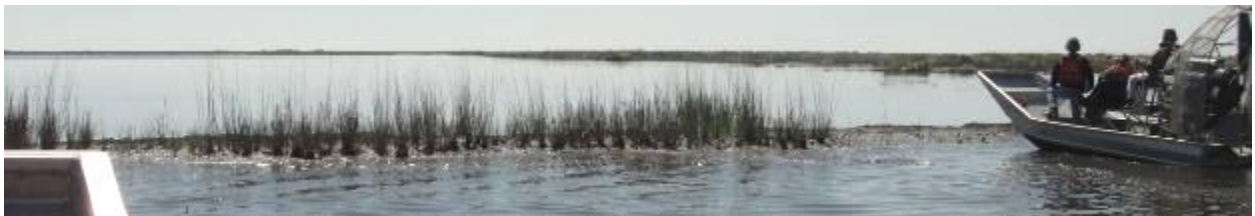
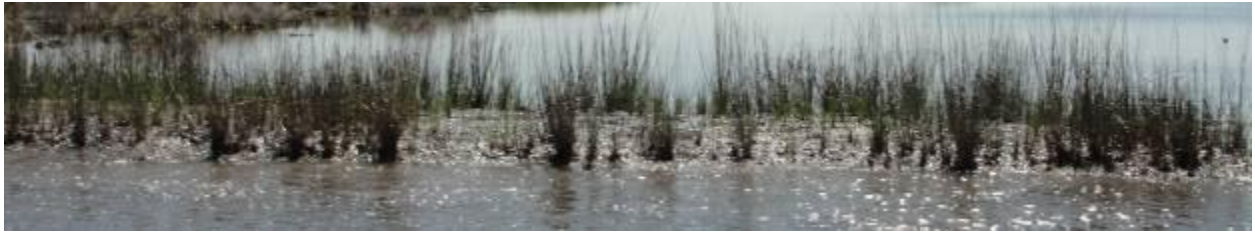
March 2010 condition of terrace segments with combination of older and recent plantings:

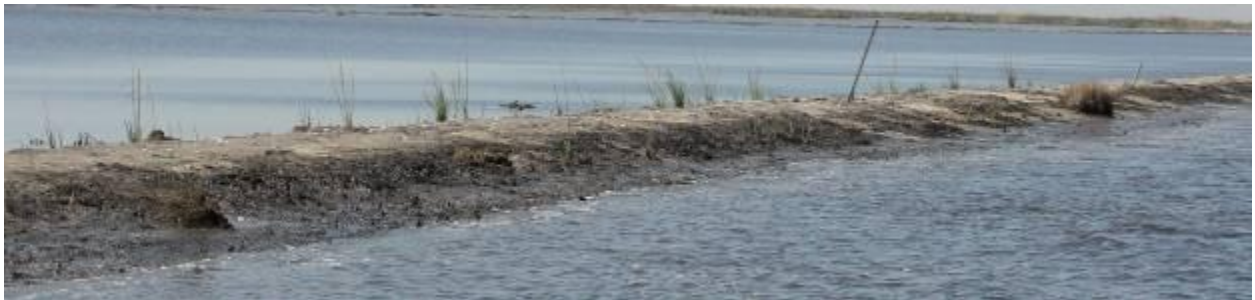
March 2010 condition of newest plantings:
