2012 Operations, Maintenance, and Monitoring Report

East Sabine Lake Hydrologic Restoration (CS-32)

State Project Number CS-32
Priority Project List 10

July 2012
Cameron Parish

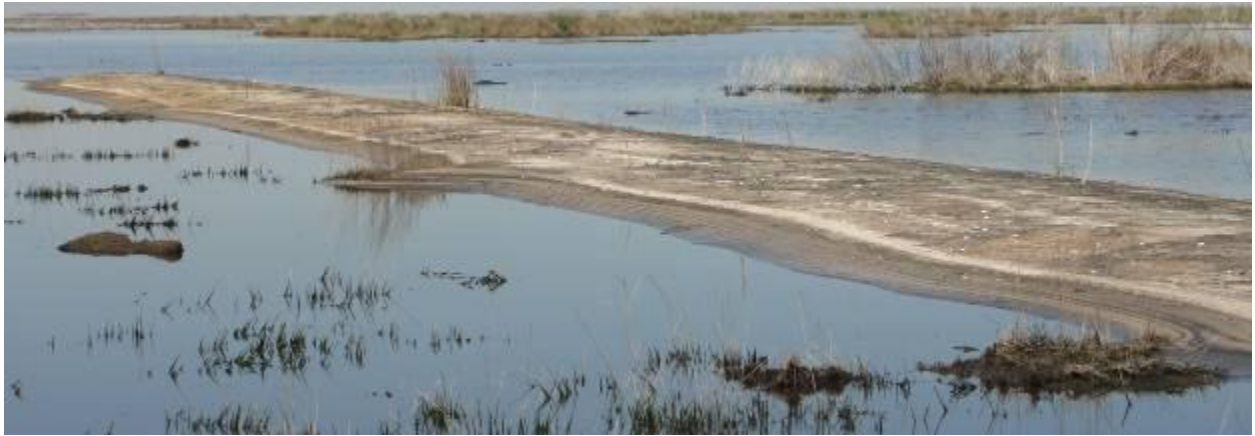
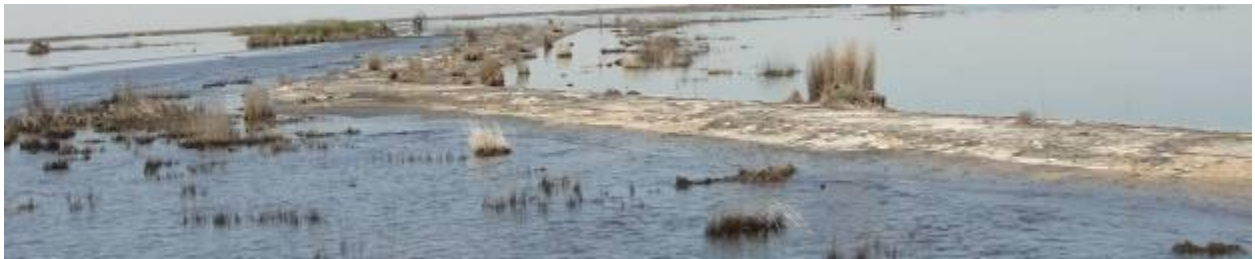
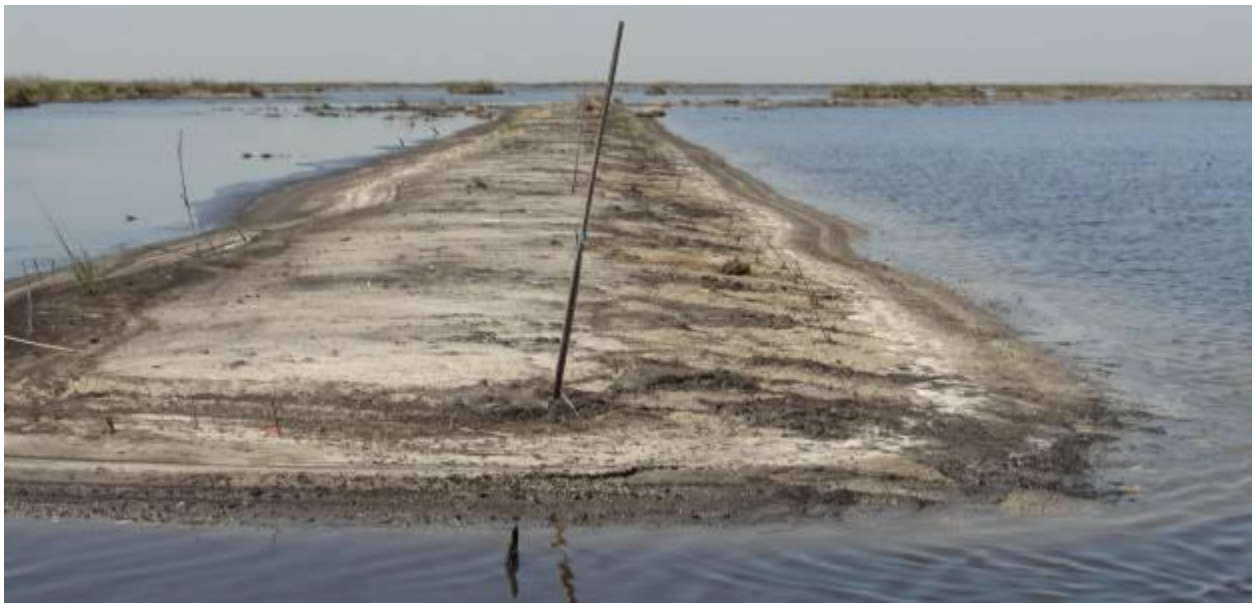
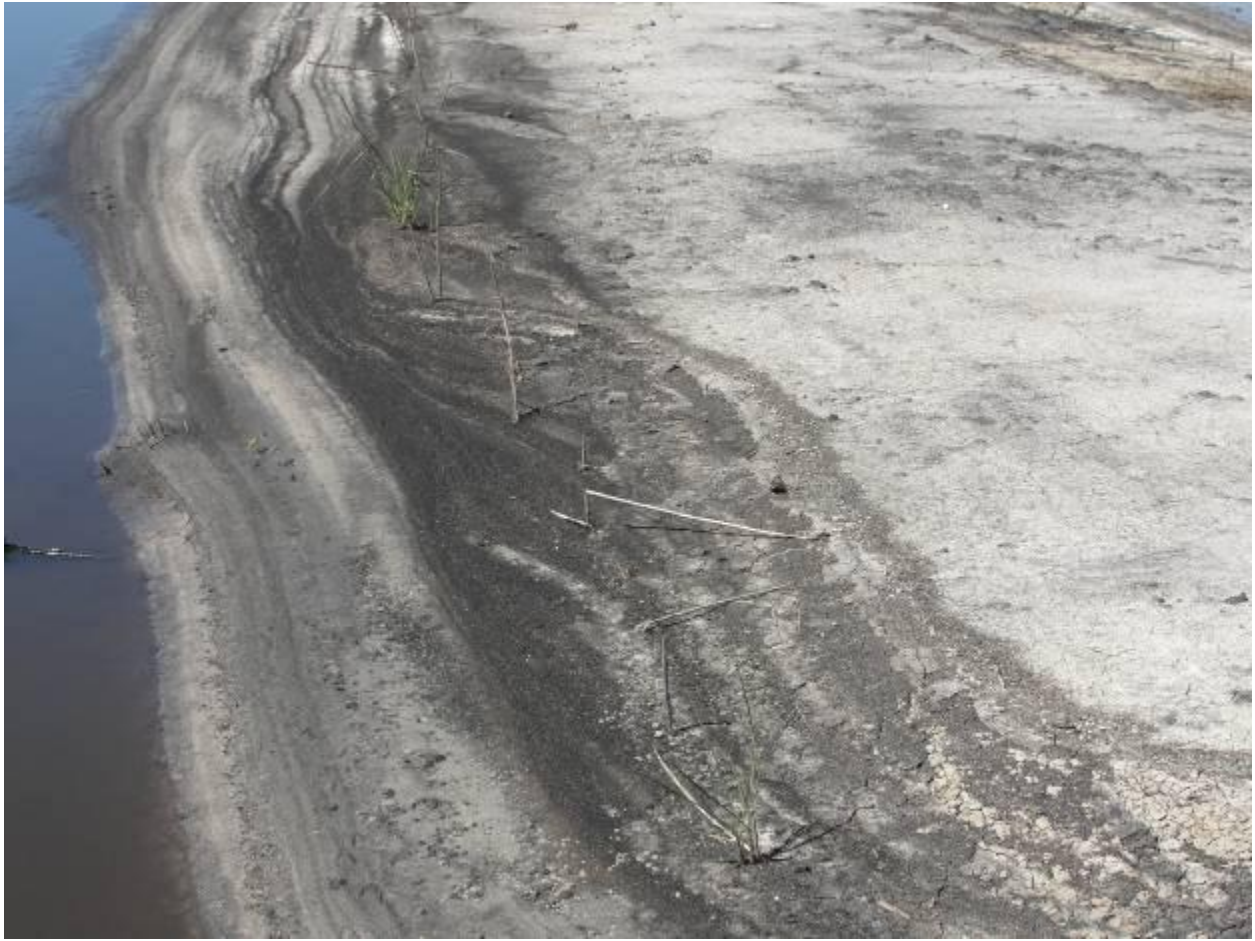
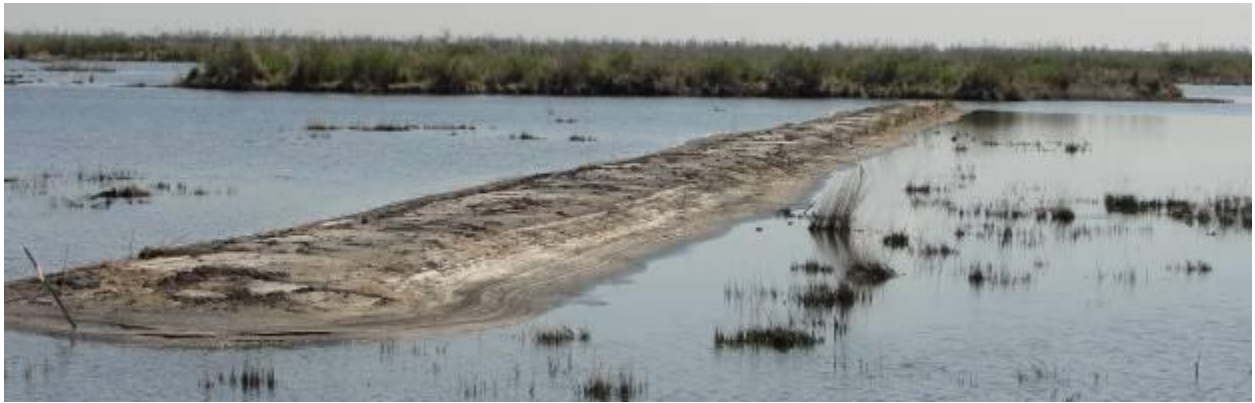
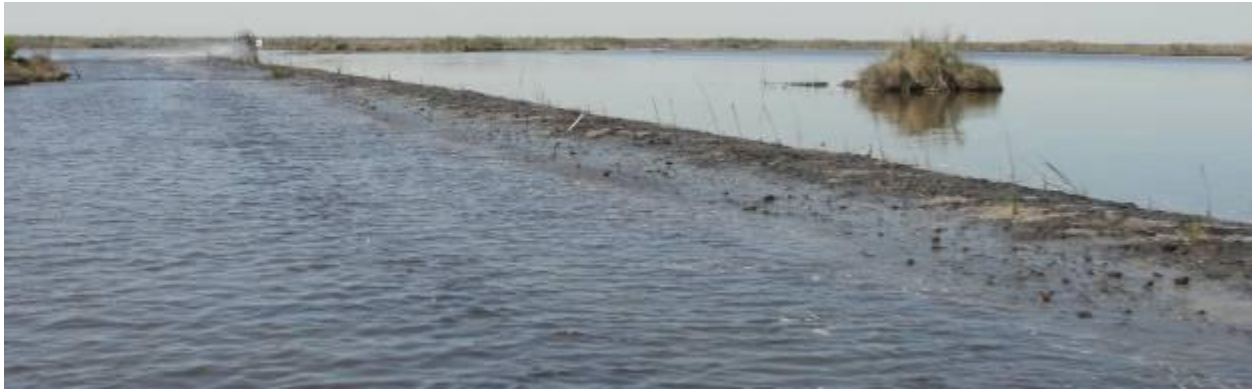
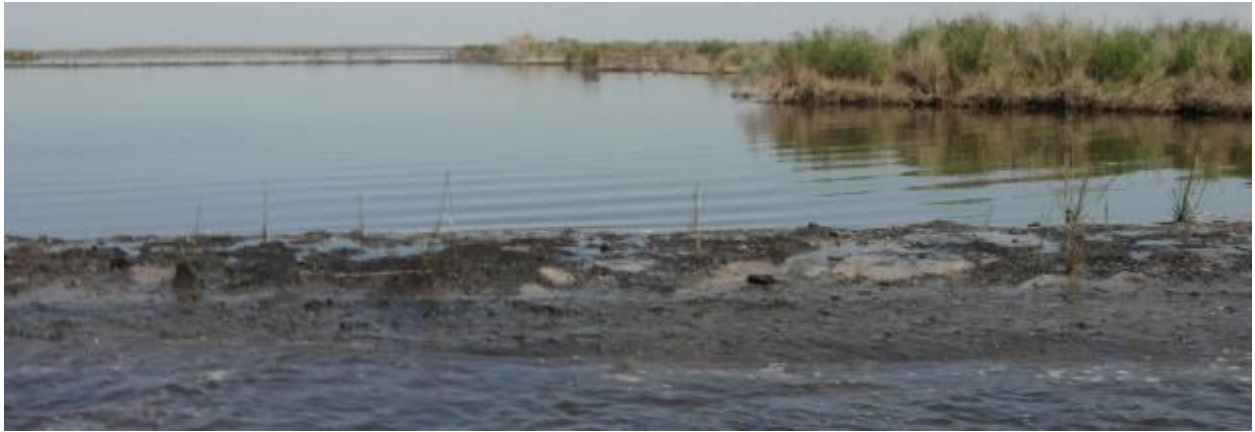
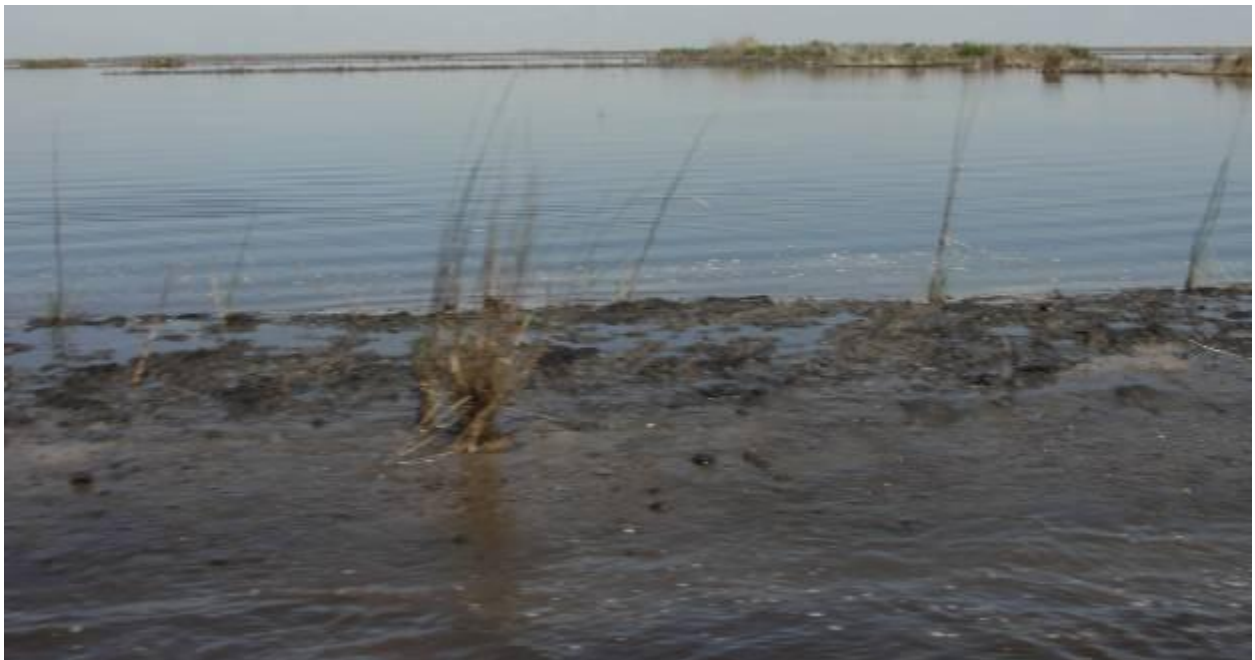
March 2010 condition of newest plantings:

For the newest CU-1B plantings, it is not likely that the source of the plants is a factor contributing to their current state, as the contract plants came from two different nurseries, one in Cameron Parish and one in Lafourche Parish, and all of the remaining plants from the other CU's generally appeared to be in the same condition on the date of this field trip.

Although mainly conjecture, weather could have played a causative role in the overall plant condition we observed. Installation of the CU-1B plantings was completed in July 2009 which turned out to be less than an ideal time for bare-root plant establishment. Following the extreme and prolonged saltwater inundation from hurricane Ike surge in September 2008, southwest LA experienced severe drought conditions in the first half of 2009, with a precipitation deficit persisting until October. In addition, discreet and continuous measurements during the summer revealed that salinities in the project area were significantly higher than normal - greater than 12ppt, and with water temperatures remaining around 85°F until September (CRMS). This may have led to stagnant or phytotoxic soil conditions until precipitation levels returned to normal in October, but by that time it was already at the end of the growing season when plants are beginning to senesce. This period was then followed by an unusually cold winter pattern that began in late November and persisted throughout south Louisiana. Minimum temperatures frequently dropped into the 30's or below for at least half of Jan and Feb 2010 dates (NWS monthly summaries for the Lake Charles/Port Arthur area). It is possible that the newest plantings experienced higher mortality or dieback of aboveground tissue from the combination of elevated stress during initial acclimation and then additional impact by the ensuing cold temperatures to any new shoot growth that did occur. Further, following a typical winter season, robust new growth is not usually seen in smooth cordgrass until March when warmer spring temperatures become entrenched. So it is also possible that this year's new growth expected for all plants in the area may still be absent because it's been retarded by the persistent winter weather pattern and the late freeze in early March.

Because of the high uncertainty at this date of what below-ground tissue remains viable, a mortality rate or pattern cannot reasonably be determined for any of the plantings, regardless of age. I recommend returning to the project site in September near the end of this year's growing season when a much more accurate assessment of the extent of plant survival can be made. Collection and analysis of soil samples may also provide additional insight in discerning actual causes of the apparent poor performance of all the plants.

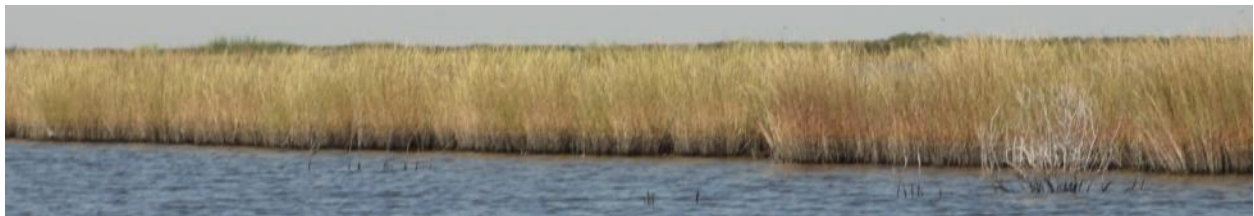
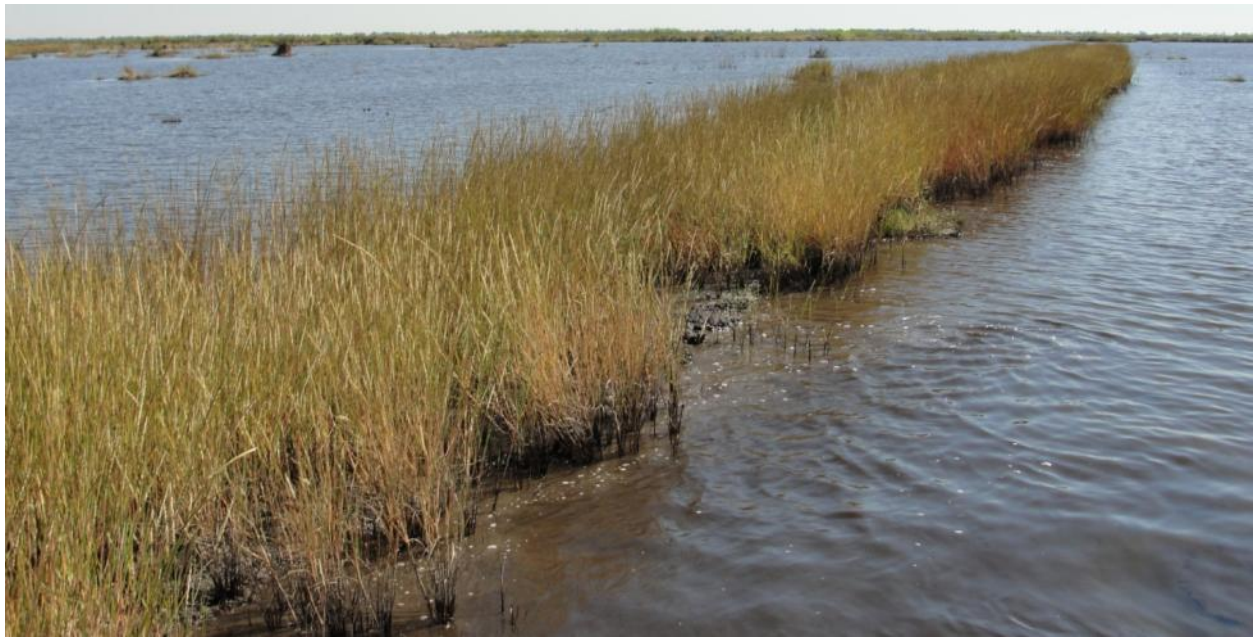
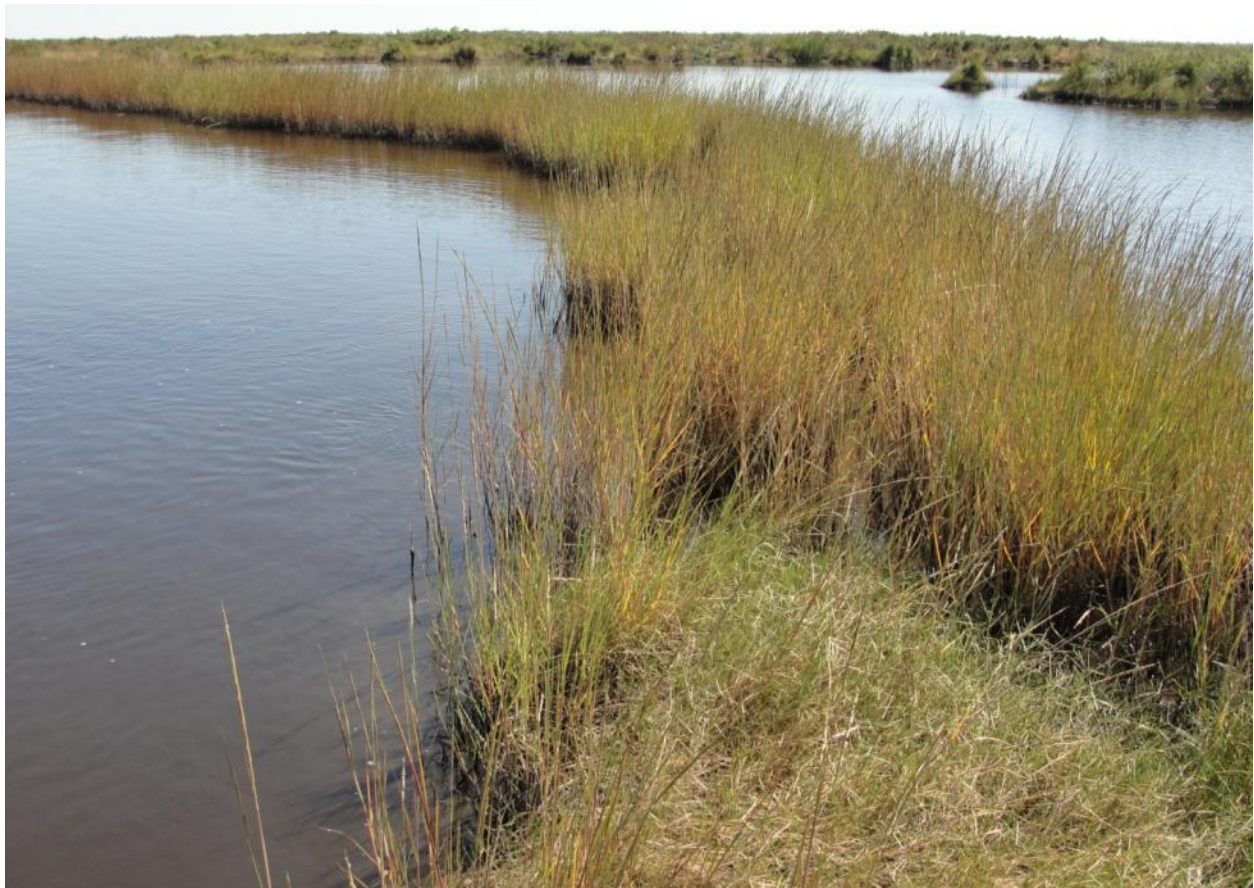
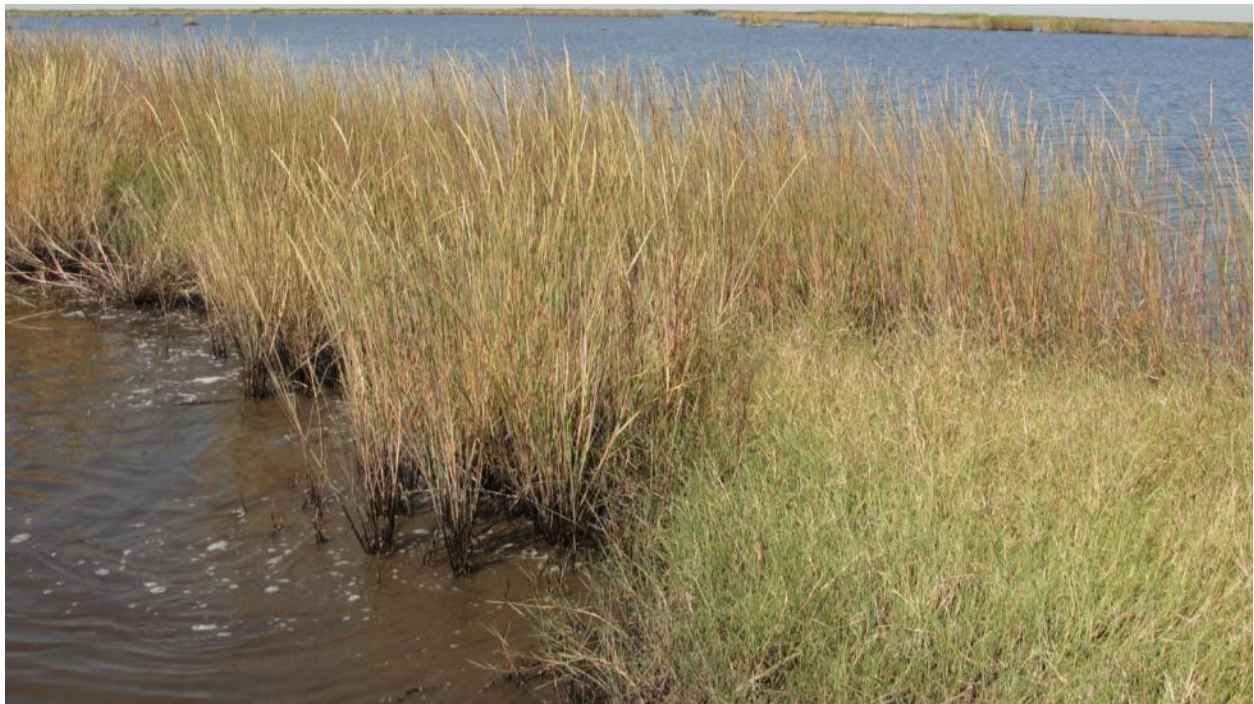
The vegetative growth of smooth cordgrass on the oldest and southeasternmost CU-1 Rows 16 to 25 looked excellent, as did that on newer CU-1A/B Rows 11 to 8, and the coverage was nearly 100%. The few gaps that were occasionally present on a few segments were minor and some gaps were occupied by other species such as seashore paspalum (*Paspalum vaginatum*) where the terrace crown was above the water elevation on this date.

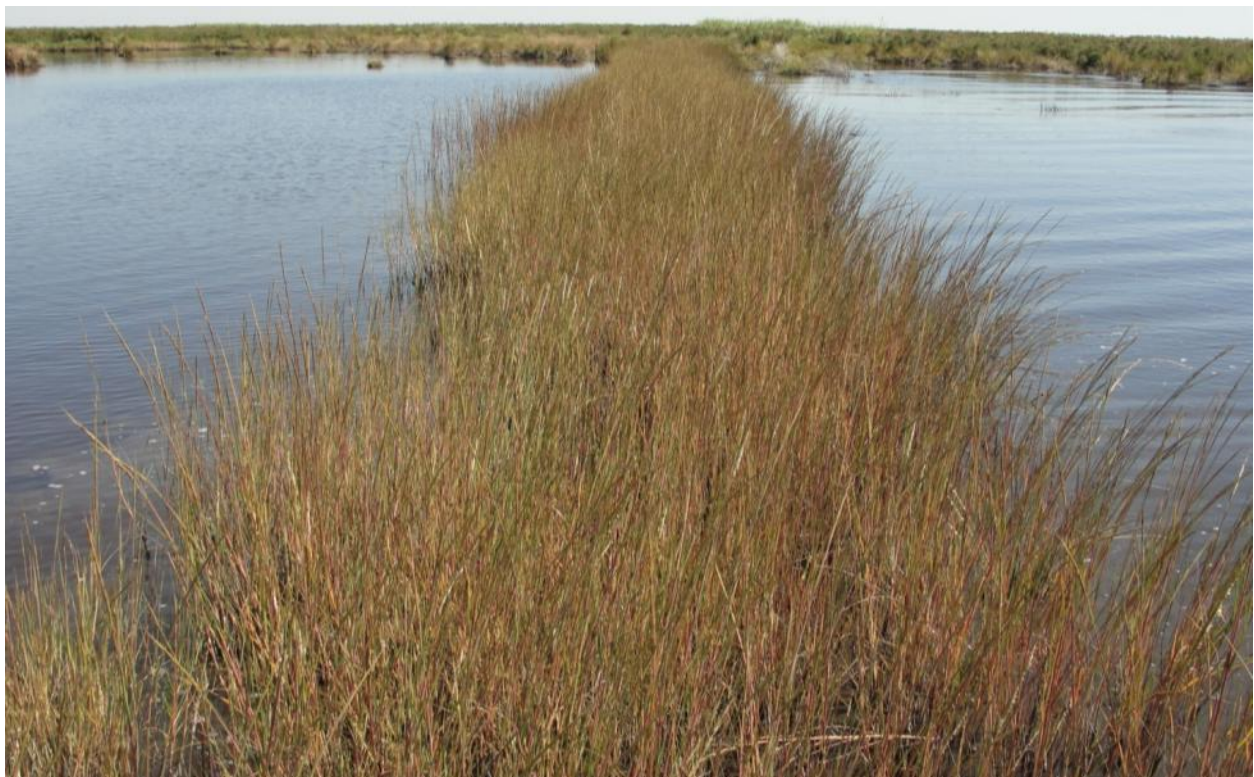
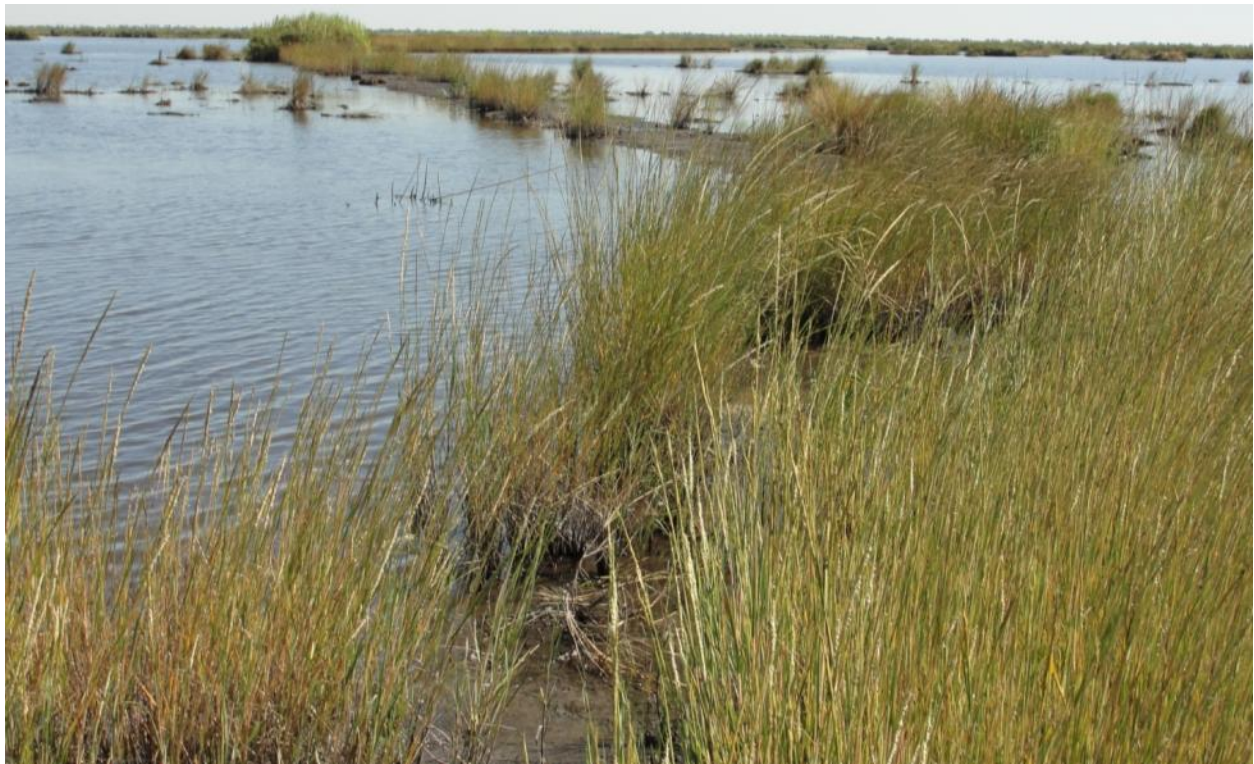
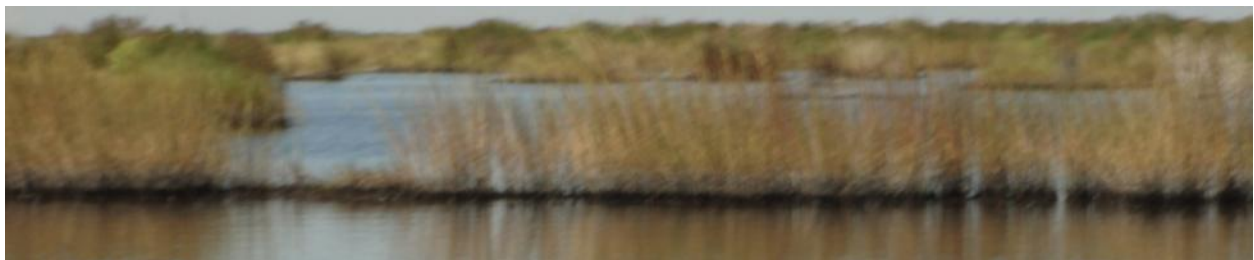
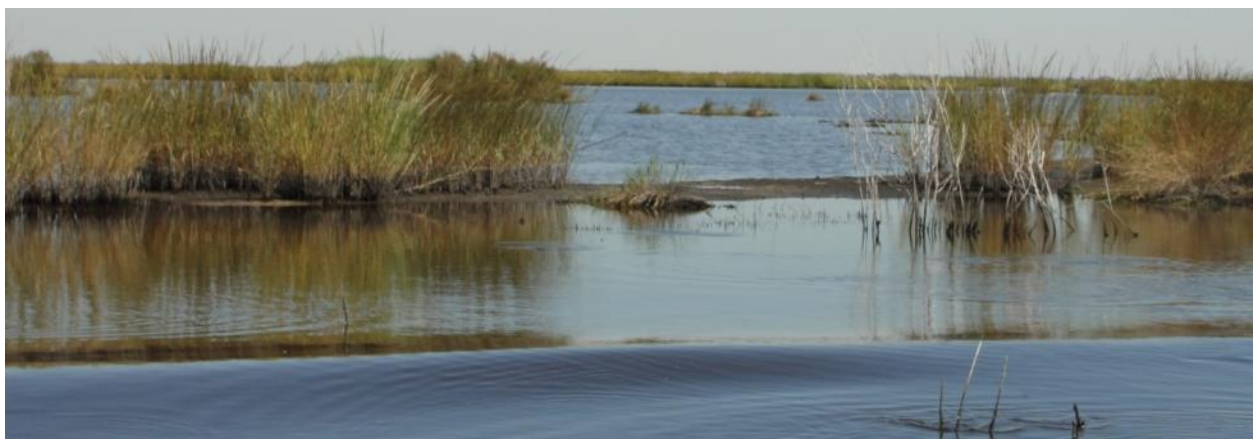
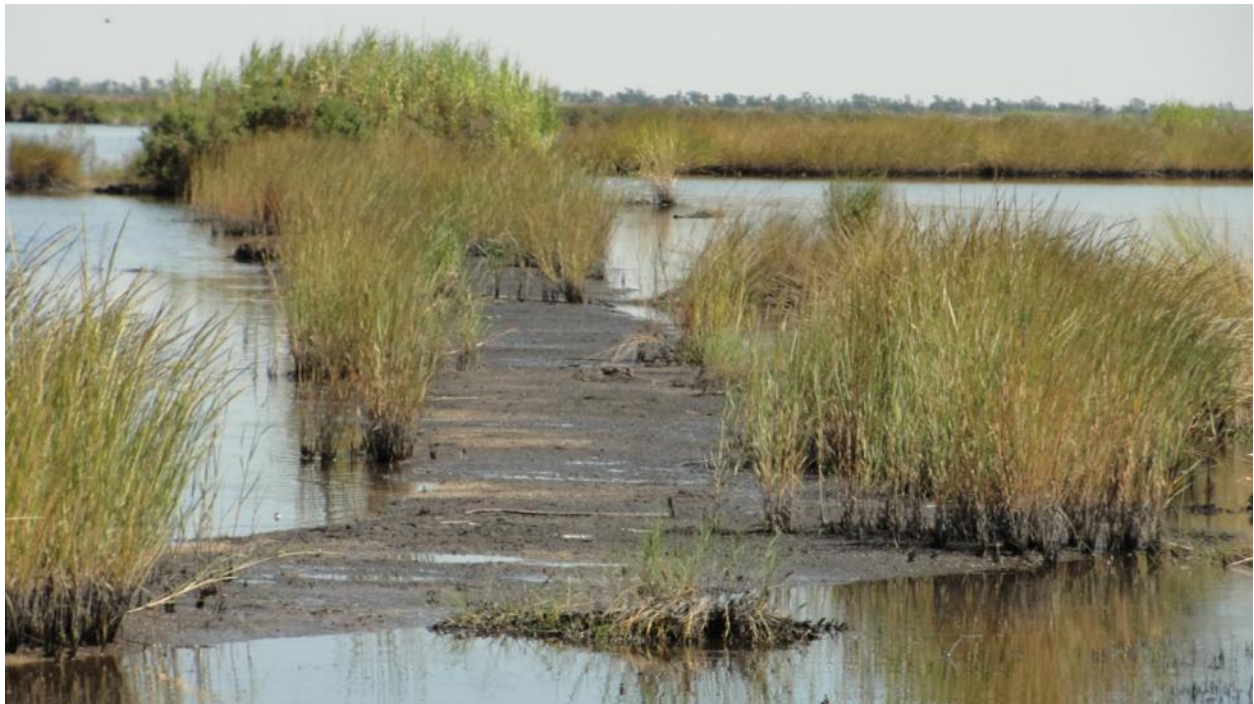
The estimated survival of the newer CU-1A/B plantings was very good in Rows 5 to 11 (greater than 80%), although the size of the gaps were more significant and narrowing of some terrace segments became more noticeable as we neared Row 5.

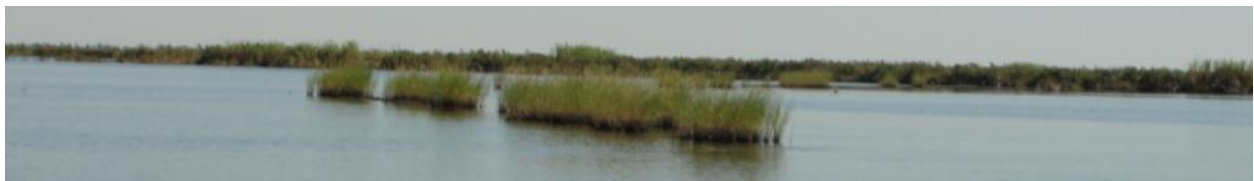
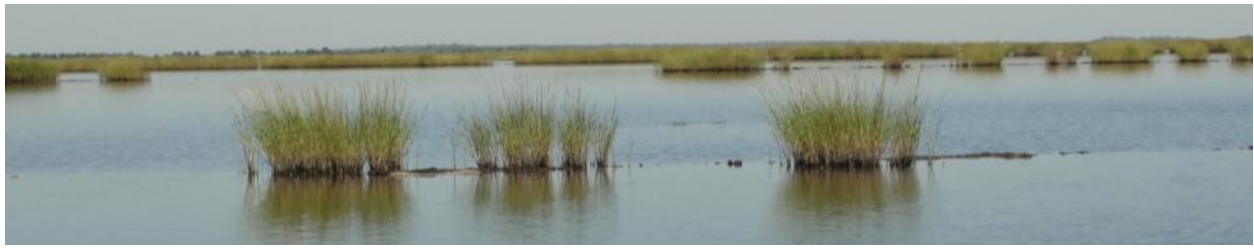
As the party continued north, the survival estimates for the rows dropped dramatically and ranged from fair to poor (5% to 50%) on the CU-1A/B Rows 4 to 2, but the vegetation that did remain appeared to be recovering well and for the most part looked very healthy.

There were a few exceptions however where some plants appeared to be struggling, but those were generally found where the terrace segments were severely impacted and were obviously narrowed with lower crown elevation.

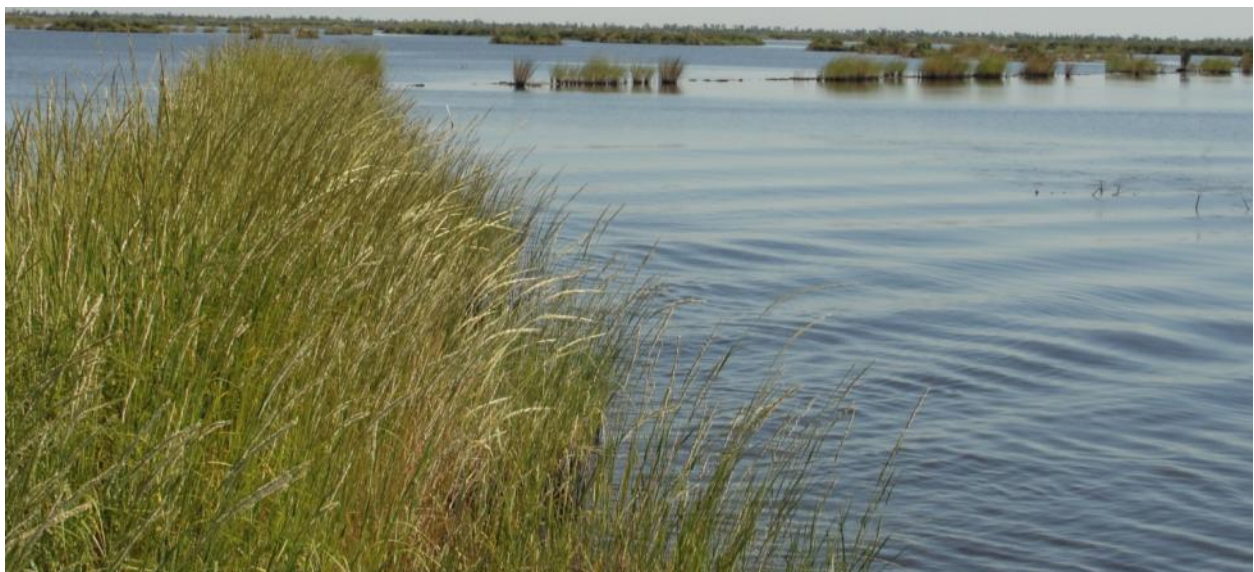
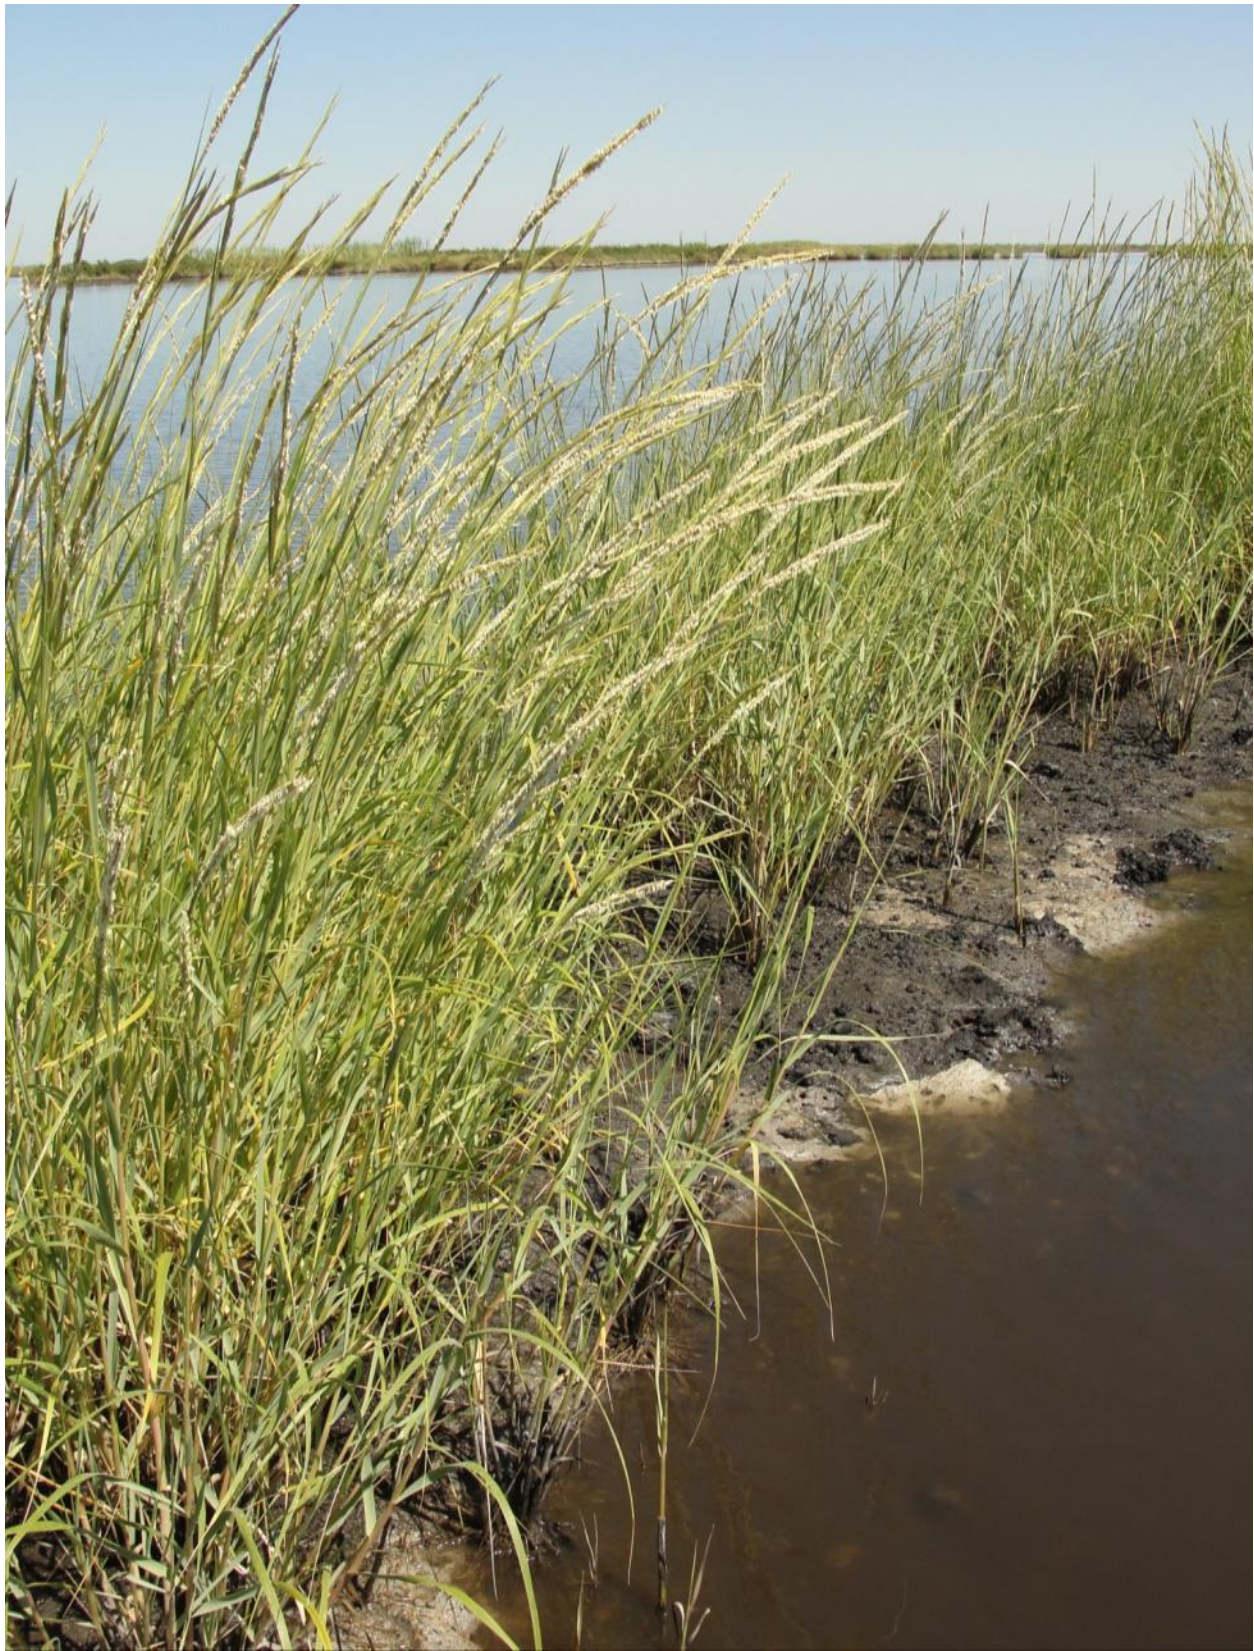
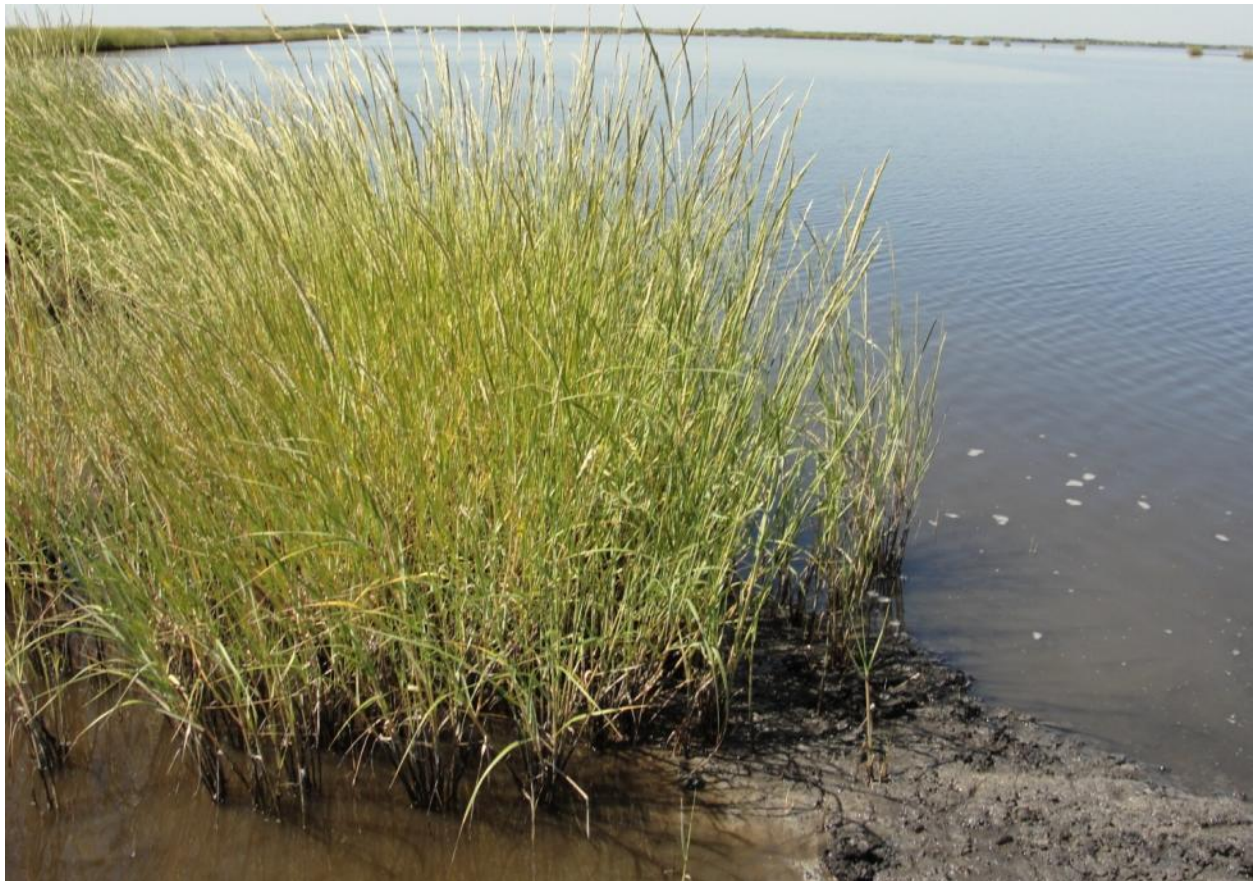
The survival on CU-1A/B Row 1, south of Green's Lake, was about 75%. Here again, the surviving plants looked very healthy and provided nearly 100% cover across the crown in some spots, but there were also other stretches bare of vegetation more than 100 feet long on this row.

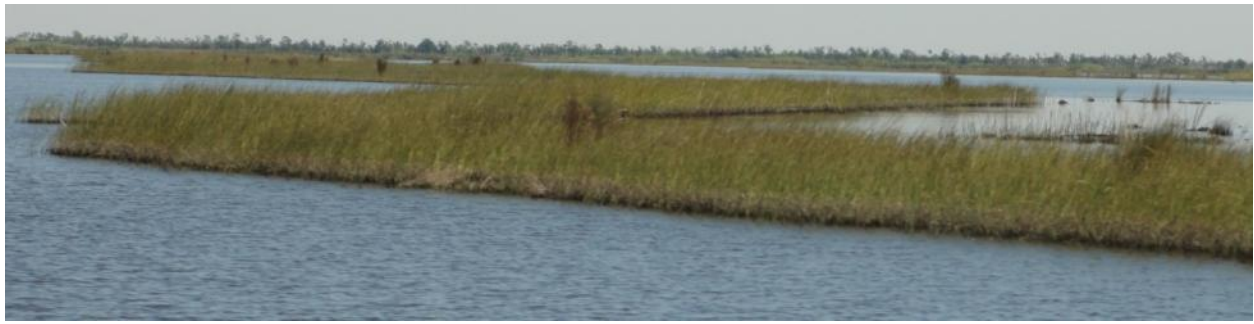
Overall, the southern rows of CU-1 group looked stable though some had obviously narrowed. There were some areas of loss observed, but there was no discernable pattern that might explain the loss, or why the smooth cordgrass was not recovering well on some segments or in spots, but on others, though providing thin cover, the individual plants looked fairly robust.
