2012 Operations, Maintenance, and Monitoring Report

East Sabine Lake Hydrologic Restoration (CS-32)

State Project Number CS-32
Priority Project List 10

July 2012
Cameron Parish

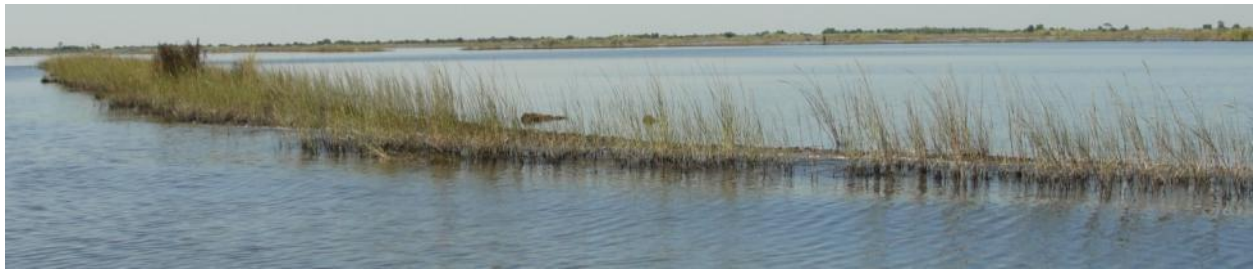
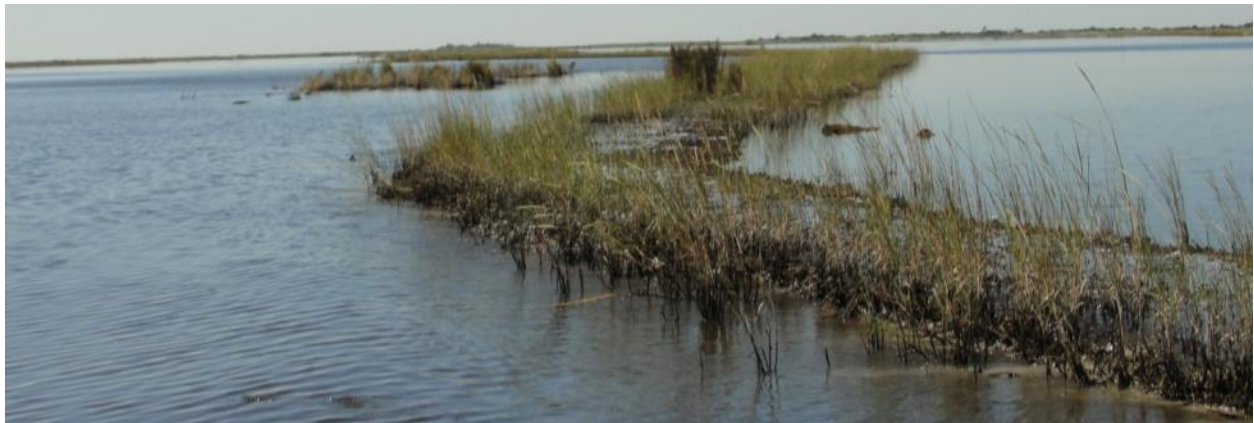
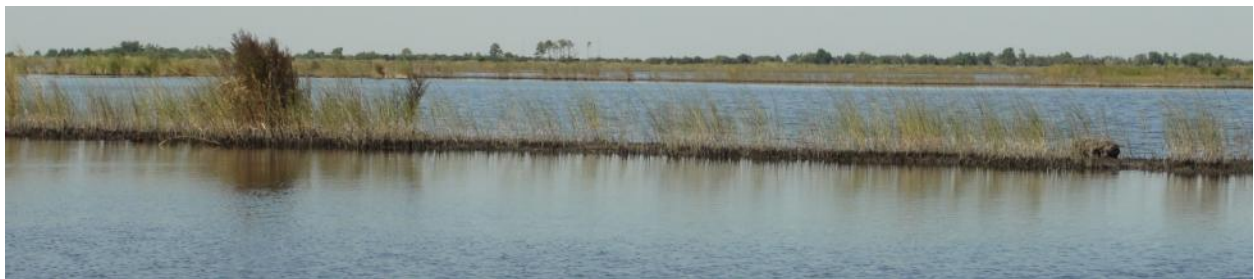
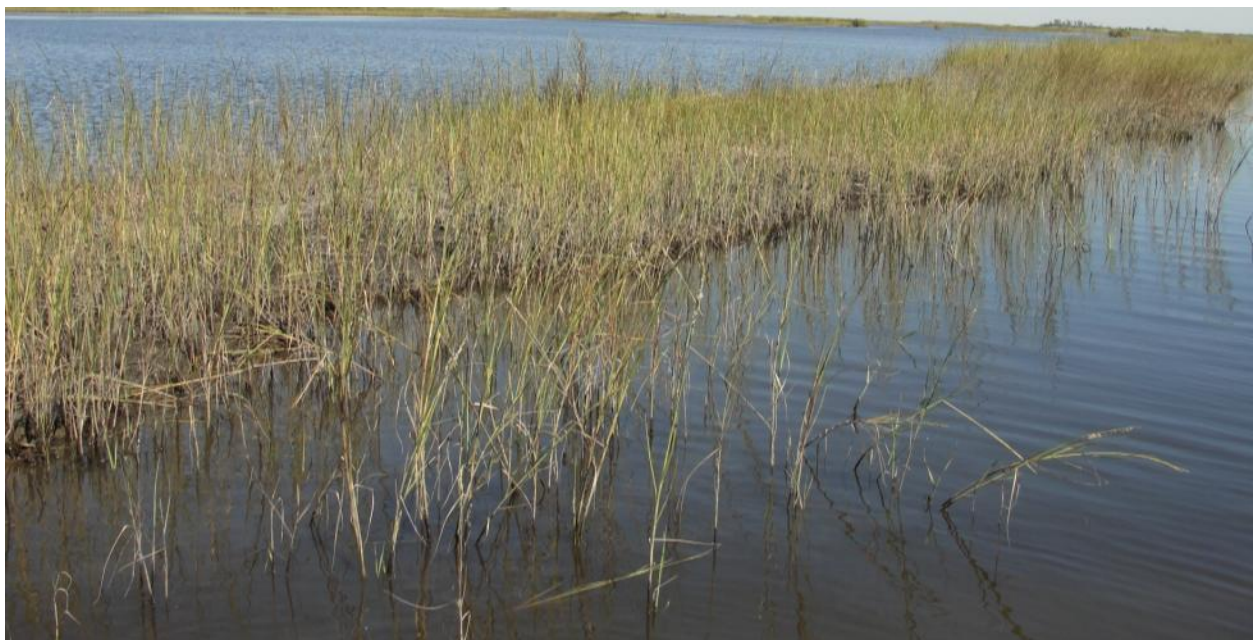
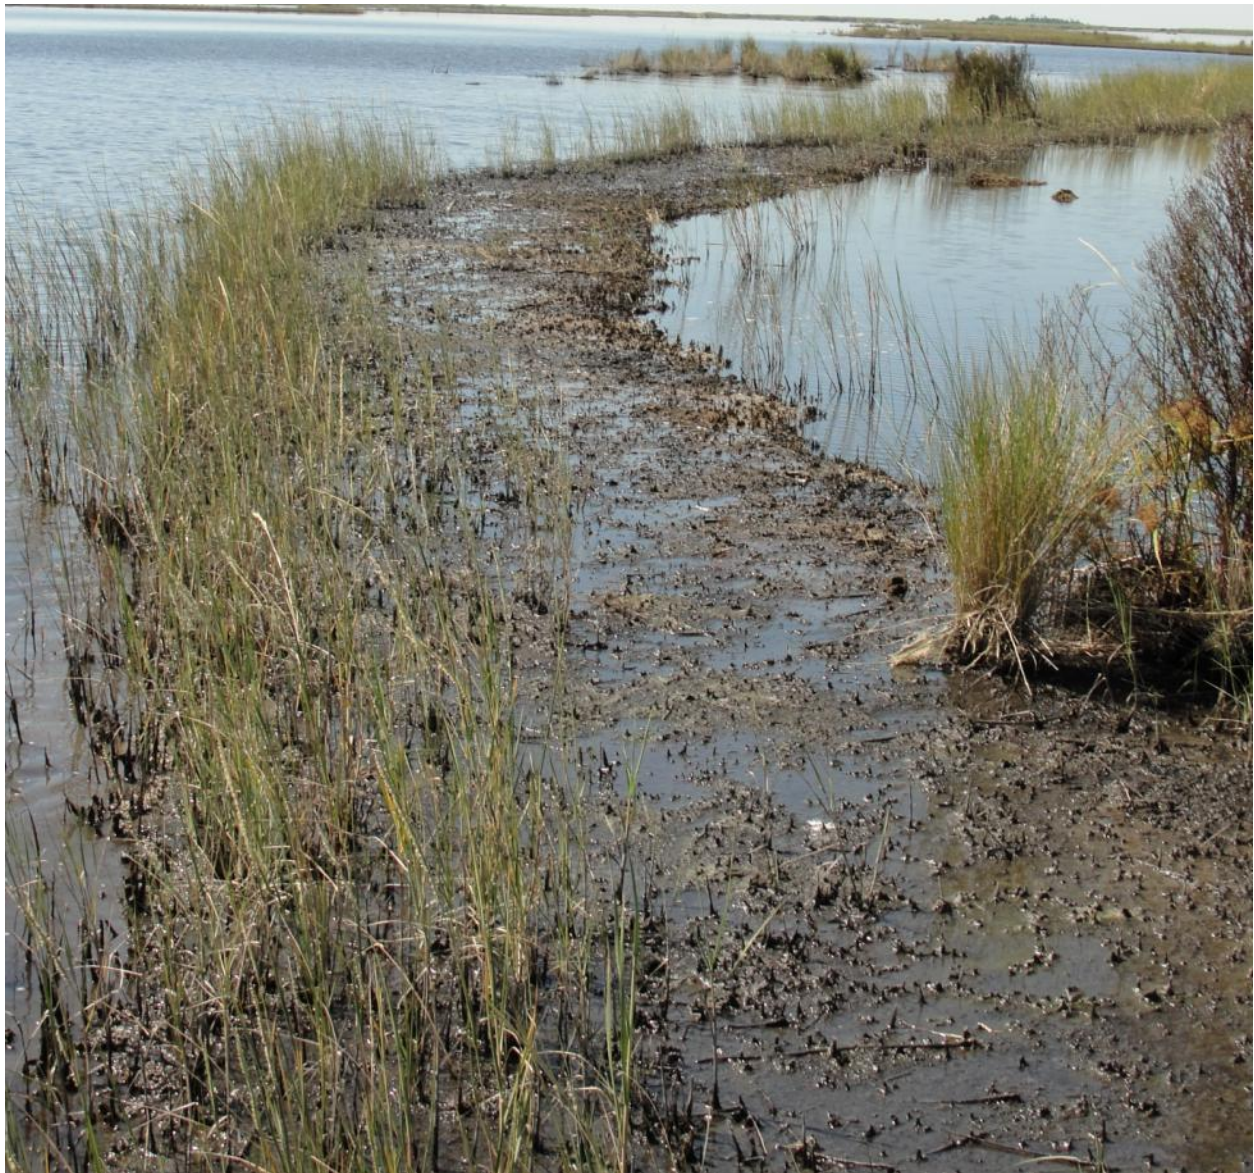
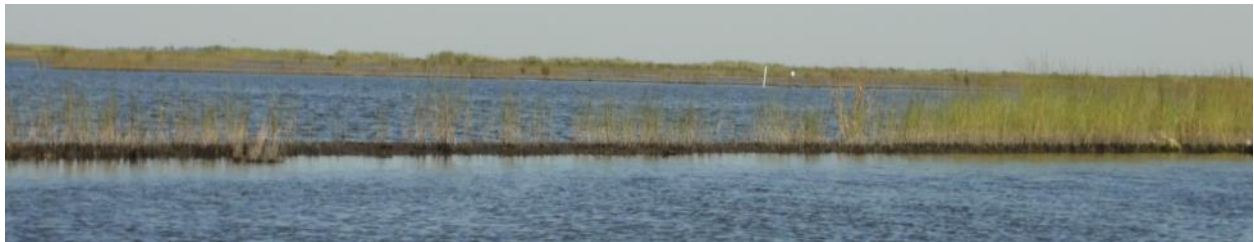
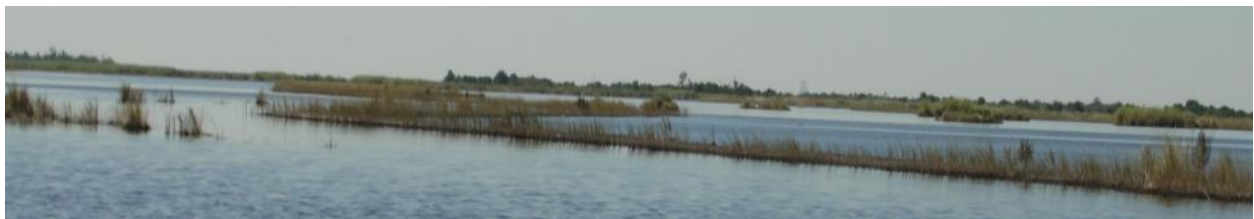
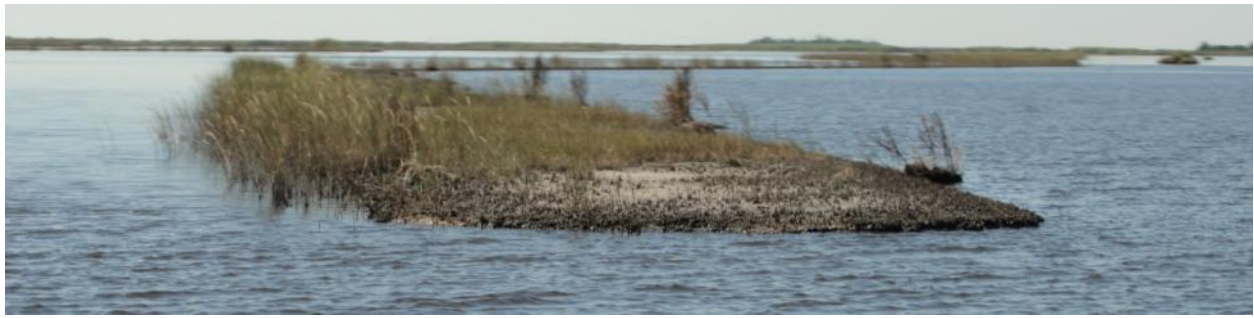
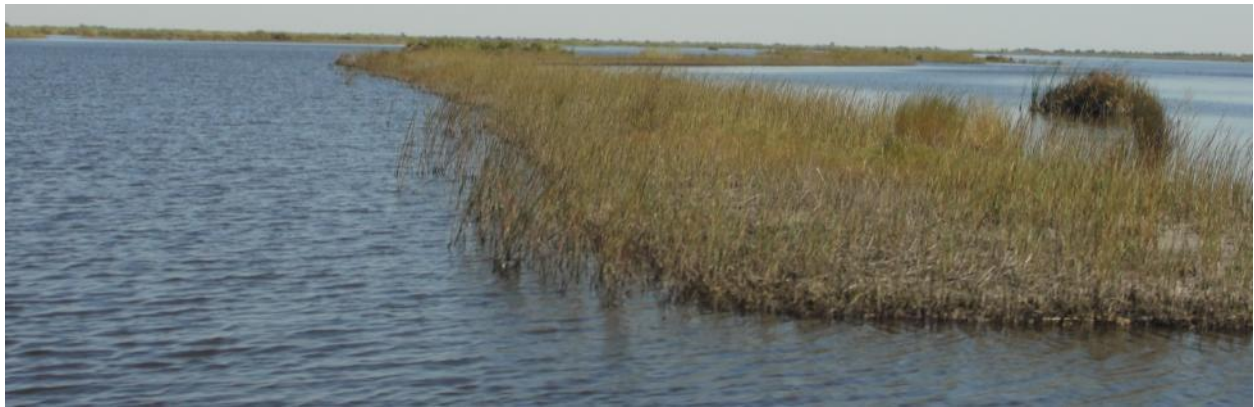
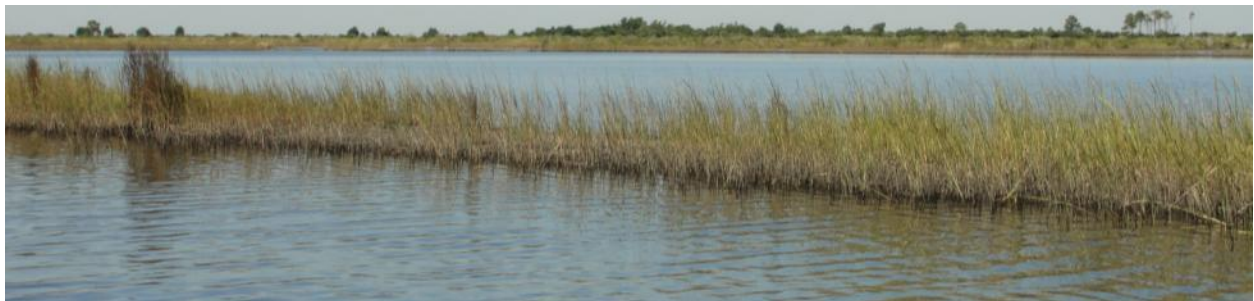
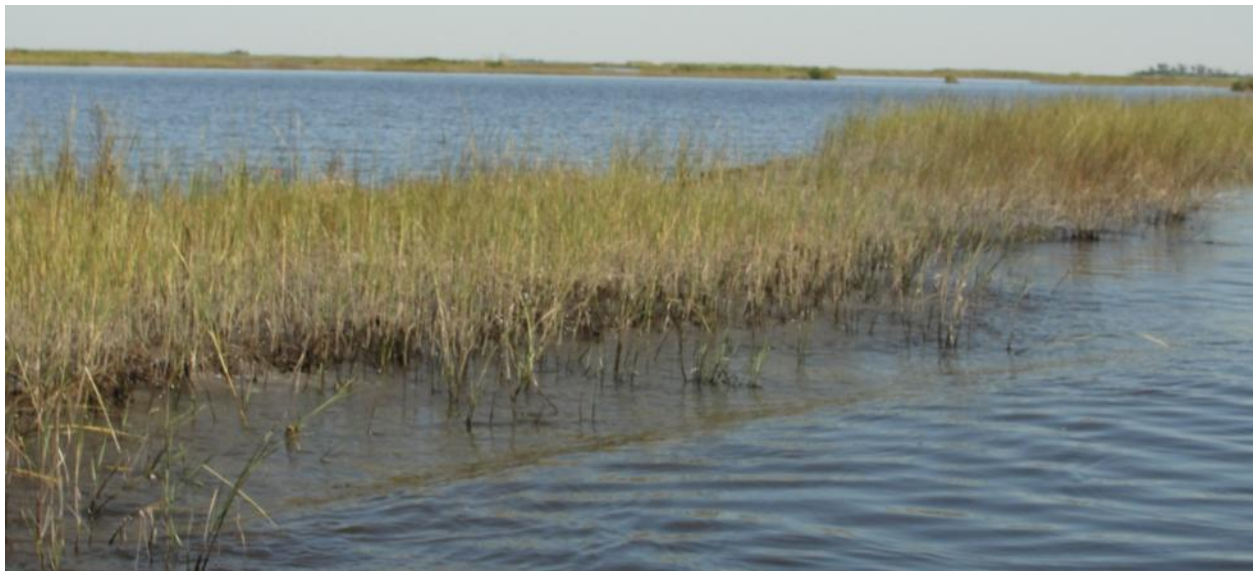
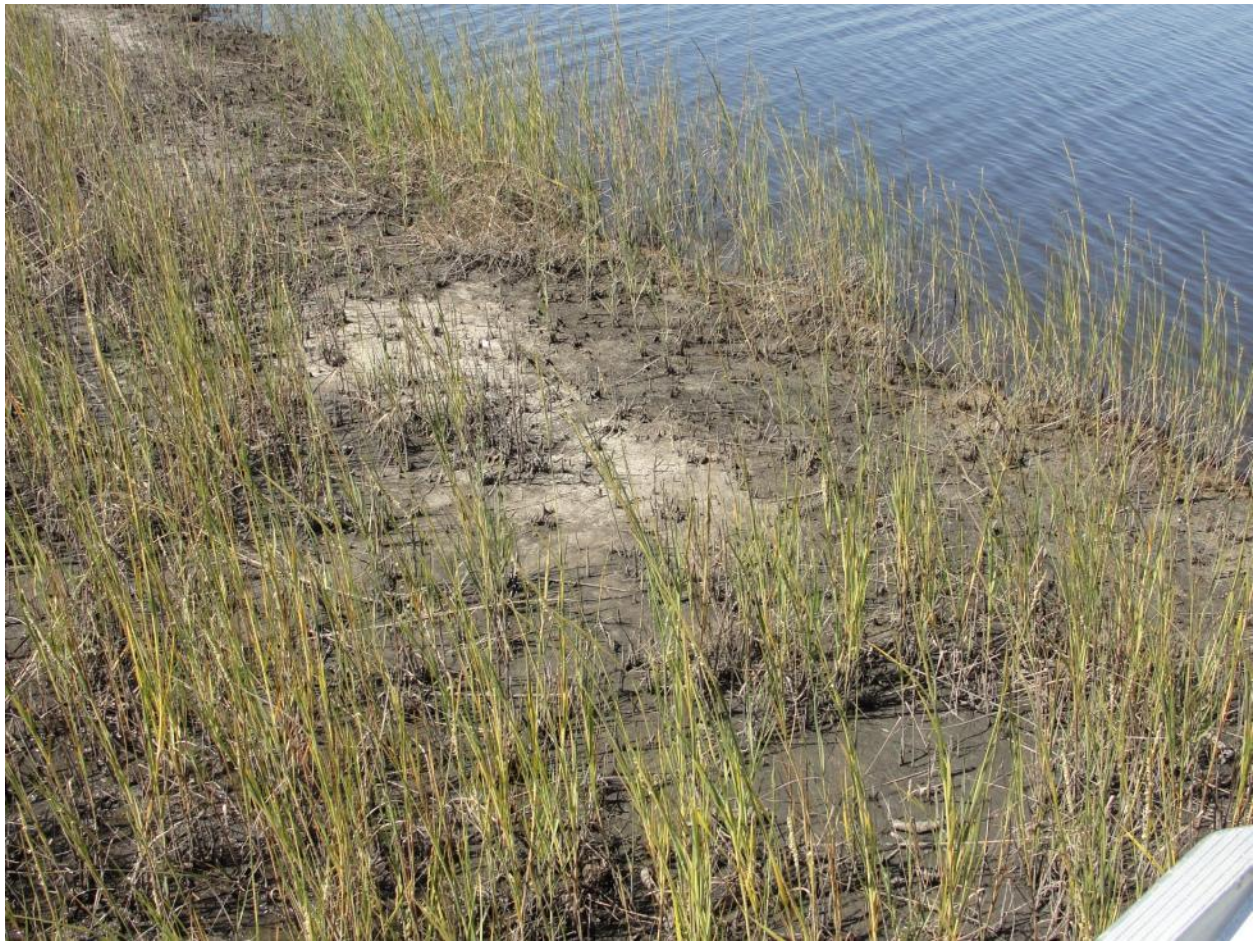
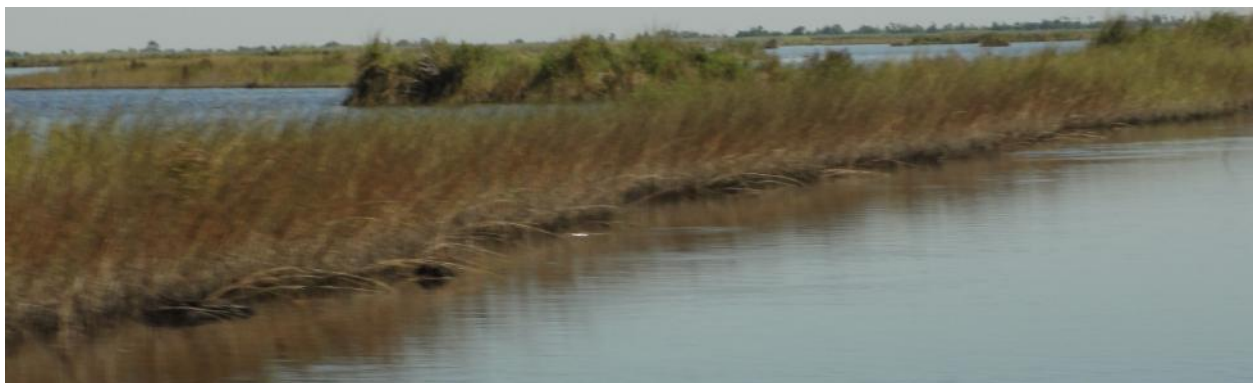
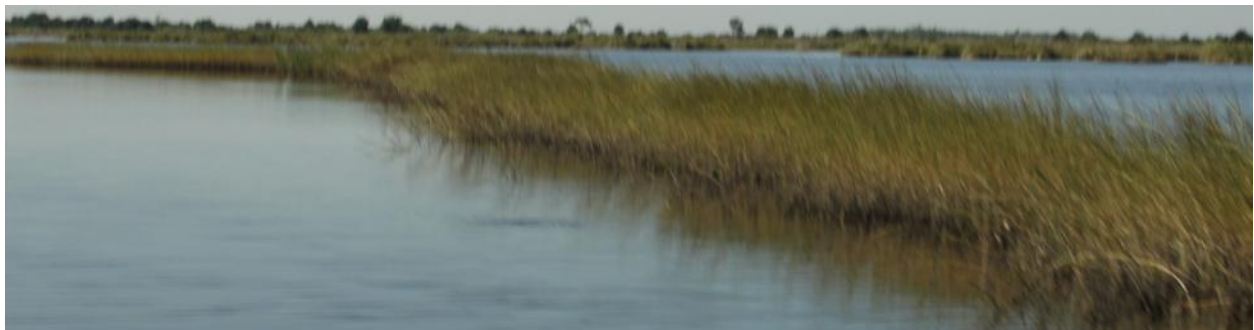
Continuing north, the survival and cover on the CU-1 terraces was found to vary quite a lot. Many terrace segments were much narrower and had poor to no cover, but there were other segments where the cover was good and the terraces retained their width. Overall though, there were only a few sites found where individual smooth cordgrass plants looked as robust as those seen to the south. It almost appeared that some plantings were just beginning to re-emerge and expand the cover.

Recommendation: The project team discussed options and it is recommended that the construction phase of this project be closed out. The remaining plantings are expected to continue to recover and expand but where there are large stretches of missing plants, it is advisable to re-vegetate with additional plantings that can be conducted through O&M. I recommend that an O&M planting to target areas with poor to no cover be planned for TY1 or 2, and could probably be accomplished for less than \$100,000 (not amortized \$). To provide for adequate cover to be maintained throughout the 20-year project life, O&M funds should also be available for an additional O&M planting event if it becomes necessary later in the project life. Darryl Clark has confirmed that there currently is \$254,428.04 in the project O&M budget, which is sufficient to fund a TY1 or 2 planting. OCPR typically implements the O&M activities, but if USFWS & OCPR agree, NRCS can design and implement the planting.

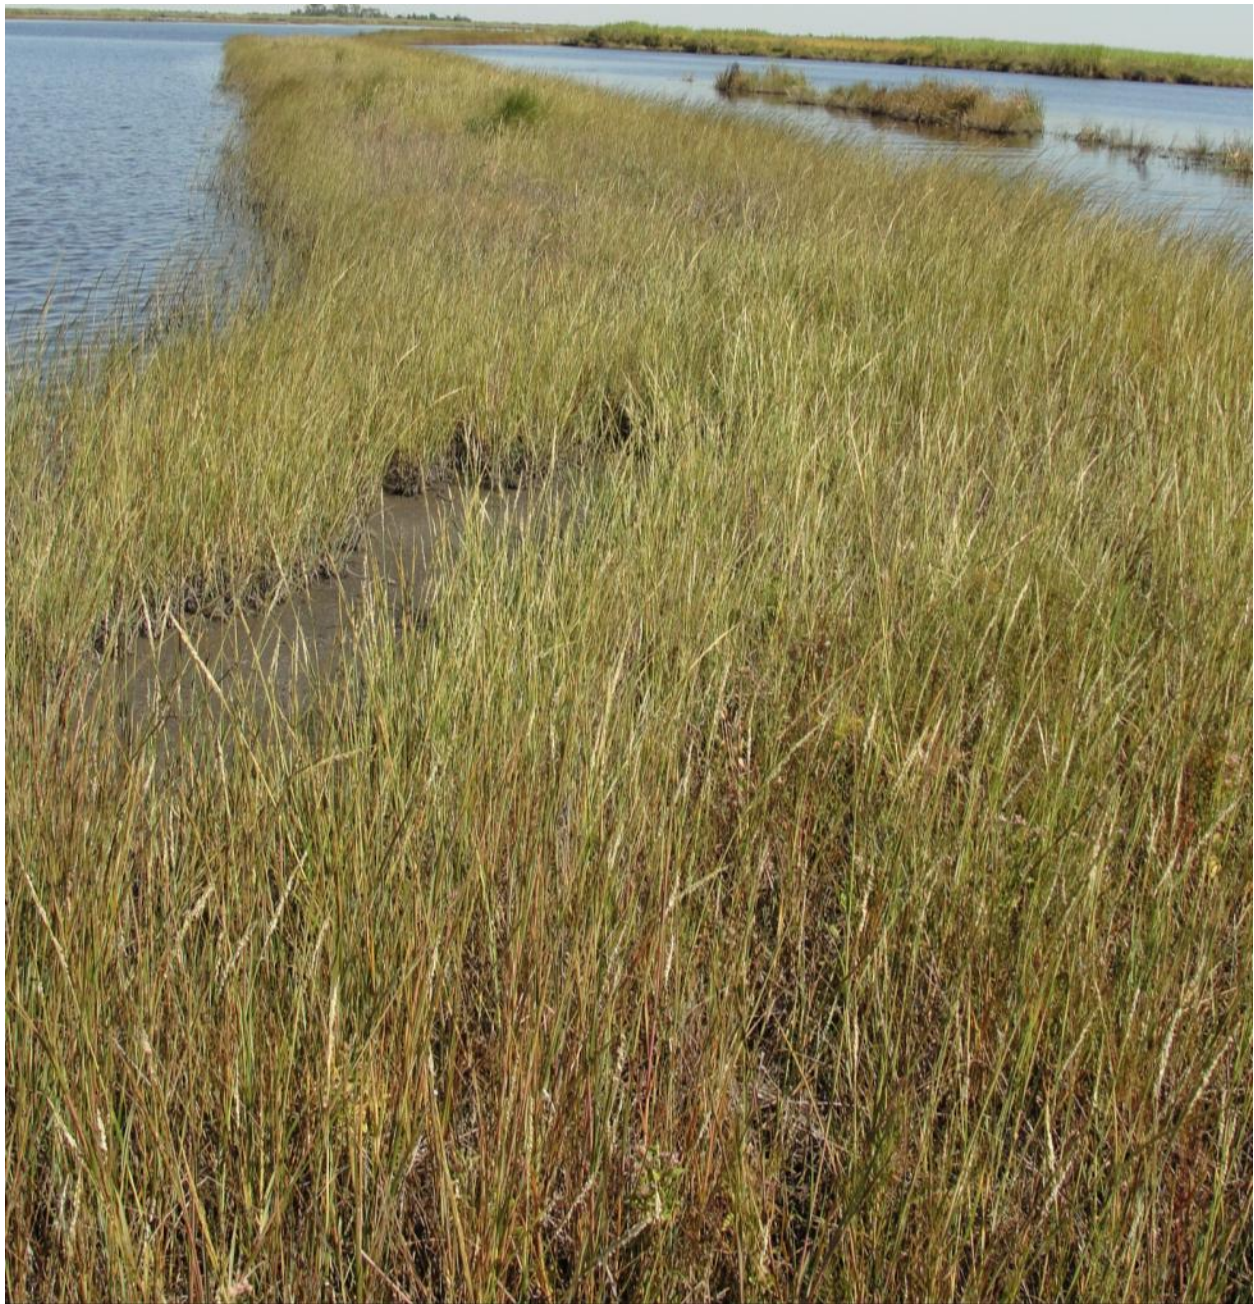
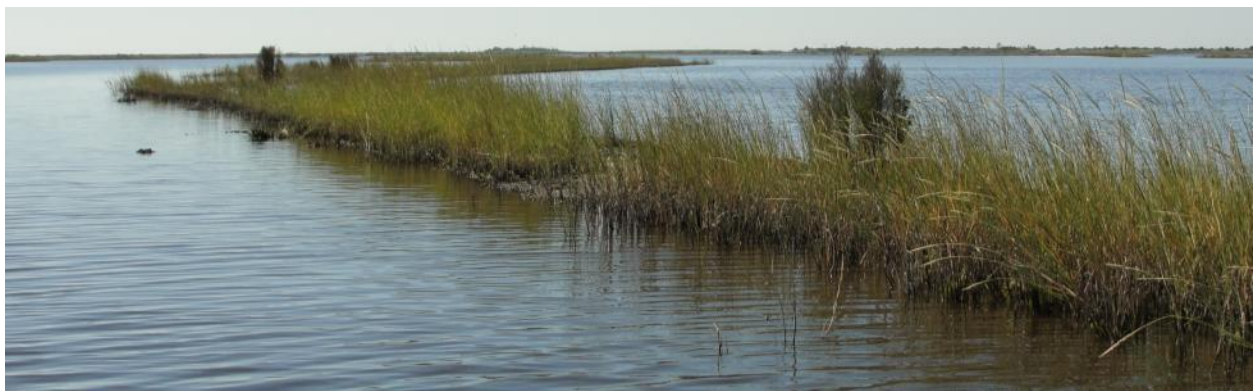
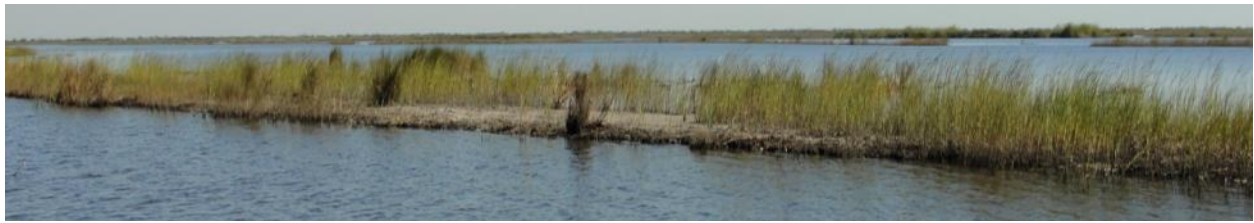
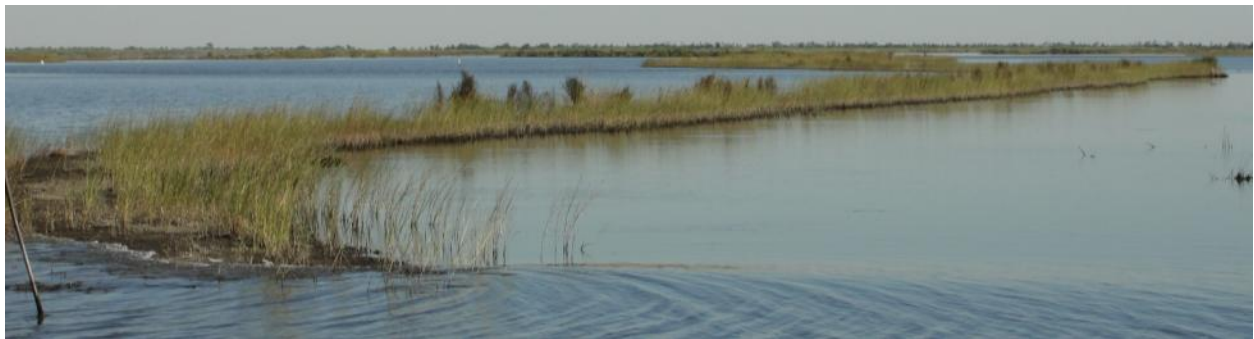
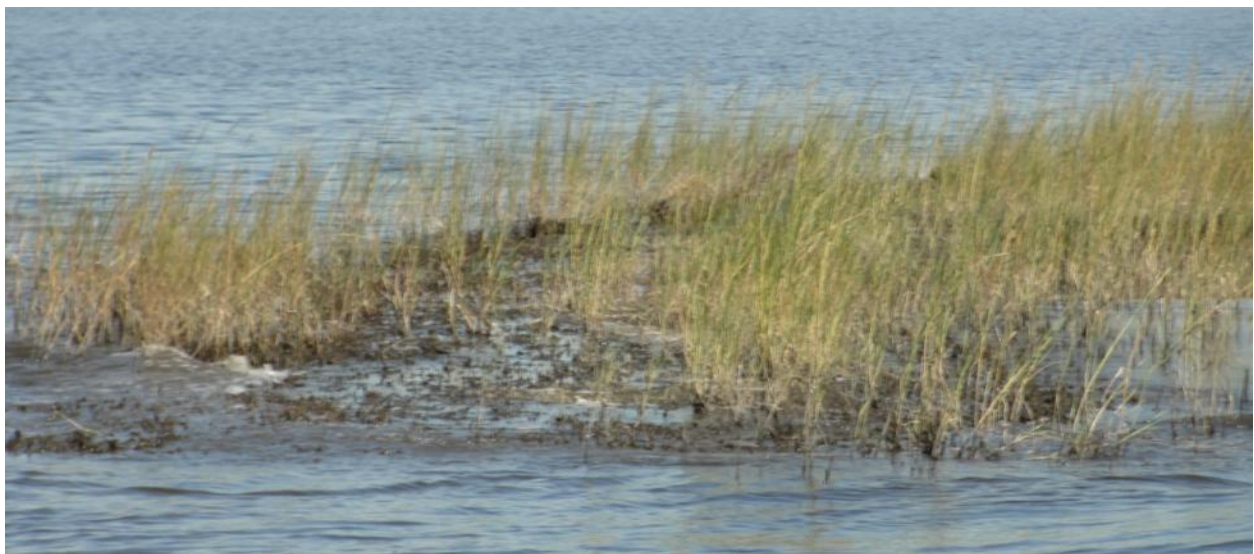
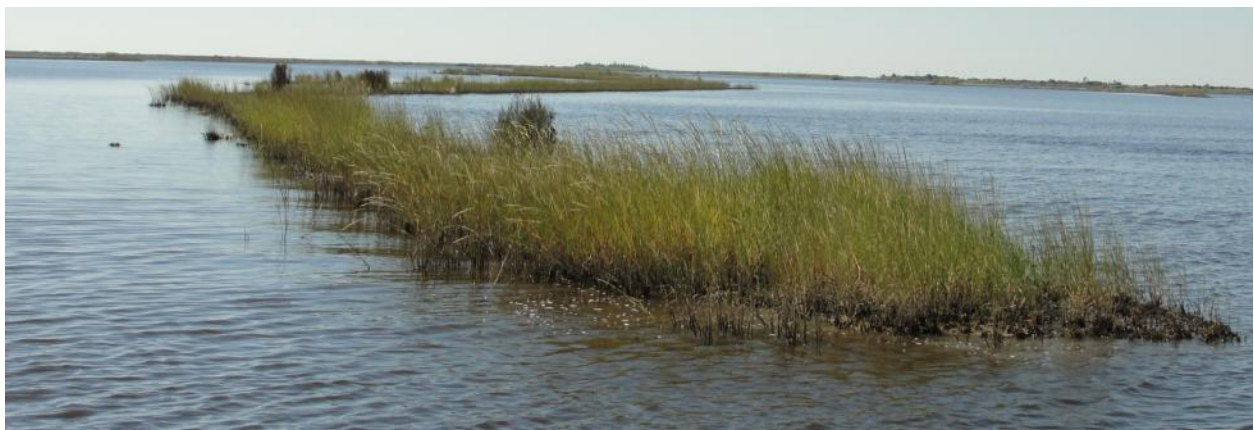
The water salinity and soil EC data, and the vegetative coverage estimates recorded by the field party are attached. A lot of photographs have been included in this report to fully illustrate just how widely

the condition of the terraces and plantings ranged over the 221,000 LF (nearly 42 miles) of terraces. Over the entire project, I would estimate that vegetative cover of the terraces is at approximately 50%. The impact of the combination of storms and repeated years of drought had been extreme, although the current soil and water salinity/EC conditions on this date were well within tolerable ranges for smooth cordgrass. A large portion of the remaining plantings still appear to be in a recovery mode and may just require more time to achieve desired vigor and expansion.

The condition of the terraces and plantings should be reassessed again by the end of October 2011 at which time a more accurate estimate of the replanting needs will be made.
