**State of Louisiana
Coastal Protection and Restoration Authority
Office of Coastal Protection and Restoration**

2012 Operations, Maintenance, and Monitoring Report

East Timbalier Island Sediment Restoration, Phase 1 & 2 (TE-25 & TE- 30)

July 2012
Lafourche Parish

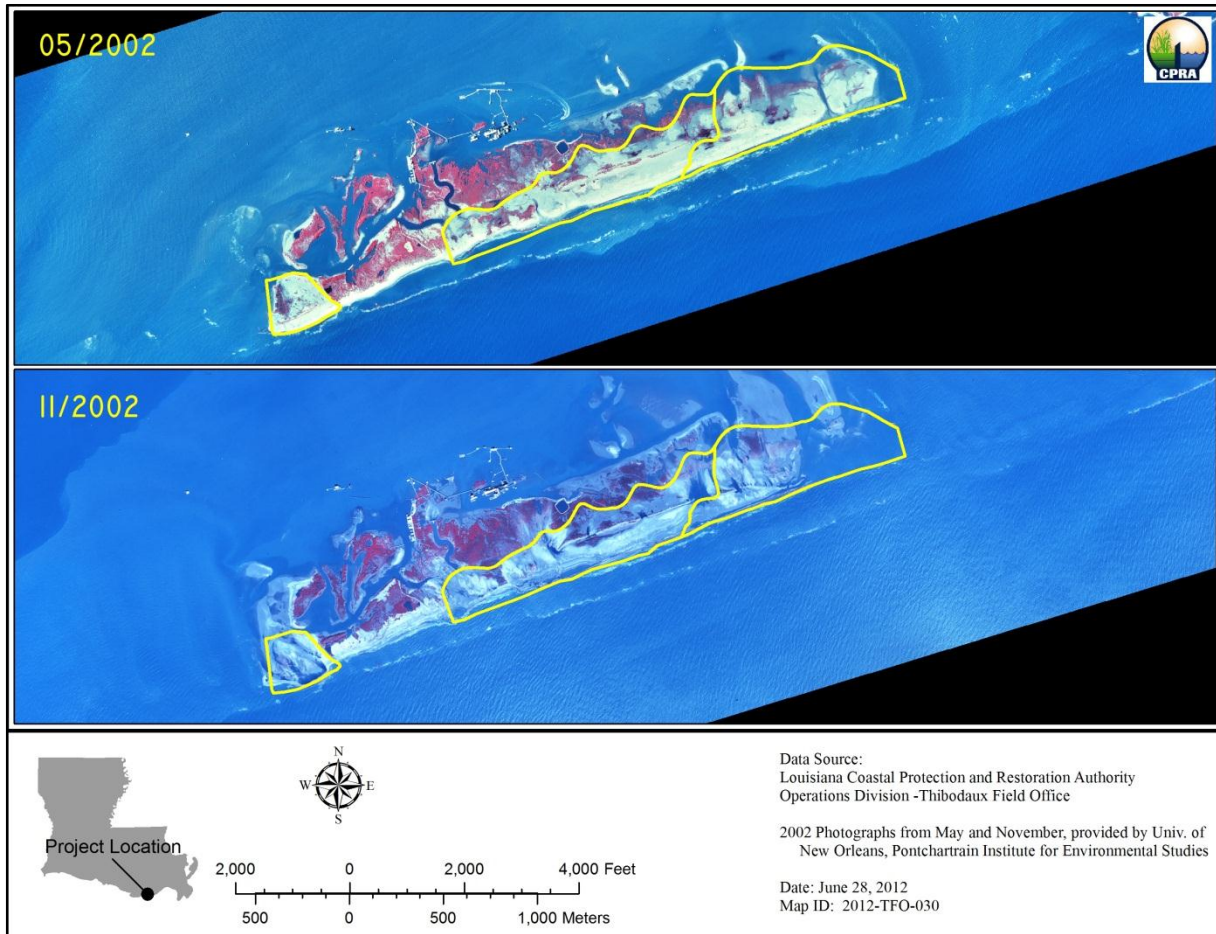
Figure 14. Aerial photography (May and Nov 2002) for East Timbalier Island. Note the erosion induced by the 2002 hurricane season (Isidore and Lili).

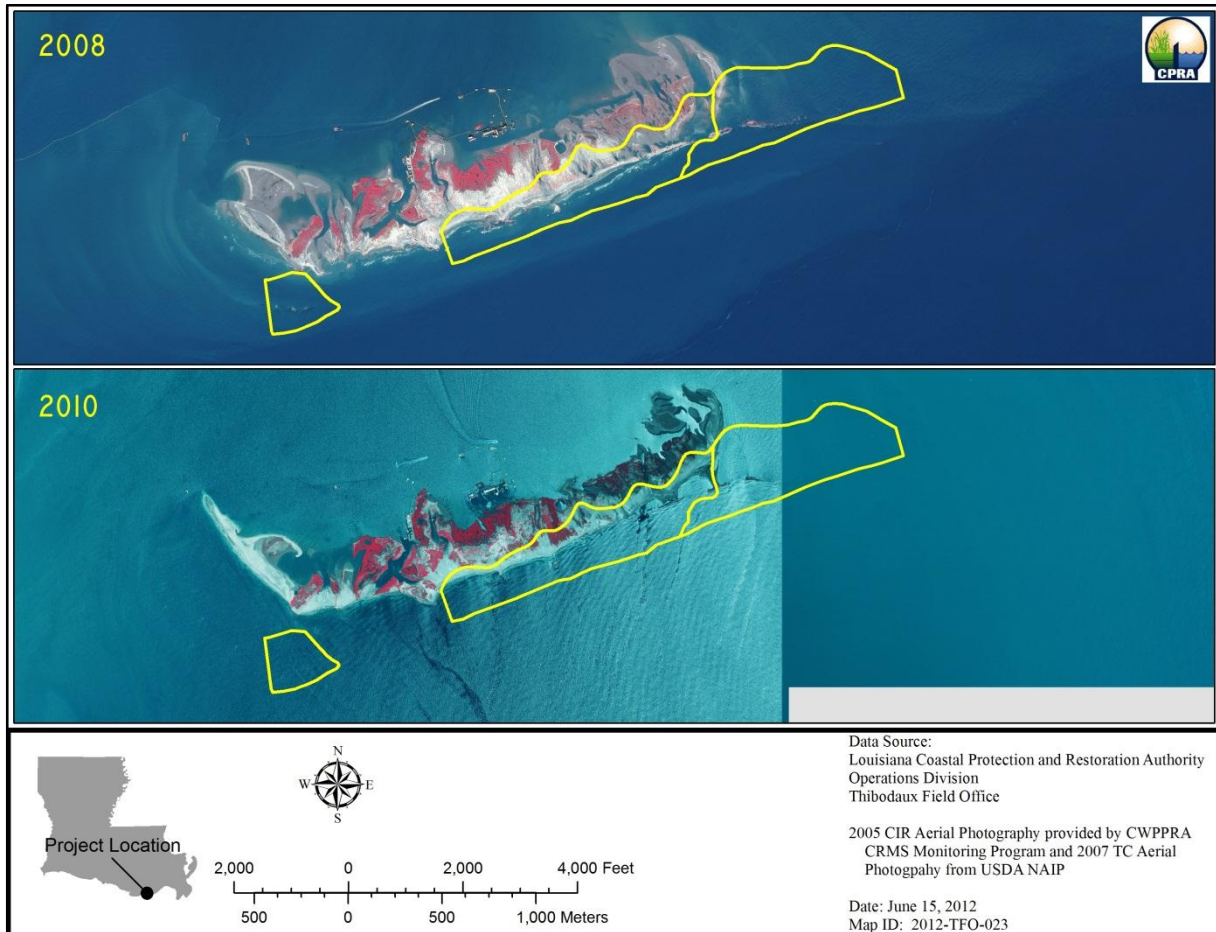
Aerial photography from 2007 (Figure 17), 2008 and 2010 (Figure 18) reflect the grid change elevation model for 2000 to 2006 (Figure 16). These images clearly show that the project is in the process of continuing degradation. By 2010 nearly the entire fill area, having lost elevation and volume, was open water. In addition, between 2008 and 2010 the island has rolled back, as can be seen by the decreasing distance between the back-side production facility and the island shore.

Figure 18. Aerial photography of East Timbalier Island from 2008 and 2010. Note the erosion induced by the 2008 hurricane season (Gustav and Ike) and the absence of a post storm recovery on the island, especially inside the project areas.

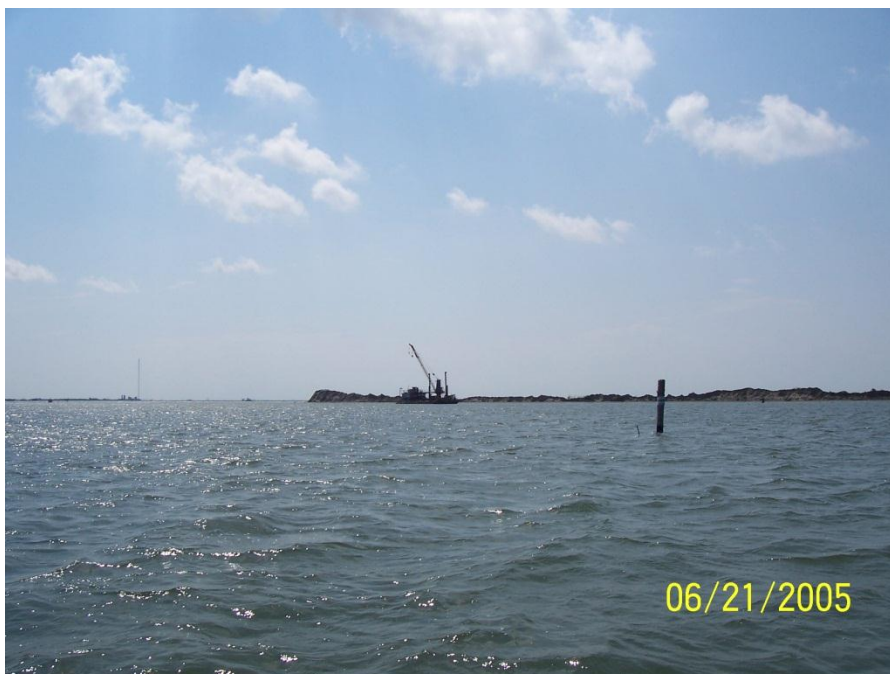
Additionally, the continued maintenance of deep water sediment sinks directly behind the island, in the form of oil and gas access canals, must be addressed in any future efforts (Figure 29). Overwash of sediment onto a shallow marsh or bay platform is a major factor increasing barrier island longevity. Therefore, "conservation of mass" is prevented by maintenance of sediment sinks which capture overwash sediments in deep holes. Sediment is then removed and dispersed by canal maintenance activities.

Figure 29. Maintenance dredging of oil and gas access canals behind East Timbalier Island immediately before Hurricanes Katrina and Rita caused island overwash (photo taken by CPRA June 21, 2005).

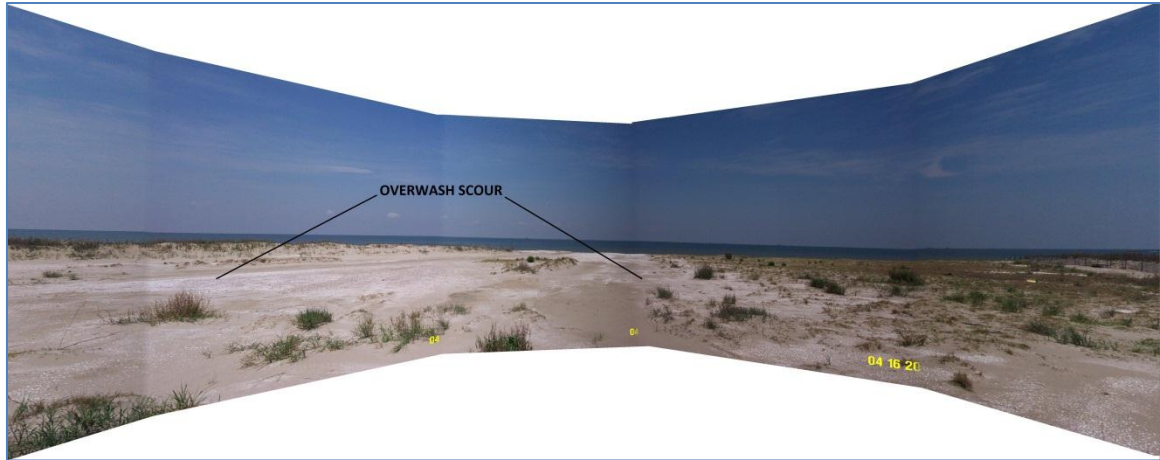
Figure 30. Panoramic photo mosaic showing the effects of non-shore parallel sand fencing at the Isle Derniers – East Island CWPRRA project (TE-20). Note the scour on the left where the overwash was focused along the dune to the bayside of the island causing complete vegetative cover removal post storm.

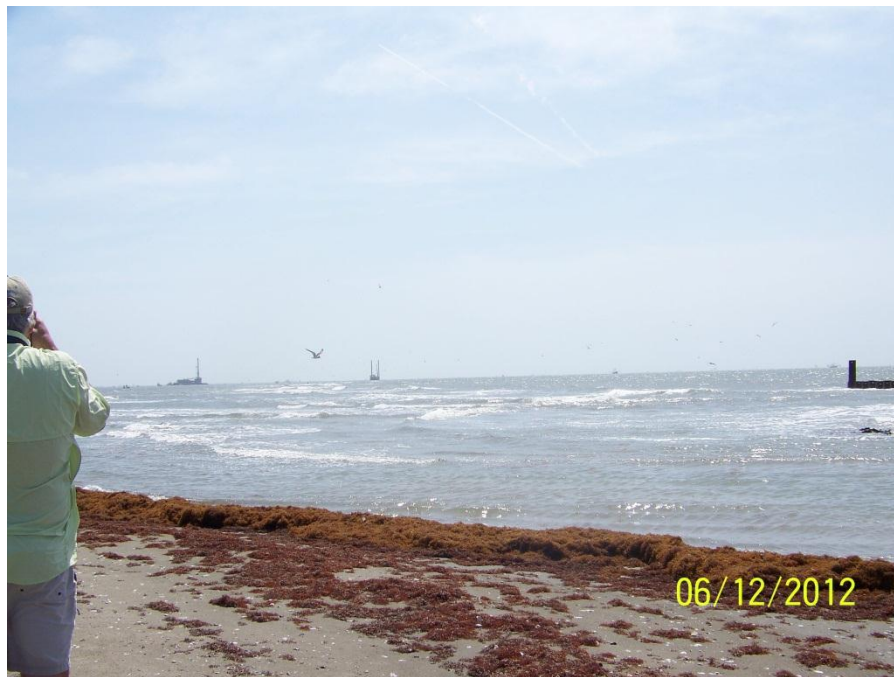
1. The project fill template is completely eroded from station 82+00 to the eastern end of the TE-30 fill area, with only sand spits and shoals remaining (App. A – Photo # 2). Additionally there is no evidence of the rock shoreline feature in this location (Appendix B)

Photo 2: Gulf Shoreline near station 66+00 looking ENE (CPRA #100_6470).

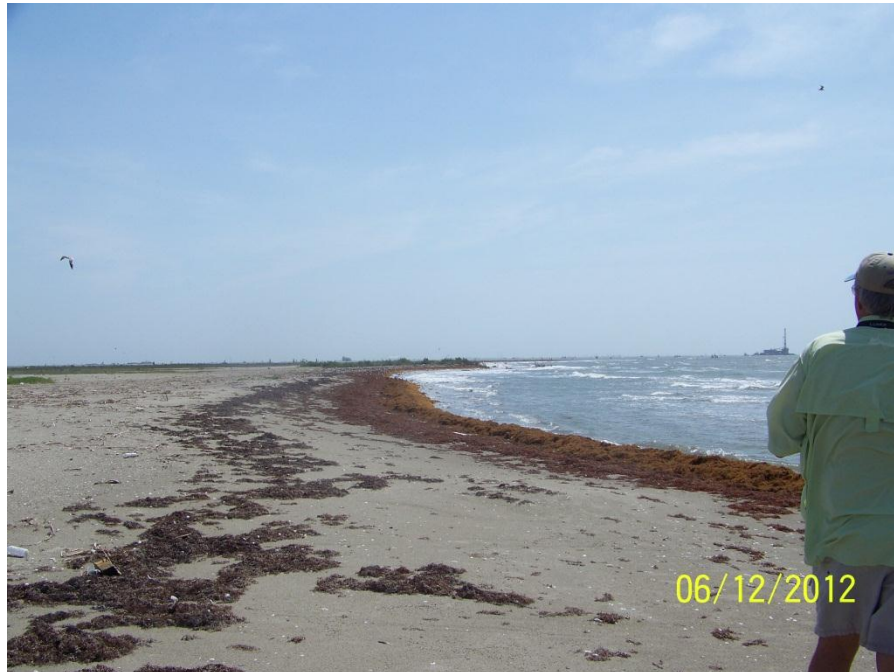
Photo 3: Gulf Shoreline near station 66+00 looking NE (CPRA #100_6471).

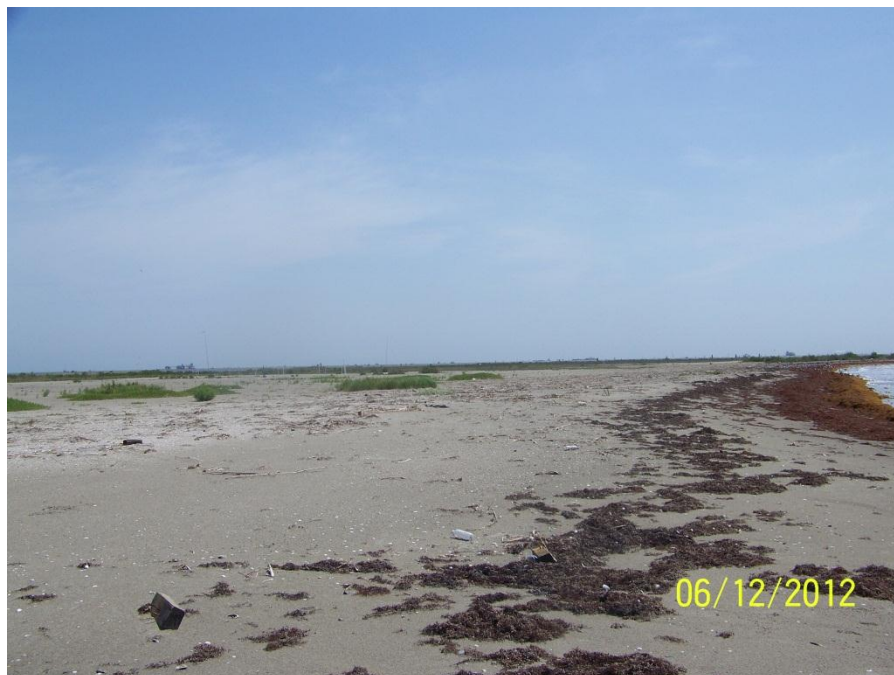
Photo 4: Gulf Shoreline near station 66+00 looking NNE (CPRA #100_6472).

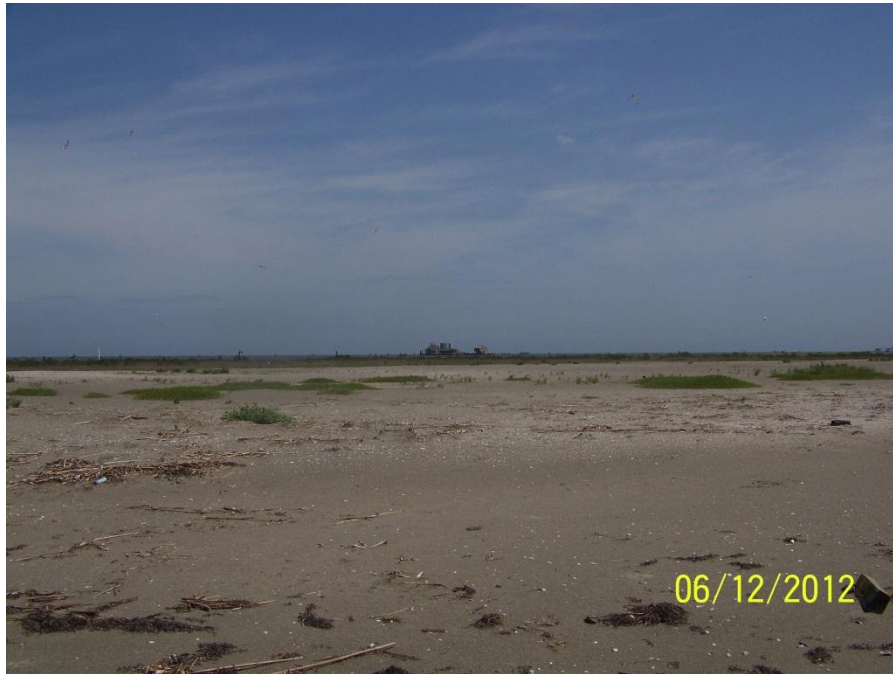
Photo 5: Gulf Shoreline near station 66+00 looking N (CPRA #100_6473).

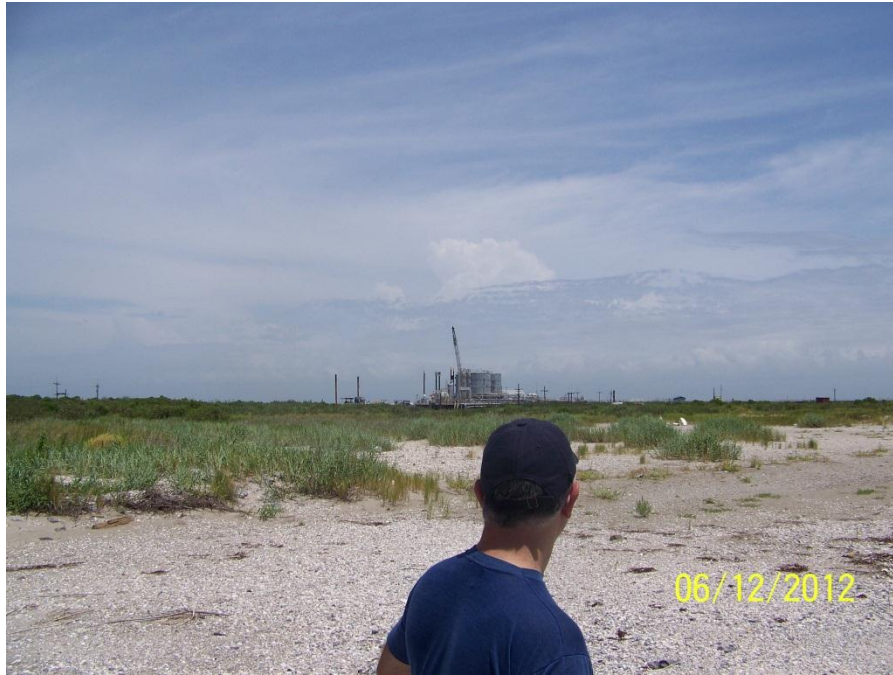
Photo 19: Gulf Shoreline near station 30+00 looking NNW (CPRA #100_6486). Note. This location is near NW corner of the eastern fill area.

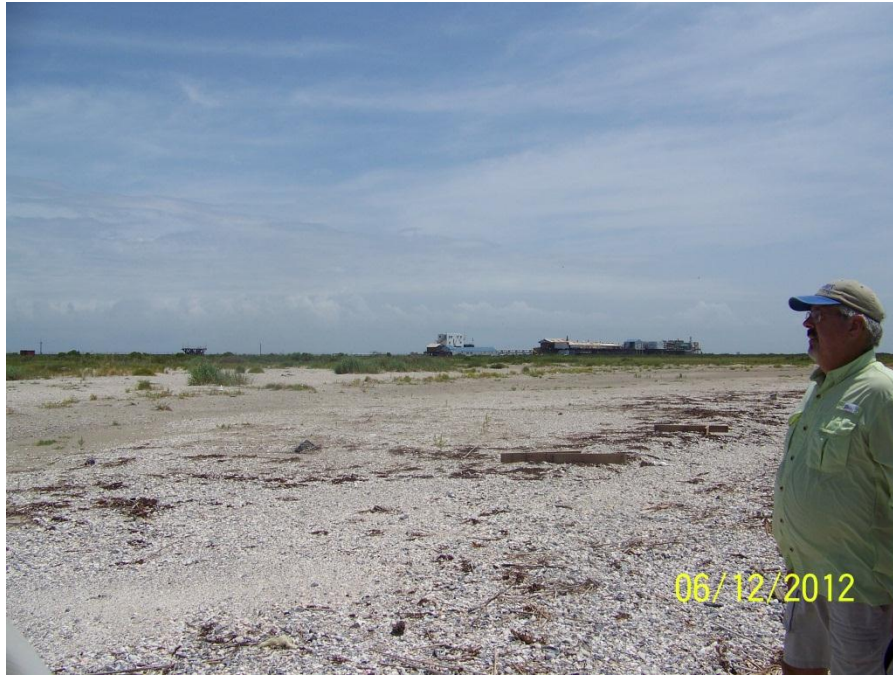
Photo 20: Gulf Shoreline near station 30+00 looking N (CPRA #100_6487). Note this location is near NW corner of the eastern fill area.

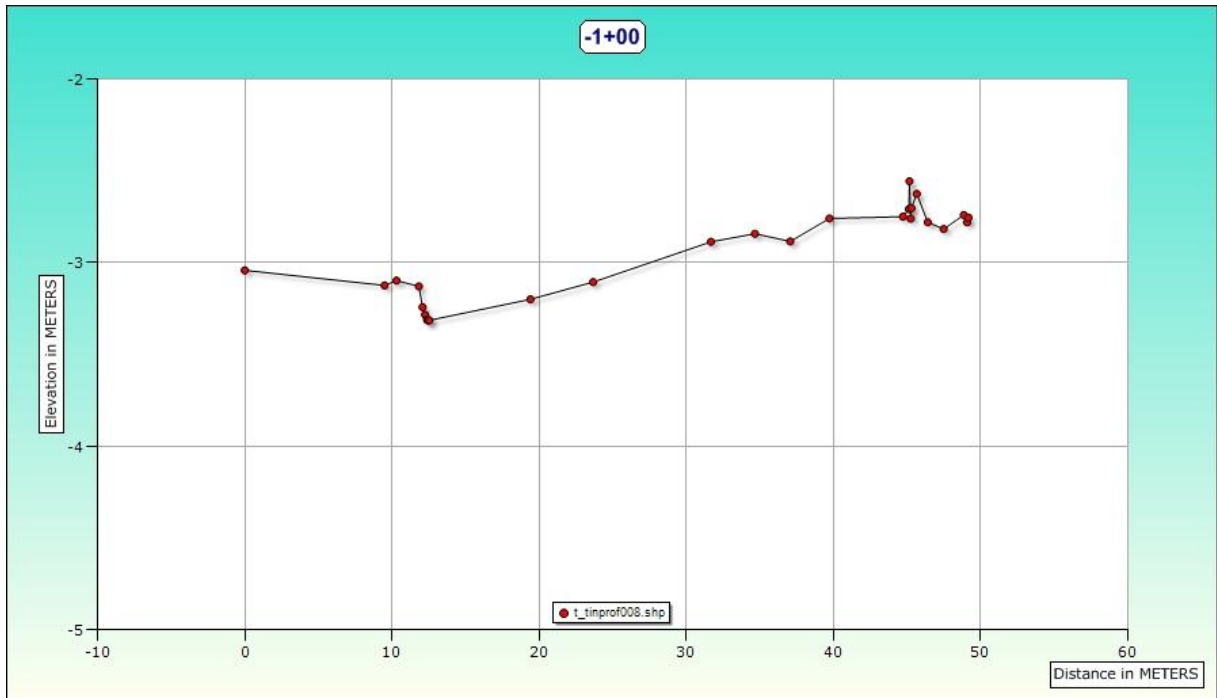
2. The western fill area from station -4+00 through 10+00 is completely eroded. In addition, the western end of the island has retreated bayward while the pass has expanded toward the east, leaving the former project footprint within the Gulf (App. A – Photo # 22). Additionally there is no evidence of the rock shoreline feature in this location (Appendix B)

BICM 2006 elevation profile at project station -1+00. Rock feature would be located at approximately 17 m along the profile.

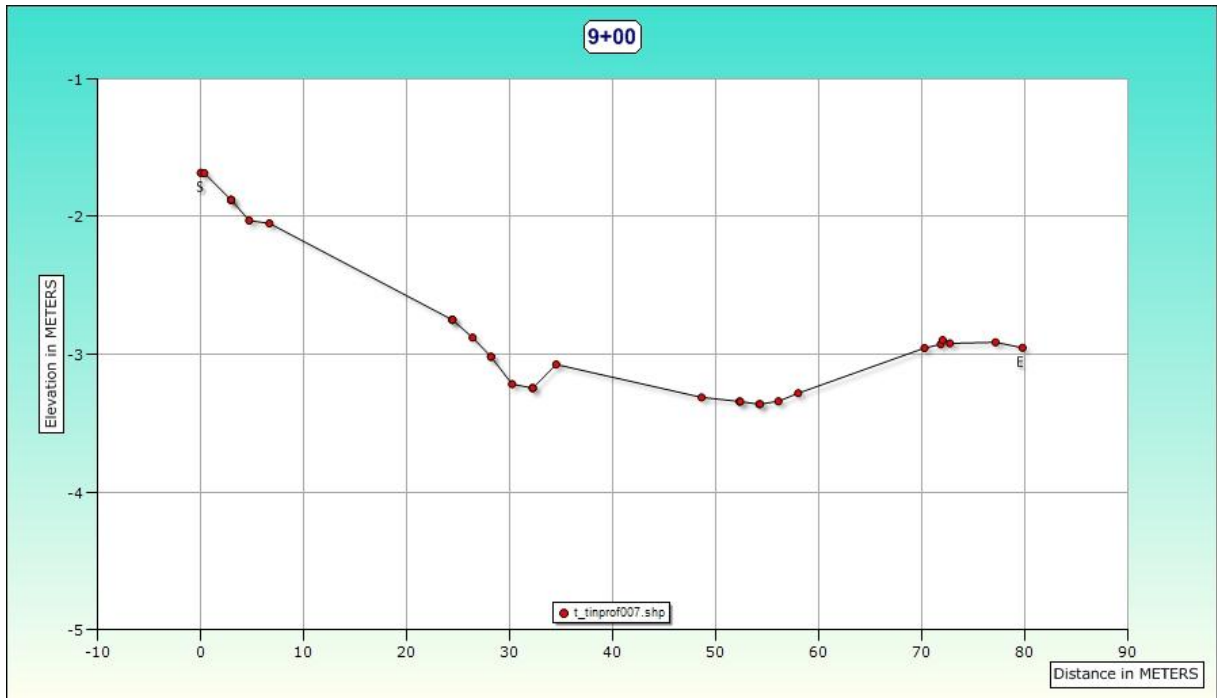
BICM 2006 elevation profile at project station 9+00. Rock feature would be located at approximately 5m and 30m along the profile.

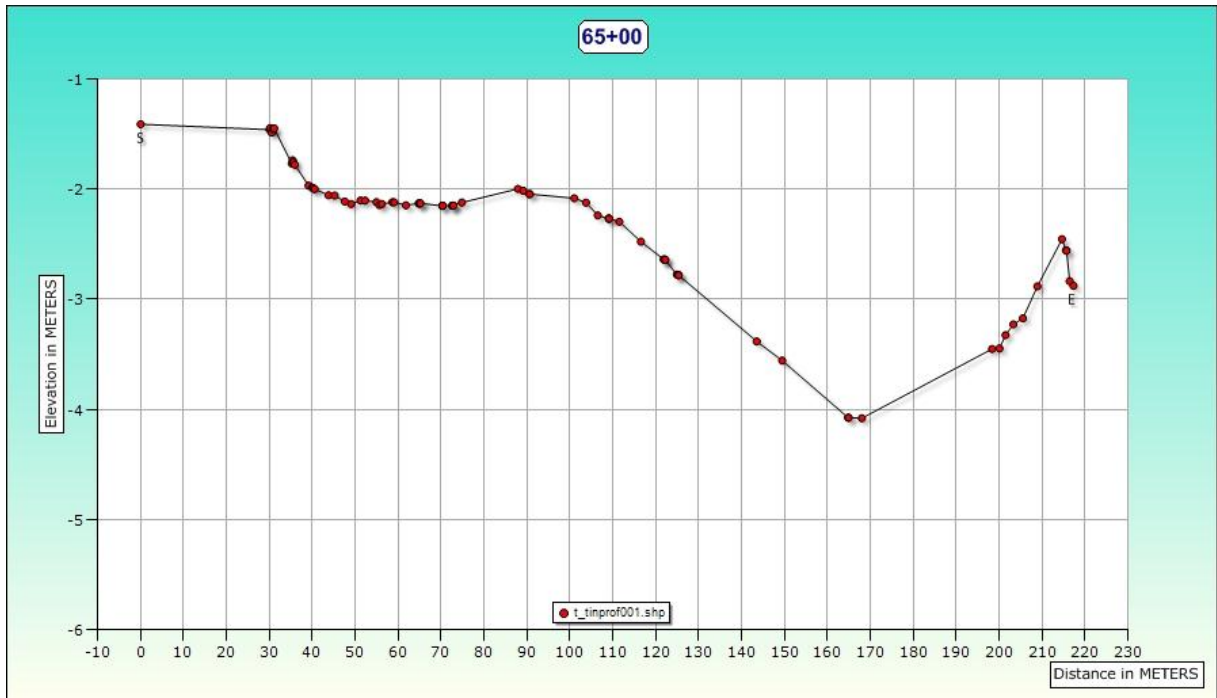
BICM 2006 elevation profile at project station 65+00. Rock feature would be located at approximately 70m along the profile. Pre-existing Gulf rock structure would be located at approximately 215m.

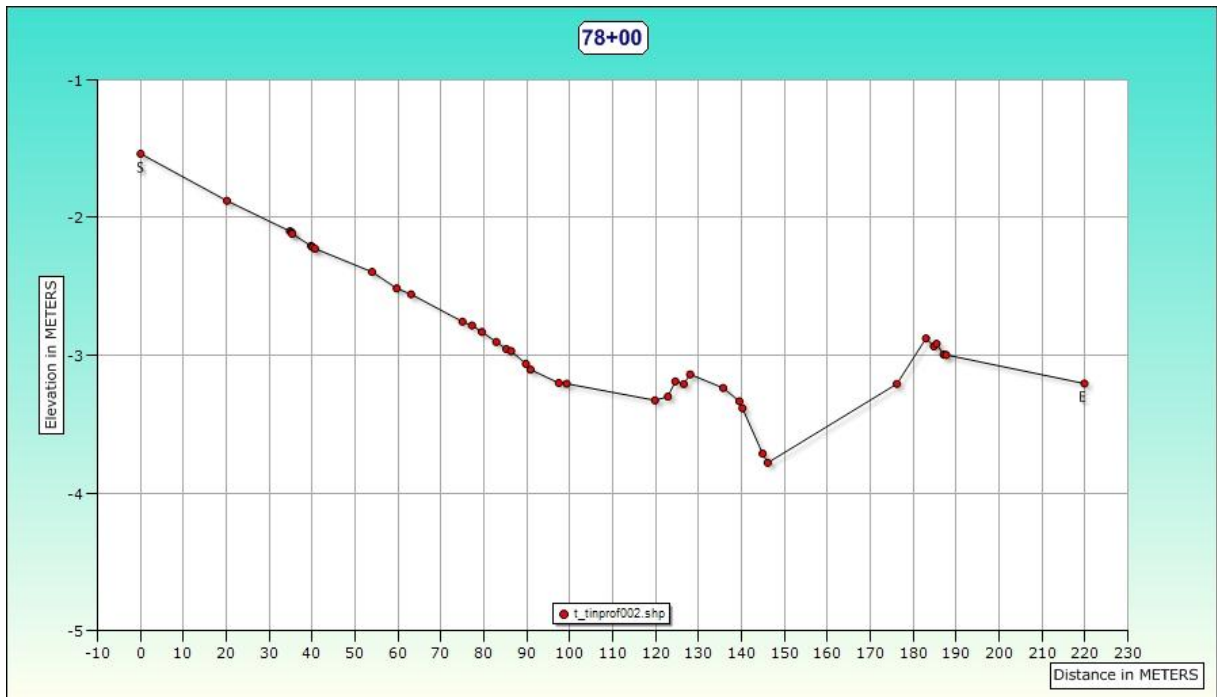
BICM 2006 elevation profile at project station 78+00. Rock feature would be located at approximately 35m along the profile.

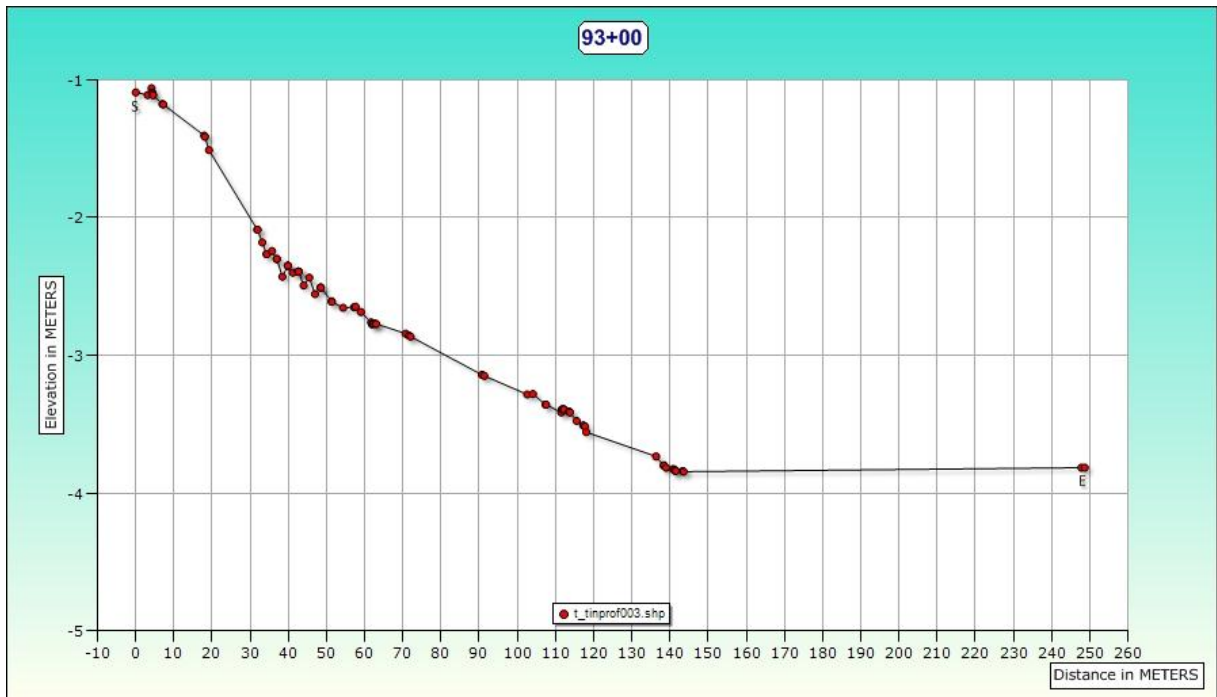
BICM 2006 elevation profile at project station 93+00. Rock feature would be located at approximately 38m along the profile.

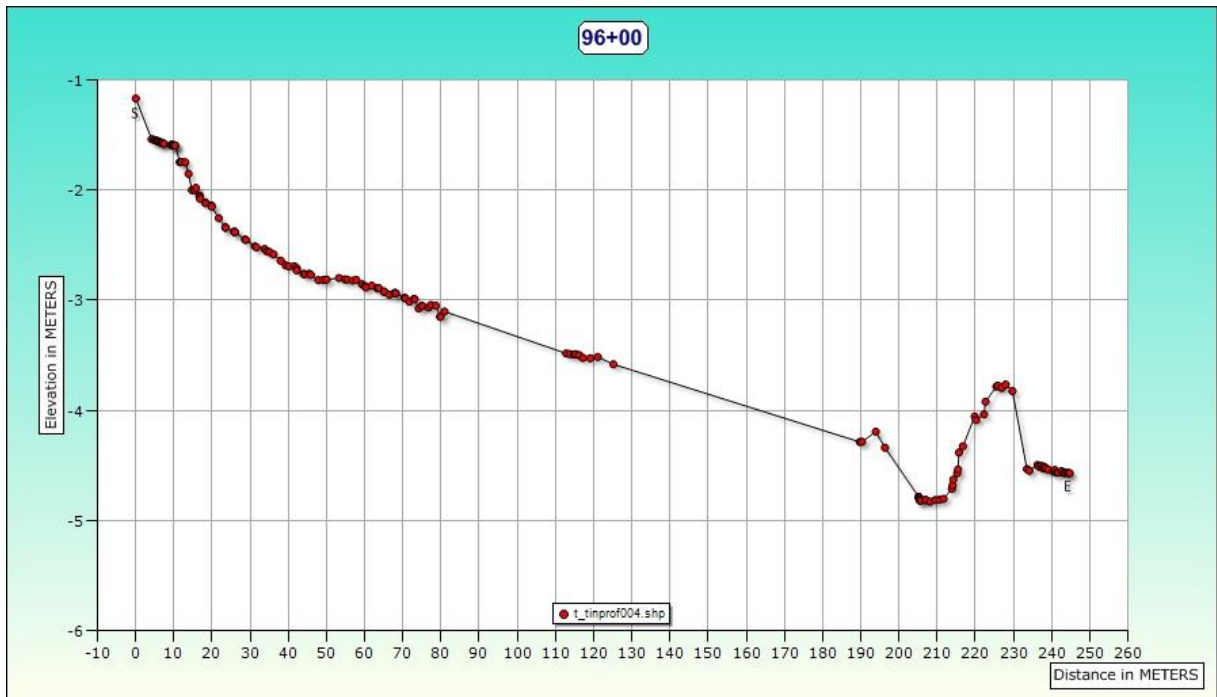
BICM 2006 elevation profile at project station 96+00. Rock feature would be located at approximately 24m along the profile. Pre-existing Gulf rock structure would be located at approximately 230m.

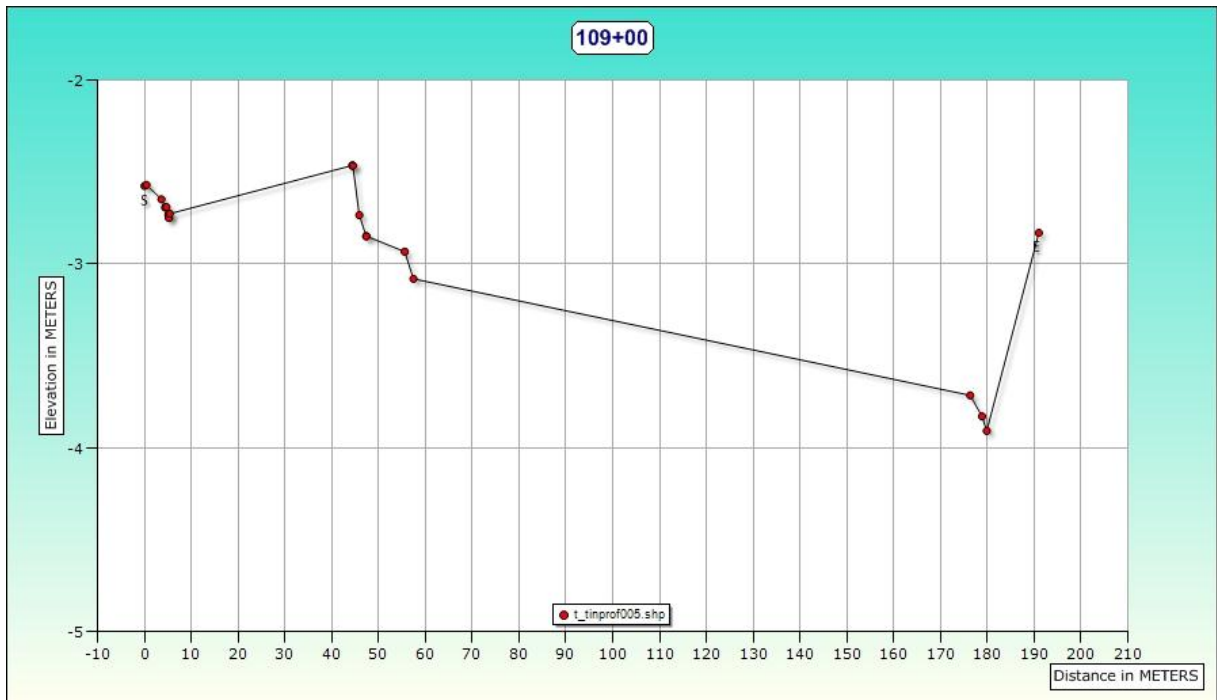
BICM 2006 elevation profile at project station 109+00. Rock feature would be located at approximately 4m along the profile.

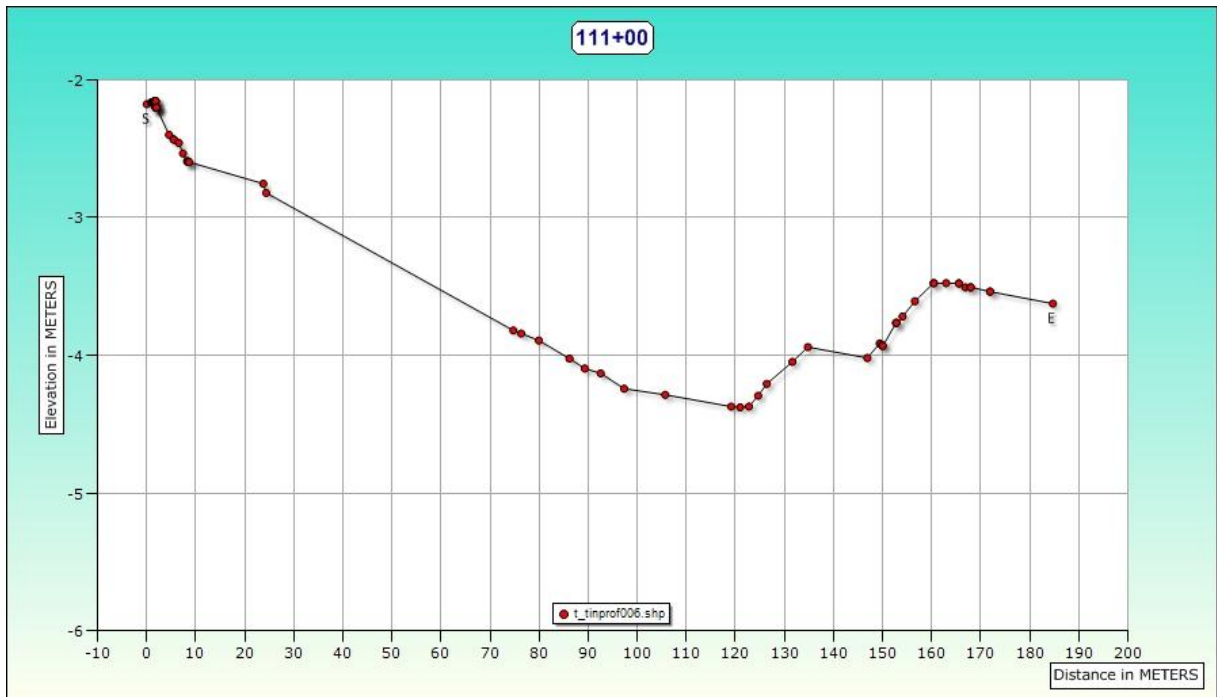
BICM 2006 elevation profile at project station 111+00. Rock feature would be located at approximately 3m along the profile.
