**Coastal Protection and Restoration
Authority of Louisiana (CPRA)**

**2011/2012 Annual Inspection
Report**

**EAST MUD LAKE MARSH
MANAGEMENT PROJECT
(CS-20)**

June 29, 2012
Cameron Parish

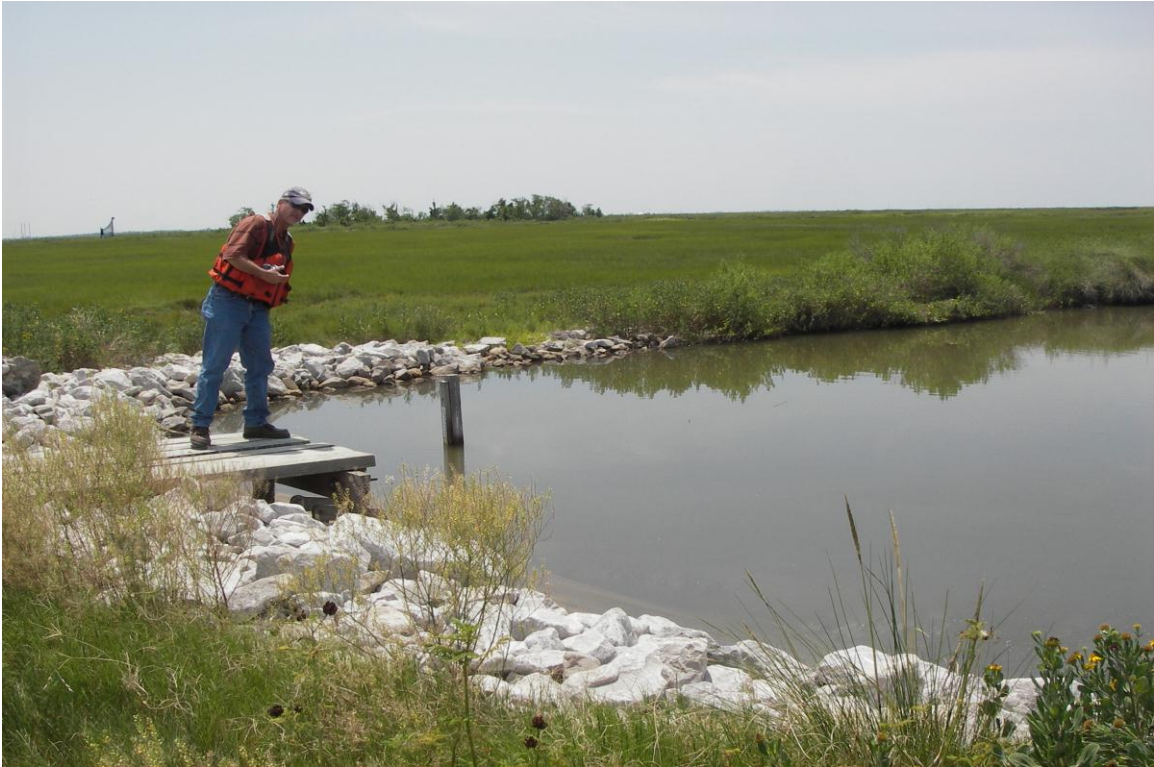
Photo 16, Flap Side, Structure 3

This is also a pre-existing structure that was incorporated into the CS-20 Project. Walkways are in excellent shape. Rock placed around the structure has stabilized the banks. (Photos: Appendix B, Photos 15 & 16).
