2012 Operations, Maintenance, and Monitoring Report

Sediment Trapping at the Jaws (TV-15)

State Project Number TV-15 Priority Project List 6

June, 2012 St. Mary Parish

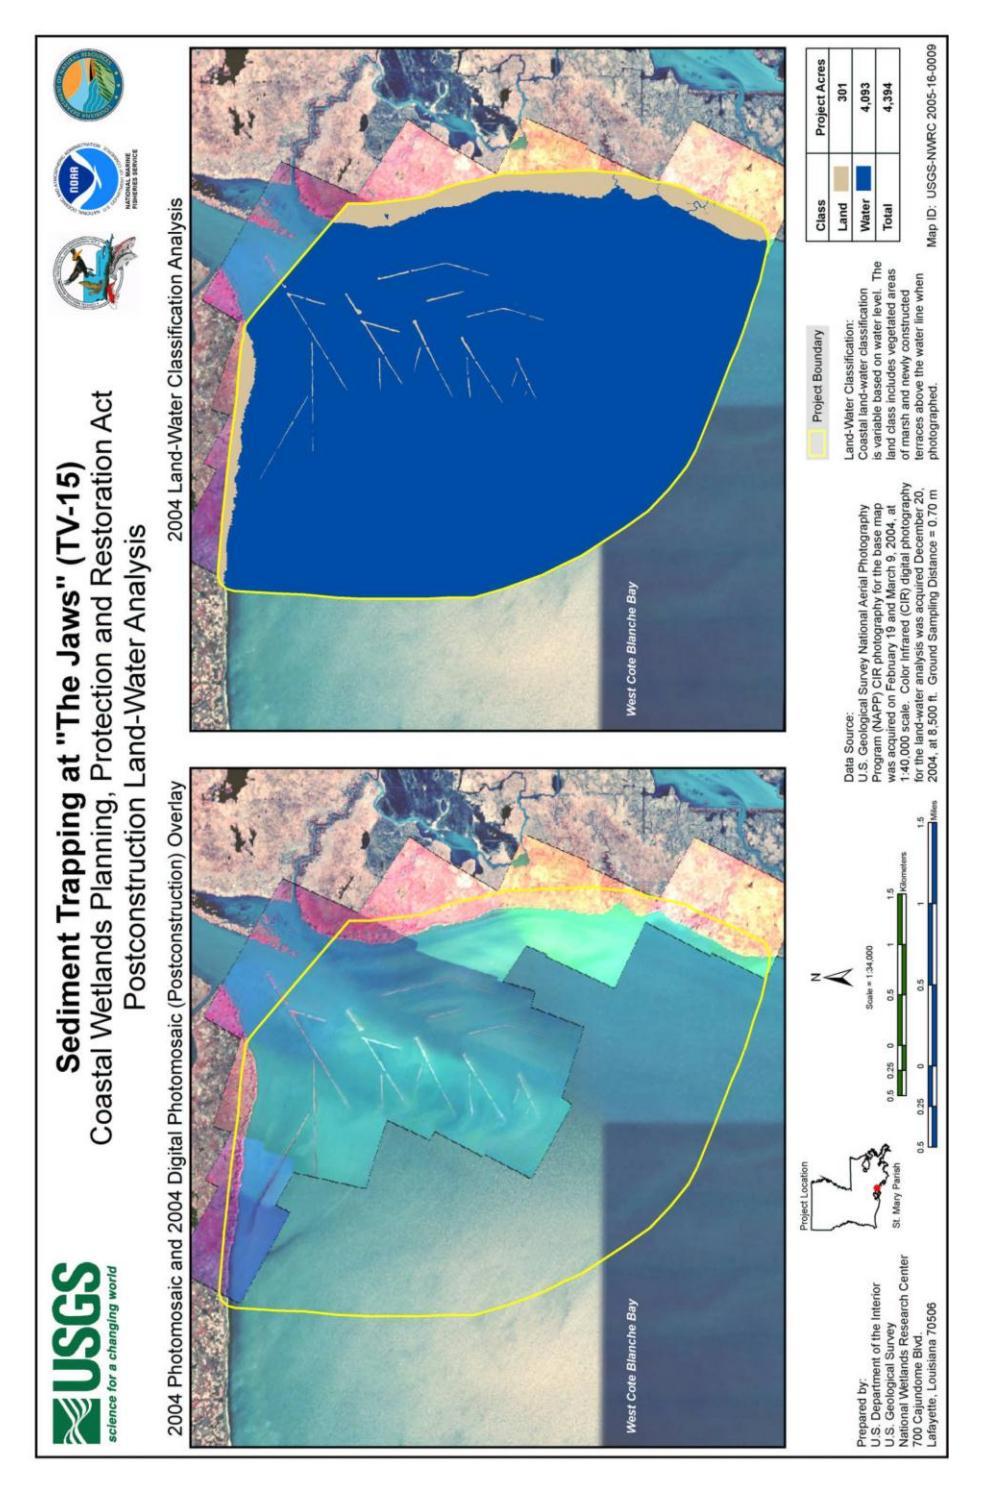
Figure 2. Land/water analysis of aerial photography taken December 20, 2004, showing the acreage of land and water in the project area of the Sediment Trapping at the Jaws (TV-15).

Project-specific aerial photography (1:40,000 scale) of the TV-15 project area was obtained on December 20, 2004, just after construction was completed from which land and water were classified (figure 2 and table 1). Project-specific photography has not been obtained again since the original imagery in 2004. Anecdotal evidence shows large mud flats and SAV beds have formed in between the deltaic ridges and the original shoreline creating quality estuarine fisheries habitat and protecting back marshes from wave energy (figure 3). The historic land loss in the project area from 1956 through 1988 reduced the amount of marsh from near 650 acres to a little over 300 acres, approximately a 50% reduction in land mass (figure 5). This was mostly due to shore line erosion from wave energy. From 1988 to 2004 the marsh gained land potentially due to continuous sediment availability from the GIWW via the Atchafalaya River. The construction of terraces in the project area in late 2004 early 2005 created an

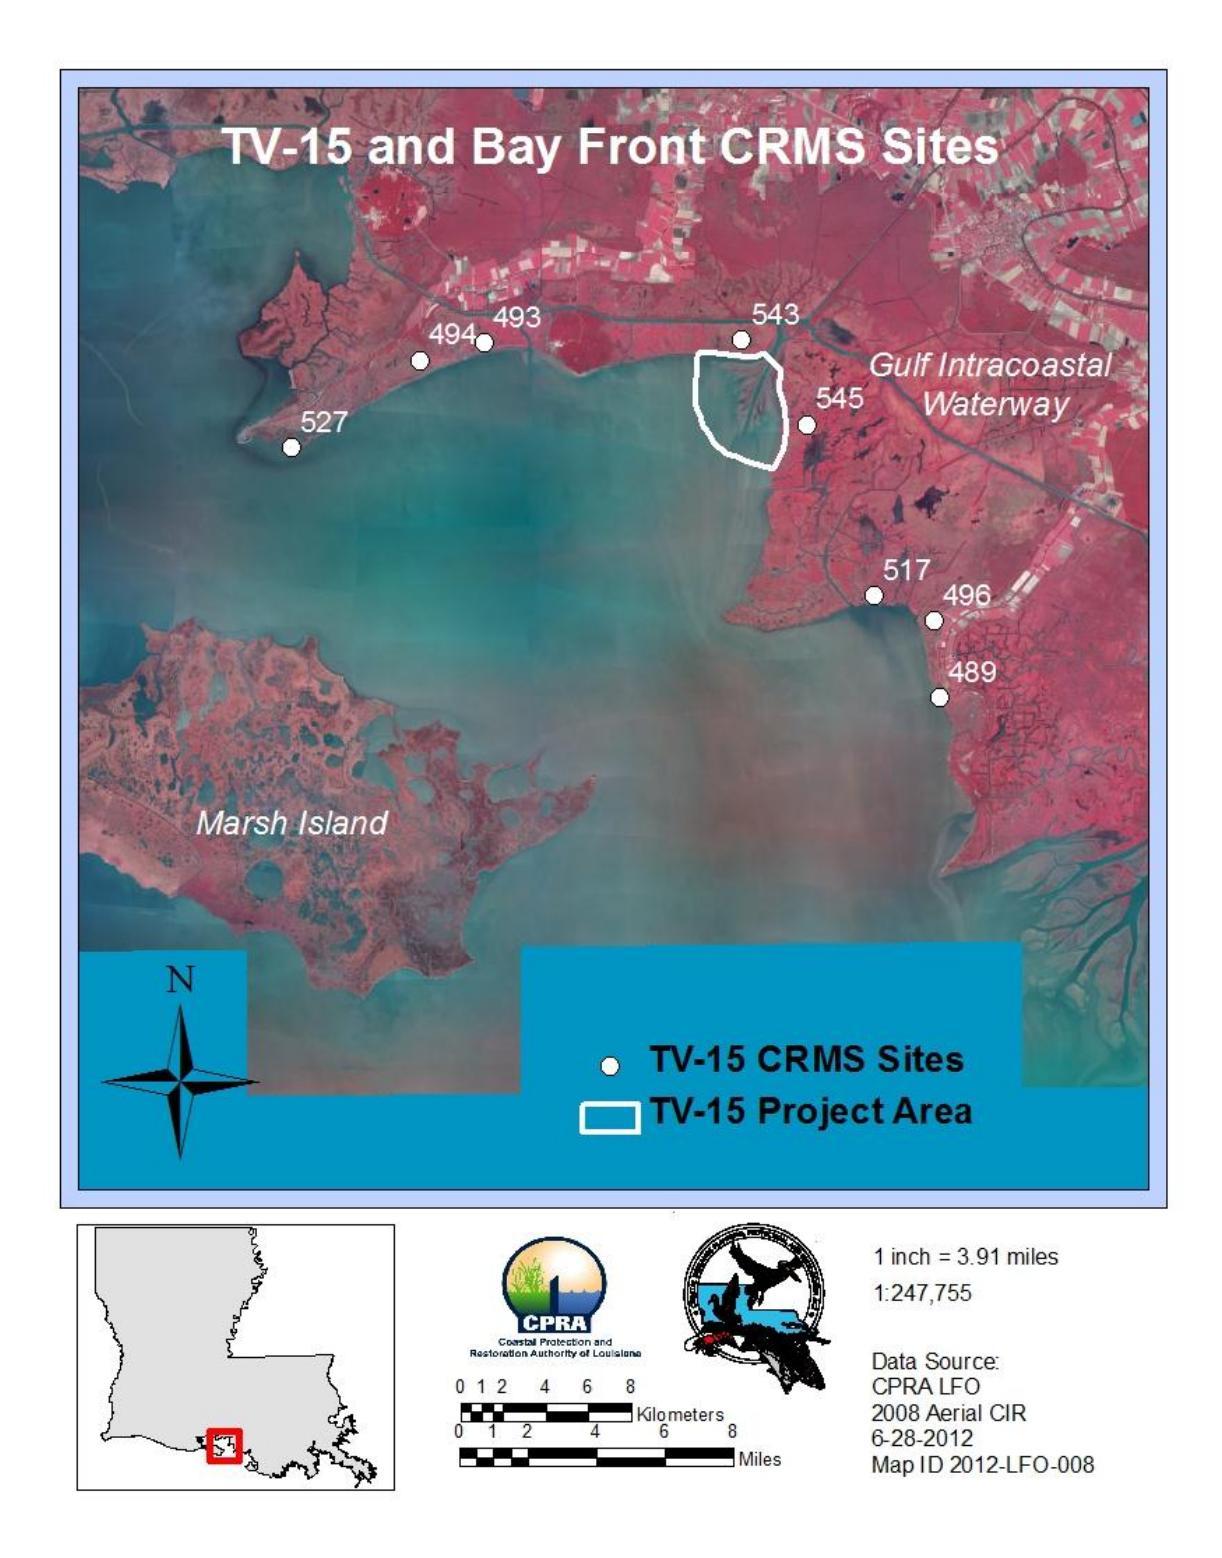
Figure 4. The location of CRMS sites with similar bay front exposers to that of TV-15 on East and West Cote Blanche Bay.

Subsidence and accretion data collected at CRMS 527, 494, 493, 543, 545, 517, 496, and 489 yields some insight as to the nature of land loss in the vicinity of TV-15 (figure 4). These near shore sites are generally maintaining elevation roughly equal to the rate of relative sea level rise (RSLR) which indicates land loss is likely to be dominated by shoreline erosion and not marsh collapse due to inundation (figure 6). The elevation change rates ranged from +2.21cm/yr to -2.91cm/yr relative to RSLR, but generally were closer to + or - 0.5 cm/yr. These values show elevation change rates along the coast of East and West Cote Blanche Bay are variable but with respect to RSLR are generally stable. CRMS site 489 had a large positive elevation change rate (+2.21 cm/yr). This is likely due to its proximity on the shoreline of East Cote Blanche Bay. This location receives sediment overwash from the surrounding water bottoms and shoreline erosion during strong winds and storms. The typical cycle in these locations is accretion building up the site until it becomes the shoreline itself and then erodes. Site 494 shows the opposite trend with a large negative elevation change rate (-2.91cm/yr). The reason for this serious loss in elevation is possibly hyper subsidence in a small area surrounding the site as this is an isolated event along both Cote Blanche Bay rims. The mechanism for this subsidence is a difficult question to answer and could be the decomposition of very organic soils, but is more likely some deeper geologic processes.

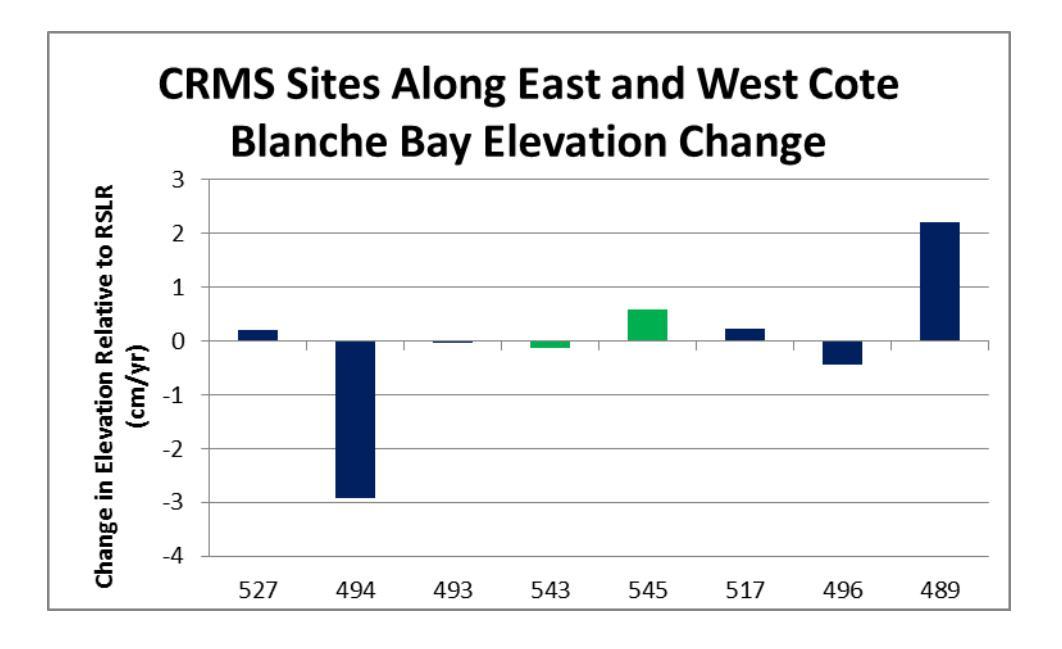
Figure 6. Net elevation change compared to RSLR along the coast of east and west Cote Blanche Bay in an east west orientation. The general trend is stability as most sites are keeping up with RSLS; the notable exception is CRMS 494 which is experiencing serious elevation loss. CRMS 543 and 545 which are behind TV-15 are shown in green.

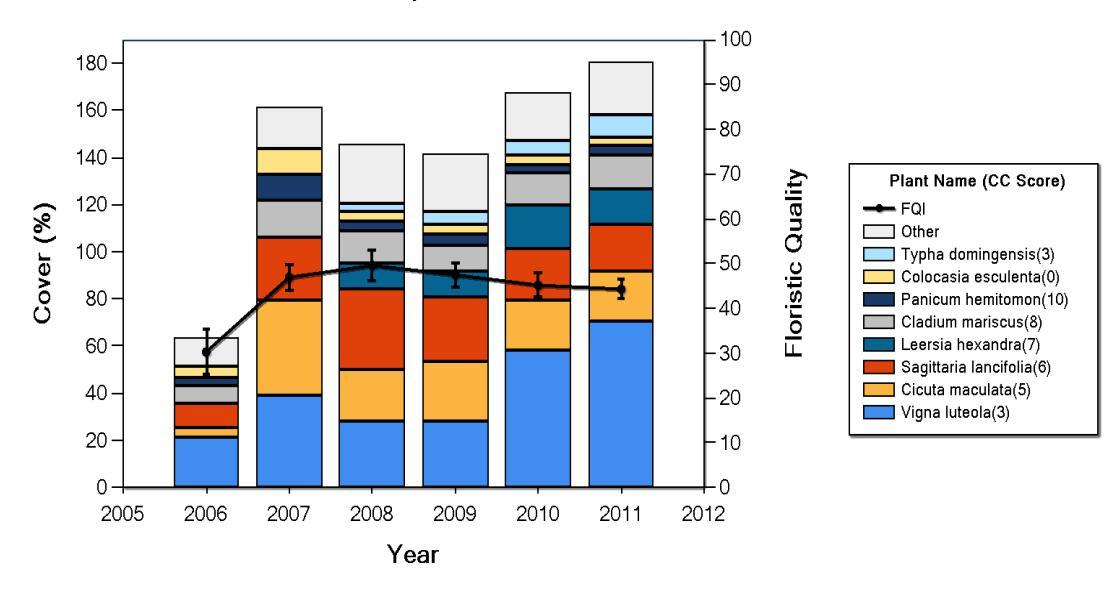
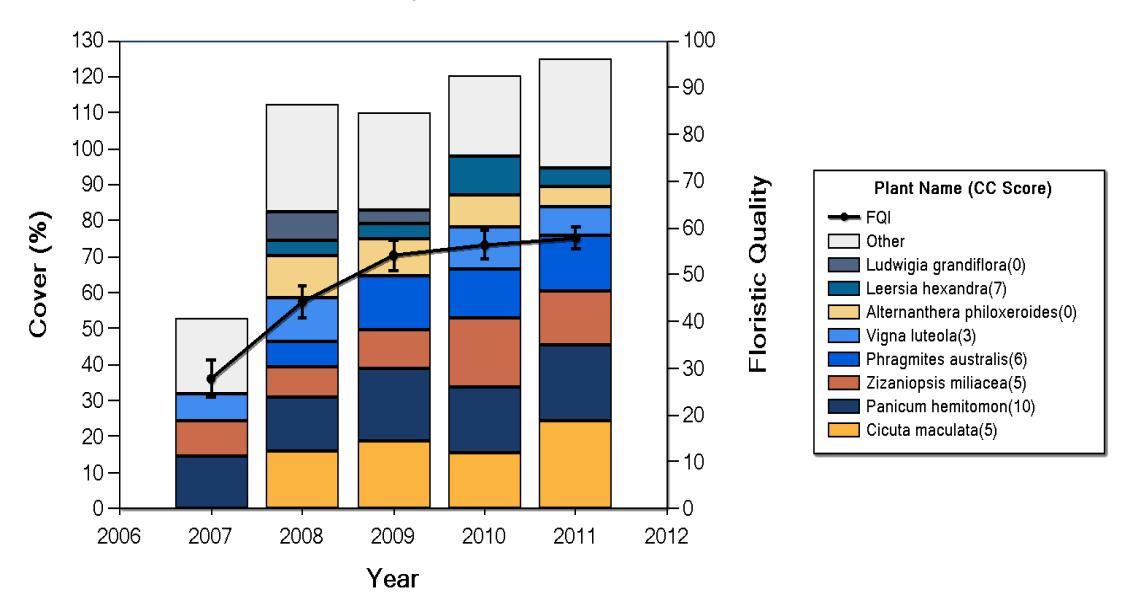
The marsh vegetation community behind the terrace and deltaic infrastructure consists mainly of *Sagittaria lancifolia* (bull tongue), *Cicuta maculata* (spotted water hemlock), *Phragmites australis* (common reed), *Vigna luteola* (hairypod cowpea), *Typha* spp. (cattail), and *Panicum hemitomon* (maidencane) (CRMS 2011 vegetation survey). Total percent cover of the vegetation within the CRMS sites behind TV-15 has increased following the hurricane season of 2005, with the species specific percent cover stabilizing at well over 100 % annually. The floristic quality Index (FQI) of these sites is low as fresh marshes have more non-native, nuisance species, and annuals that tend to receive lower scores. However the species richness is very high with greater than ten species found at each site during the 2011 vegetation sampling period (figure 7). This cannot be directly coupled to the project's effect but is representative of marsh type in the project area.

Figure 7. CRMS sites 545 and 543 are productive fresh marshes located behind the protective mud flats and terraces of TV-15.
