2013 Operations, Maintenance, and Monitoring Report

Delta Wide Crevasses (MR-09)

State Project Number MR-09 Priority Project List 6

July 2013 Plaquemines Parish

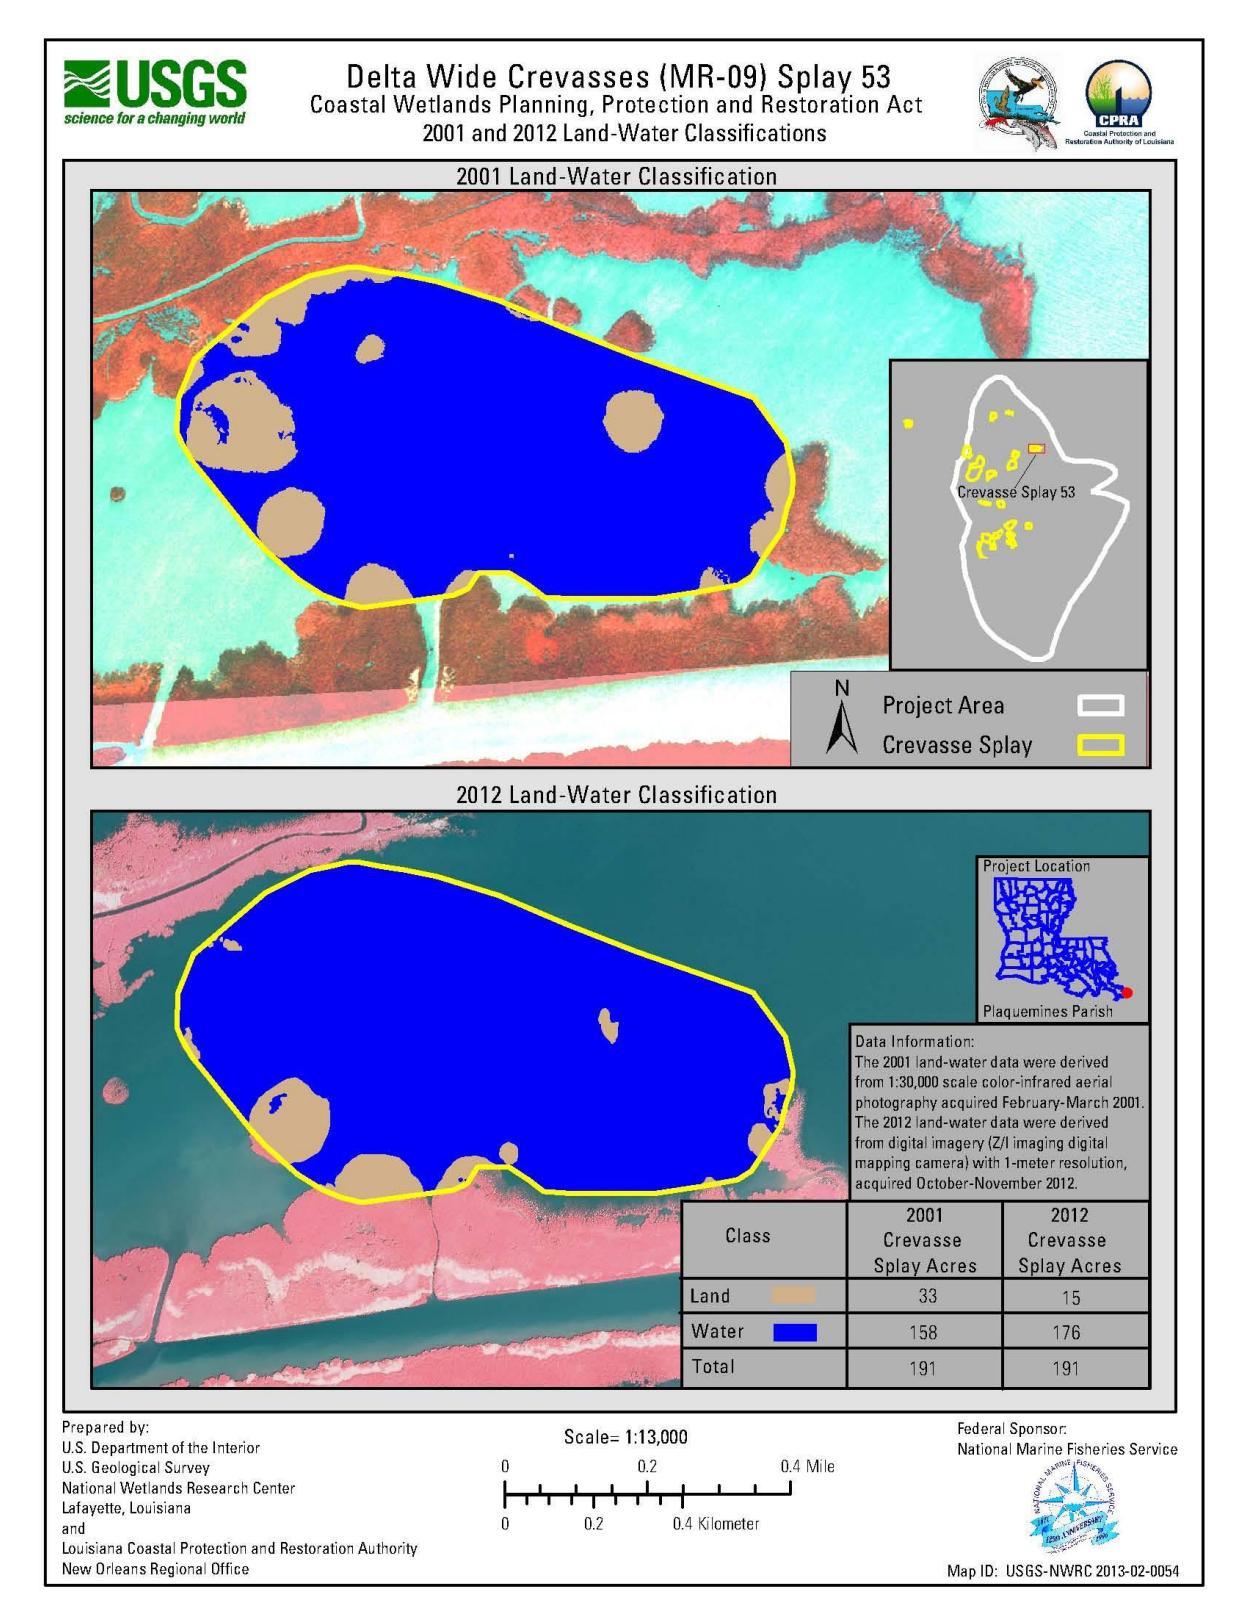
Color infrared aerial photography obtained in 2000 (as-built), 2002, 2007, and 2012 has been analyzed by the USGS and are presented as land-water analysis. There were a total of 18 crevasses analyzed including the 6 used for vegetation data. Table 1 shows a summary of land gain/loss in acres including the relative change and rate (per year). The total land gain recorded for the MR-09 project area since construction is 519 ac. with an average land gain of 29 ac. per crevasse. This translates to a total land gain of 66.5% across the project area. The largest land gain for a single crevasse occurred at Crevasse 31 (Figure 4) with a land gain of 139 ac. (+207.5%). The largest relative gain occurred at Crevasse 81 (Figure 5) with an increase of 270% (27 ac). One crevasse experienced net land loss. Crevasse 53 (Figure 6) lost 18 ac of land between 2001 and 2012.

Figure 6. Land-water analysis for Crevasse 53 in 2001 and 2012.

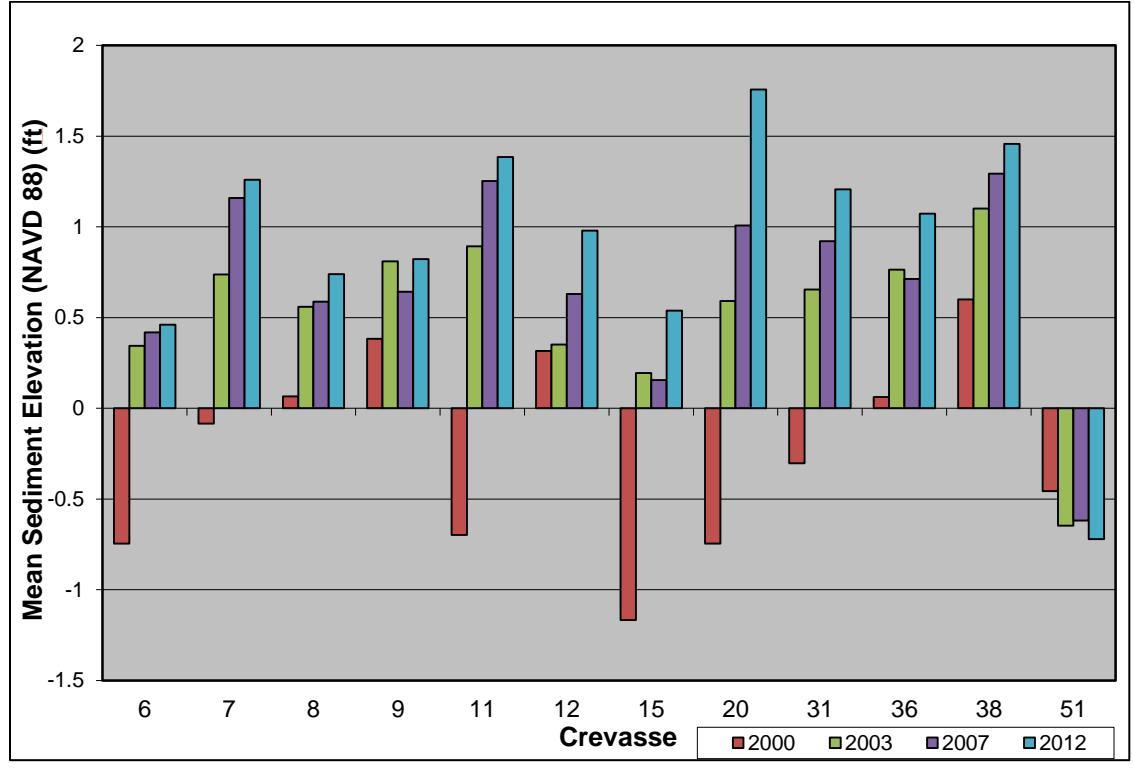
Elevation surveys were conducted in 2000 (as-built), 2003, 2008 and 2012 (postconstruction) on 12 crevasses in the MR-09 project area. Analysis of the elevation data in the receiving areas shows a trend in elevation gain across all crevasses except Crevasse 51 (Table 2, Figures 11 and 12) since construction of the project. When analyzed across all 12 crevasses, there has been a mean gain in elevation of 1.14 ft in the project area from construction to 2012 (Table 2). However it is worth noting that much of that elevation gain occurred in the first few years after construction. Mean elevation gain from 2000 to 2003 was 0.76 ft., while mean elevation gains from 2003 to 2008 and 2008 to 2012 were 0.15 ft. and 0.23 ft. respectively. Elevation gain was impacted by crevasse angle of orientation and width. Mean elevation gain from 2000 to 2012 for crevasses oriented 60° from the parent channel was 1.52 ft, twice the elevation gain of crevasses oriented at 90°, 0.77 ft. Similarly, wide crevasses (>150 ft. across) outgained narrow crevasses (<100 ft. across) 1.40 ft. to 0.96 ft. for the same time period. The greatest elevation gains were observed in wide, 60° crevasses (1.54 ft), while the least gains were observed in the narrow, 90° crevasses (0.28 ft).

Figure 11. Mean sediment elevation (NAVD 88) in the receiving bays of twelve Phase I crevasses of Delta Wide Crevasses (MR-09) in 2000 (as-built), 2003, 2008, and 2012 (post construction).

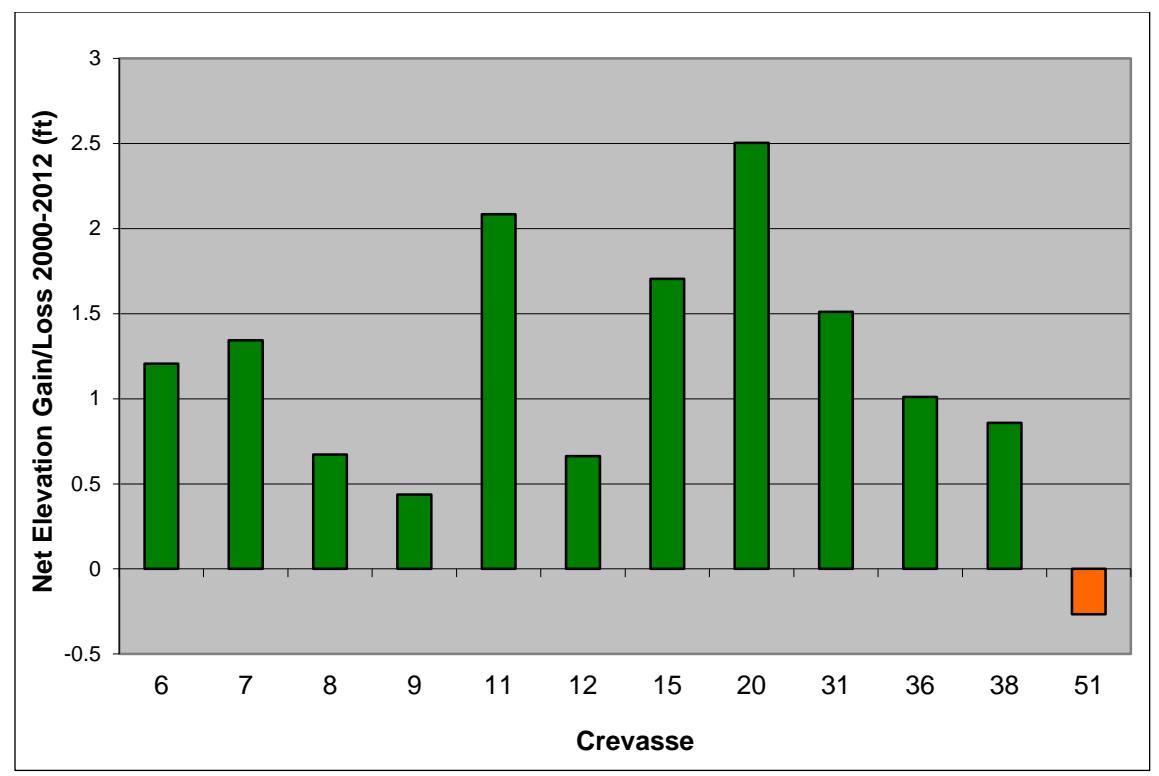
Figure 12. Elevation gain/loss between 2000 and 2012 for each of the twelve crevasses in Phase I of Delta Wide Crevasses (MR-09). Green bars represent an overall increase in mean elevation while orange bars represent an overall decrease in mean elevation.

Elevation loss in the Crevasse 51 receiving area may be due to sedimentation of the crevasse channel. The elevation survey of the crevasse channel and the land-water analysis of the aerial photography suggest that the channel is filling in with sediment. Sedimentation in the crevasse channel prevents water and sediments from passing through the crevasse into the receiving area.
