## **2013 Operations, Maintenance, and Monitoring Report**

### **East Marsh Island Marsh Creation**

State Project Number TV-21  
Priority Project List 14

June 2013  
Iberia Parish

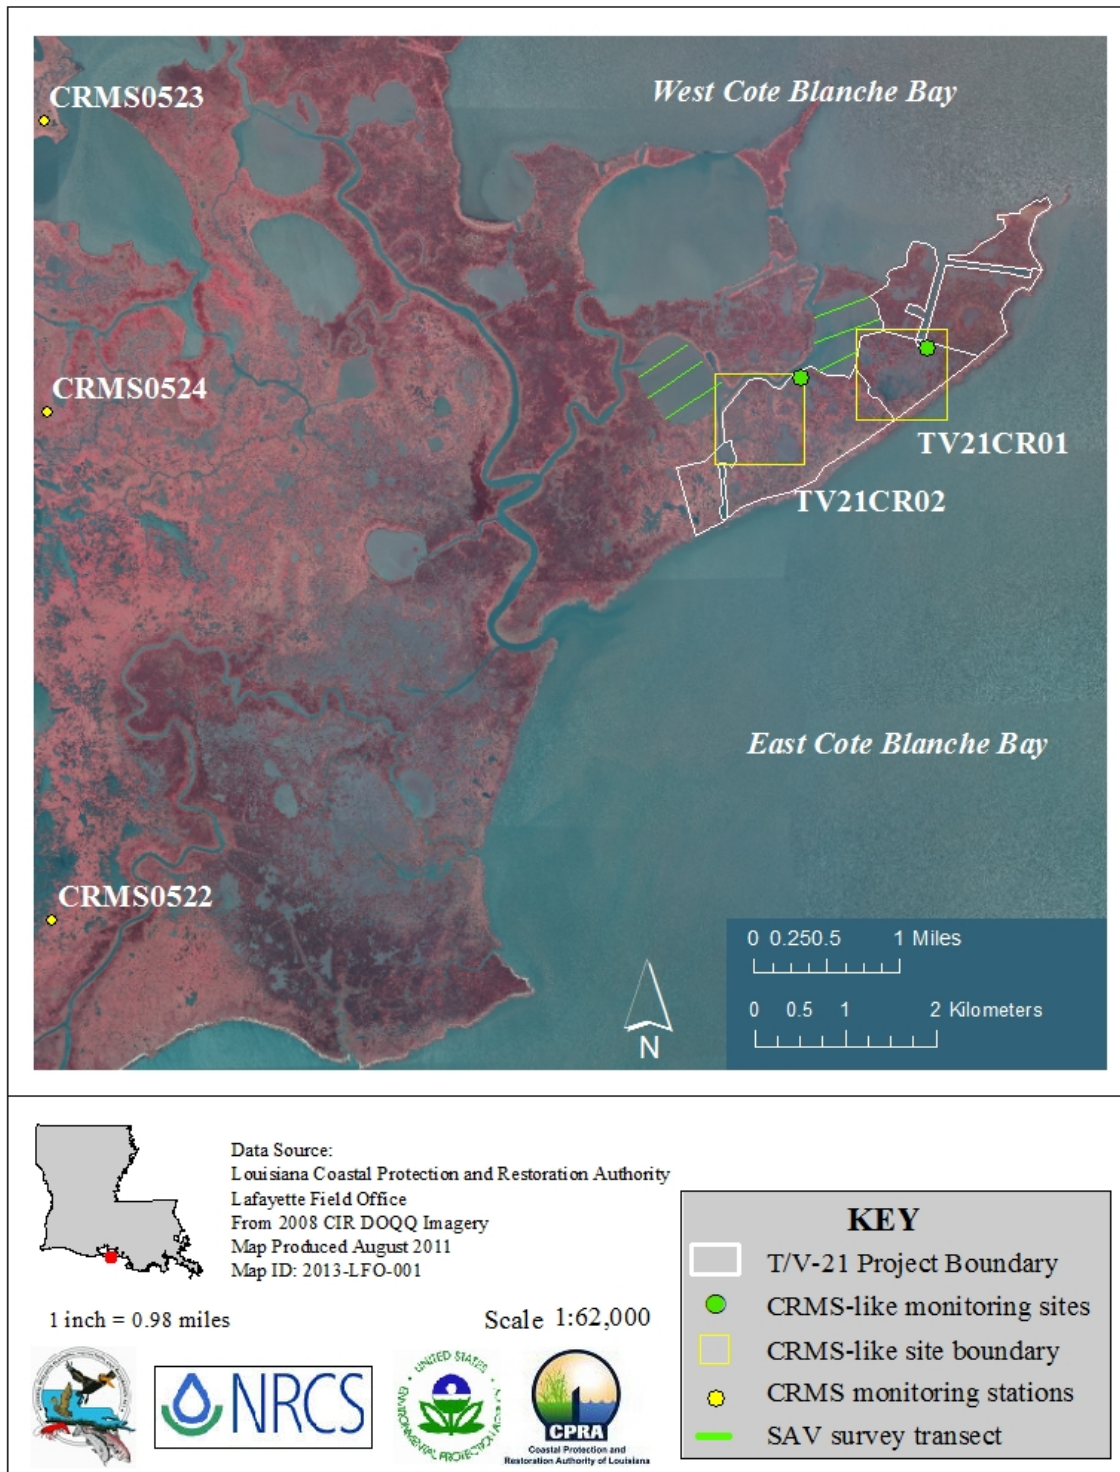
To document changes in the occurrence of SAV, two ponds adjacent to the project area were monitored using the rake method to determine if a breach into the northernmost pond had an effect on SAV abundance (Chabreck and Hoffpauir 1962) (figure 2). No ponds were monitored within the project area. Three transects (minimum 20 samples/transect) were established across open water in each pond. Submerged aquatic vegetation was sampled repeatedly along each transect by dragging a garden rake on the pond bottom for one second. The presence or absence of vegetation was recorded for each sample to determine the percent occurrence on a transect (% occurrence = (number of samples with SAV/number of samples) × 100). When vegetation was present, the species present was recorded in order to determine the frequencies of individual species (Nyman and Chabreck 1996). SAV was monitored post-construction in the fall of 2012. Monitoring will continue in the fall of 2013 and 2015.

**Figure 2.** Location of CRMS-like monitoring sites within the East Marsh Island Marsh Creation (TV-21) project area, SAV transects and nearby CRMS sites to be used for comparison.

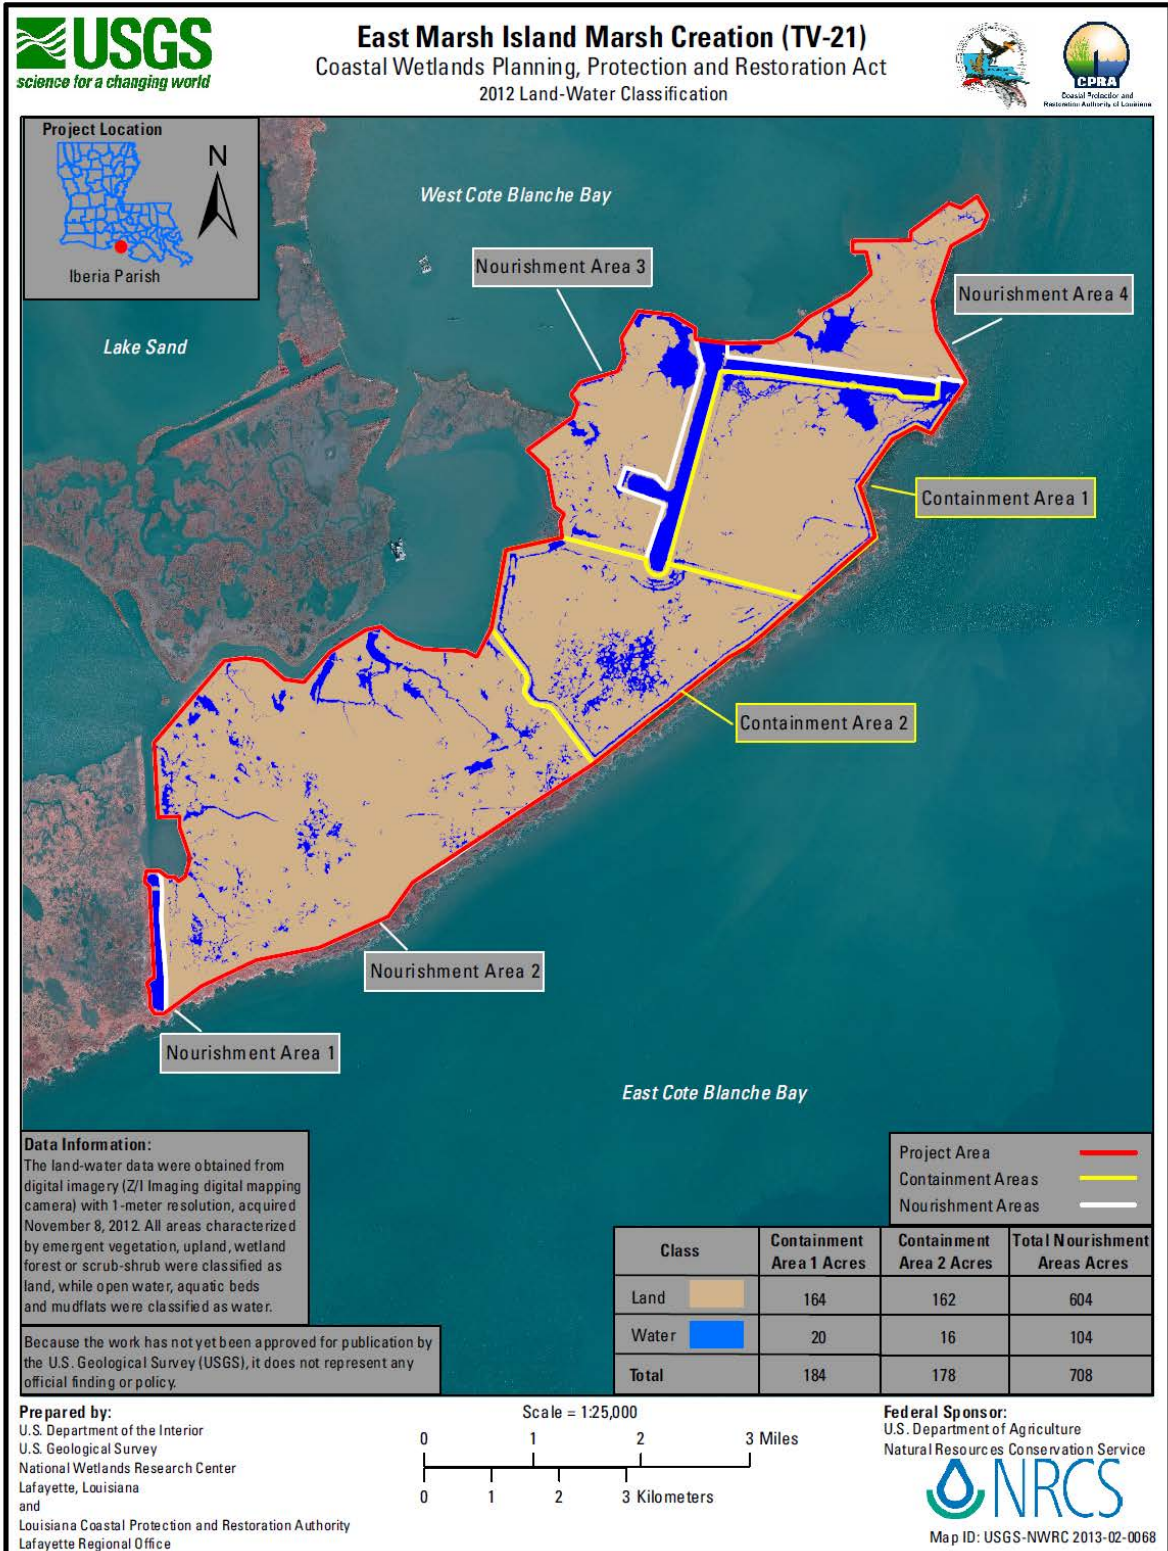
Post-construction land/water analysis was completed for the 2012 aerial photography (figure 3). Results indicated 89.13% land and 10.87% water within containment area 1, 91.01% land and 8.99% water within containment area 2, and 85.31% land and 14.69% water within the nourishment areas. Future analysis will help to determine the project's effect on land change.

**Figure 3.** East Marsh Island Marsh Creation (TV-21) project 2012 land/water analysis.

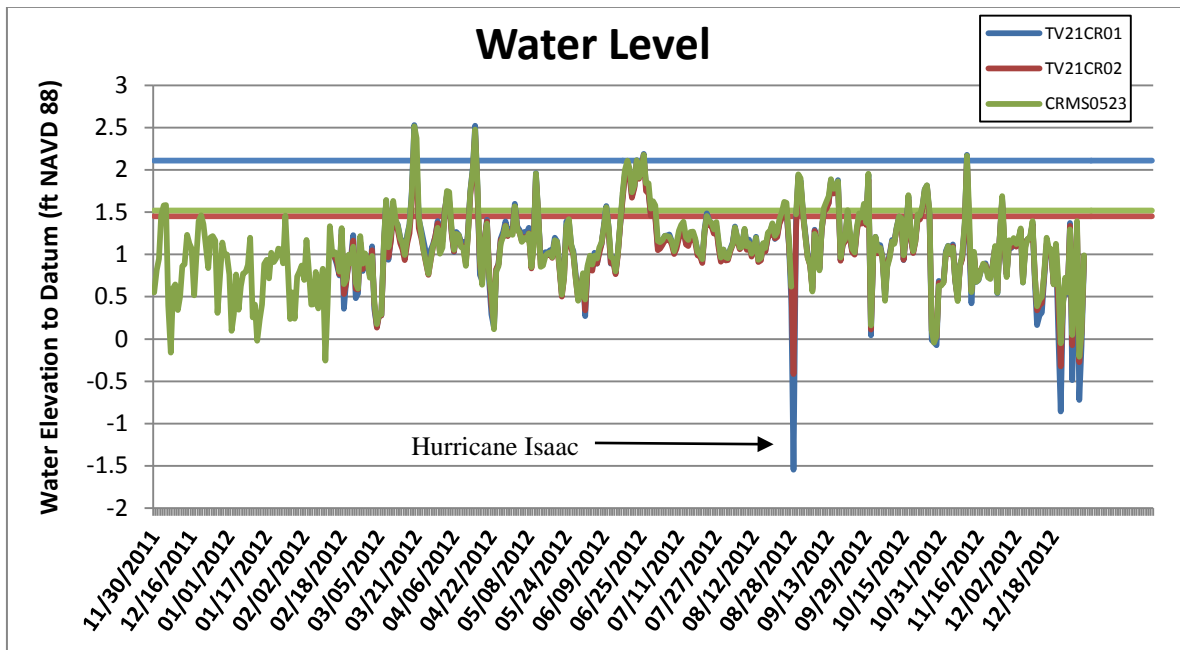
Water levels were nearly identical in both project sites and CRMS0523, differing only during extreme low water events, such as the landfall of Hurricane Isaac (figure 5a). A non-parametric one way median analysis determined there was not a significant difference in water

level between the two project sites ( $\chi^2=0.042$ ,  $p=0.837$ ) nor between the project and reference site CRMS0523 ( $\chi^2=1.094$ ,  $p=0.296$ ).

**Figure 5a.** Daily means of water level data collected and marsh elevations at project and CRMS reference sites.

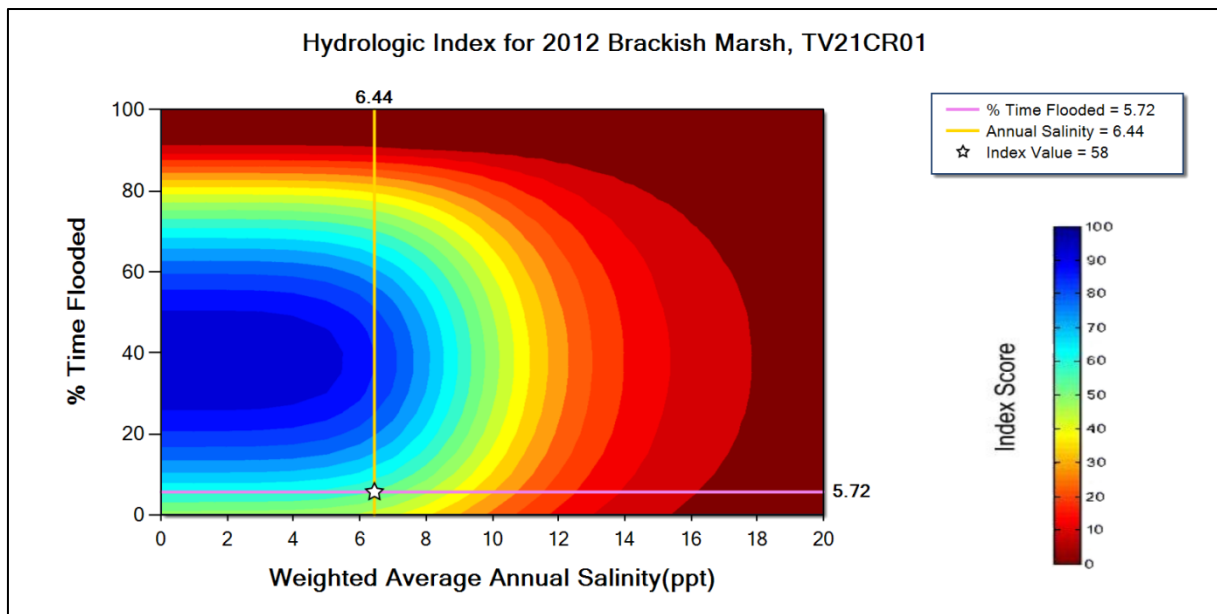
TV21CR02 and CRMS0523 both scored high on the Hydrologic Index (93 and 89, respectively), while TV21CR01 only had an HI score of 58 (figures 5b – 5d). Though the 3 sites had very similar annual salinities and water levels, TV21CR01 has a higher marsh elevation, resulting in a much lower percent time flooded then the other two stations and thus a lower HI score.

**Figure 5b.** Hydrologic index score for TV21CR01 based on the combined influences of average annual salinity (horizontal axis) and flood duration (vertical axis).

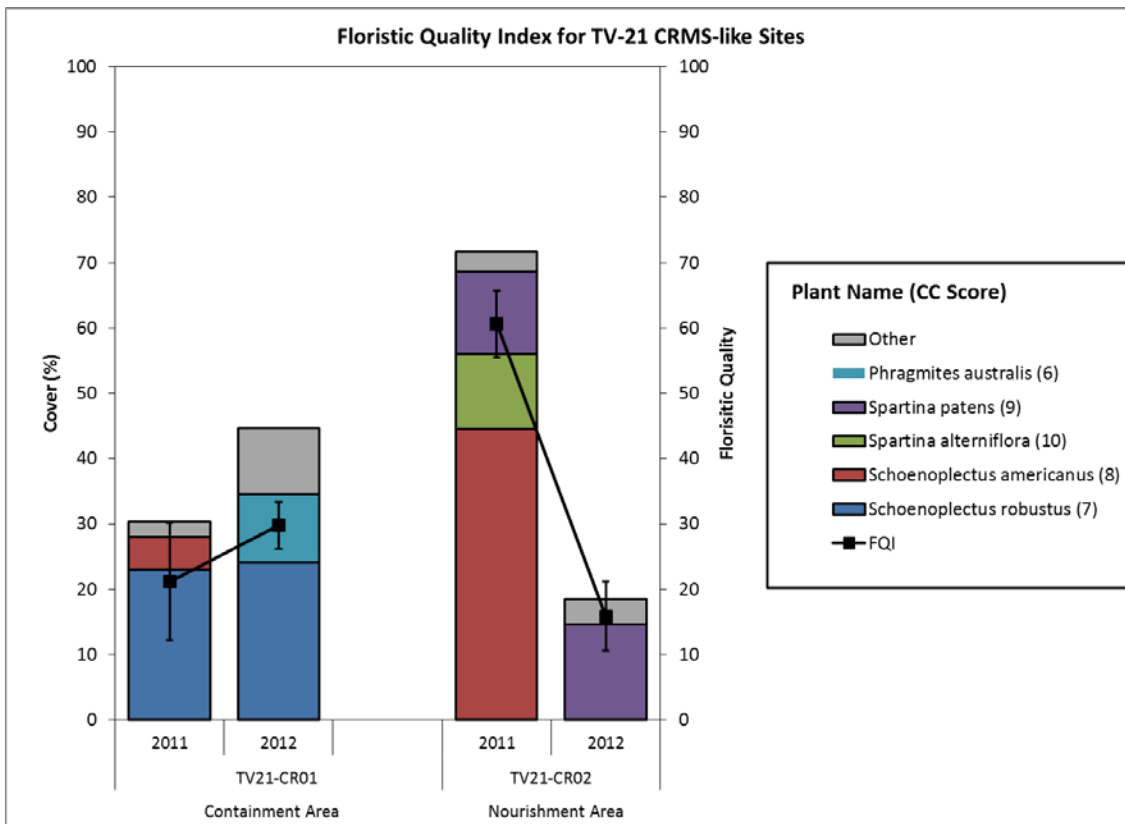
Containment area 2 had begun to vegetate by late summer of 2011 (TV21-CR01) and increased in cover to near 50% by 2012 (figure 6a). Vegetation in nourishment area 2 (TV21-CR02) was doing quite well in the first year after construction, but declined drastically in both cover and FQI in 2012 due to heavy herbivory damage from nutria. By 2012, the nutria had eliminated almost all of the *Schoenoplectus americanus* (a preferred food source) and *Spartina alterniflora* from the area, which were dominant species in the 2011 survey. Minor herbivory was noted in containment area 2, but the nutria weren't as prolific as in the nourishment area. This could be due to a smaller percentage of *S. americanus*.

**Figure 6a.** Percent coverage and floristic quality index of species collected from stations TV21-CR01 and TV21-CR02 within the project area in years 2011 and 2012. The CC scores represent the quality of individual species from 1 to 10 where 1 represents disturbance species and 10 indicates stability.

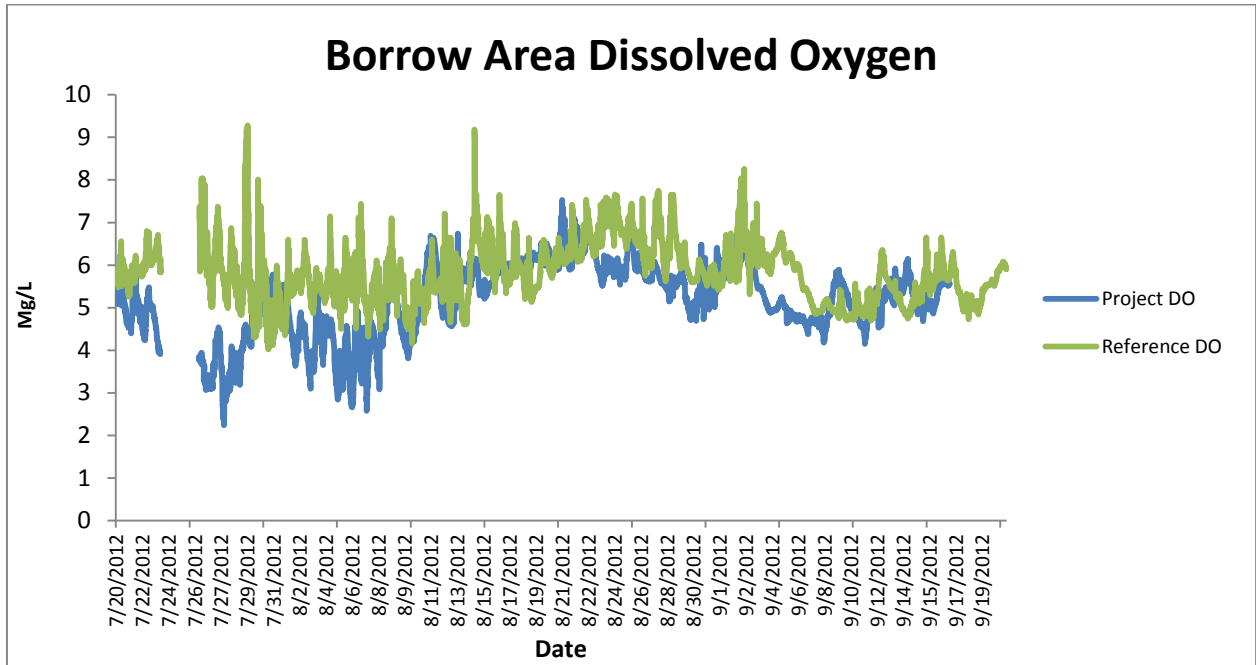
Dissolved oxygen levels were monitored in the borrow area and a reference area, just outside of the borrow area, in July through September 2012 (figure 9). Data was not collected in 2011 due to an equipment malfunction. A non-parametric one way median analysis was run to compare the 2012 data from both areas. It was found that dissolved oxygen levels were significantly lower in the borrow area than the reference area, particularly during the beginning of the sampling period ( $\chi^2=10.54$ ,  $p=0.0012$ ). Slightly higher water temperatures were recorded during the beginning of the sampling period, when compared to mid-August through September which may have caused this effect. Hypoxic conditions ( $<2$  mg/L) did not occur in either area, though. The lowest dissolved oxygen levels occurred on July 28 in the borrow area and were 2.24 mg/L. The post-construction surveys completed in March 2012 showed significant infilling of the borrow area during the first year since construction.

**Figure 9.** Dissolved oxygen levels (Mg/L) in the TV-21 borrow and reference areas from July-September 2012.
