**State of Louisiana
Coastal Protection and Restoration
Authority**

2013 Annual Inspection Report

**LITTLE LAKE SHORELINE
PROTECTION / DEDICATED
DREDGING NEAR ROUND LAKE
(BA-37)**

State Project Number BA-37
Priority Project List 11

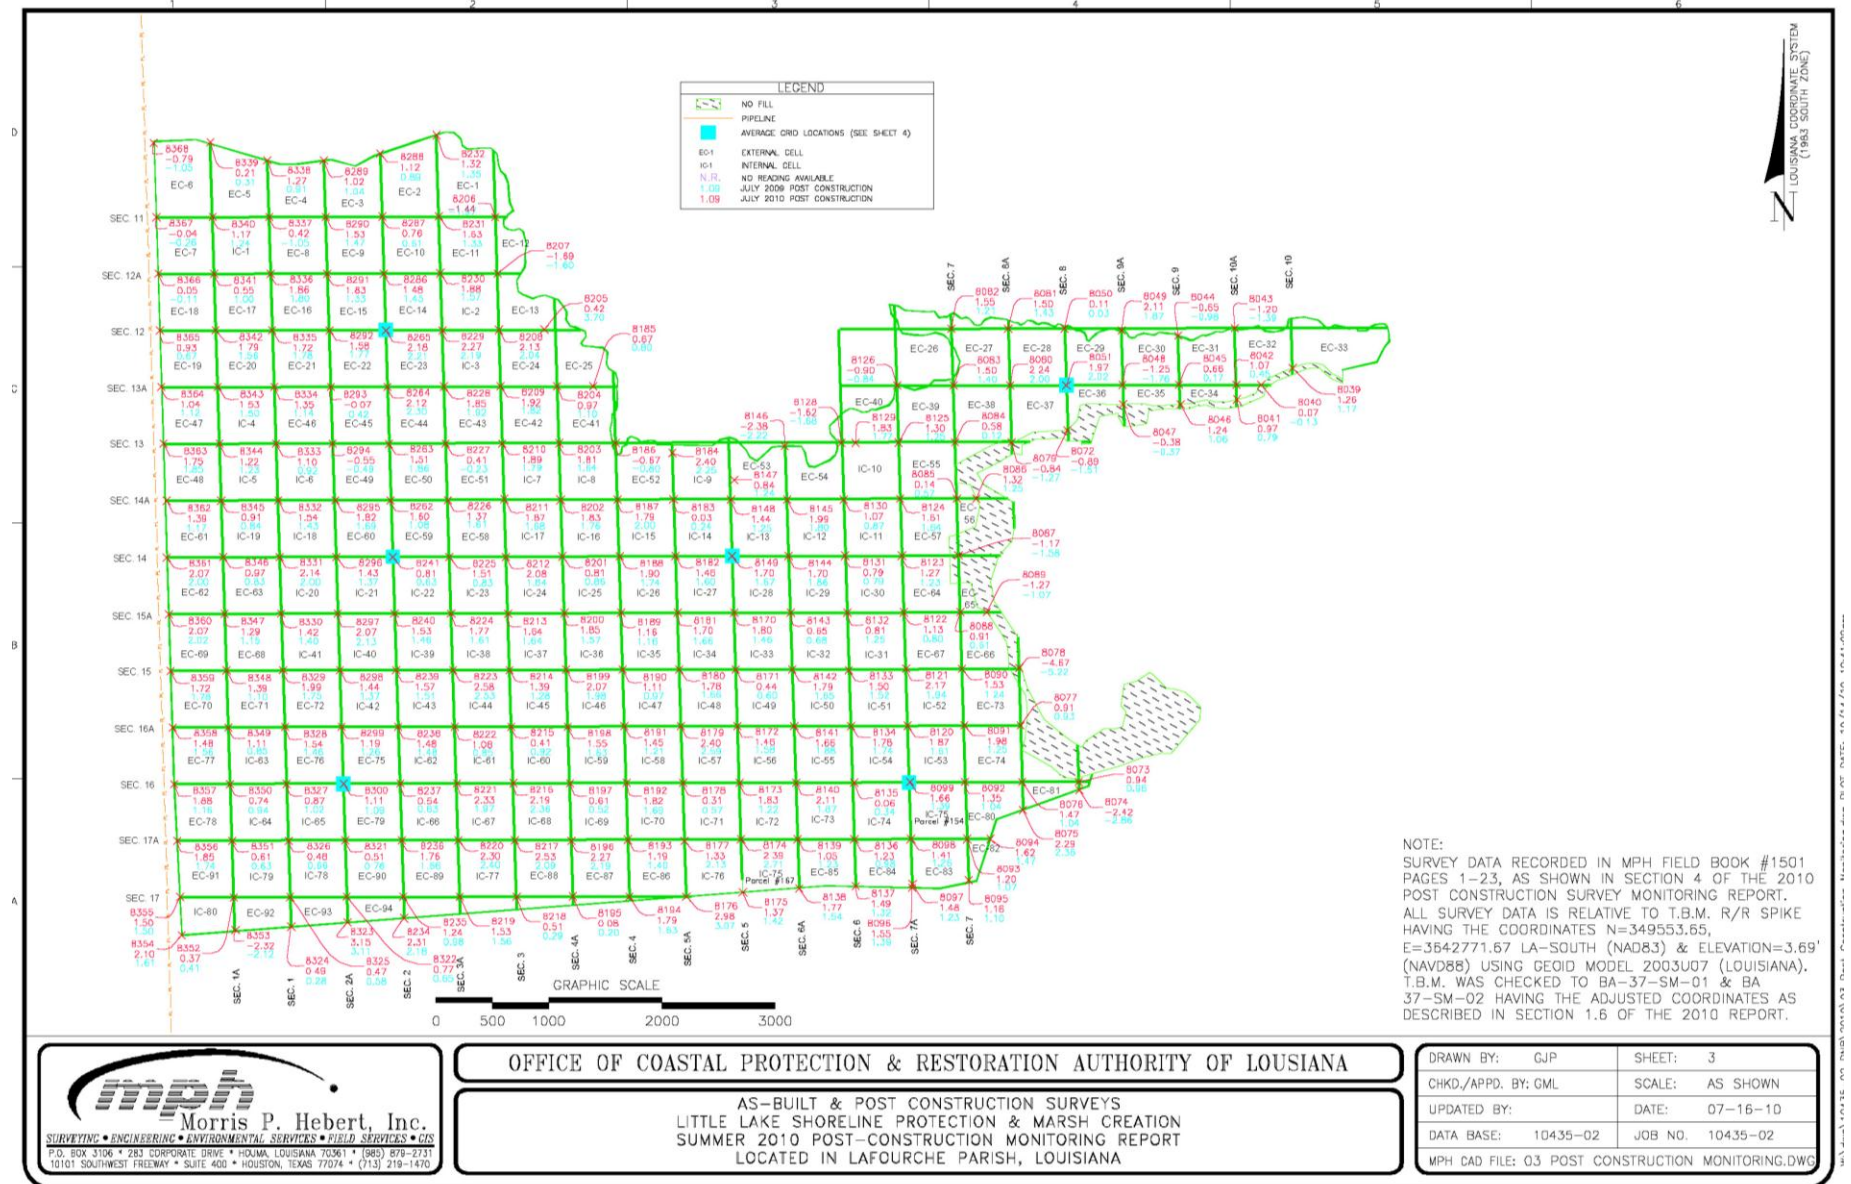
Figure 3. Marsh Creation Area Grid Survey showing June 2009 and July 2010 Elevations

The marsh creation area appears to be completely vegetated and the surveys indicate its elevations are approaching the average marsh elevation for the area. There are no funds allocated for the marsh creation portion of the project other than the surveying of the area grid points. We recommend that the 2011 survey be the last of the first five annual surveys as we will have five total data sets for post-construction analysis, in addition to the 10 and 15 year survey as per the O&M Plan. The survey data along with the annual visual inspections will monitor the consolidation and settlement of the fill material and the resulting elevations within the marsh creation area.
