2016 Annual Inspection Report

**LITTLE LAKE SHORELINE
PROTECTION / DEDICATED
DREDGING NEAR ROUND LAKE
(BA-37)**

State Project Number BA-37
Priority Project List 11

May 19, 2016
Lafourche Parish

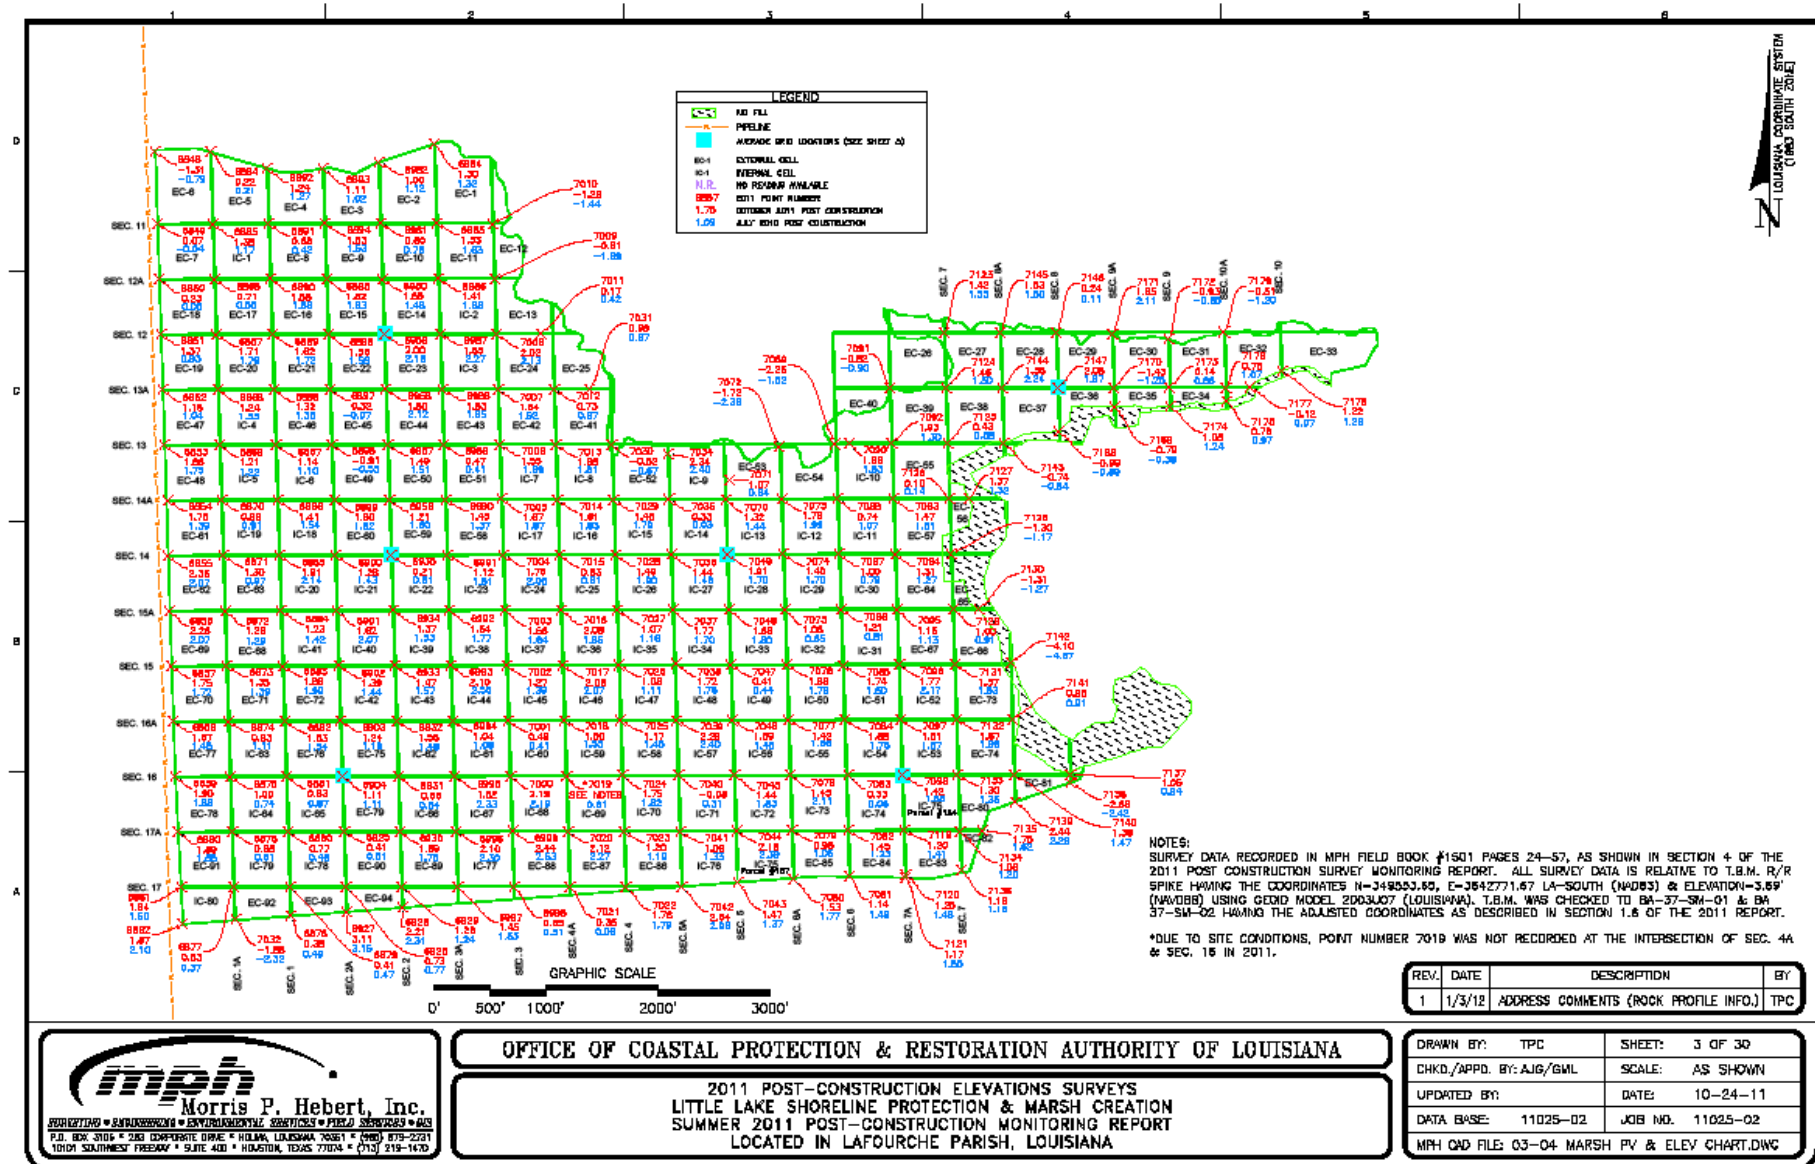
Figure 1. Marsh Creation Area Grid Surveying showing July 2010 and September 2011 Elevations

We were only able to visually inspect the marsh creation area from the perimeter of the project and marsh fringe along Round Lake and the southern containment dike. The fill material in the marsh creation area appeared to be in very good condition and fully vegetated. The latest post construction survey of the fill area was completed in 2011. Below is a table showing the average grid elevations from 2006, the year construction was completed, through 2010. The final post construction survey of the marsh fill area was conducted in 2011 and is shown in Figure 1. The next scheduled post-construction survey of the marsh creation area is recommended for 2017. Since we will be conducting design surveys for degrading Segment 1 and 2 dikes, we would also recommend that the planned marsh surveys for 2017 be included as well. There is a cost savings to performing this work at the same time as surveying for the maintenance event and profiling of the rock dike.
