State of Louisiana Coastal Protection and Restoration Authority

2019 Annual Inspection Report

Delta Management at Fort St. Philip (BS-11)

State Project Number BS-11 Priority Project List 10

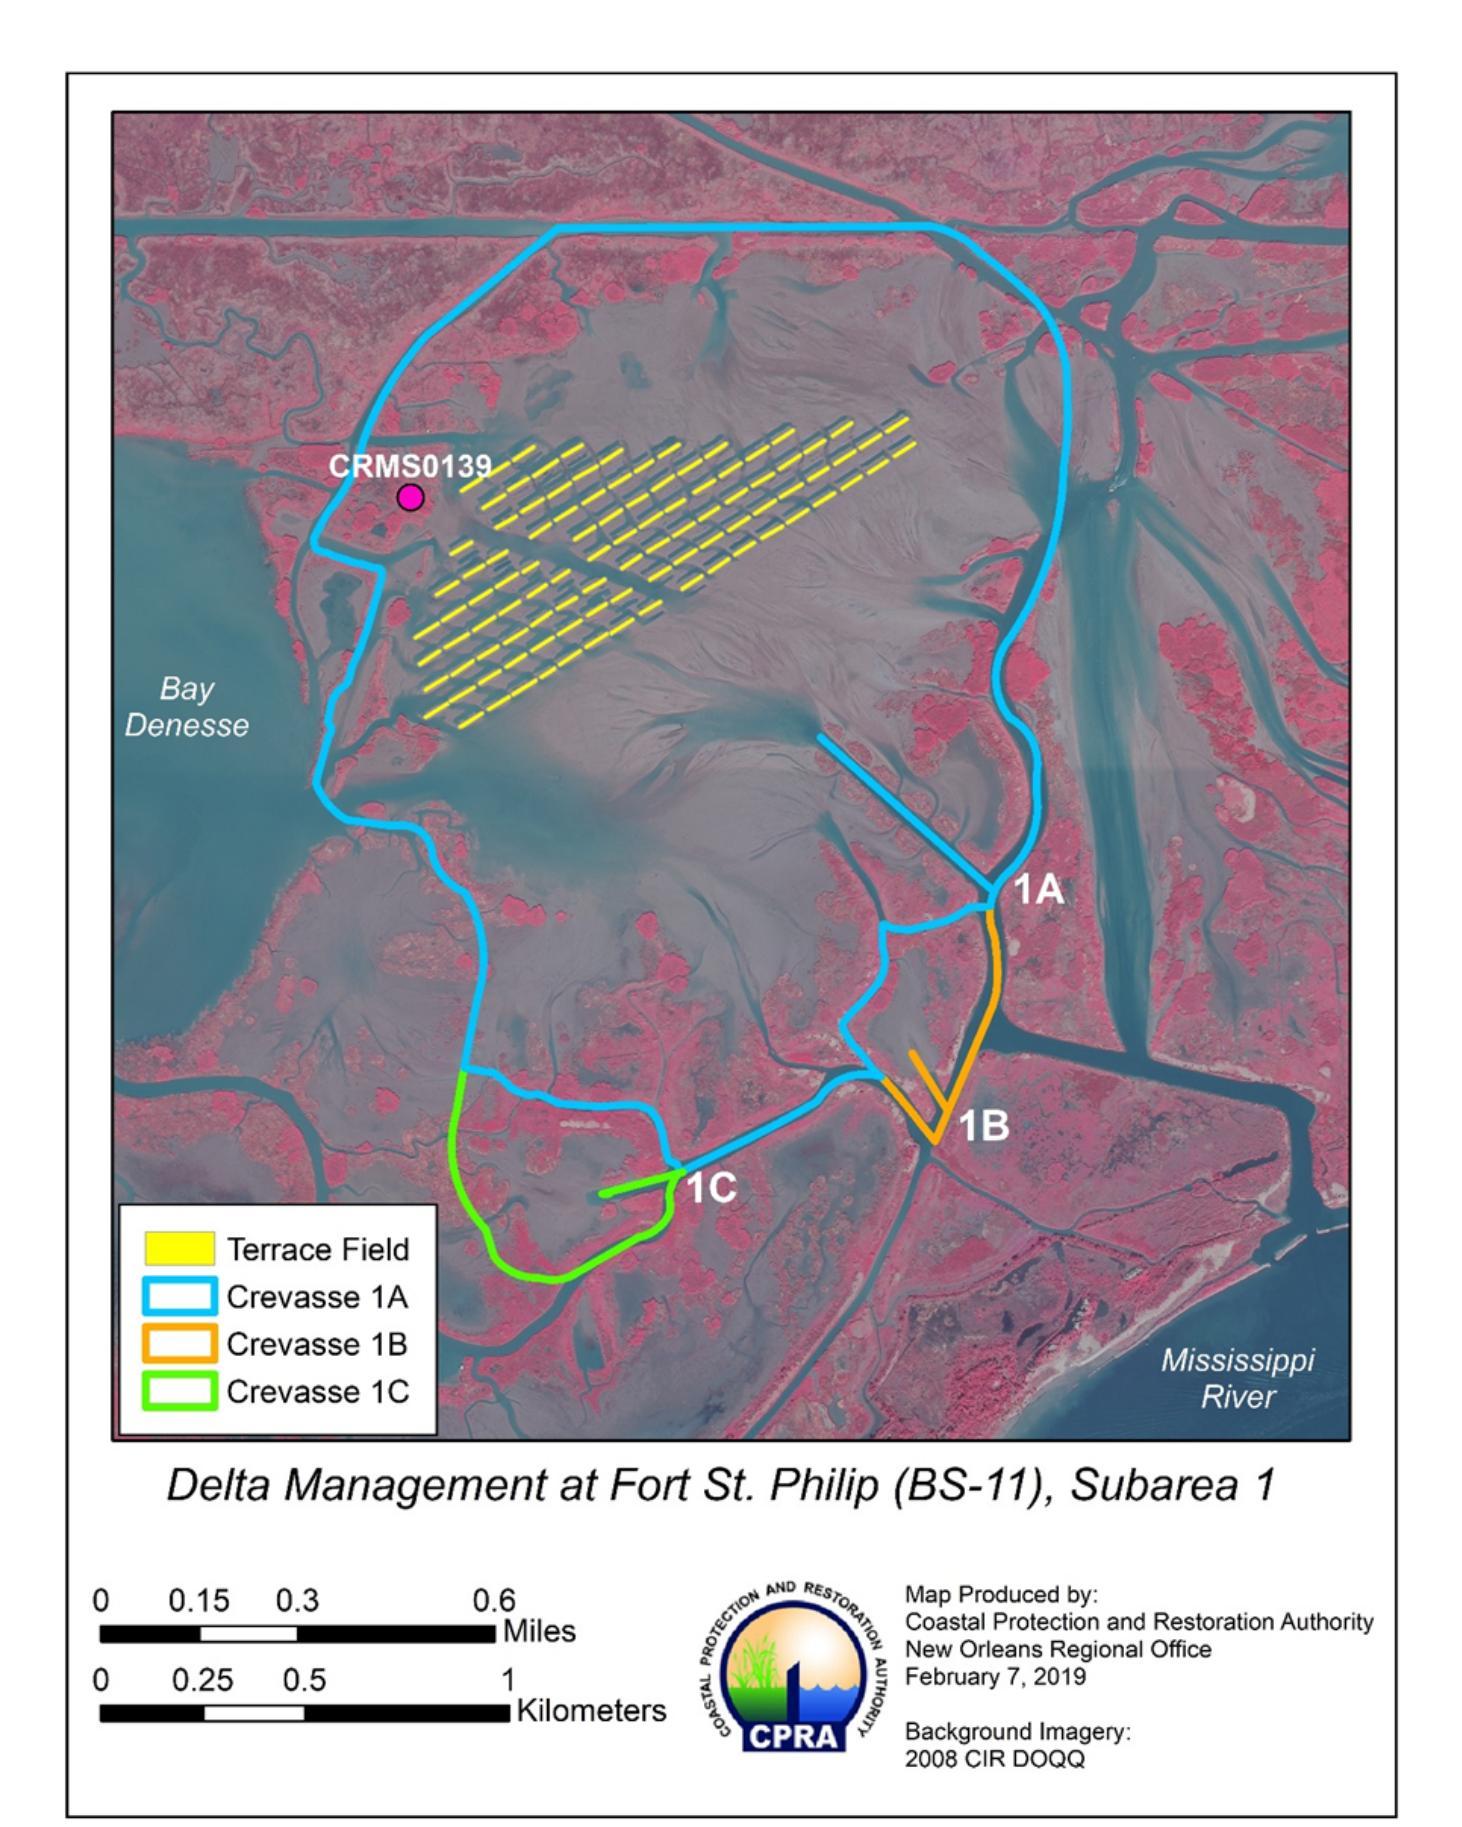
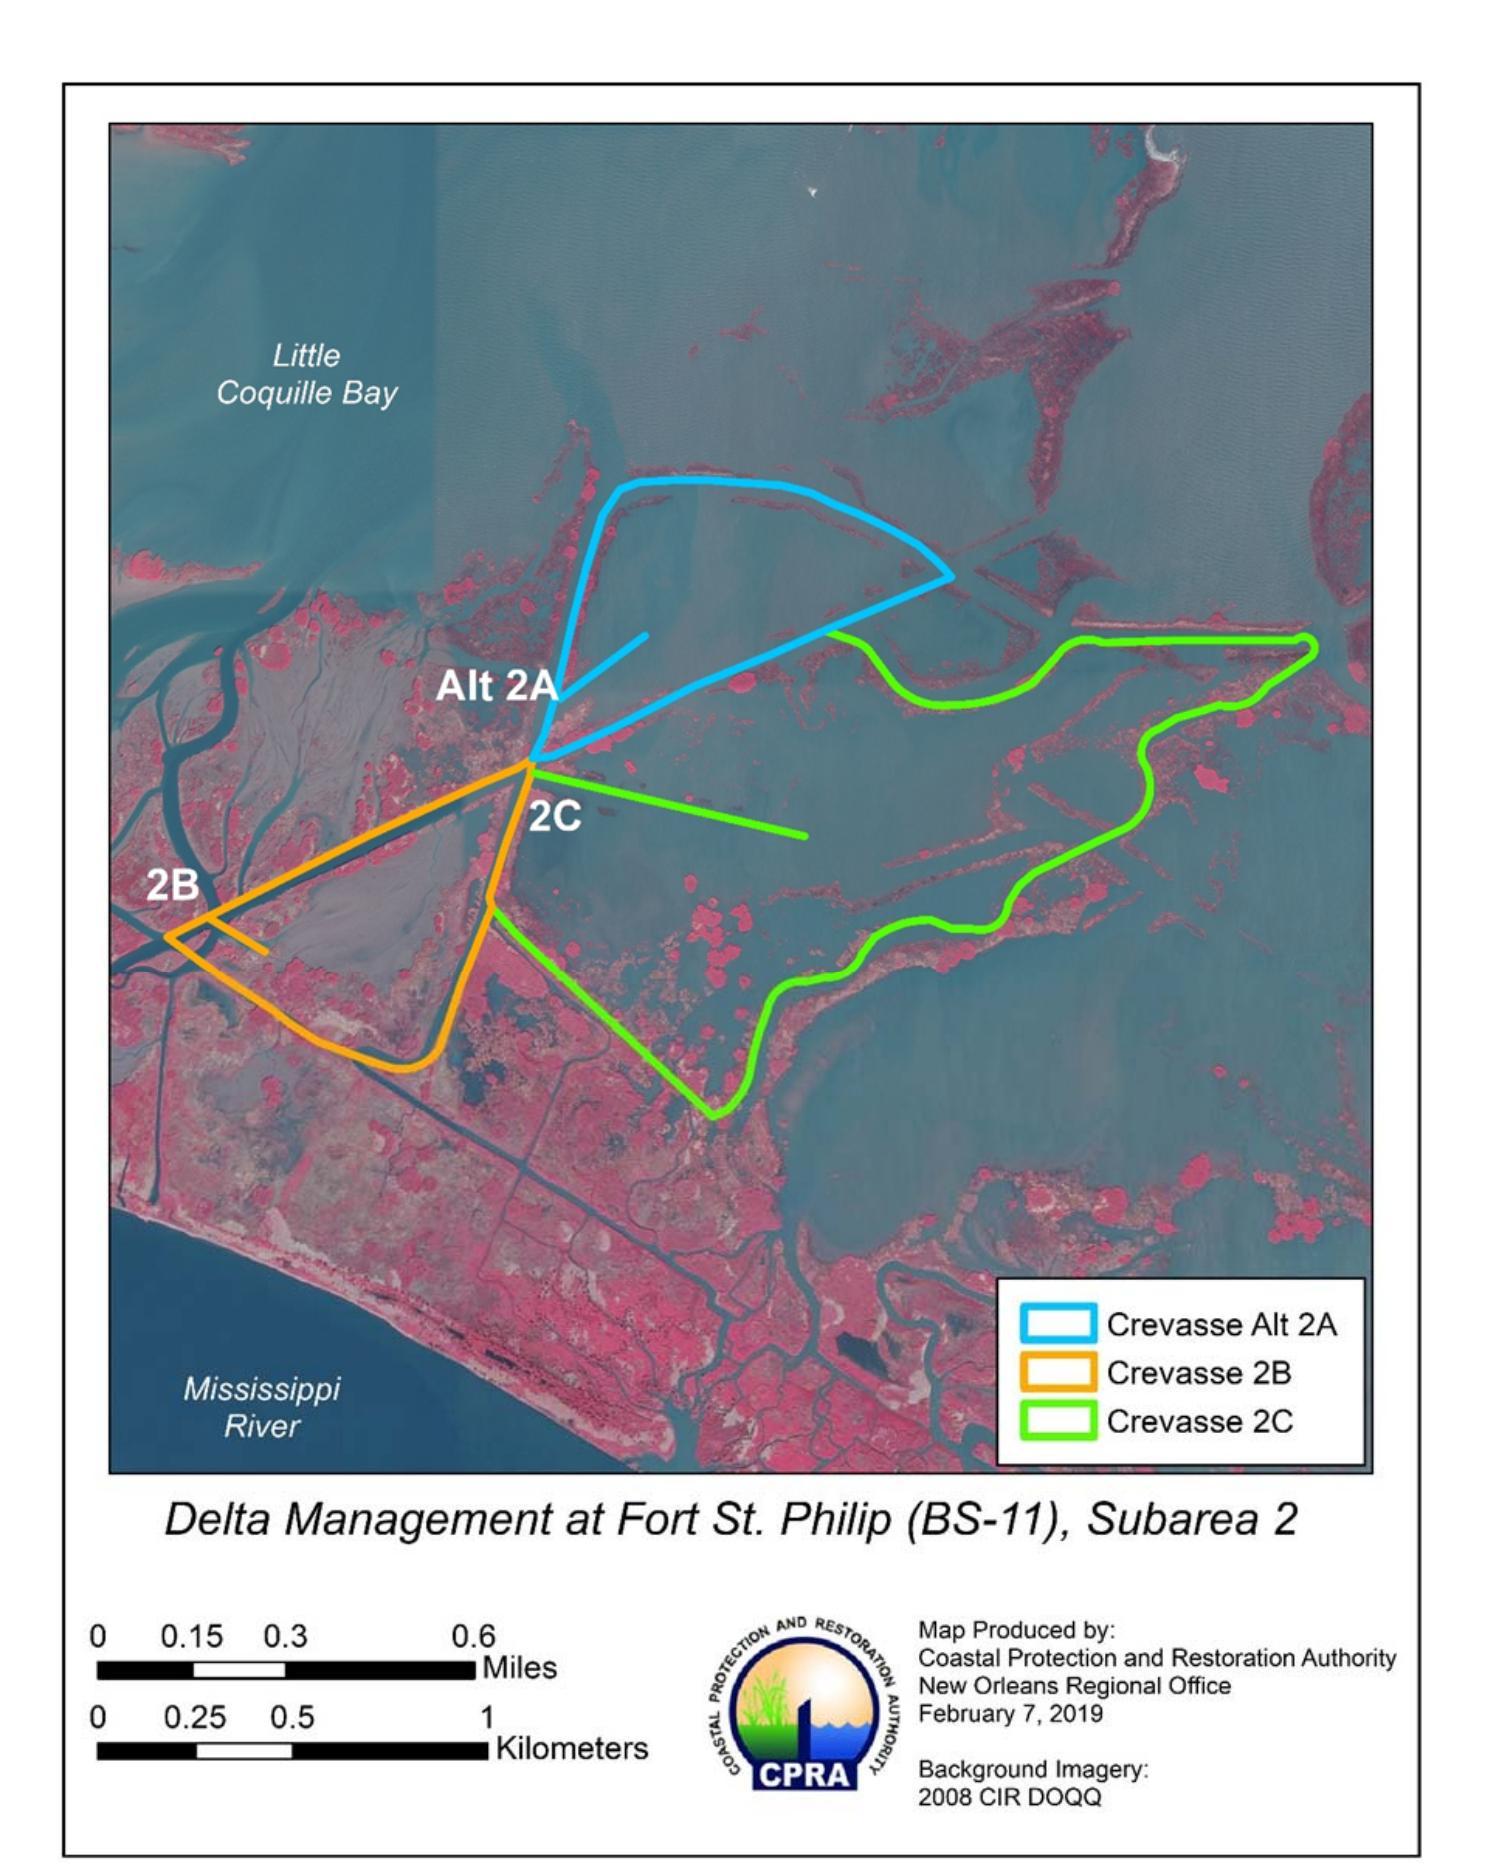
Project Features Maps

- C. <u>Crevasse No. 1B</u>: This crevasse has infilled. The channel outfall shows colonization of emergent vegetation.
- **D.** <u>Crevasse No. 1C</u>: The crevasse remains intact. Dense growth of emergent vegetation was observed just beyond the outfall, and healthy marsh grass rings the entire perimeter of this site.

- E. <u>Crevasse No. Alt. 2A</u>: The crevasse remains intact, channel banks are well-vegetated, and significant emergent vegetation was observed in the receiving area.

- **F.** <u>Crevasse No. 2B</u>: The crevasse remains intact. Dense growth of emergent vegetation was observed in the receiving bay.
- **G.** <u>Crevasse No. 2C</u>: The crevasse appears to have begun infilling. The receiving area appears to have large areas of emergent vegetation near the crevasse outfall.

The recommendation from the project team is to continue annual inspection and assessment of site conditions utilizing updated aerial imagery
