**Coastal Protection and Restoration
Authority (CPRA)**

2017 Operations, Maintenance, and Monitoring Report

Perry Ridge Shore Protection

State Project Number CS-24
Priority Project List 14

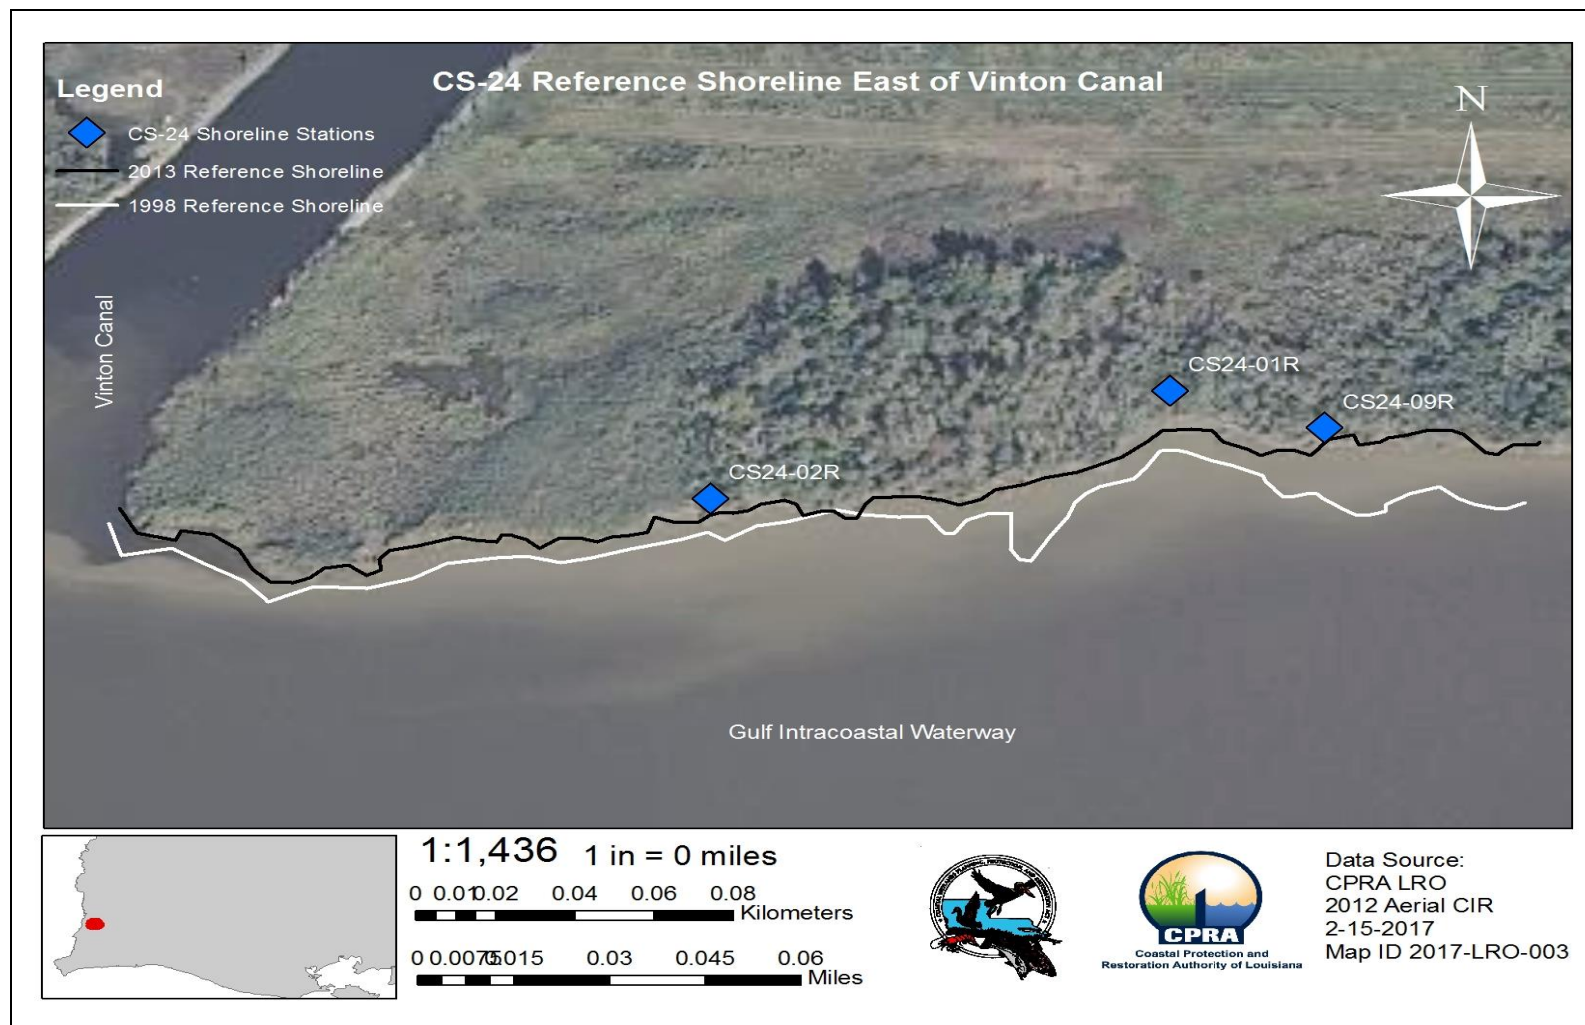
Figure 7. The reference shoreline at Perry Ridge (CS-24) containing shoreline stations and historic shoreline positions at the confluence of the Vinton Canal and the GIWW just east of the project area.

increased current and water movement in the GIWW was an erosive force in the reference area where station CS24-9R was completely washed away between 2013 and the 2016 survey (Figure 7). This means that a minimum of fifty feet of shoreline erosion occurred in the reference area since project inception to the 2016 survey and likely significantly more, which can no longer be accurately measured due to the benchmark being lost to open water.
