**State of Louisiana
Coastal Protection and Restoration Authority**

2015 Operations, Maintenance, and Monitoring Report

East Sabine Lake Hydrologic Restoration (CS-32)

State Project Number CS-32
Priority Project List 10

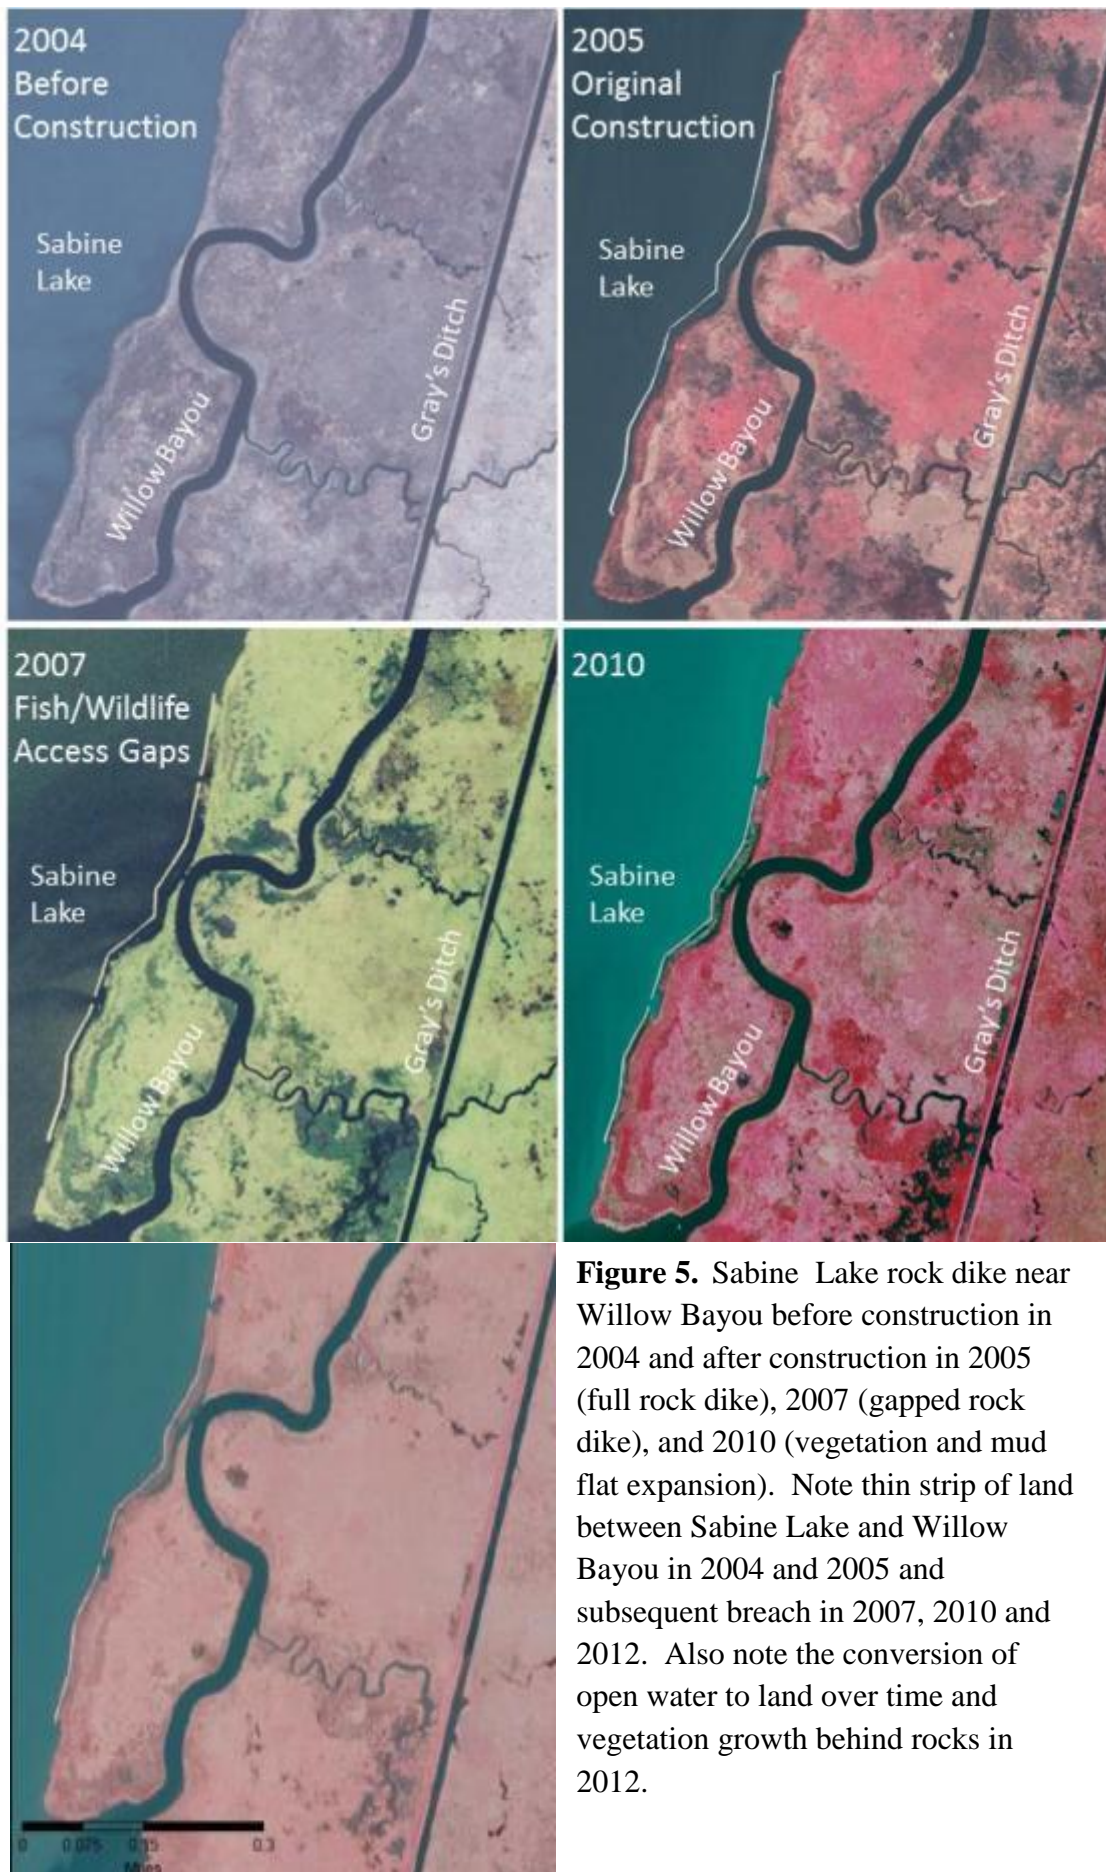
Land expansion in the Sabine Lake Rock Dike area (Area 5) will be limited by the rock dike. Much of the area had converted from open water to land between construction in 2005 and the 2015 site inspection. Mud flats have formed and vegetation has been established in fifty percent of the area behind the rock dike except for areas behind the gaps in the rock dike (both ends and two in the middle) which allow for fish and estuarine organisms access to the shoreline (Figure 5). The rock dike did not prevent the breaching of Sabine Lake and Willow Bayou; however, subsequent mud flat formation and vegetation in the vicinity of the breach behind the rock dike is expected to diminish hydrologic exchange between the two water bodies.

Figure 5. Sabine Lake rock dike near Willow Bayou before construction in 2004 and after construction in 2005 (full rock dike), 2007 (gapped rock dike), and 2010 (vegetation and mud flat expansion). Note thin strip of land between Sabine Lake and Willow Bayou in 2004 and 2005 and subsequent breach in 2007, 2010 and 2012. Also note the conversion of open water to land over time and vegetation growth behind rocks in 2012.

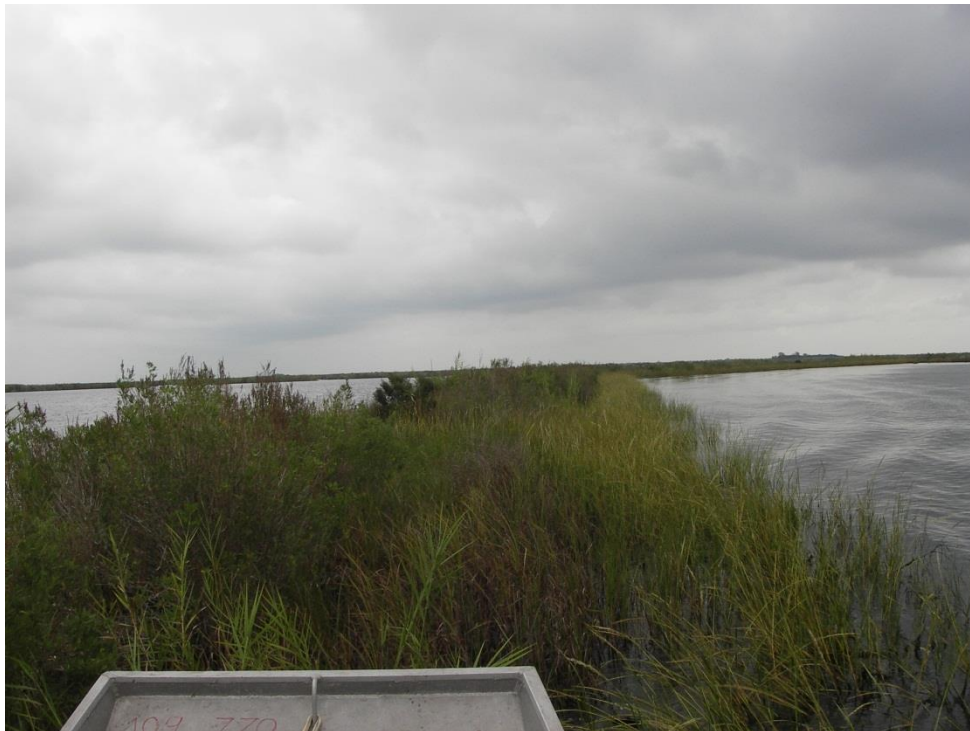
An annual field inspection of the rock dike, weirs and culverts was conducted by CPRA and Federal sponsor staff on September 29, 2014. Findings of the plant condition were better in 2014 with more expansion into the water by smooth cordgrass. The percent cover for the total length of terraces was estimated at appx. 90%. The inspection began on the north end of the terrace field and proceeded south. Each air boat took a row of terraces meeting up along the way to discuss what was seen. The northern section of terraces (CU1) had a variety of vegetation, i.e. smooth cordgrass, roseau cane, baccharis, iva, and a few cattails. The terraces narrowed heading south (CU1A), but there was still good cordgrass spread out beyond the terrace width. There were skips in vegetation coverage noted, averaging 5%-7% bare areas. (See Appendix A, Photos 1-5)

Photo No.1 –Northern Section of Terraces – Variety of Vegetation

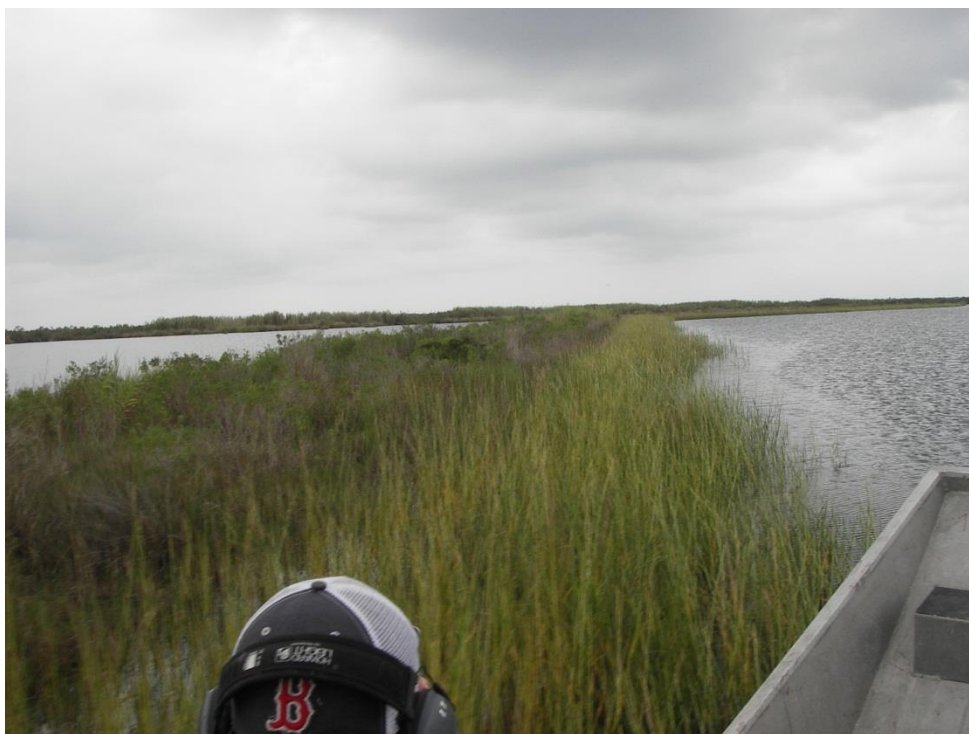
Photo No. 2 –Northern Section of Terraces - Expansion

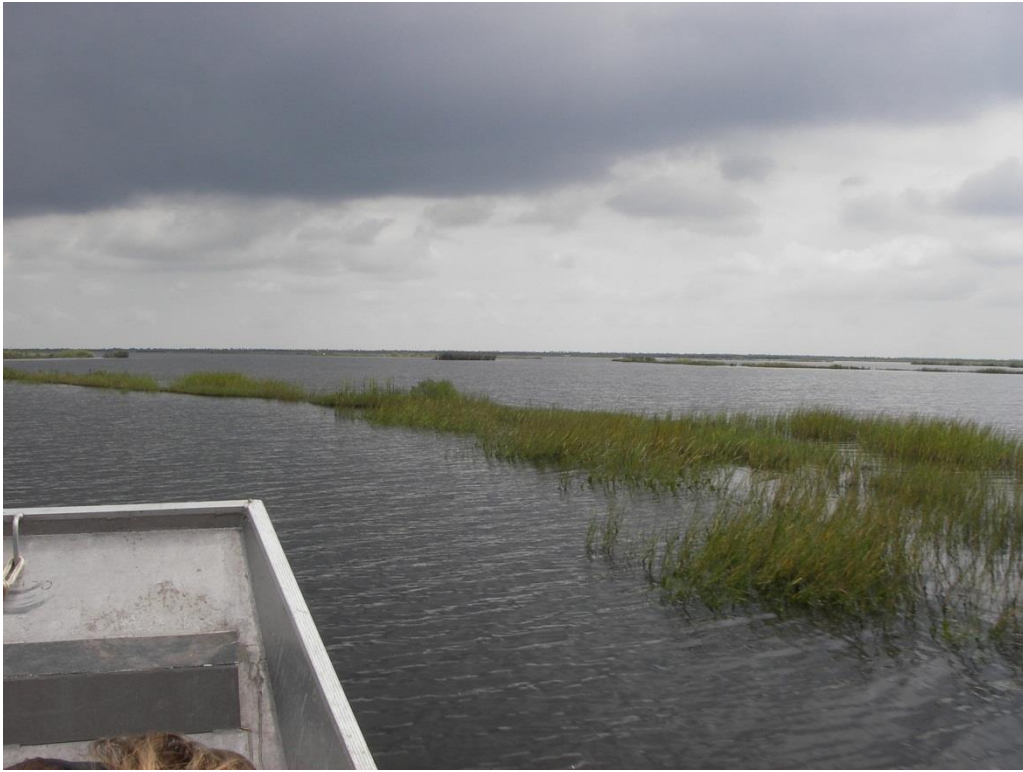
Photo No. 3 – Some Narrowing of Terraces Going South

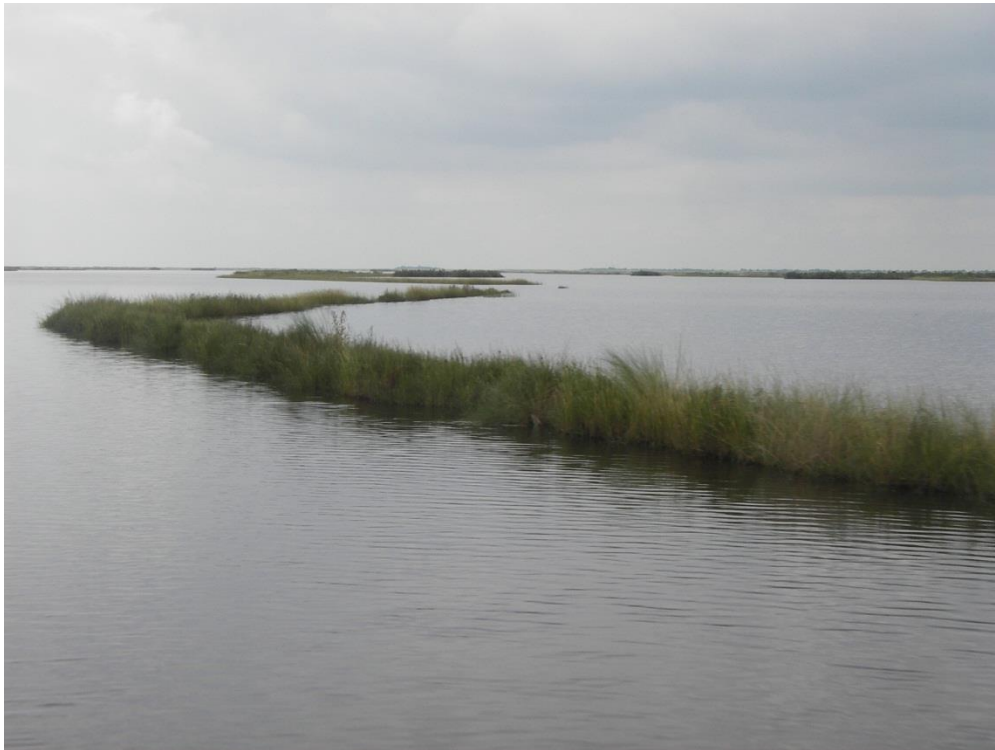
Photo No. 4 – Southern Terraces

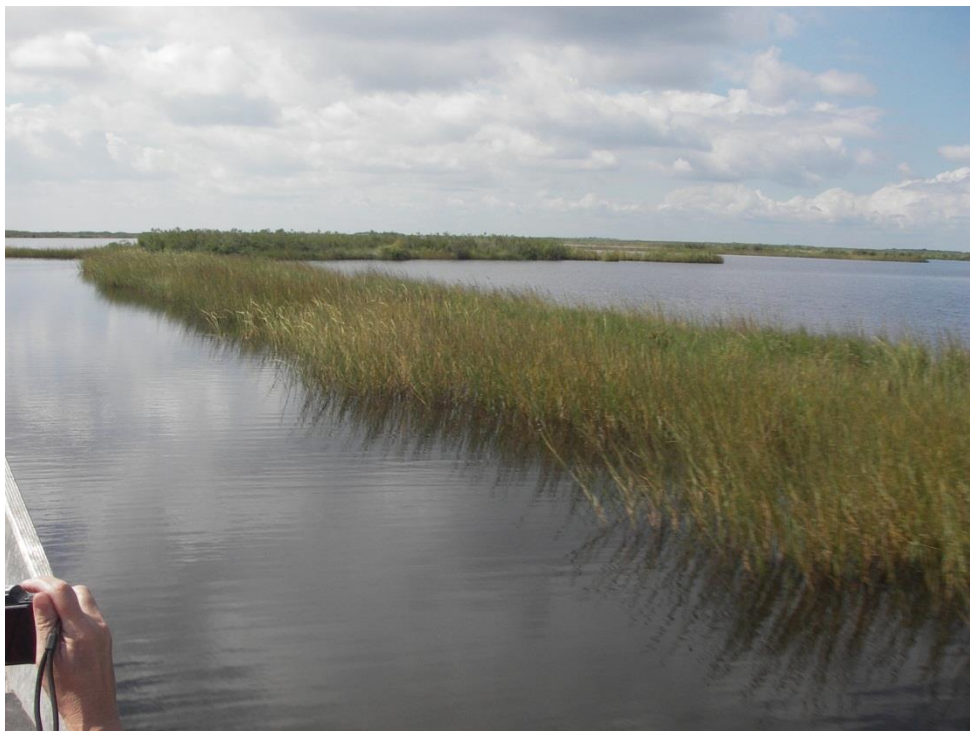
Photo No. 5 – Southern Terraces

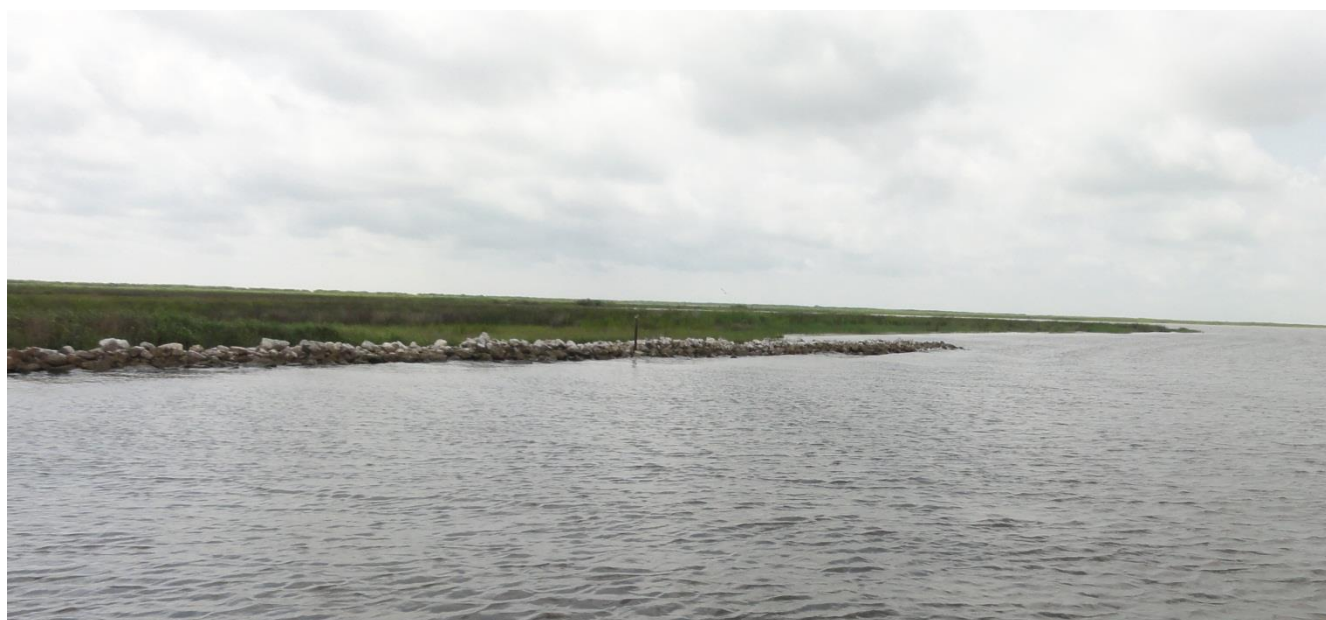
Photo No. 6 – South End of Sabine Lake Foreshore Rock Dike

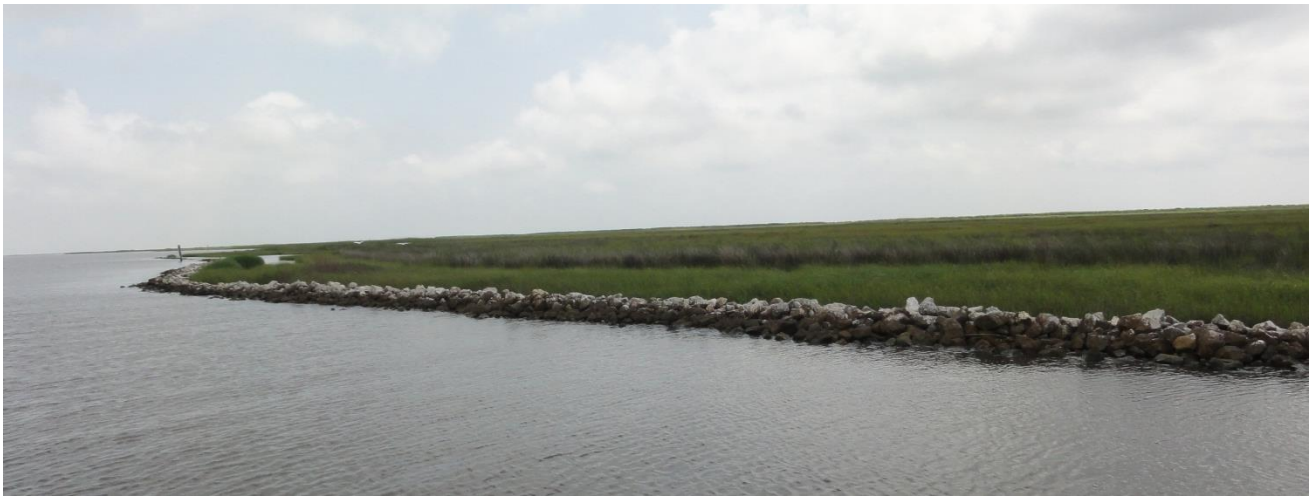
Photo No. 7 – Sabine Lake Foreshore Rock Dike, South of Southern Warning Sign

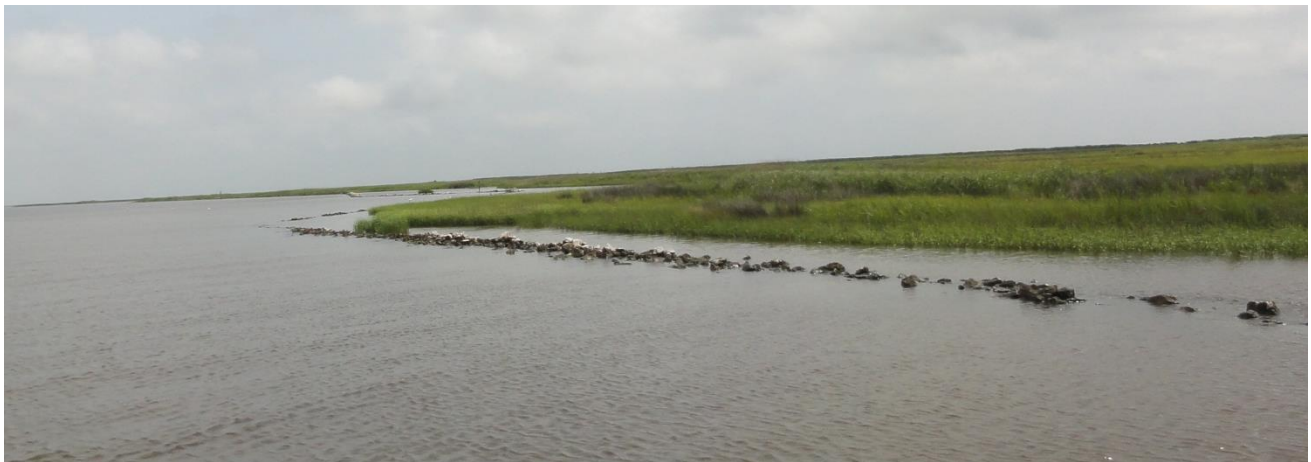
The water level was approximately a foot higher than normal. Although there were low areas of the rock dike noted between the south warning sign up to just south of the bend in Willow Bayou, the foreshore rock dike was in good condition and performing as intended. The higher water was contributing to the low appearance of the rock dike and there were no signs of damage to the original marsh behind the rock dike. This area will continue to be monitored.

Photo No. 8– Sabine Lake Foreshore Rock Dike, Low area of Rock

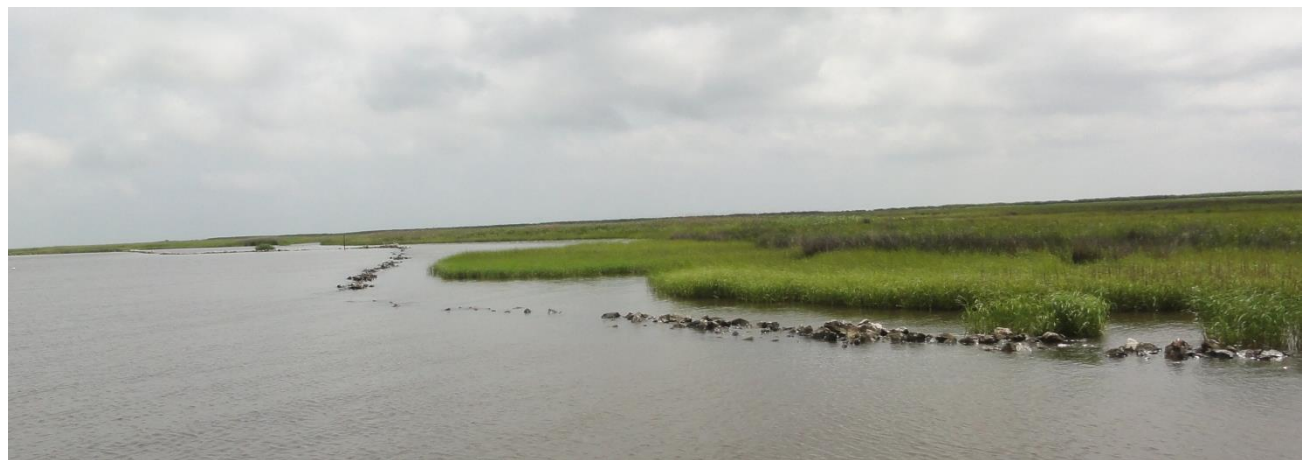
Photo No. 9– Sabine Lake Foreshore Rock Dike, Low area of Rock

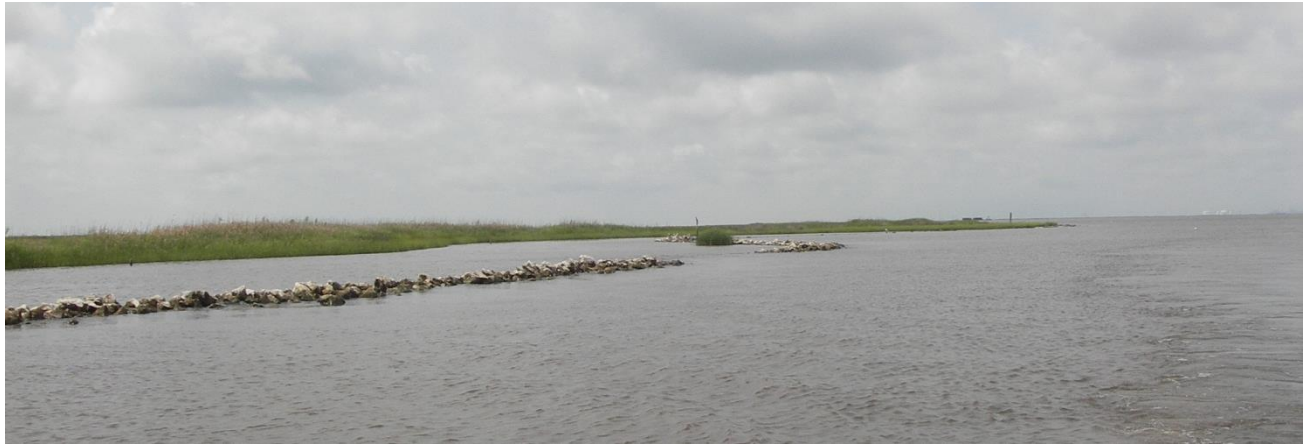
The vegetation has filled in nicely behind several segments of the rock dike. Willow Bayou however has broken through to the dike. There is a segment of rock dike in the vicinity of Willow Bayou that has settled and warrants installing signs. Temporary signs were installed the

Photo No. 10– Sabine Lake Foreshore Rock Dike, Low area at Willow Bayou bend (looking south)

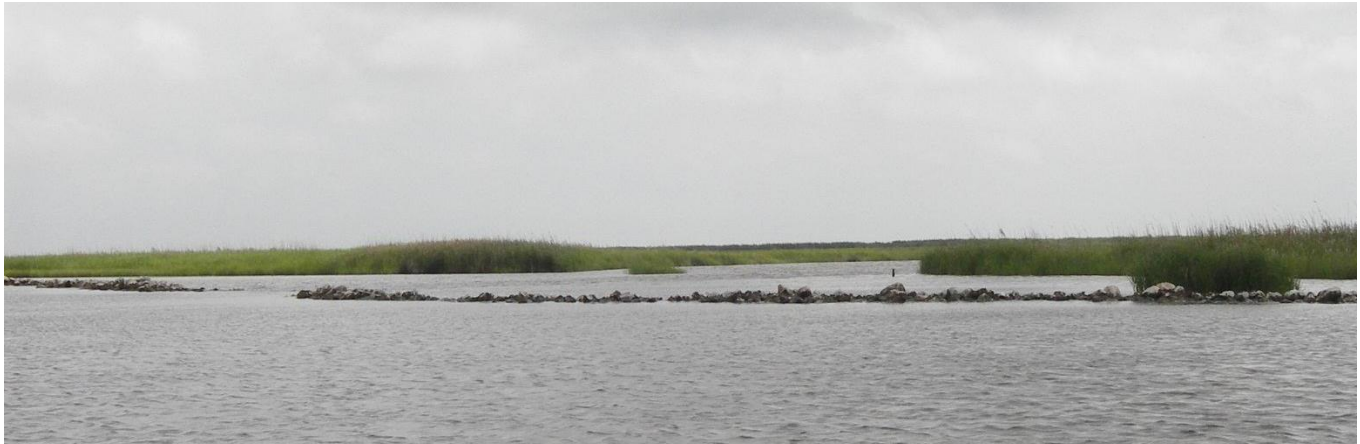
Photo No. 11– Sabine Lake Foreshore Rock Dike, Low area at Willow Bayou bend
(Same Location as Photo 10)

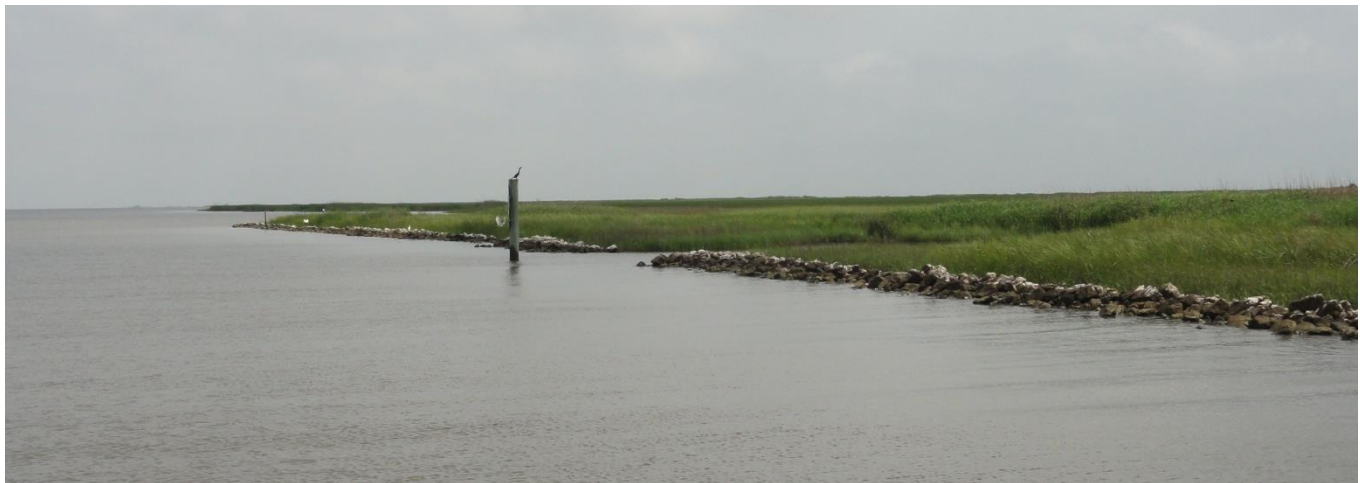
Photo No. 12– Sabine Lake Foreshore Rock Dike, near North Warning Sign

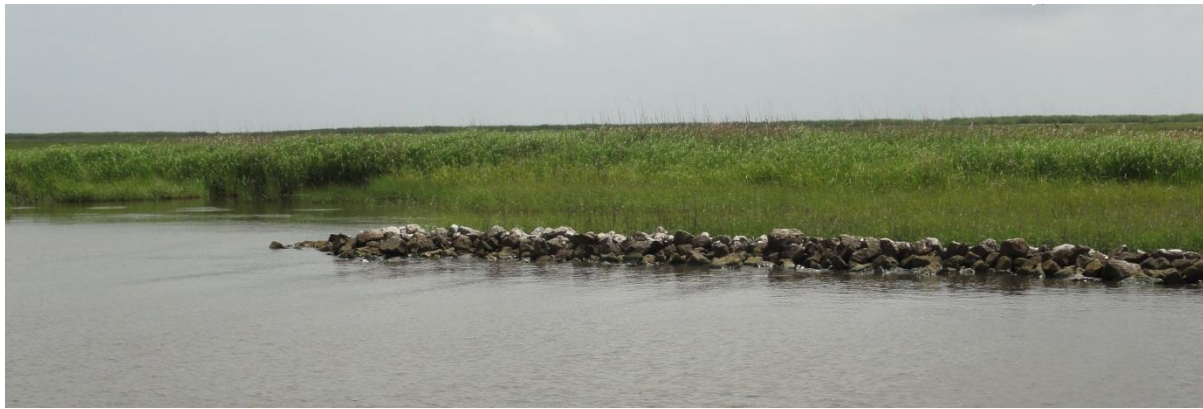
Photo No. 13– Sabine Lake Foreshore Rock Dike, North End

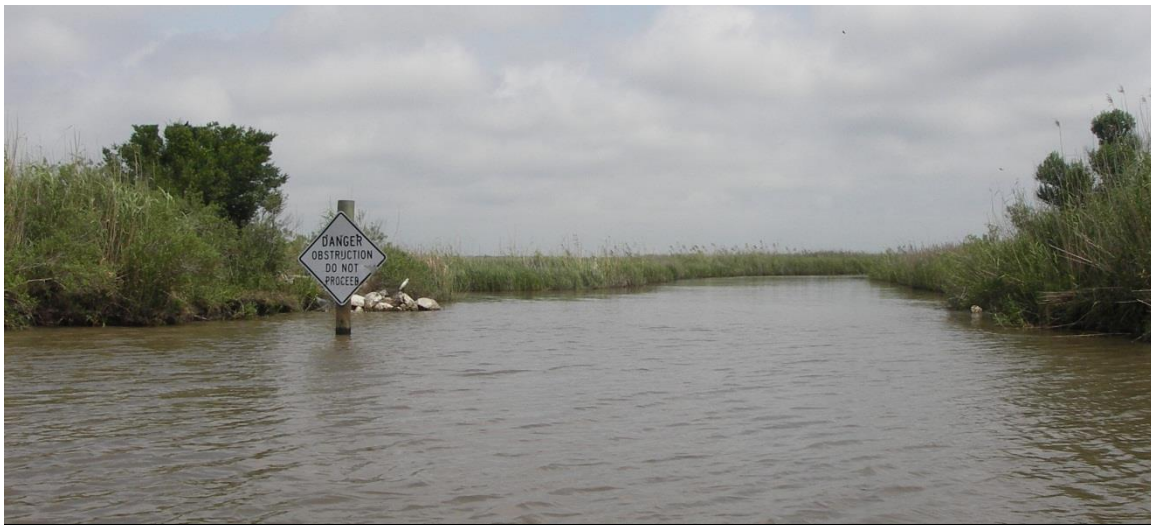
The Cameron Parish Gravity Drainage District No. 7 removed the weir in 2010 for drainage after Hurricane Ike, and placed the rock on the spoil bank adjacent to the plug location. From probing during the 2013 site visit, it was found that the center of the plug was approximately the same water depth as the Southline Canal, and therefore no longer functioning as a weir. There doesn't appear to be a significant impact on the project area. The drainage district replaced the rock in the summer of 2015 and it appears to be about 2 feet above water level. We expect it to subside and compact to water level or below in the near future.

Photo No. 14– Pines Ridge Weir, From outside

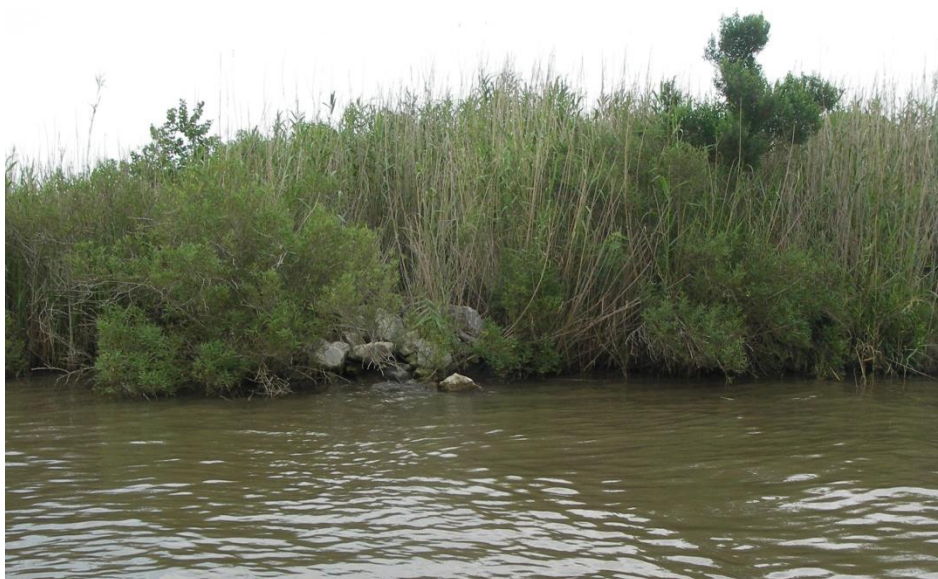
Photo No. 15– Pines Ridge Weir, East bank of weir

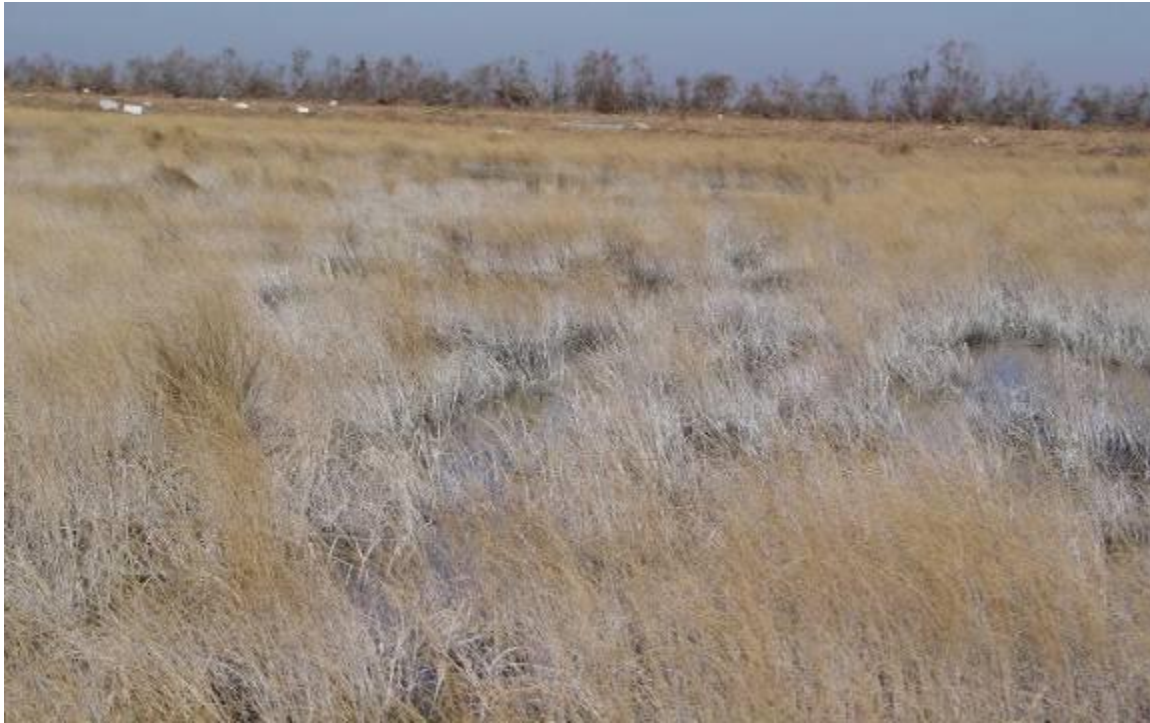
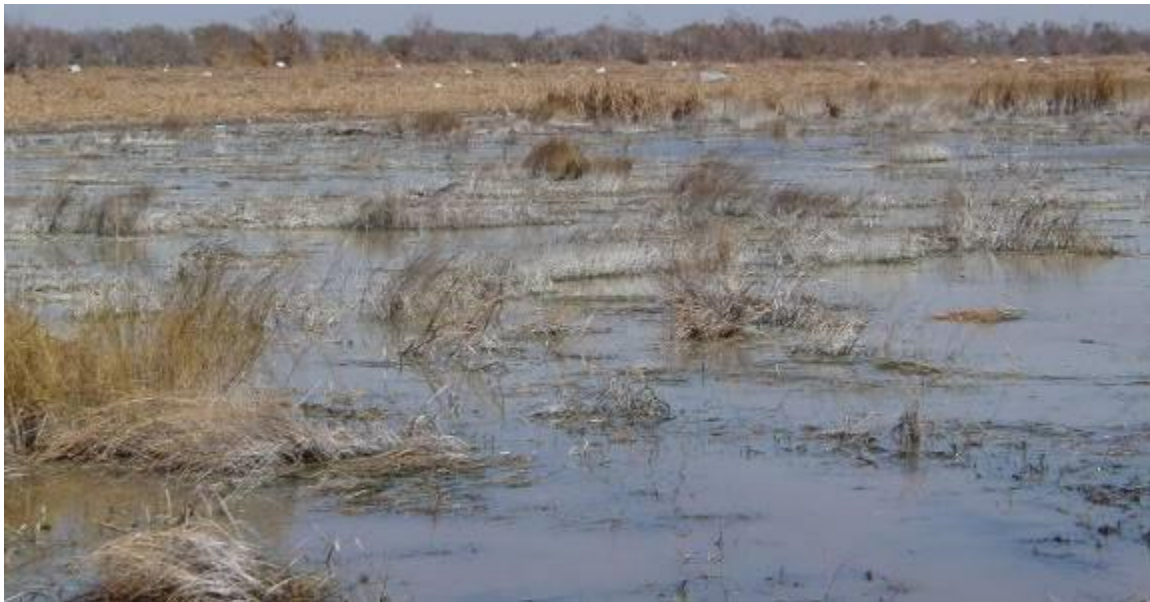
On the October 2005 trip, the investigating party traveled west by airboat, from near USFWS Sabine Refuge Headquarters on Hwy 27, across Refuge marshes to the project area. Huge swaths of wrack, composed of vegetative and anthropogenic material (tanks, lumber, 18-wheeler trailers, etc.), had been deposited on top of the marshes. All emergent marsh vegetation that could be seen was completely brown and much of it was covered with what appeared to be fine-grained sediment and precipitated salt (below).

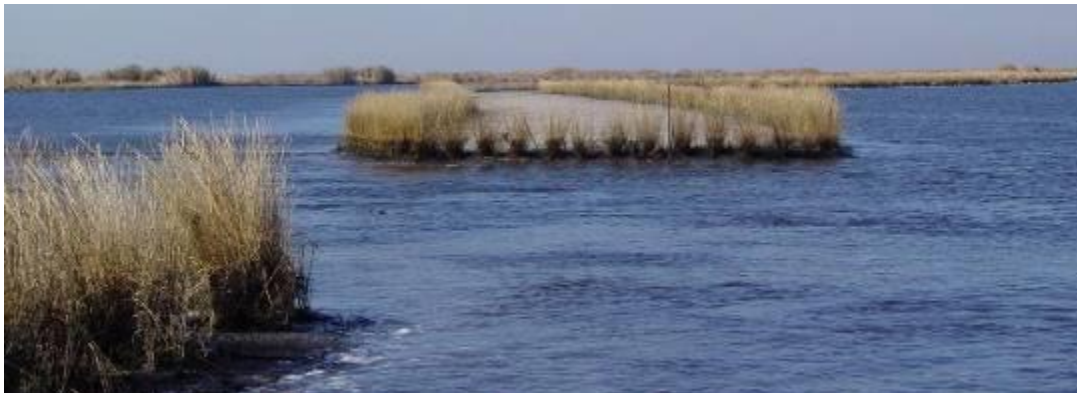
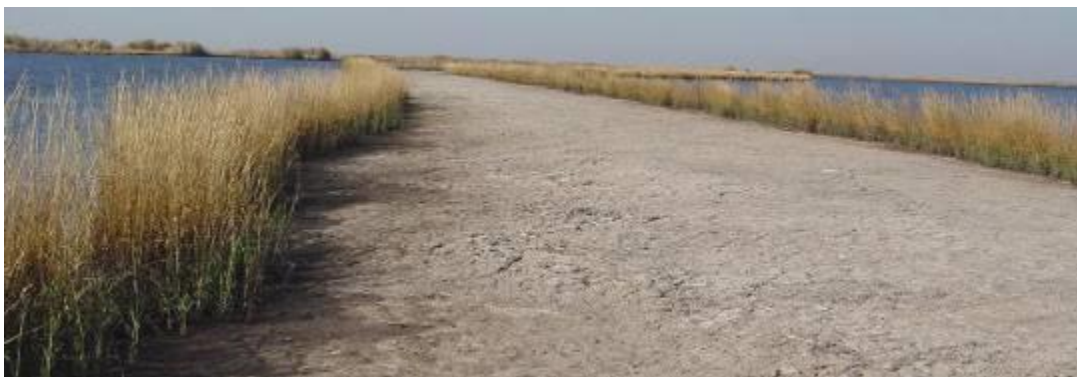
At the project area, although the plants on the southernmost terrace rows appeared to have produced significant growth and spread prior to the storm and the plants' physical structure was mostly intact, we found that all contract plantings on all of the terraces were considerably browned (below).

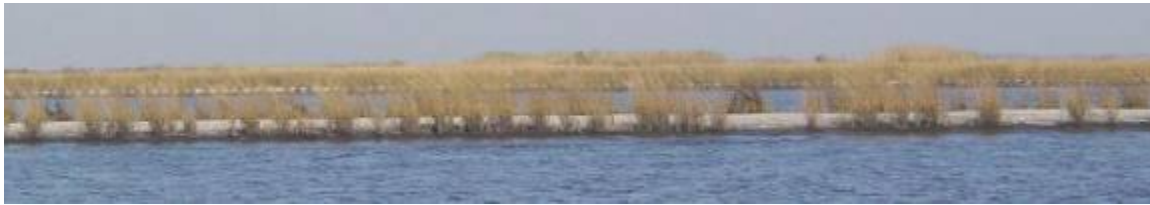
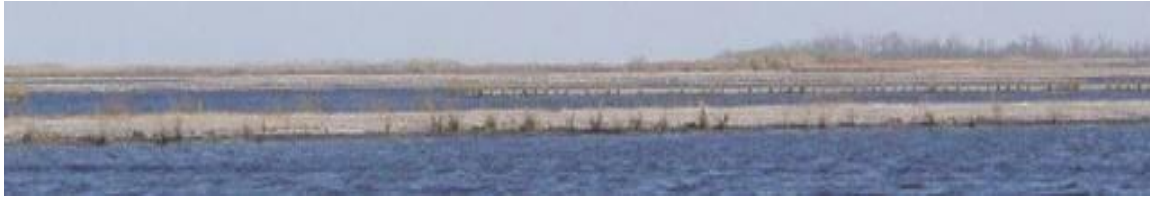
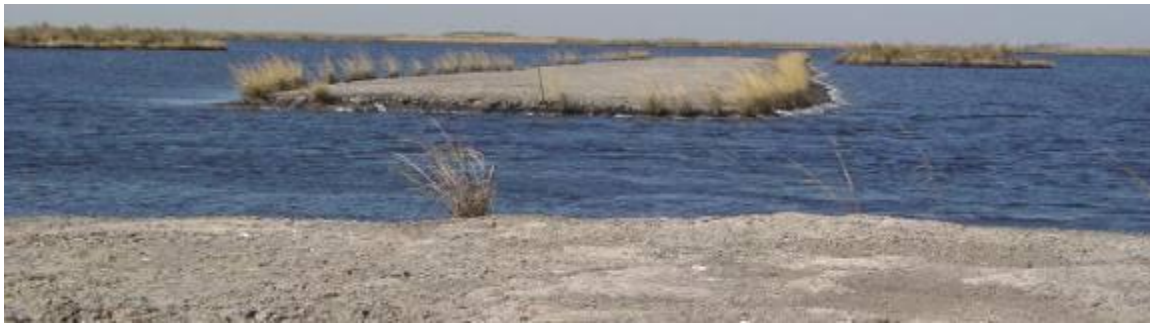
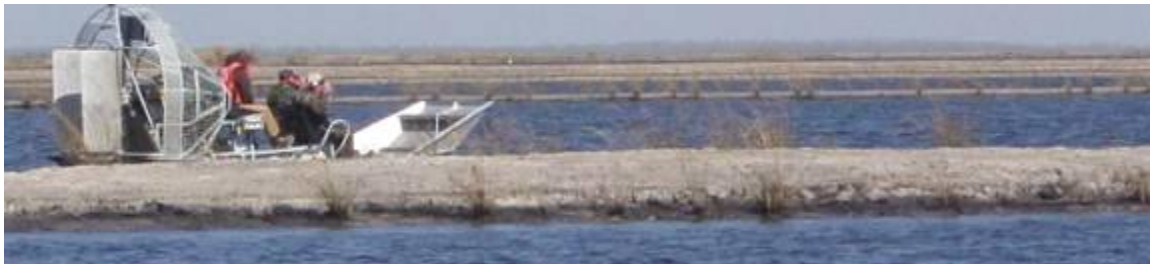
Proceeding northward, we began to note gaps in the planted rows and the number of plants missing on each terrace segment progressively increased.

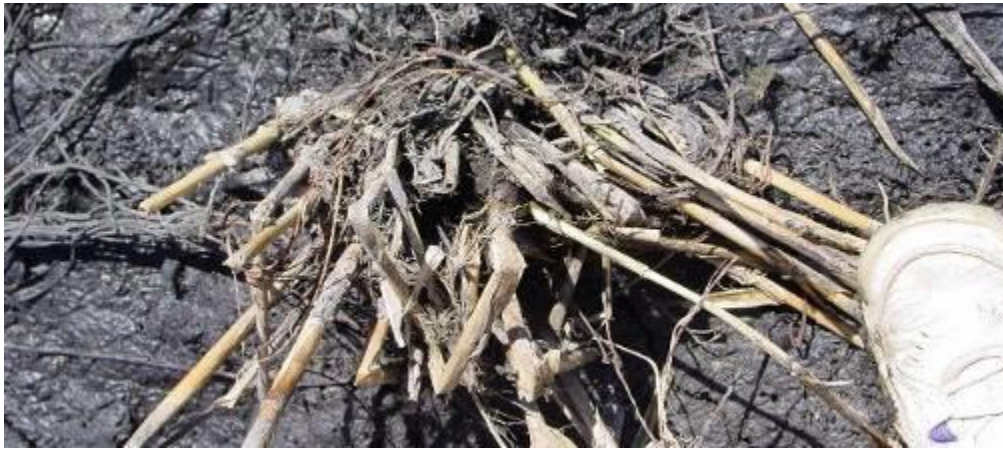
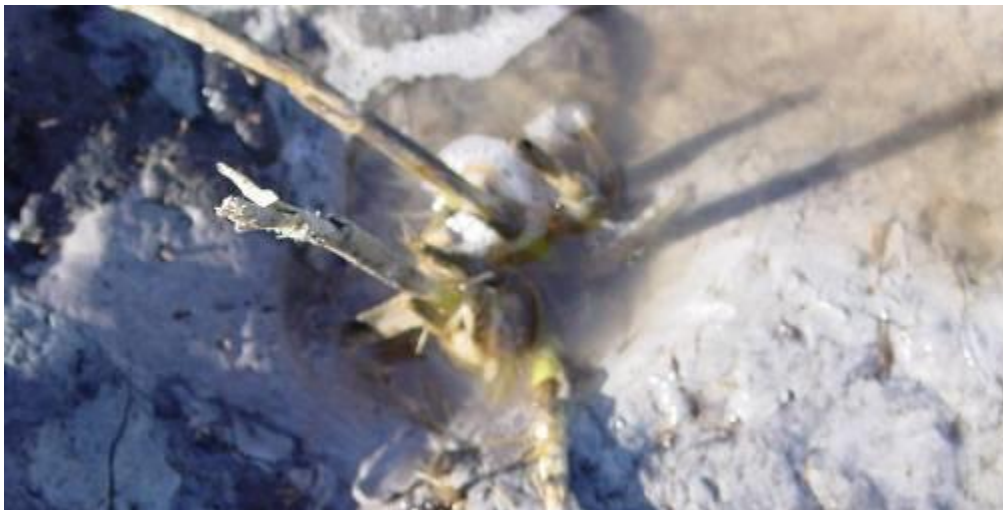
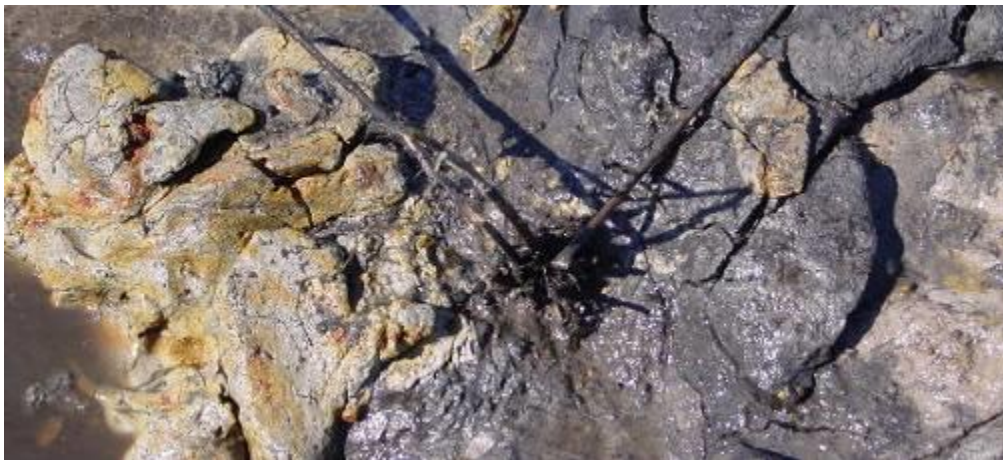
In addition, the younger a transplant was, the less old and new growth was present. From oldest to youngest, mortality increased, and the base of the plant stems ranged in color from pale yellow/green to brown/black and rotten at the base.

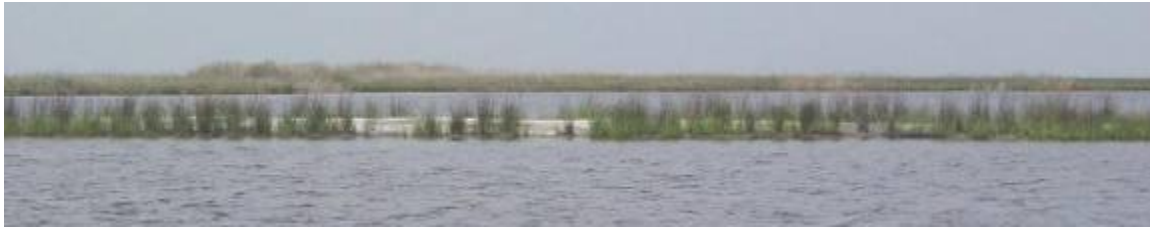
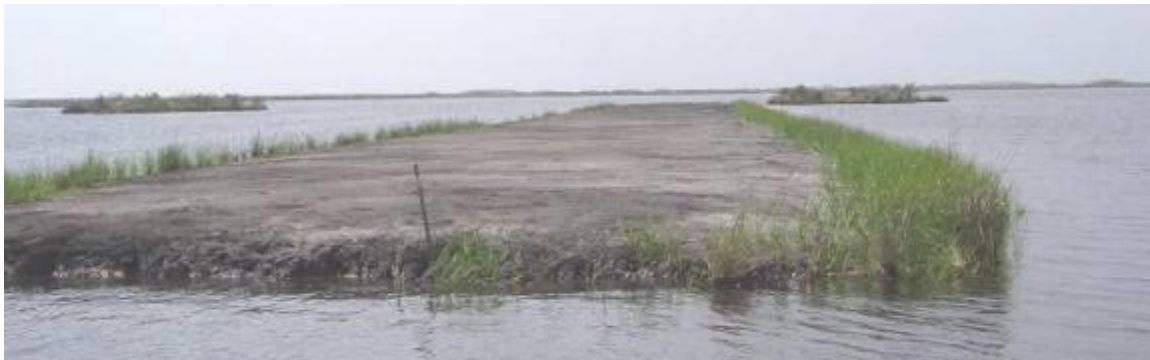
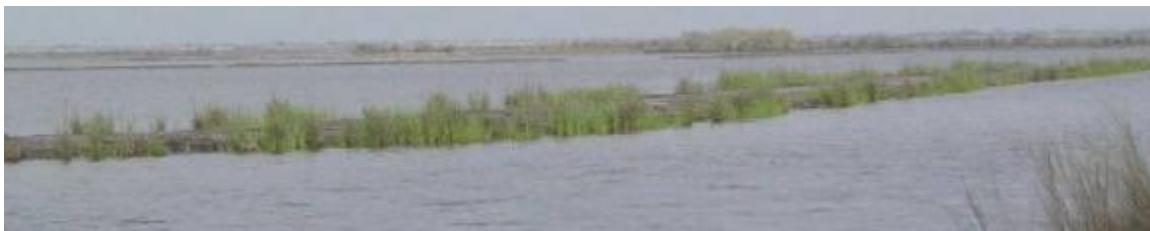
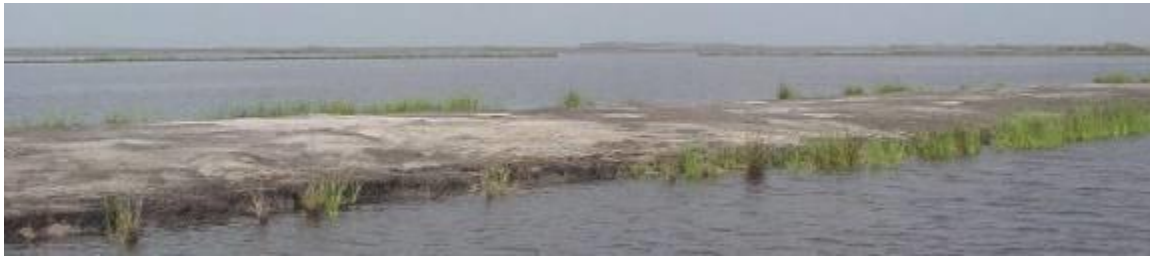
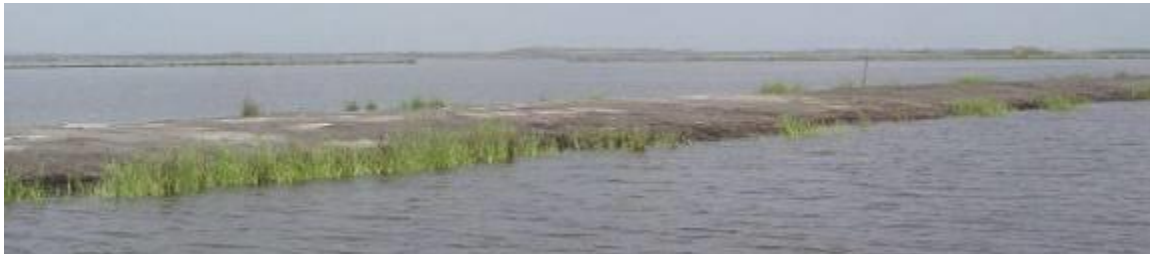
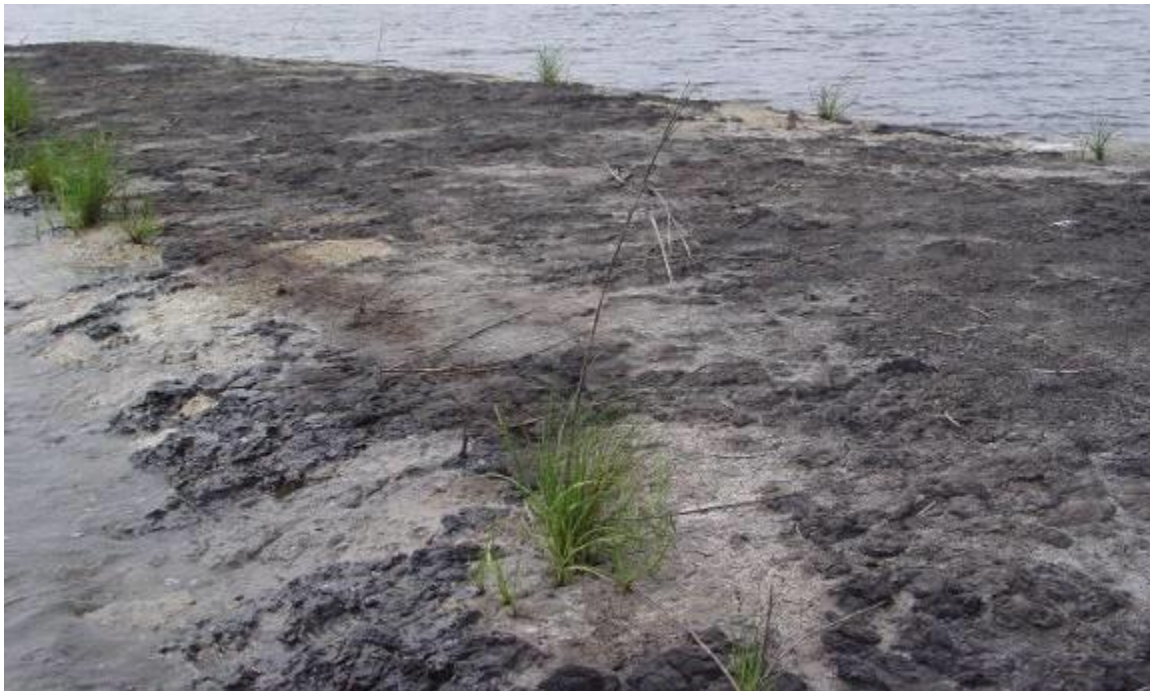
However, moving northward, we found that as age of the plantings decreased, mortality increased, until the plantings no longer formed a continuous vegetative hedge at the toe of the terrace segments. On the newest terrace segments, remaining plants formed very sparsely

distributed live clumps, or single plants with a couple of stems each. There was no longer difficulty in calculating the plant mortality.

Plant mortality was estimated for each row of constructed terrace segments, and ranged from zero to 92%. All mortality was found to have occurred within the plantings on terrace rows 6 through 15. The plantings on rows 16 through 25 had 100% survival and were producing new growth. Based on the known constructed lengths of each terrace segment within the rows, the total linear footage of terrace edge that will require replanting was calculated by row and totals 103,022 linear feet. To replace the destroyed plantings on the 2.5 foot center spacing, per the contract specifications, will require 41,209 plants. To allow for changes in field conditions, a three percent allowance should be added for a total of 42,500 plants to be replaced. The original government cost estimate for the contract planting component was approximately three dollars per plant installed plus mobilization and demobilization. Based on recent successful bids for post-hurricane vegetative planting contracts, increases in local labor and fuel costs, and damages reported by Louisiana wetland plant nurseries, the government cost estimate for the replacement planting would be \$3.50 per plant installed for a total of \$148,750 plus mobilization and demobilization.

It is recommended that the destroyed plantings be replaced as soon as possible, in order to achieve the necessary stabilizing vegetative cover on the exposed tops and edges of the earthen terraces, particularly now that the start of hurricane season is days away. Please contact me and the LDNR and USFWS project and O&M managers to discuss how, and how soon, this can be accomplished.

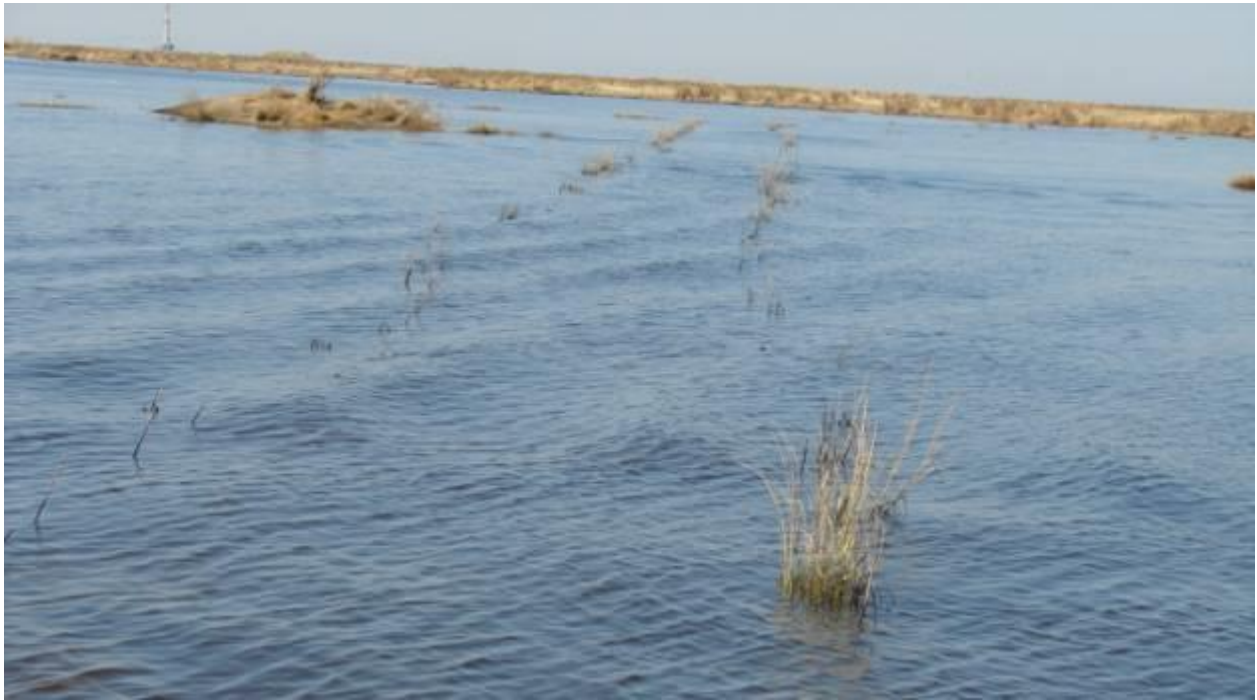
The Sabine Lake area lies within the swath of Louisiana-Texas coastal area most severely impacted by Hurricane Ike (Figure 3). The project area was inundated by the storm surge that exceeded 10 feet, and then remained submerged under unusually high water levels for over a month following landfall (Figures 4 and 5). In addition, elevated salinities well above normal have persisted in the project area to date. Vermilion' smooth cordgrass is very flood and salt tolerant, and naturally occurs in the intertidal zones (approx. between mean high and mean low water) of brackish and saline wetland habitats. Nevertheless, a significant abrupt increase in salinity and prolonged elevation of water levels can severely impact smooth cordgrass plants, causing die-back of plant portions or complete mortality. The specific effects of any particular event are influenced by the degree and duration of the increase in water and soil salinity, depth and duration of flooding, temperature, season, and condition of the plants (for example, recently transplanted vs. established).

Figure 4. Project terraces remained flooded one month following Hurricane Ike landfall.
