**State of Louisiana
Coastal Protection and Restoration Authority**

2015 Operations, Maintenance, and Monitoring Report

East Sabine Lake Hydrologic Restoration (CS-32)

State Project Number CS-32
Priority Project List 10

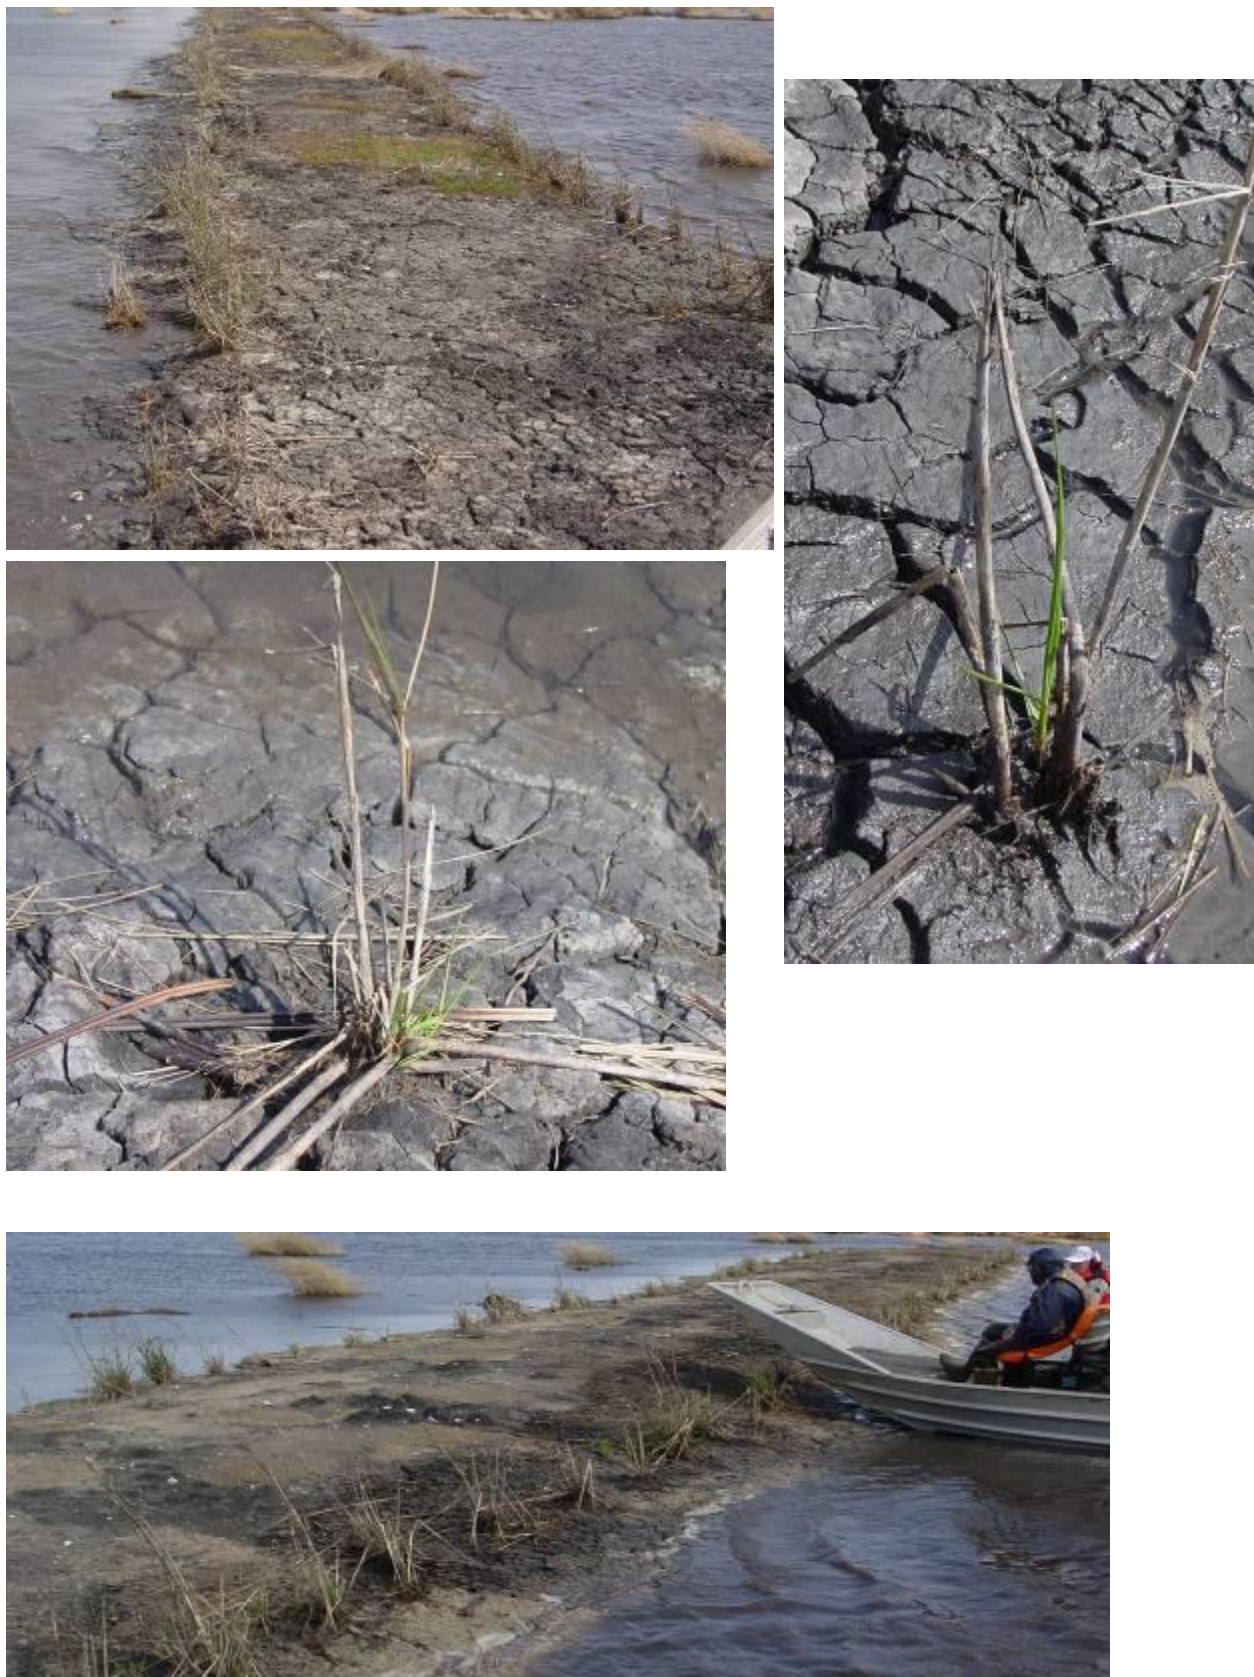
Findings: To determine the extent of storm damage to the project area, the investigating team of above attendees traveled to the project site on February 26, 2009 to assay the condition of the terraces and plantings. While traveling to the project area from the Cameron-Meadows boat launch, significant damage was observed to the Sabine area marshes in the form of extensive, browning, breakup and reconfiguration of emergent areas. Salinities within the project area on that date ranged from 13 ppt to 15 ppt from south to north respectively. The condition of the newest CU-1A plantings was similar to that of the CU-1 plantings following hurricane Rita (see April 3, 2006 Trip Report, Subject: *CS-32 Post Hurricane Plant Damage Assessment of Terrace Vegetation*), but the overall mortality rate of the CU-1A plantings appeared to be more severe. All of the adjacent natural herbaceous marsh and all contract plantings that remained had been completely browned. Many contract plants were missing or appeared dead. The bases of some of the plants that were believed dead were black and rotten-looking and the root material did not appear to be viable (Figure 6). For many of the other contract plants that remained, a few stems of very new, tender growth were observed just emerging from the base (Figure 7).

Figure 7. Composite of typical examples of surviving plants.

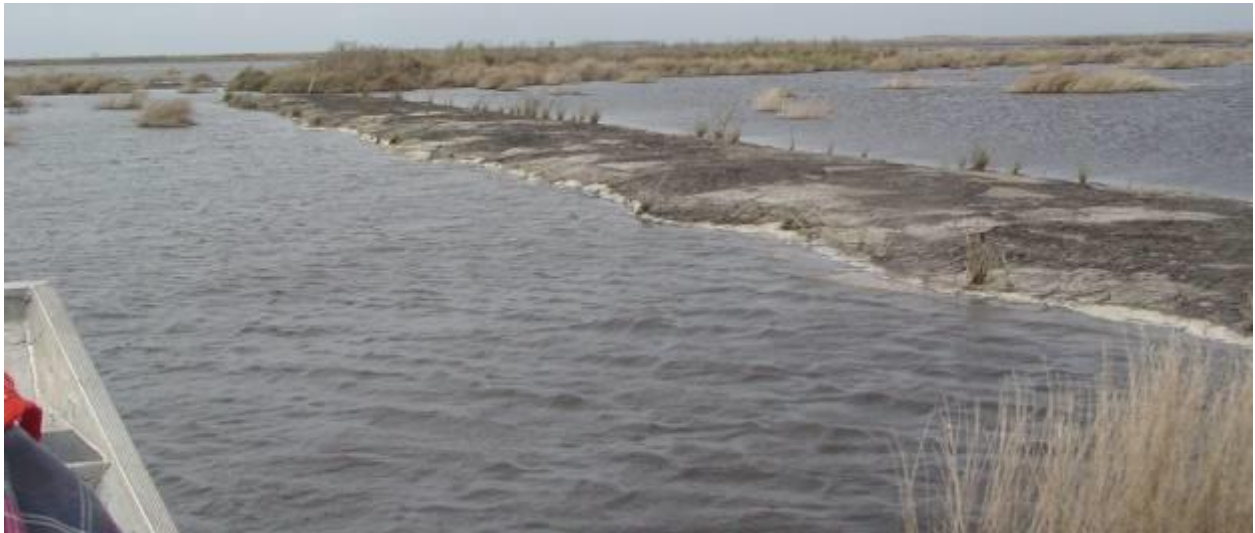
Plant mortality and loss appeared to generally follow three patterns: One, over all rows, mortality or loss was the greatest on those terrace segments that were exposed to open water with longer fetch lengths, especially to the south (i.e., Row 10) (Figure 8). Plantings seemed to fare better when there was at least some emergent marsh adjacent to the terrace segment, even when the marsh consisted of very small fragments (Figure 9). Two, within each row, plantings on the north sides of the rows/segments fared better than on the south sides (Figure 10). Three, over all rows, mortality appears to increase as the age of the plantings decrease (Figure 11).

Figure 8. Greater mortality and loss seen where exposed to open water with longer fetch.

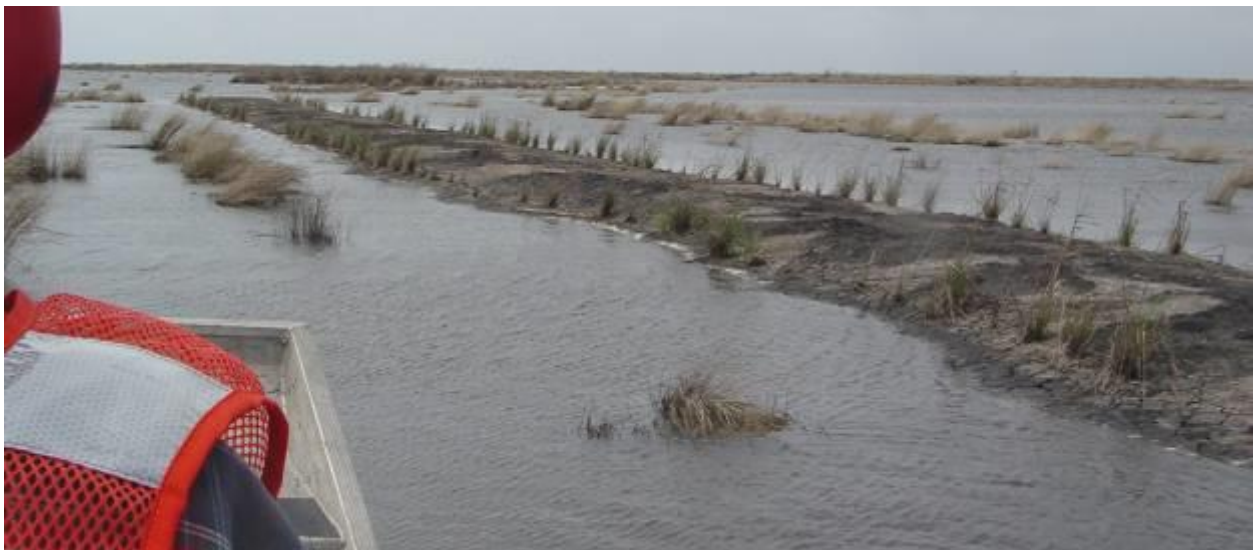
Figure 9. Survival tended to be greater on terrace segments where there was some adjacent fragmented marsh.

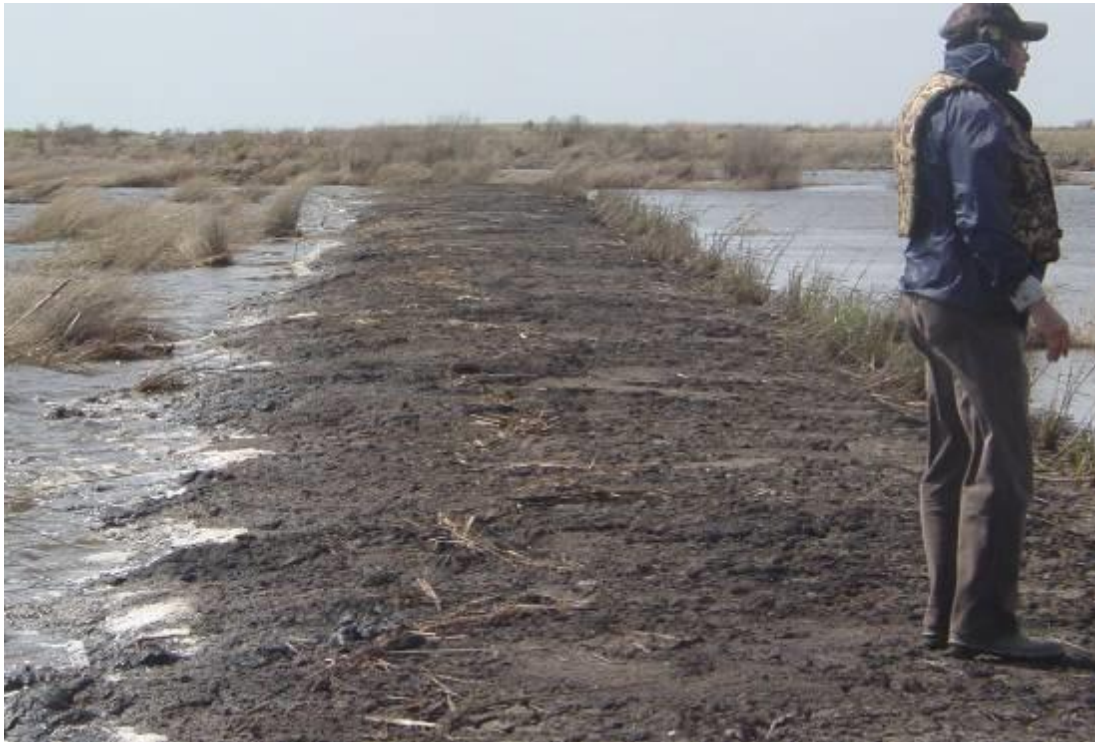
Figure 10. Comparison of mortality and loss on a terrace segment's south (left) side vs. the north (right) side.

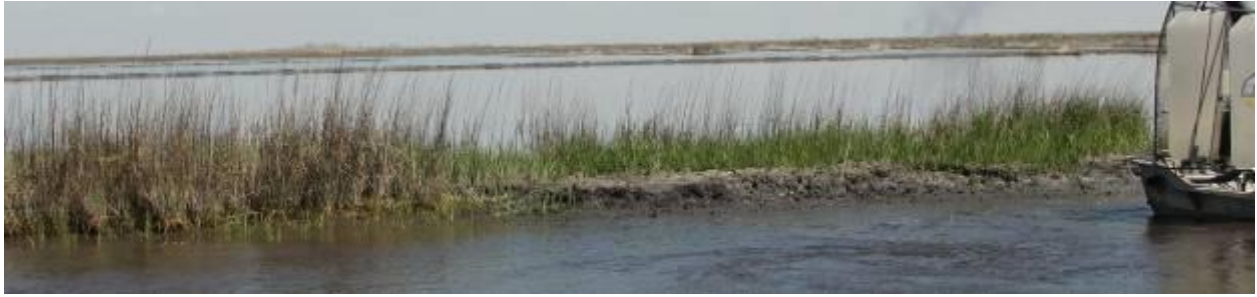
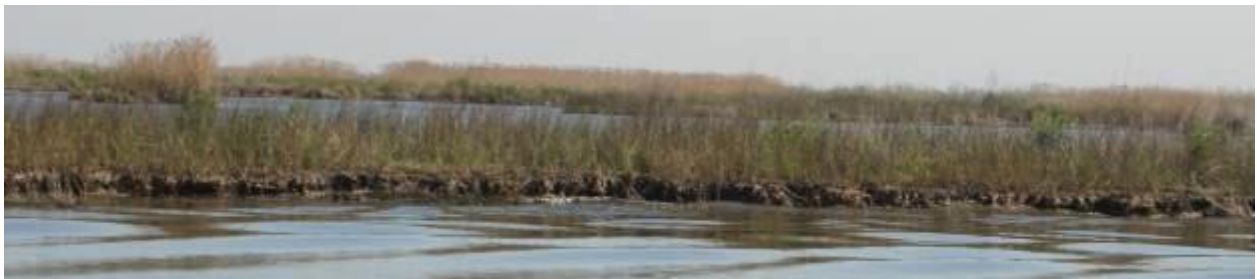
Contrast above with the appearance of the condition of those older plantings in March 2010:

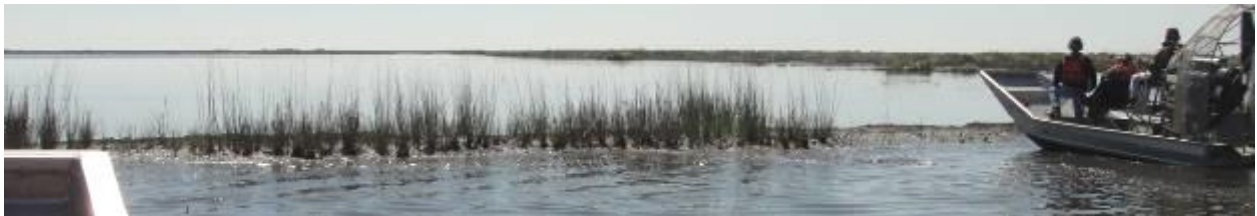
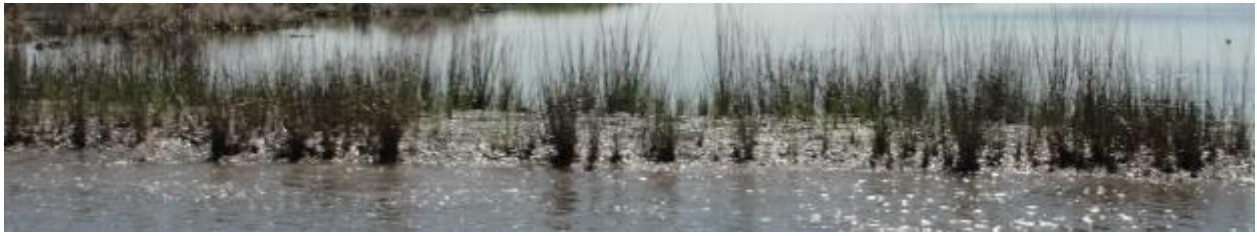
March 2010 condition of terrace segments with combination of older and recent plantings:

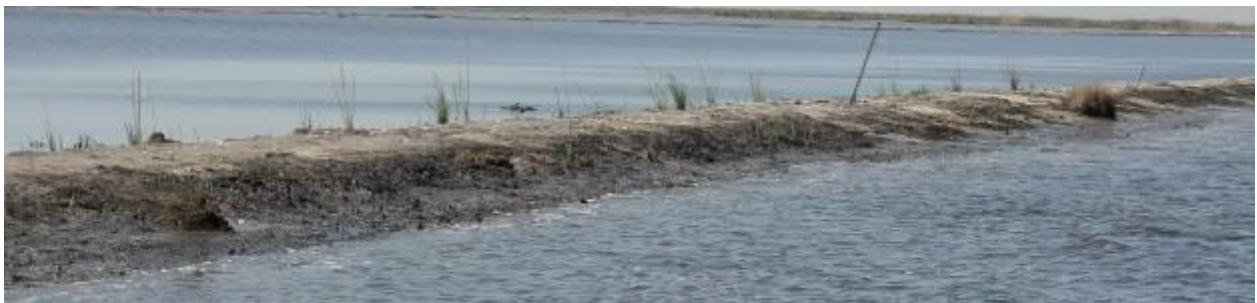
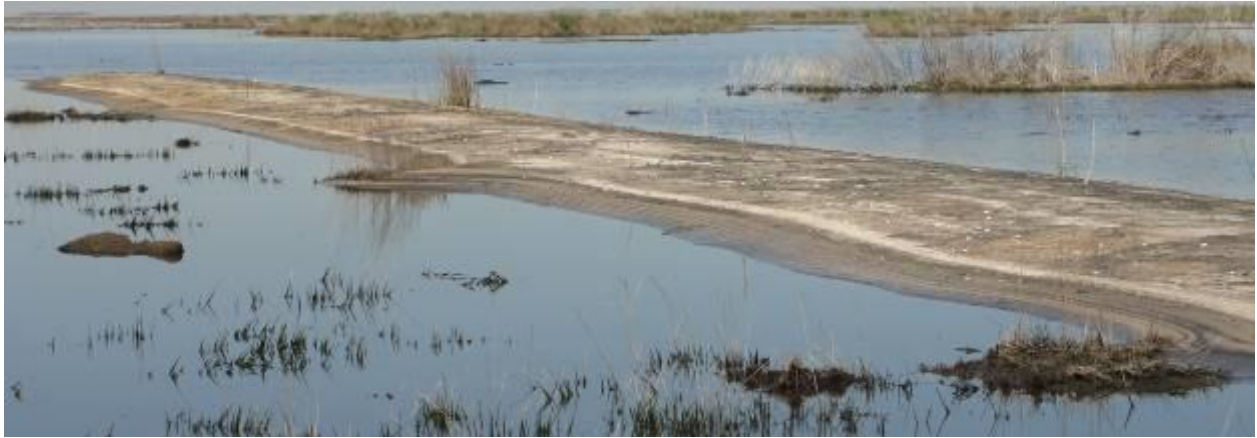
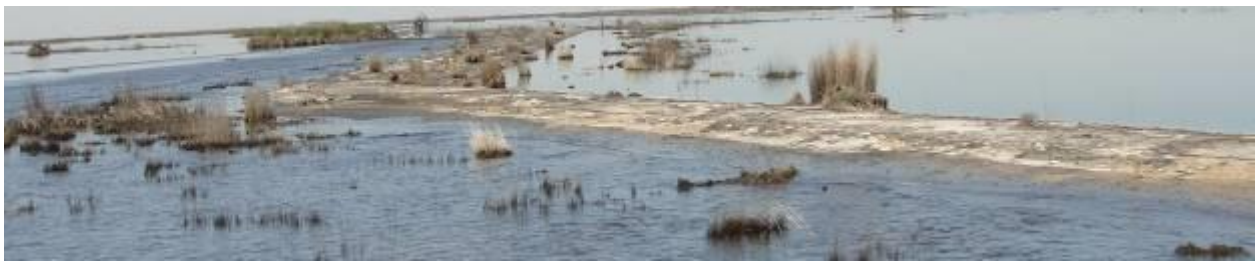
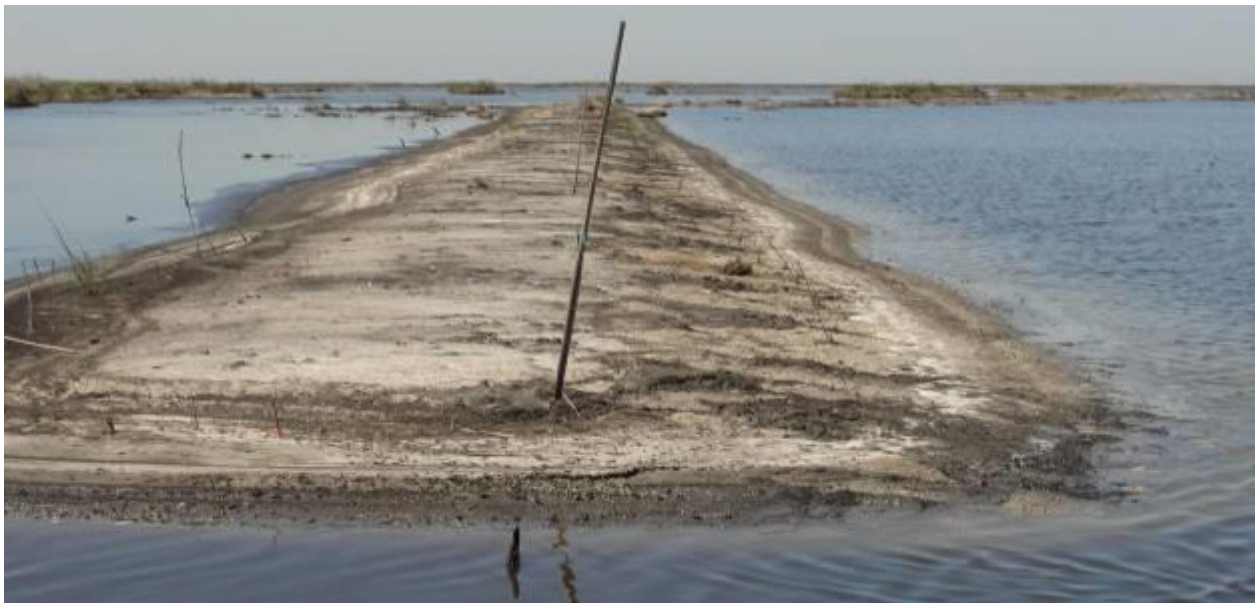
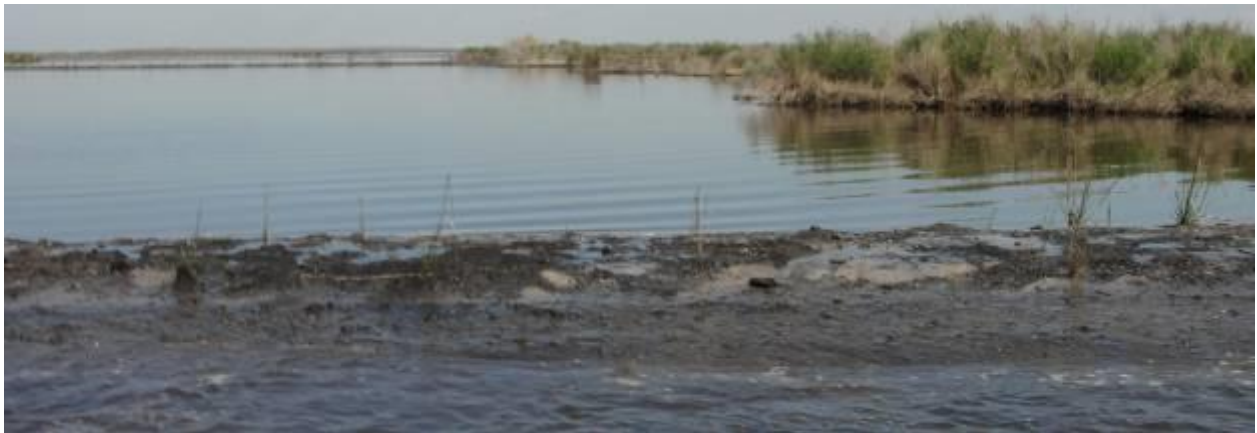
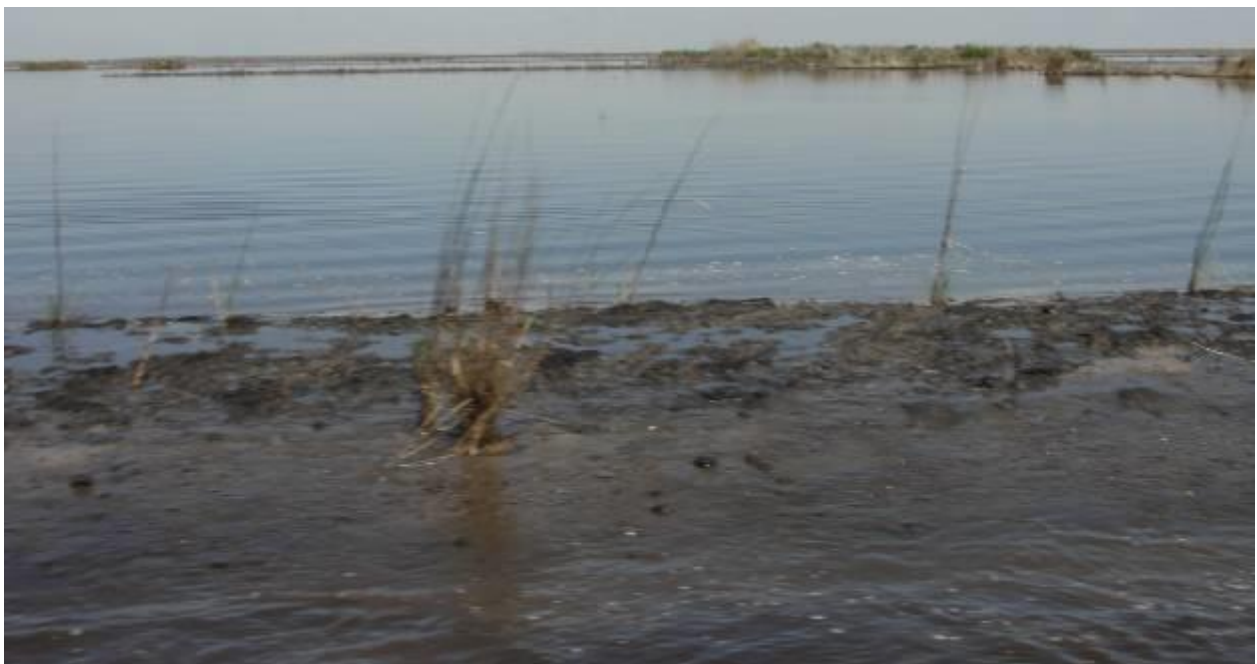
March 2010 condition of newest plantings:

For the newest CU-1B plantings, it is not likely that the source of the plants is a factor contributing to their current state, as the contract plants came from two different nurseries, one in Cameron Parish and one in Lafourche Parish, and all of the remaining plants from the other CU's generally appeared to be in the same condition on the date of this field trip.

Although mainly conjecture, weather could have played a causative role in the overall plant condition we observed. Installation of the CU-1B plantings was completed in July 2009 which turned out to be less than an ideal time for bare-root plant establishment. Following the extreme and prolonged saltwater inundation from hurricane Ike surge in September 2008, southwest LA experienced severe drought conditions in the first half of 2009, with a precipitation deficit persisting until October. In addition, discreet and continuous measurements during the summer revealed that salinities in the project area were significantly higher than normal - greater than 12ppt, and with water temperatures remaining around 85°F until September (CRMS). This may have led to stagnant or phytotoxic soil conditions until precipitation levels returned to normal in October, but by that time it was already at the end of the growing season when plants are beginning to senesce. This period was then followed by an unusually cold winter pattern that began in late November and persisted throughout south Louisiana. Minimum temperatures frequently dropped into the 30's or below for at least half of Jan and Feb 2010 dates (NWS monthly summaries for the Lake Charles/Port Arthur area). It is possible that the newest plantings experienced higher mortality or dieback of aboveground tissue from the combination of elevated stress during initial acclimation and then additional impact by the ensuing cold temperatures to any new shoot growth that did occur. Further, following a typical winter season, robust new growth is not usually seen in smooth cordgrass until March when warmer spring temperatures become entrenched. So it is also possible that this year's new growth expected for all plants in the area may still be absent because it's been retarded by the persistent winter weather pattern and the late freeze in early March.

Because of the high uncertainty at this date of what below-ground tissue remains viable, a mortality rate or pattern cannot reasonably be determined for any of the plantings, regardless of age. I recommend returning to the project site in September near the end of this year's growing season when a much more accurate assessment of the extent of plant survival can be made. Collection and analysis of soil samples may also provide additional insight in discerning actual causes of the apparent poor performance of all the plants.

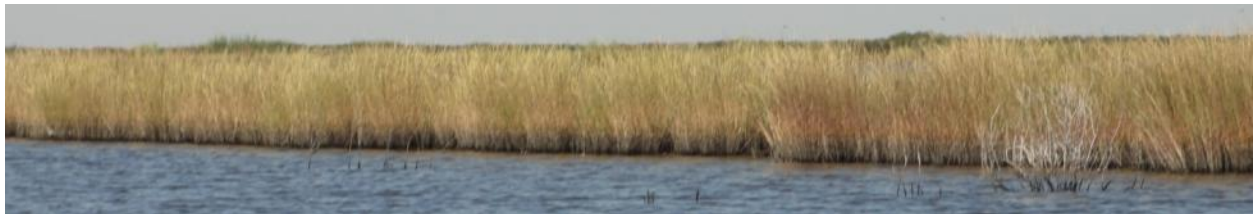
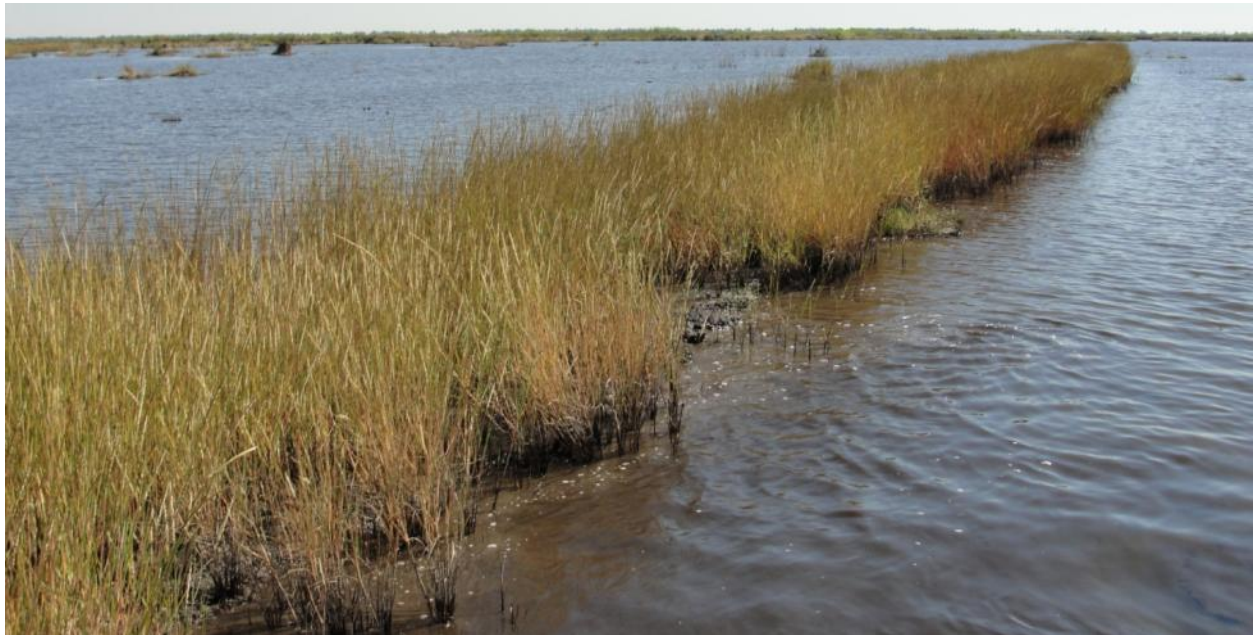
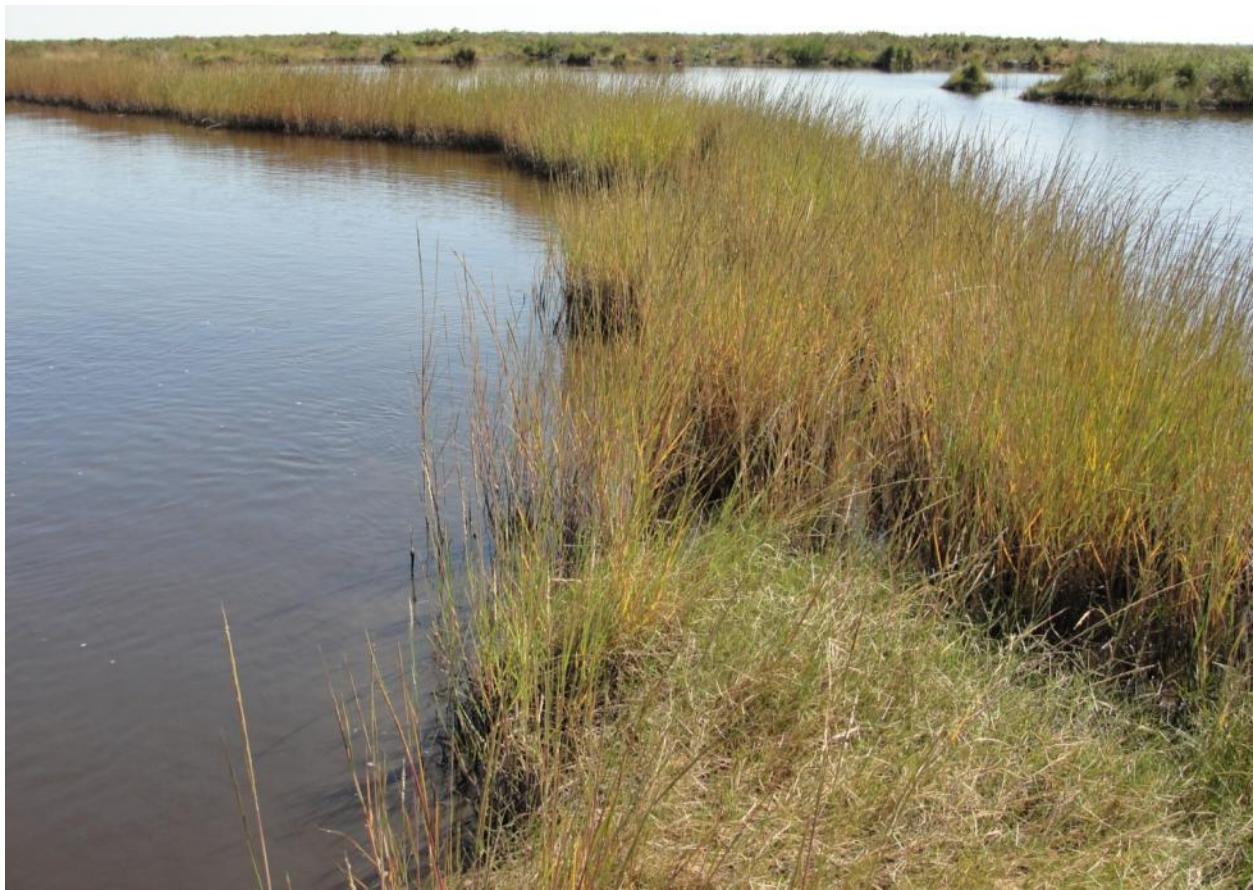
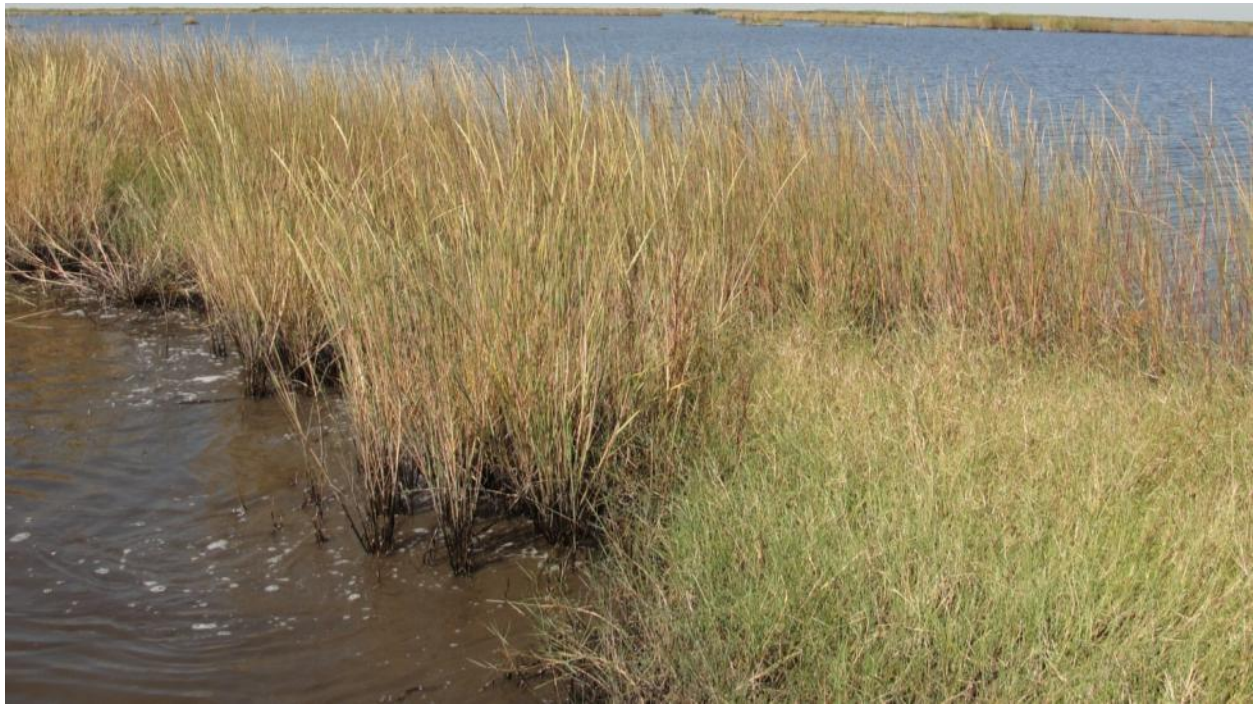
The vegetative growth of smooth cordgrass on the oldest and southeasternmost CU-1 Rows 16 to 25 looked excellent, as did that on newer CU-1A/B Rows 11 to 8, and the coverage was nearly 100%. The few gaps that were occasionally present on a few segments were minor and some gaps were occupied by other species such as seashore paspalum (*Paspalum vaginatum*) where the terrace crown was above the water elevation on this date.

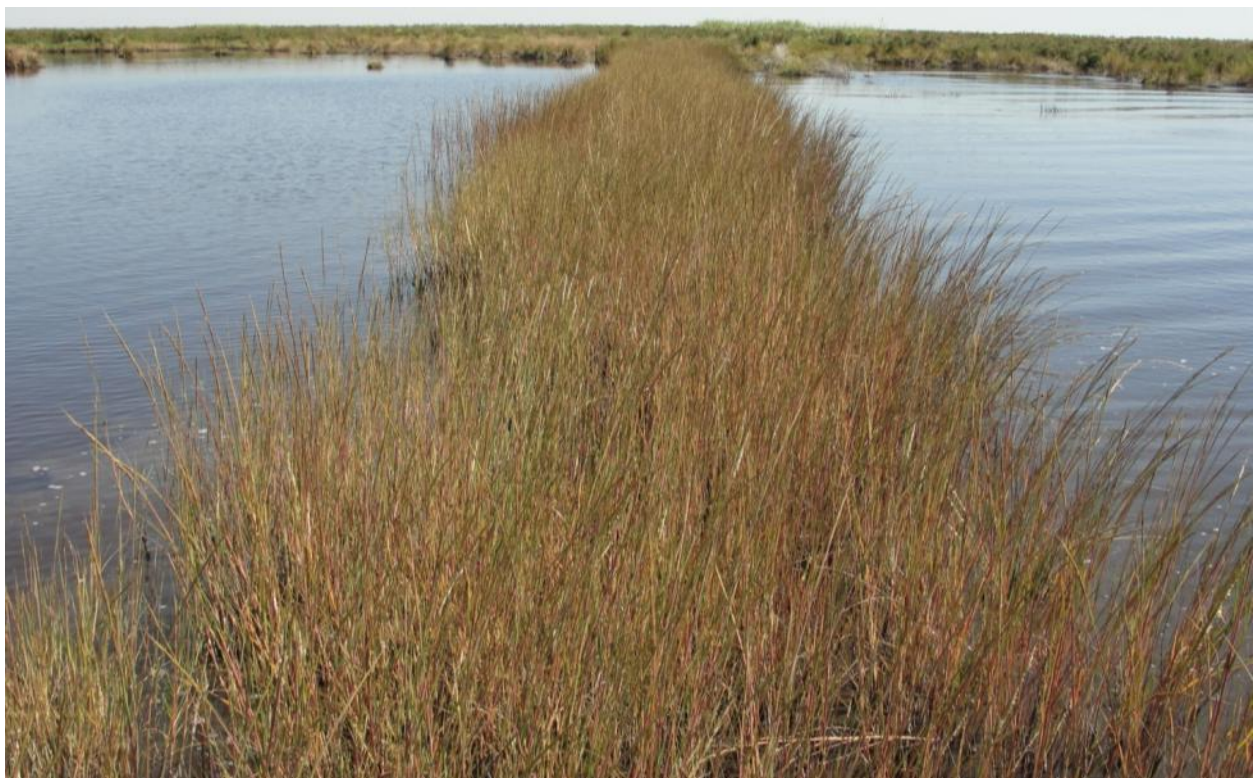
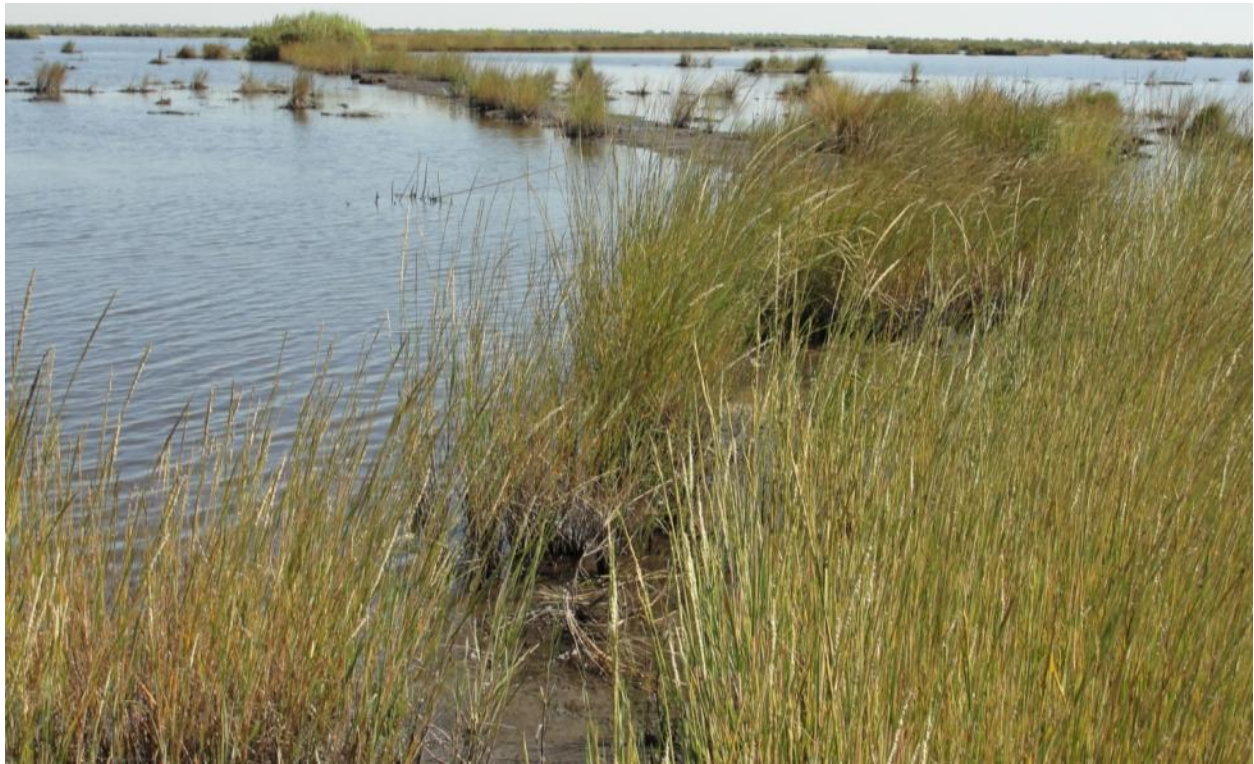
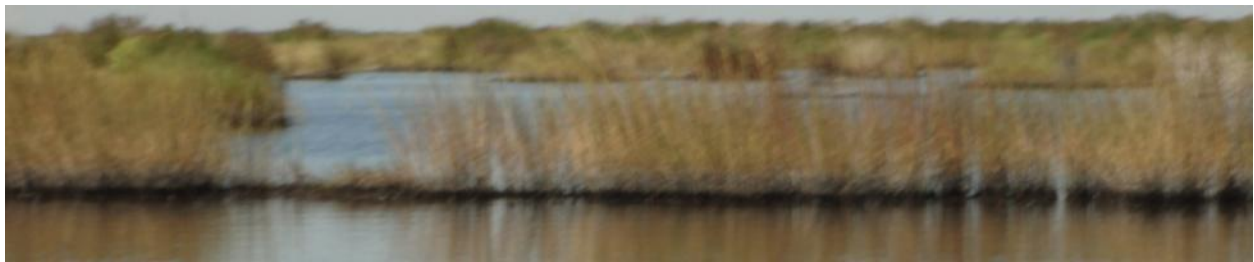
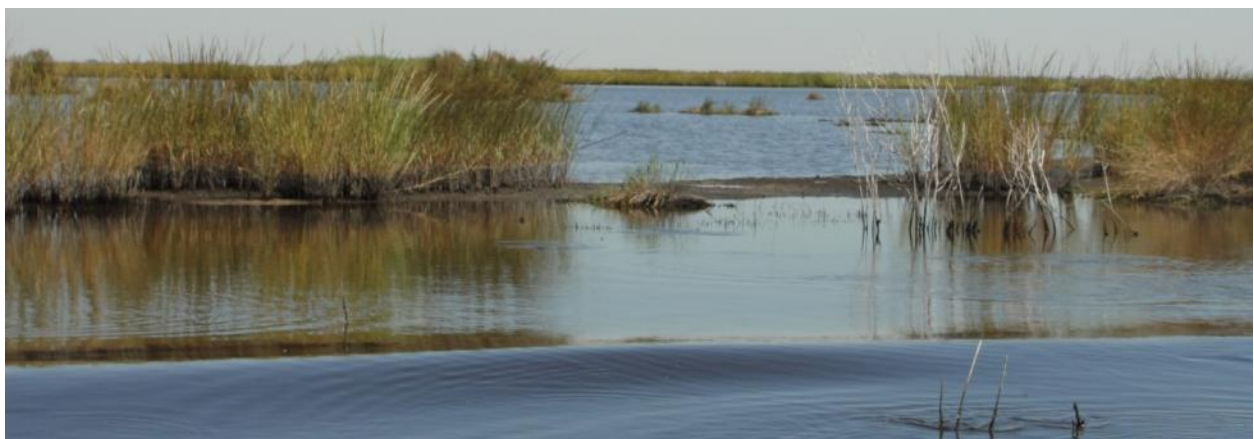
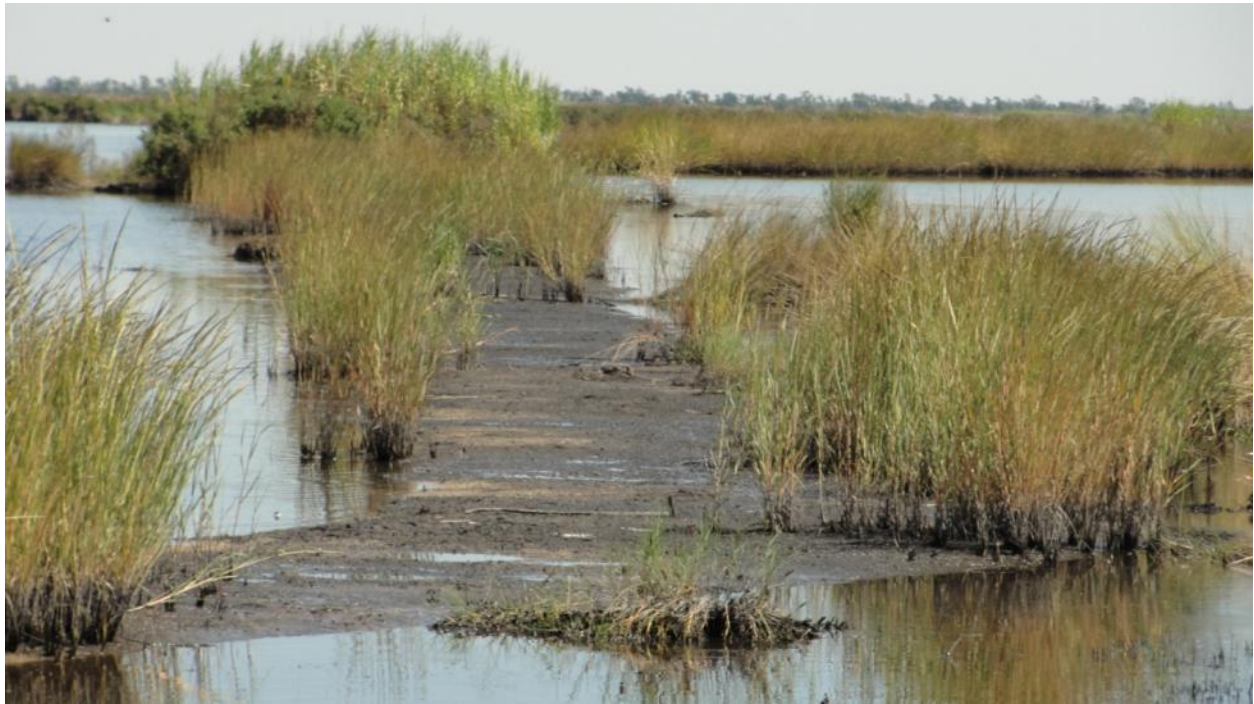
The estimated survival of the newer CU-1A/B plantings was very good in Rows 5 to 11 (greater than 80%), although the size of the gaps were more significant and narrowing of some terrace segments became more noticeable as we neared Row 5.

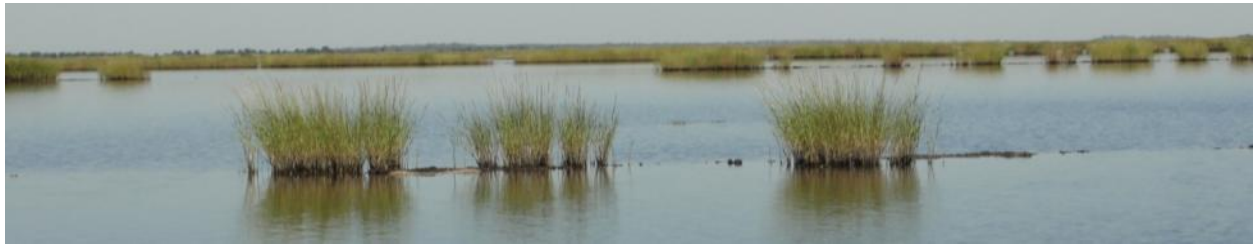
As the party continued north, the survival estimates for the rows dropped dramatically and ranged from fair to poor (5% to 50%) on the CU-1A/B Rows 4 to 2, but the vegetation that did remain appeared to be recovering well and for the most part looked very healthy.

There were a few exceptions however where some plants appeared to be struggling, but those were generally found where the terrace segments were severely impacted and were obviously narrowed with lower crown elevation.

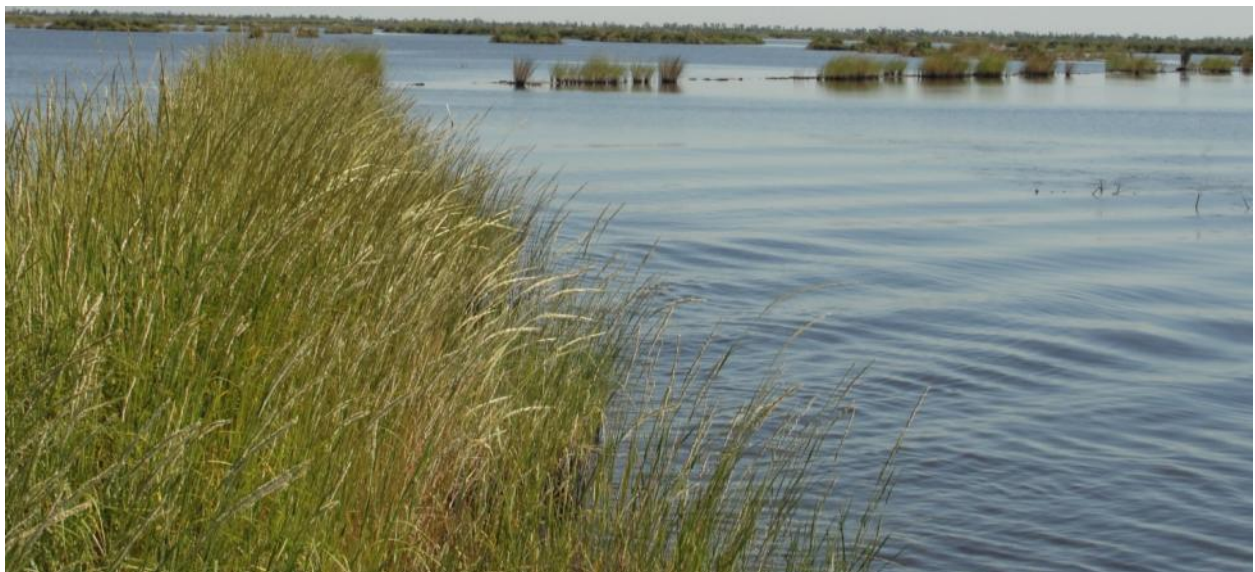
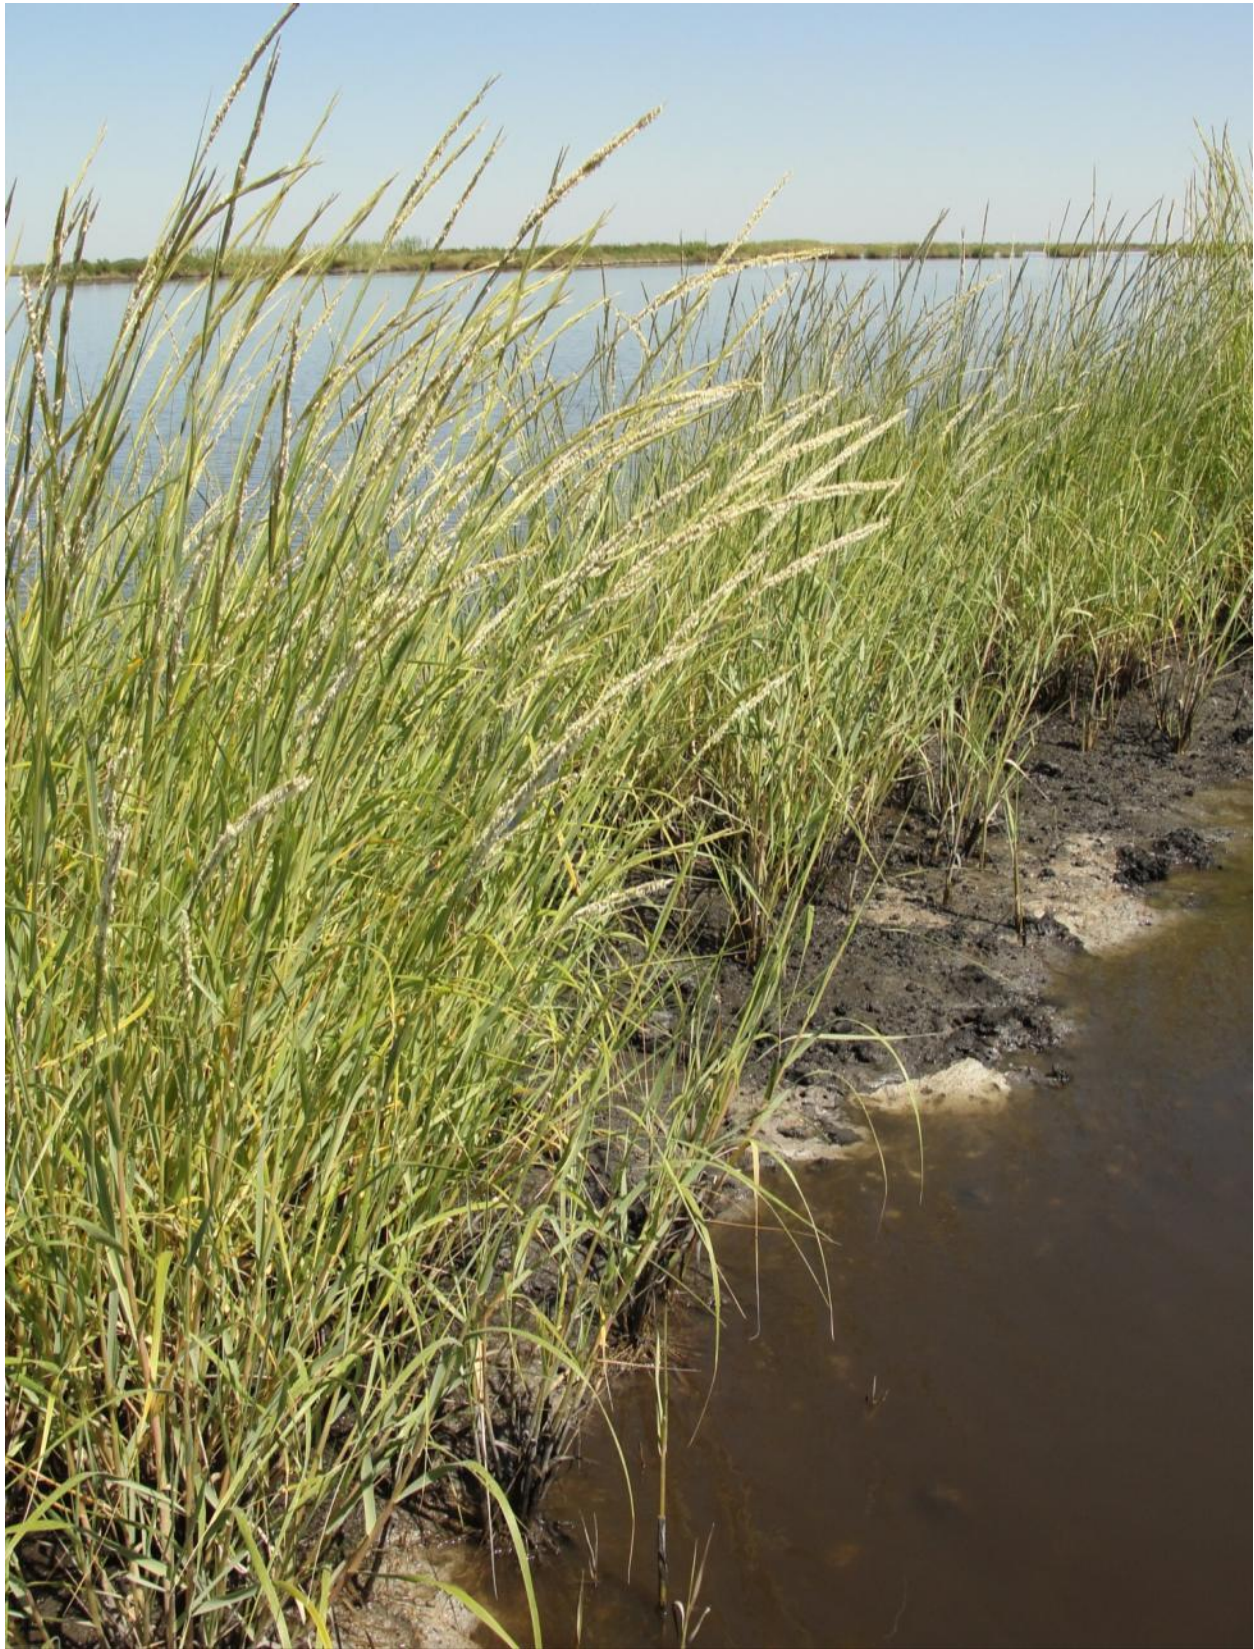
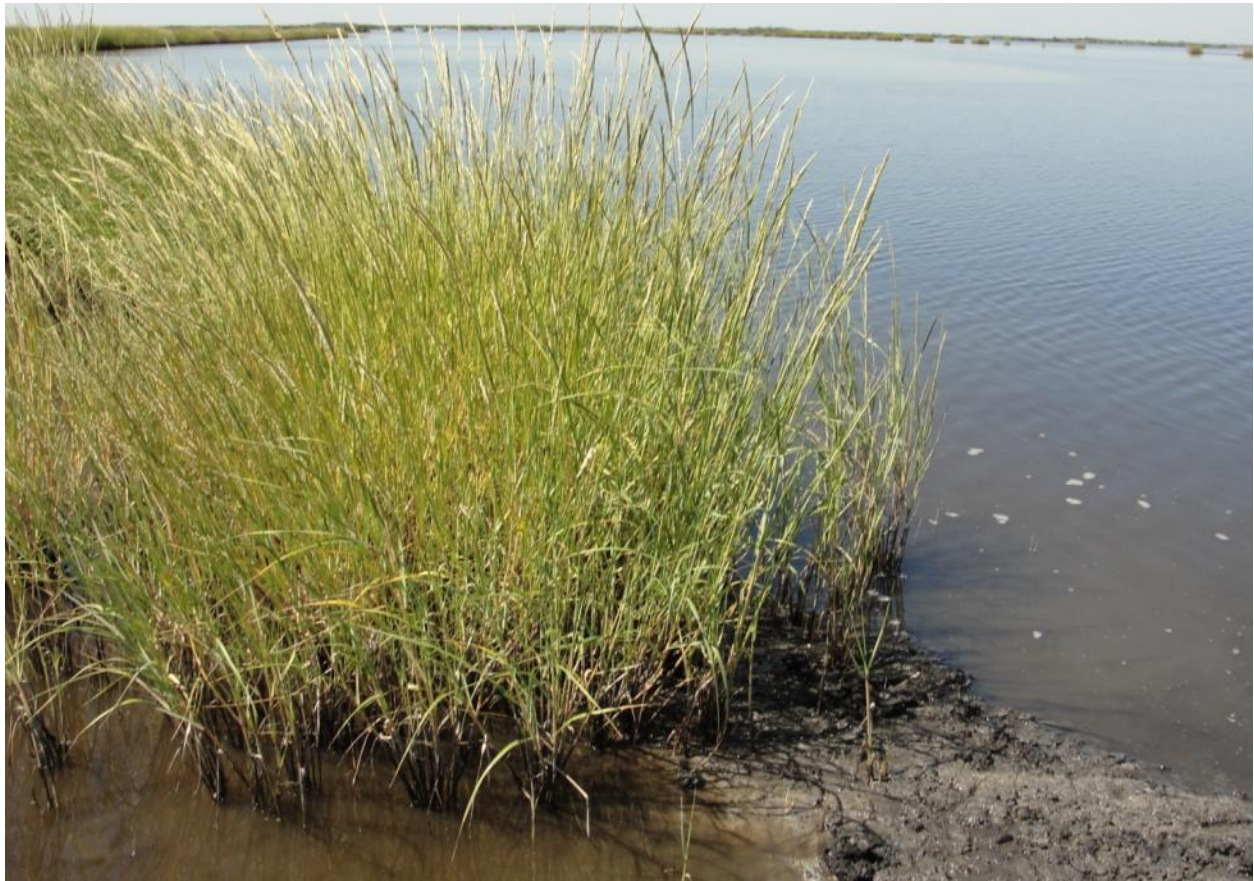
The survival on CU-1A/B Row 1, south of Green's Lake, was about 75%. Here again, the surviving plants looked very healthy and provided nearly 100% cover across the crown in some spots, but there were also other stretches bare of vegetation more than 100 feet long on this row.

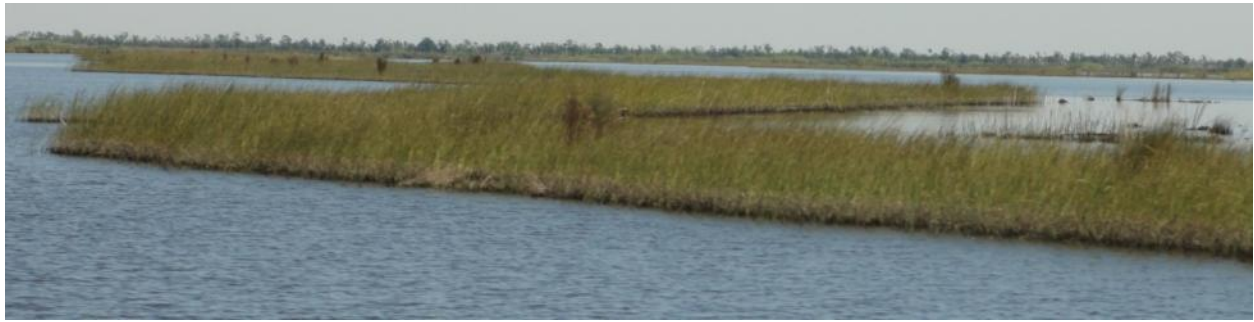
Overall, the southern rows of CU-1 group looked stable though some had obviously narrowed. There were some areas of loss observed, but there was no discernable pattern that might explain the loss, or why the smooth cordgrass was not recovering well on some segments or in spots, but on others, though providing thin cover, the individual plants looked fairly robust.

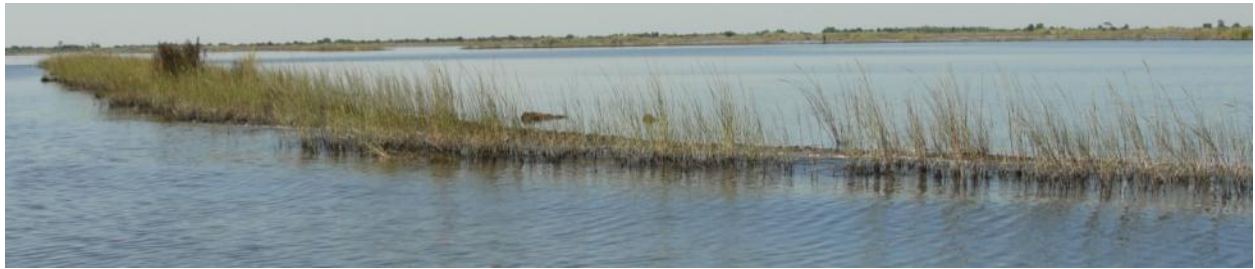
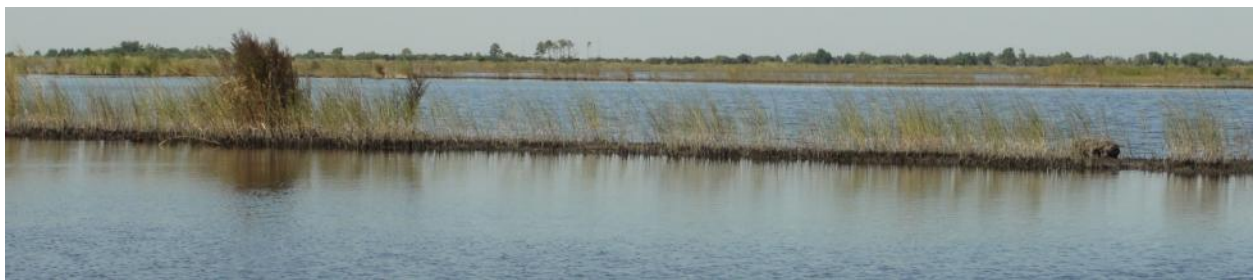
Continuing north, the survival and cover on the CU-1 terraces was found to vary quite a lot. Many terrace segments were much narrower and had poor to no cover, but there were other segments where the cover was good and the terraces retained their width. Overall though, there were only a few sites found where individual smooth cordgrass plants looked as robust as those seen to the south. It almost appeared that some plantings were just beginning to re-emerge and expand the cover.
