**State of Louisiana
Coastal Protection and Restoration Authority**

2015 Operations, Maintenance, and Monitoring Report

East Sabine Lake Hydrologic Restoration (CS-32)

State Project Number CS-32
Priority Project List 10

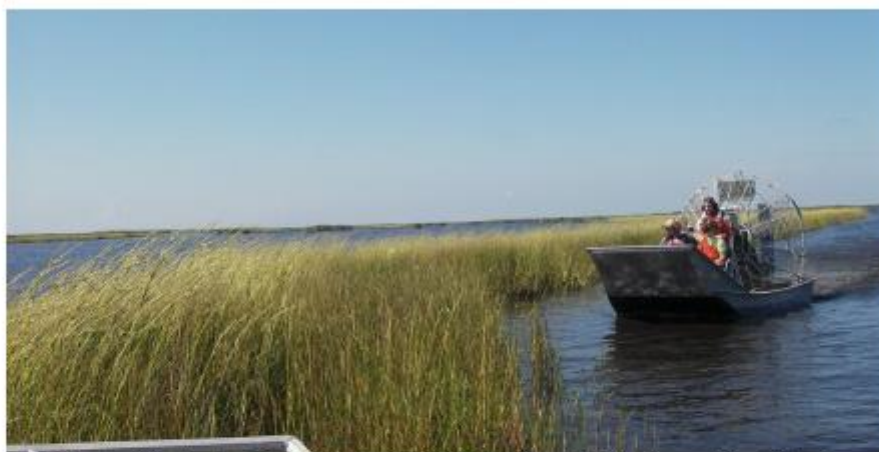
Photo No.1 –Typical Terrace in CU1A - Row 1 (Northern Most Row)

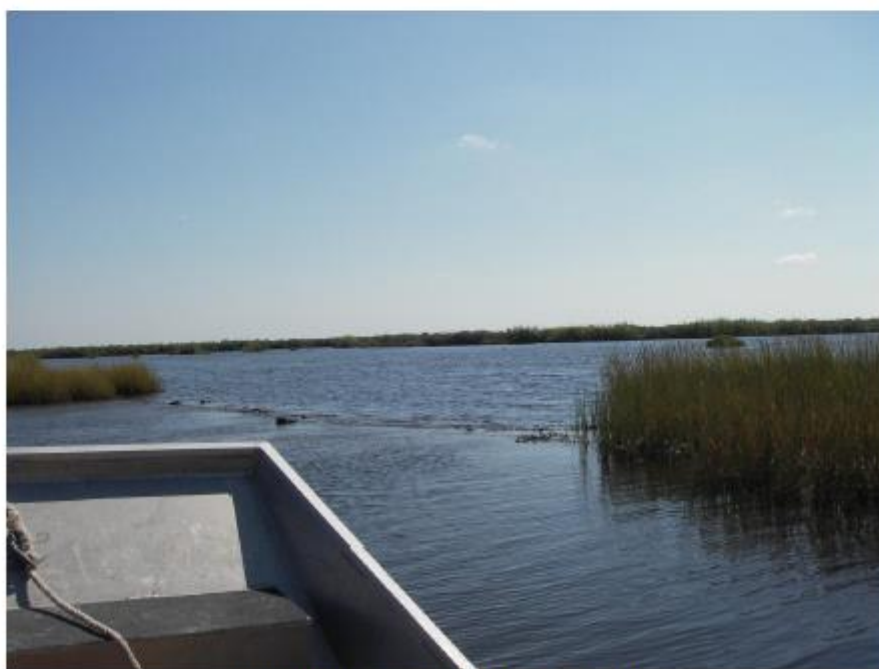
Typically the terraces are in good condition with slight narrowing or settling. On CU1A Rows 1-3 & 5 there were a few gaps where the terraces were bare with good vegetation on either side. (Appendix B: Photo No. 2) CU1A Rows 3, 7, & 8 show signs of narrowing where Row 8 has a cut bank on the south side. (Appendix B: Photo No. 4) There are a couple of segments on the

Photo No. 2 –CU1A Bare Segments

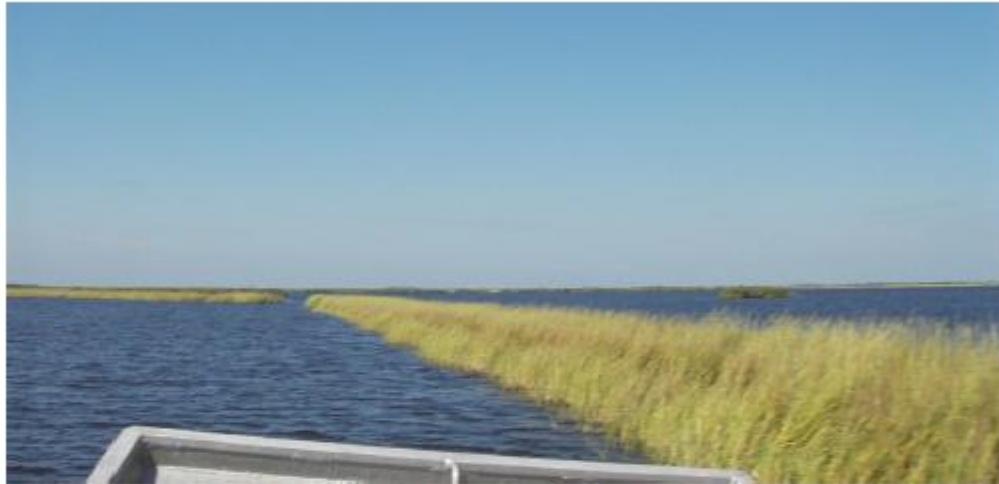
Photo No. 3 - CU1A Rows Slightly Narrowed with Good Vegetation

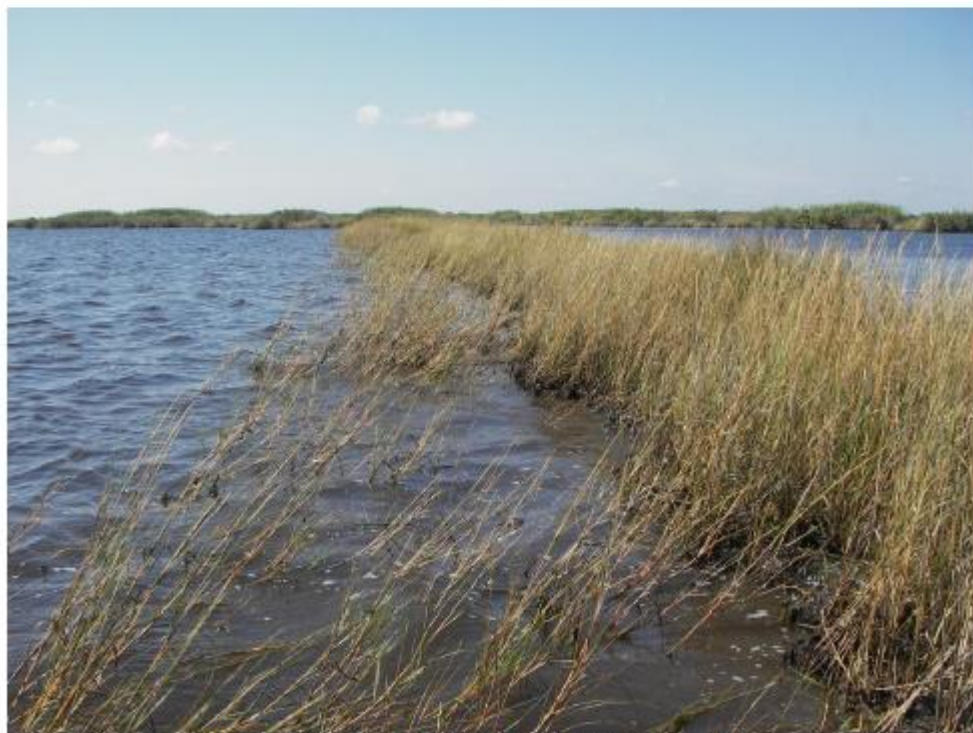
Photo No. 4 - CU1A Row 8 Cut Bank on South Side

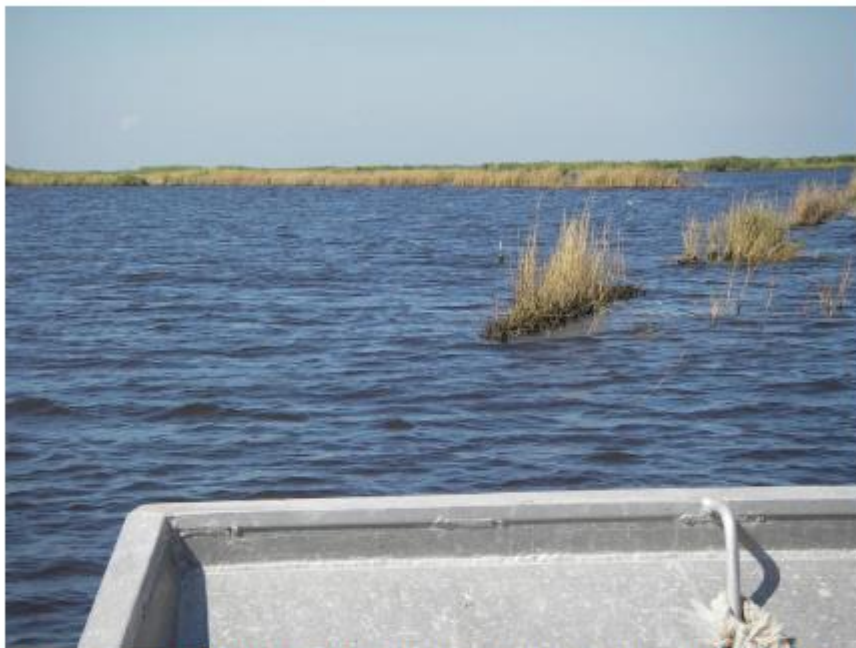
west side of CU1A Row 10 that have been washed away by wave action. (Appendix B: Photo No. 5)

Photo No. 5 - CU1A Row 10 (Southern End of CU1A Terraces – West Side of Row)

Considering lessons learned for future projects, it is recommended that a 300 foot separation between terrace rows is considered to reduce wave action.

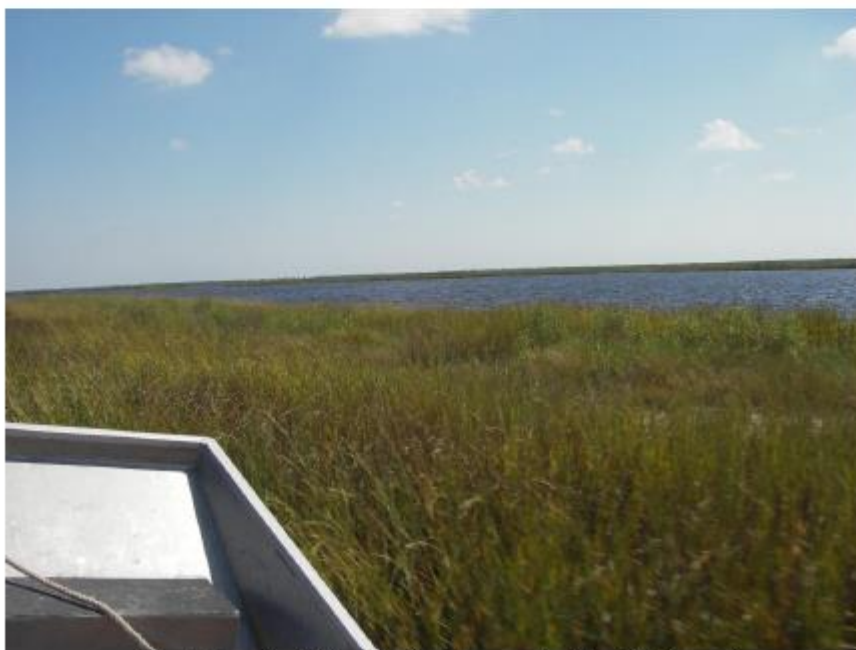
The southern end of CU1 tended to have narrower widths than the northern end of the terrace field. On Row 1B – Row 6, the terrace width and vegetation were in very good condition. (Appendix B: Photos No. 6) Narrowing of the terrace width has occurred on Rows 10, 12, & 13. (Appendix B: Photos No. 7) There were small segments of terraces with bare spots on Row 10 – Row 14A. Some locations were bare with vegetation on either side where as some locations were bare on the terrace crown with vegetation growth expanding outward into the water. (Appendix B: Photos No. 8)

Photo No. 6 - CU1 - Typical Terrace in Row1B-Row 6

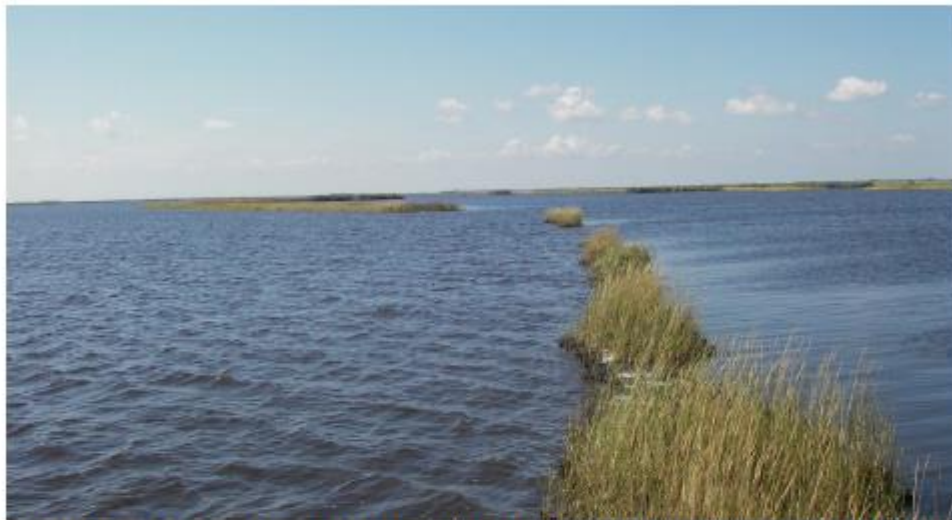
Photo No. 7 - CU1 – Narrowing Terrace Widths - Typical Terrace in Rows 10, 12, & 13

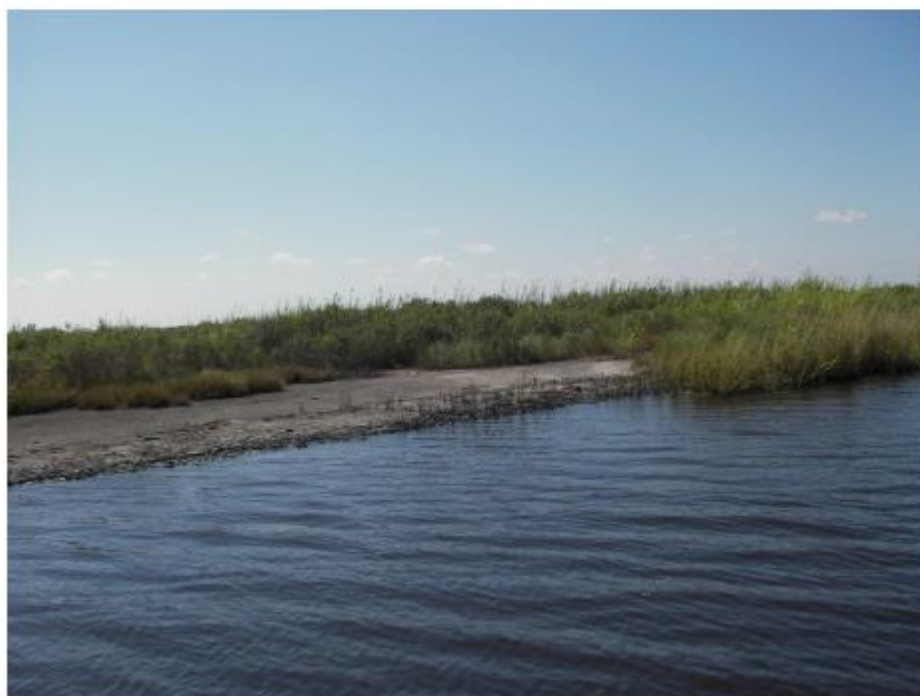
Photo No. 8 - CU1 – Typical Bare Spots in Row 10 - Row14A
