**Coastal Protection and Restoration
Authority (CPRA)**

2023 Operations, Maintenance, and Monitoring Report

Oyster Bayou Marsh Restoration

State Project Number CS-0059
Priority Project List #21

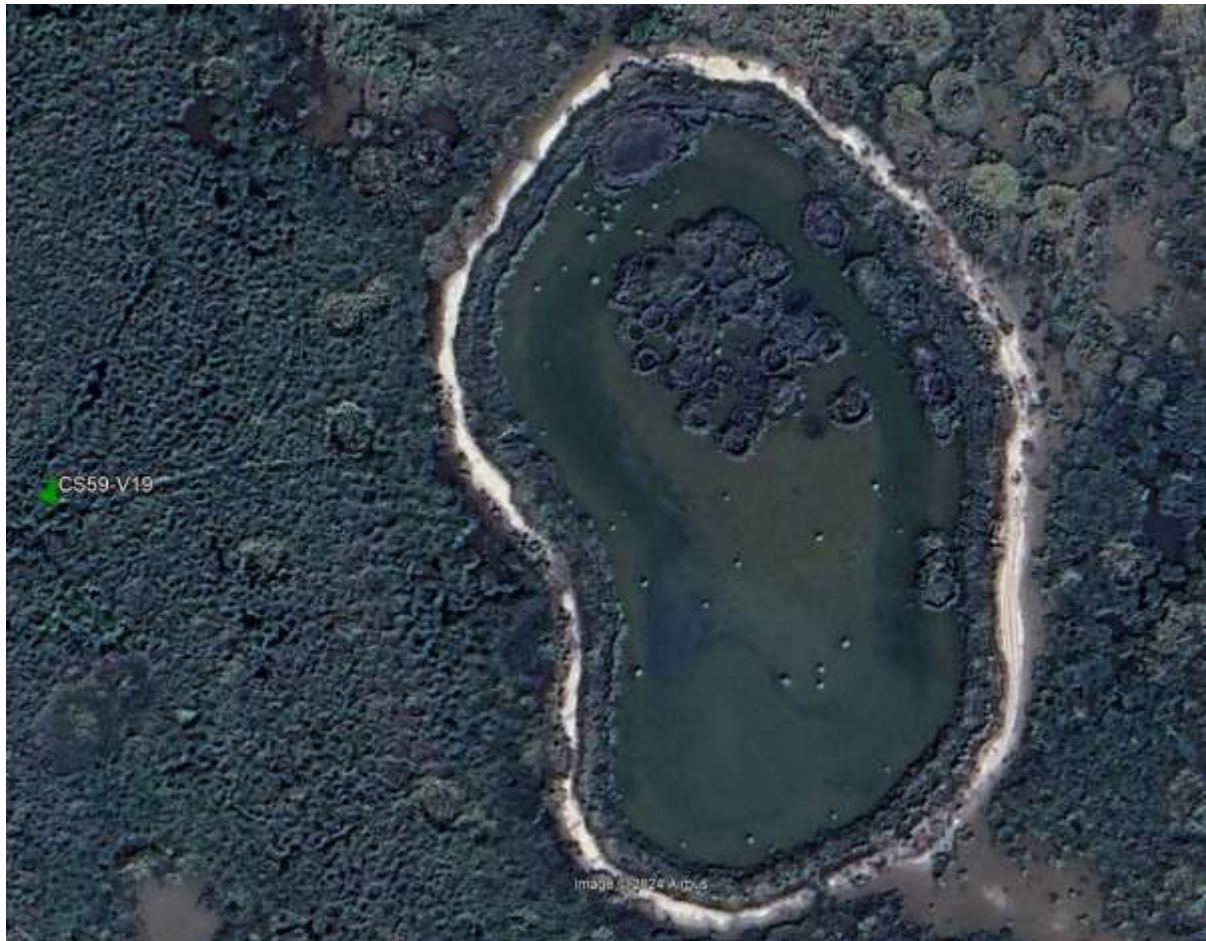
Figure 4A. Oyster Bayou Marsh Restoration (CS-0059) Google Earth imagery from 12/2022 showing a pre-excavated tidal pond in MCA 3, this has been the most successful of the project's three ponds, consistently holding water for wildlife usage.

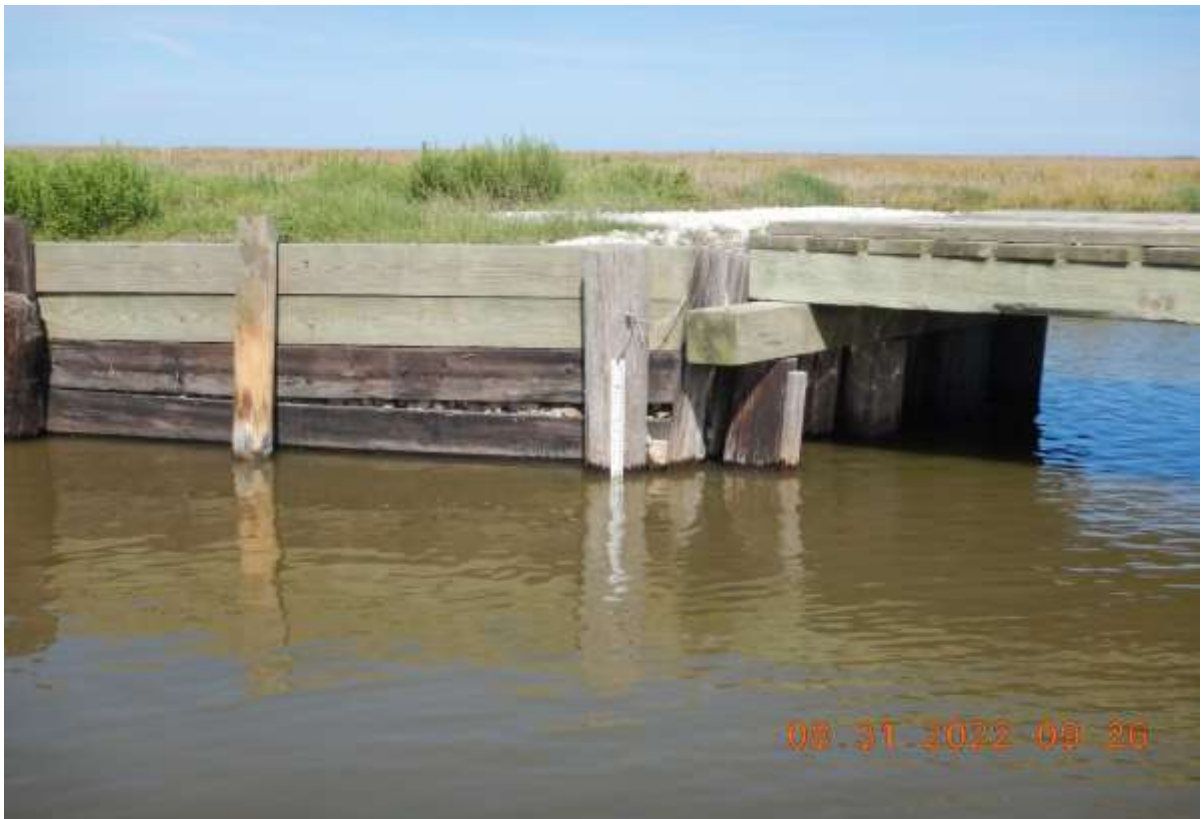
Figure 14. Staff gauge reads 0.95 ft G12A during 2022 data collection site visit; CRMS sites 0655 and 0672 recorded 1.0 ft and 1.04 ft 26 minutes earlier at 9 AM.

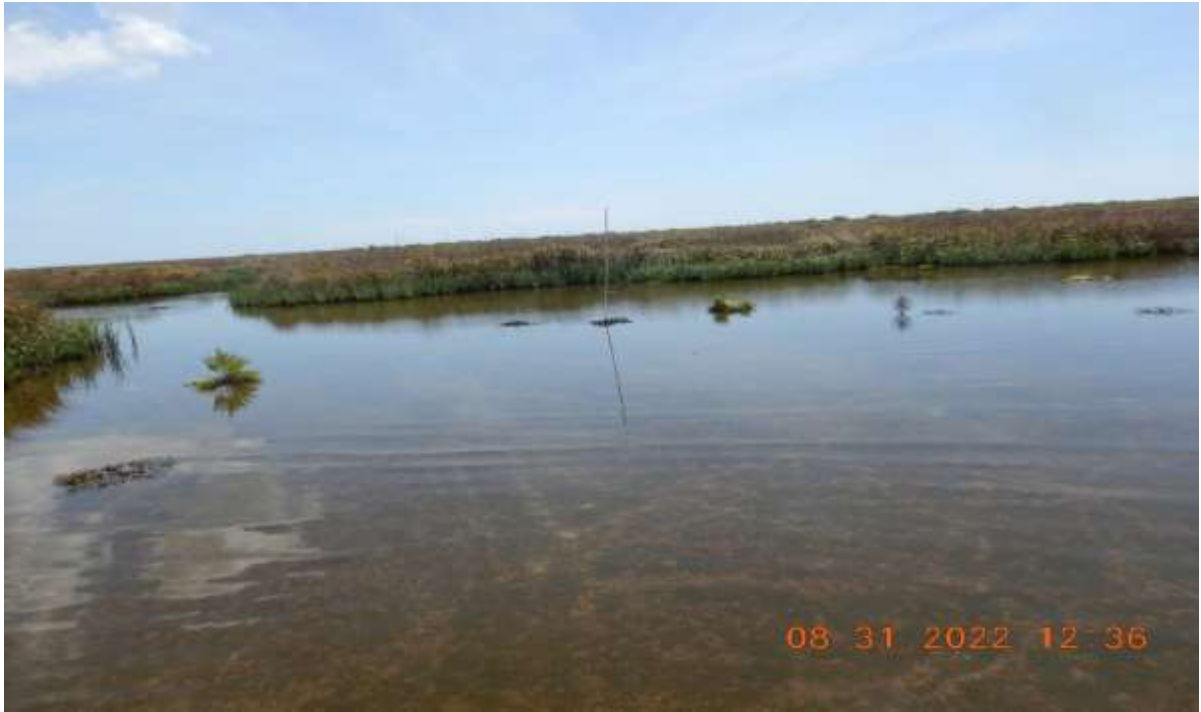
Figure 15. Vegetation monitoring station V14 in MCA2 with a surface elevation of 2.0 ft, which when using hydro data was not flooded at the time of the photo. Showing the local effect of topography, rainfall, and trapped high tides on flooding.

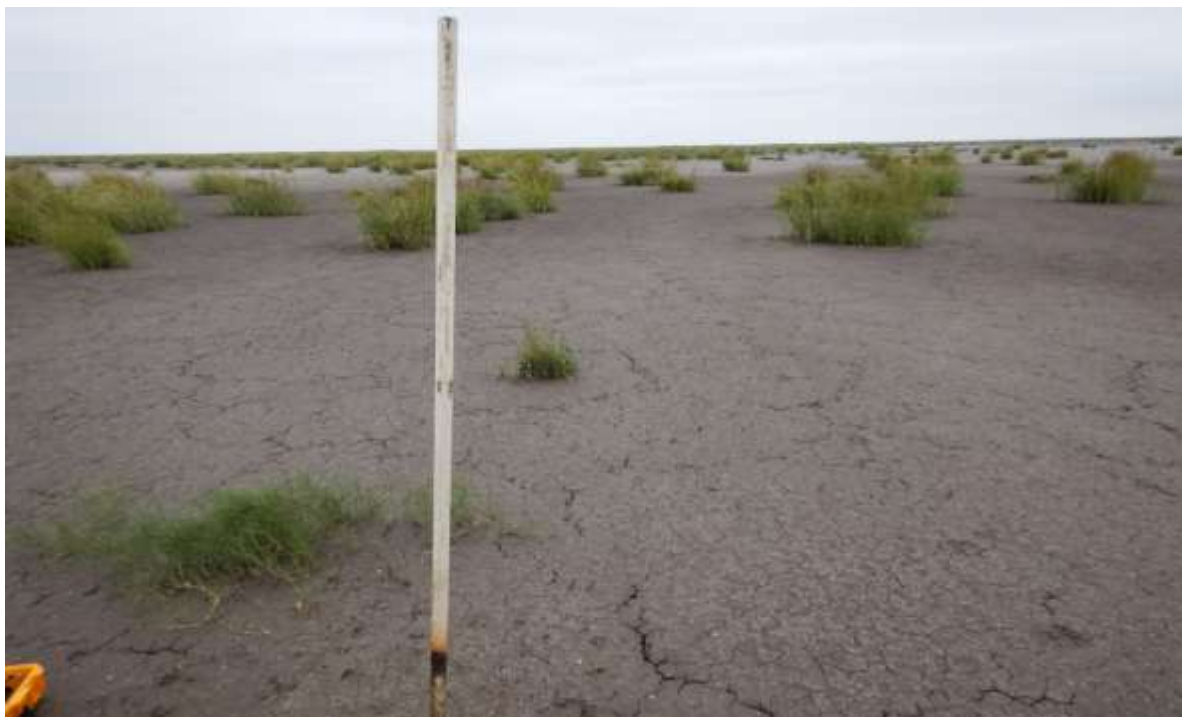
Figure 18. View of vegetation station V08 in MCA 5 on October 2019; the colonization of salt marsh vegetation has begun.

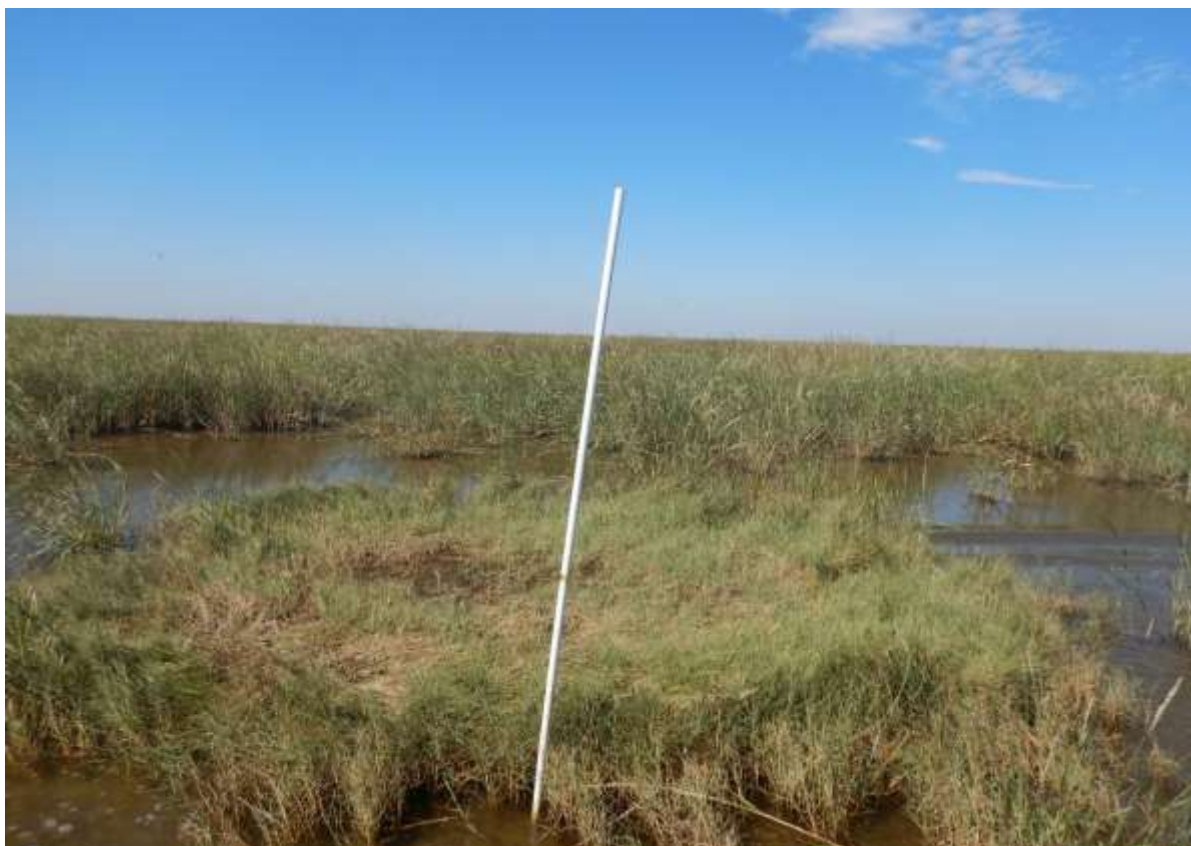
Figure 19. View of vegetation station V08 in MCA 5 on October 2020, with noteworthy vegetation expansion.

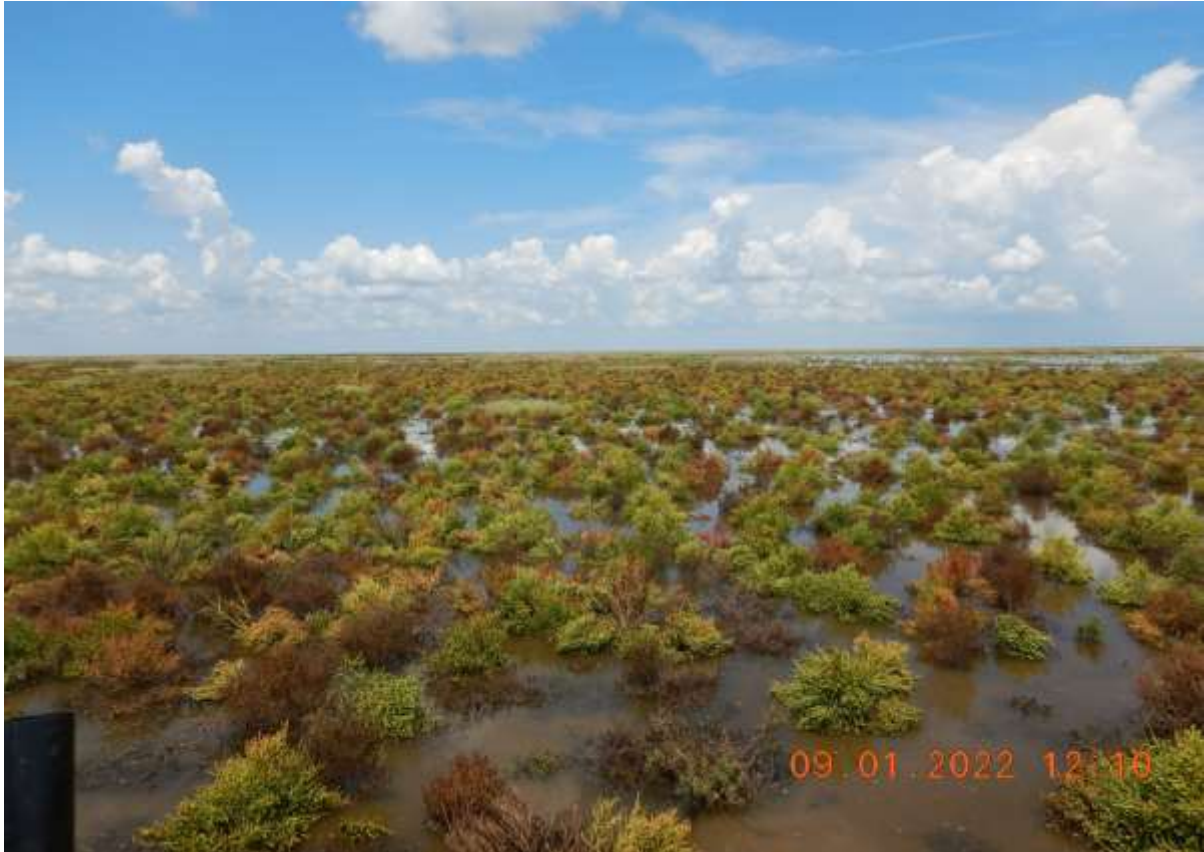
emergent vegetation (Figure 21). The higher elevations are dominated by *Salicornia depressa* and *Borrchia frutescens* that are more adept at managing both saline flooding and drought conditions. These higher areas are generally confined to MCA1 and 5, and have had substantial dieback and recovery following the prolonged flooding from Hurricanes Laura and Delta in 2020 (Figure 22). The vegetative response to project construction is still in its initial phases of colonization and further surveys will determine where the plant community finds equilibrium, but the initial outcome has yielded positive results.

Figure 22. View of some of the highest elevations in the project area between MCA1 and MCA5 dominated by *Salicornia* in September 2022.

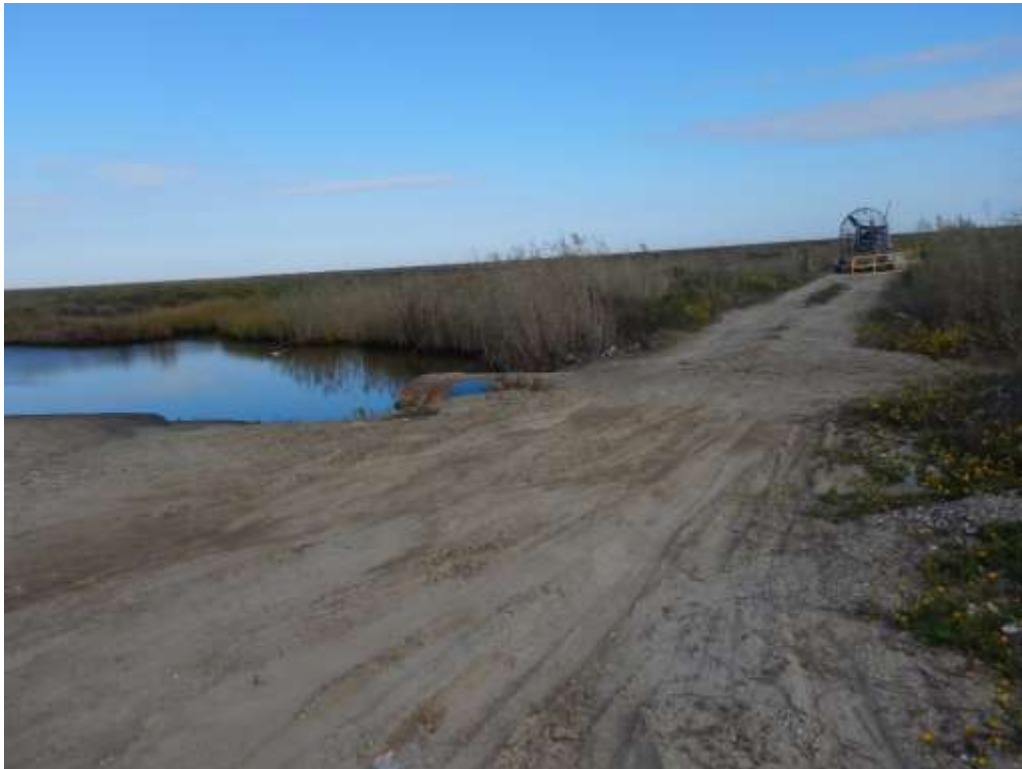
Photo 2: Photo of CS-0059 Project From Southern Extents of Project Site, Team Vehicle and Airboat on Oil Field Road Shown to the Right, Pictured Near LA 27/82 (looking Northwest), 11/3/2023

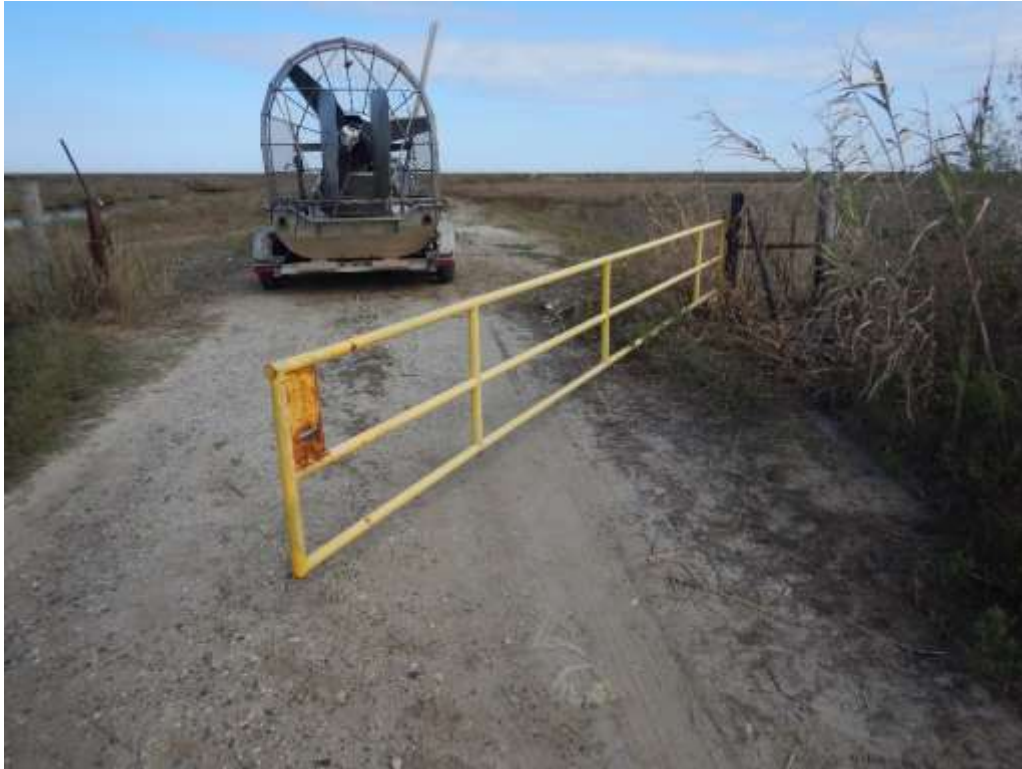
The condition of Oil Field Road was observed during the site visit and inspection, and observed to be in proper working order. Several dike gapping locations were visited, and in particular the ones observed on the eastern side of the project appeared to be promoting proper hydrologic exchange. See photos in **Appendix B**.

Photo 3: Photo of CS-0059 Project Team Vehicle and Airboat on Oil Field Road, Pictured Near Access Gate, Marsh Creation Areas in the Background (looking North), 11/3/2023

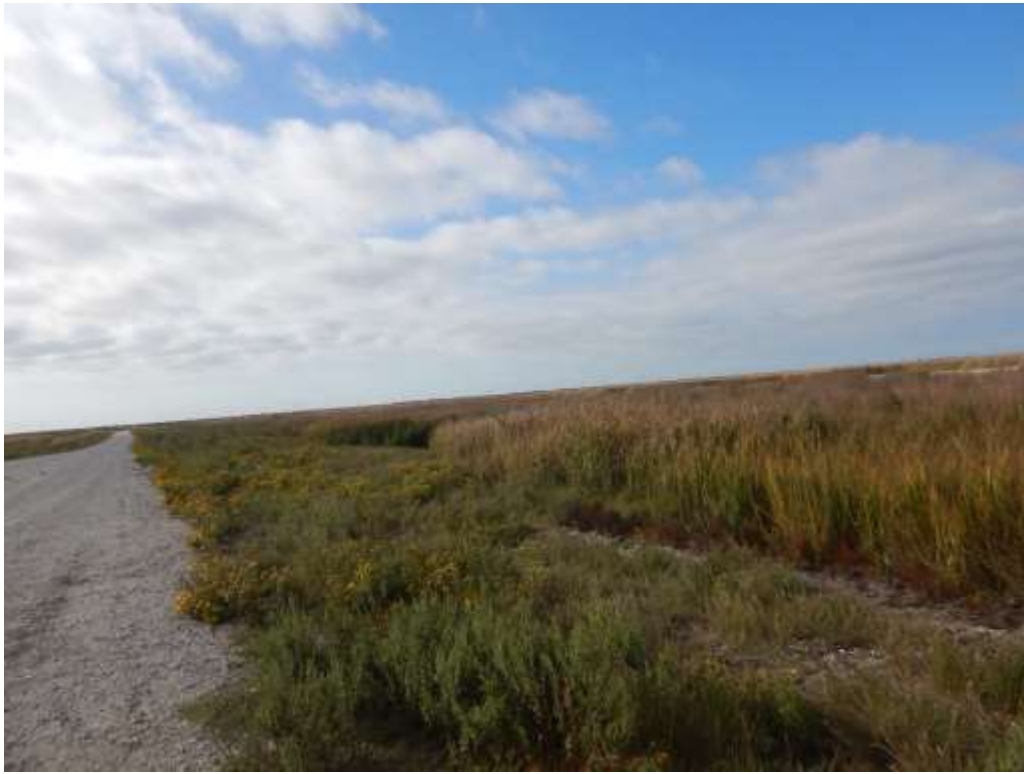
Photo 5: Photo of MCA1 near Oil Field Road (looking South), 11/3/2023

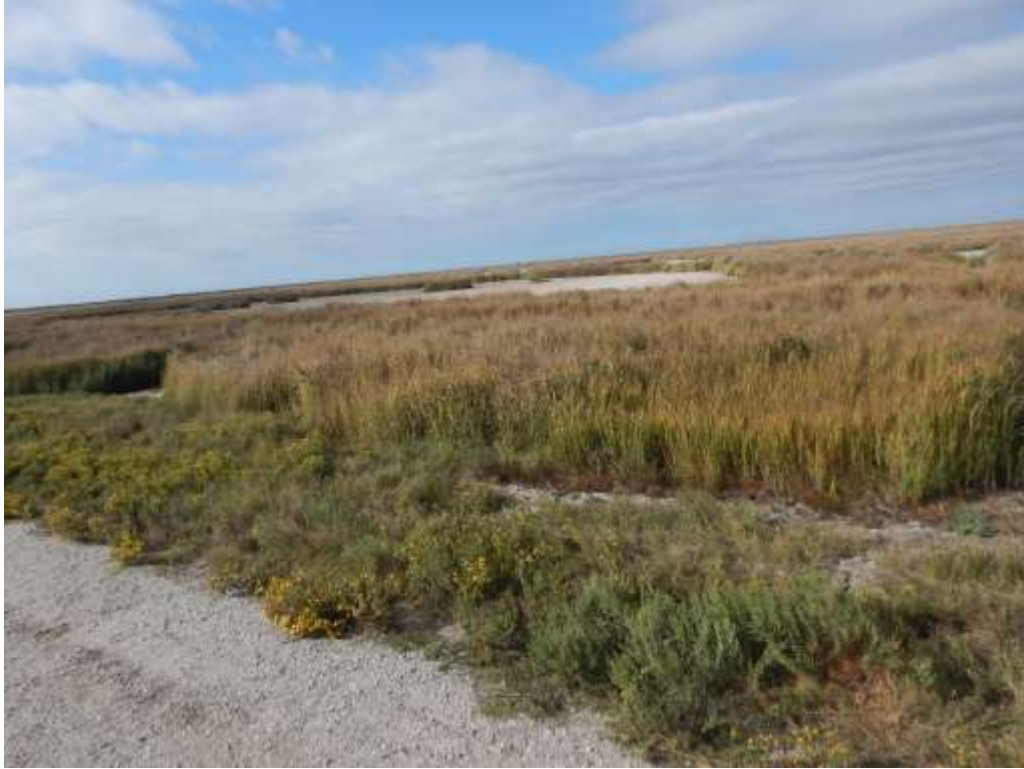
Photo 7: Photo of MCA3 with Duck Pond Visible in Background (looking West), 11/3/2023

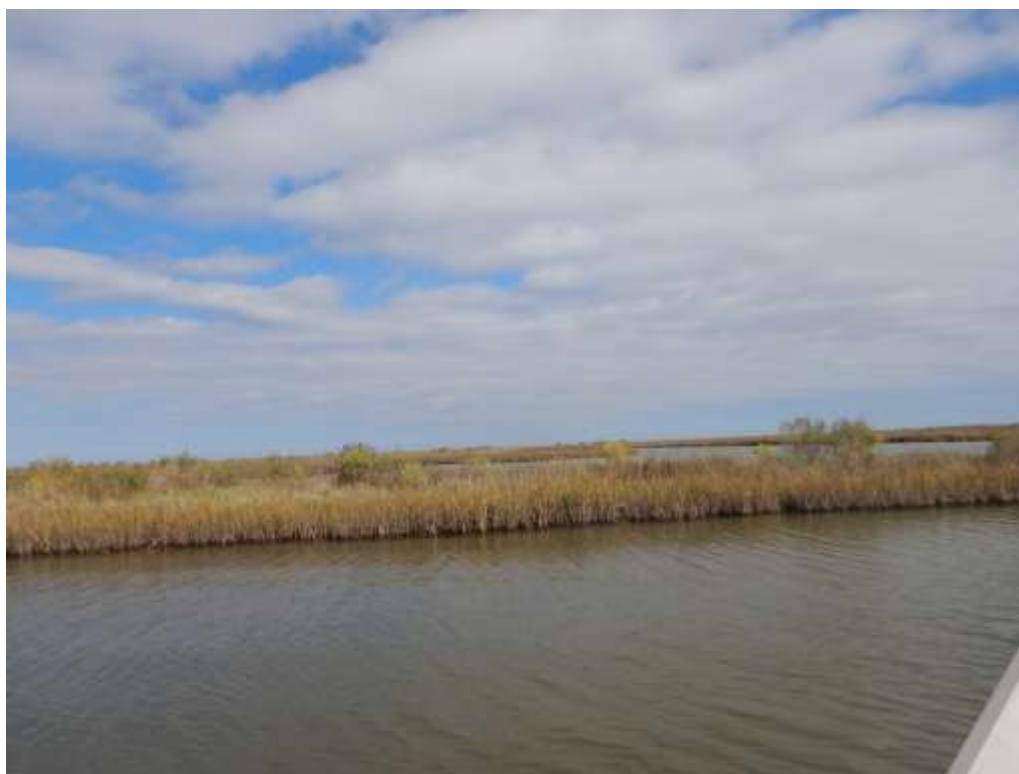
The marsh creation and nourishment areas appear to be recruiting and maintaining healthy emergent vegetation consistent with saline marshes. During construction, portions of the CS-0059 marsh creation cells were pumped very high, less marsh creation material was required to construct the project than estimated in the project design, which resulted in an underrun of the contract quantity. After target elevations and allowable construction tolerances for marsh fill were met the construction team decided to pump additional material into the MCA 5A, additional material was also allowed to flow over a low-level weir into the unconfined nourishment area. During design of CS-0054, additional project features included three (3) duck ponds encircled by remnant marsh and containment dikes built with in situ material, as well as a total of 11,637 linear feet of trenasses positioned to provide hydrologic connectivity to the pond features. See figure 4A below for an example of present-day conditions of the duck pond and trenasse features, with more information available in APTIM 2019. Despite the high pump elevations and the settled elevation existing above design settlement curve for this point in its post construction lifespan, significant expanses of marsh vegetation were observed during the November 2023 inspection. In addition to the November inspection, emergent vegetation data was collected in the years leading up to the inspection, with onsite observations and vegetation data analysis showing saline marsh species proliferating in the area. Several end-of-construction-phase dike gapping locations were also observed, which appear to be functioning properly, and in some cases exhibiting signs of natural hydrologic exchange. While still early to tell, the CS-0059 team has observed at least one location likely to

Photo 11: Photo Showing Restored Marsh within MCA4 (looking North), 11/3/2023

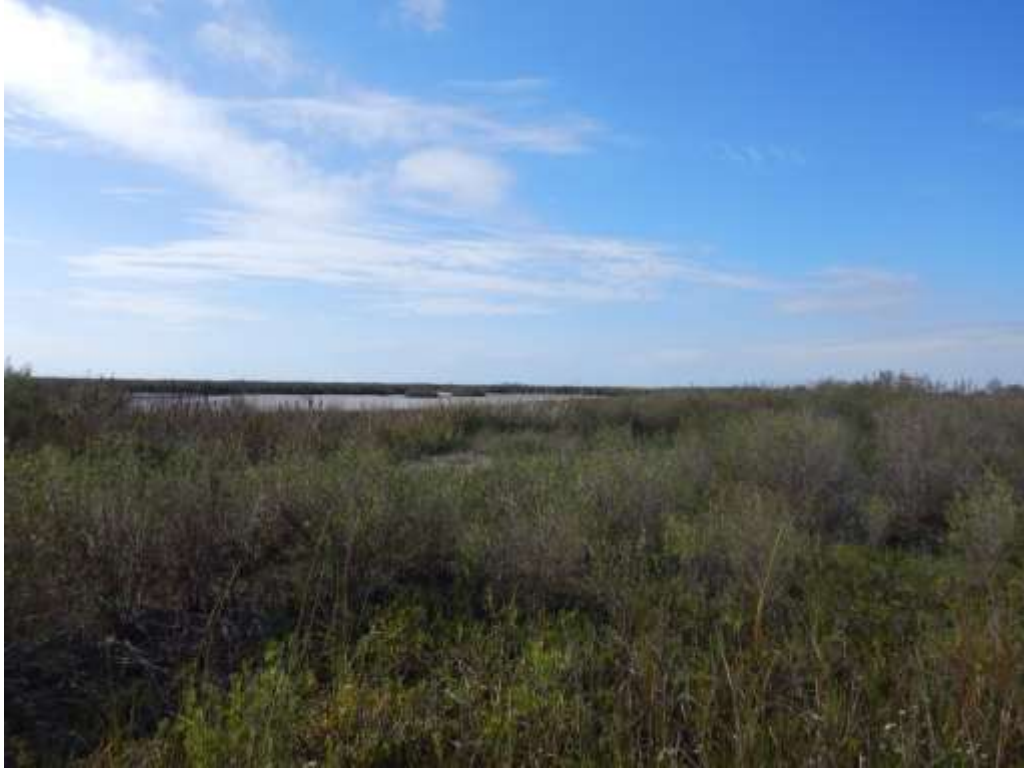
Photo 13: Photo Showing Nourishment Area near unconfined nourishment area and MCA5A (looking North), 11/3/2023

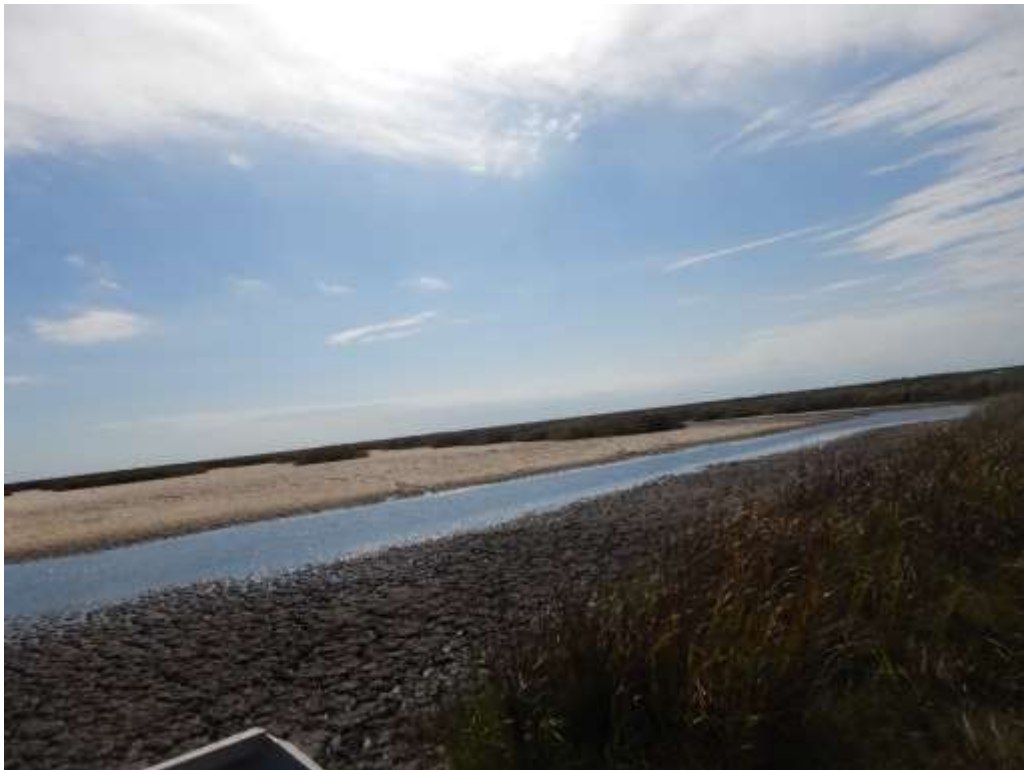
Photo 14: Photo Showing MCA1 Area Pictured From MCA5, 11/3/2023
