**Coastal Protection and Restoration
Authority of Louisiana (CPRA)**

**2022 Operations, Maintenance,
and Monitoring Closeout Report.**

**SWEET LAKE/WILLOW LAKE
HYDROLOGIC RESTORATION**

State Project Number CS-11B
Priority Project List 5

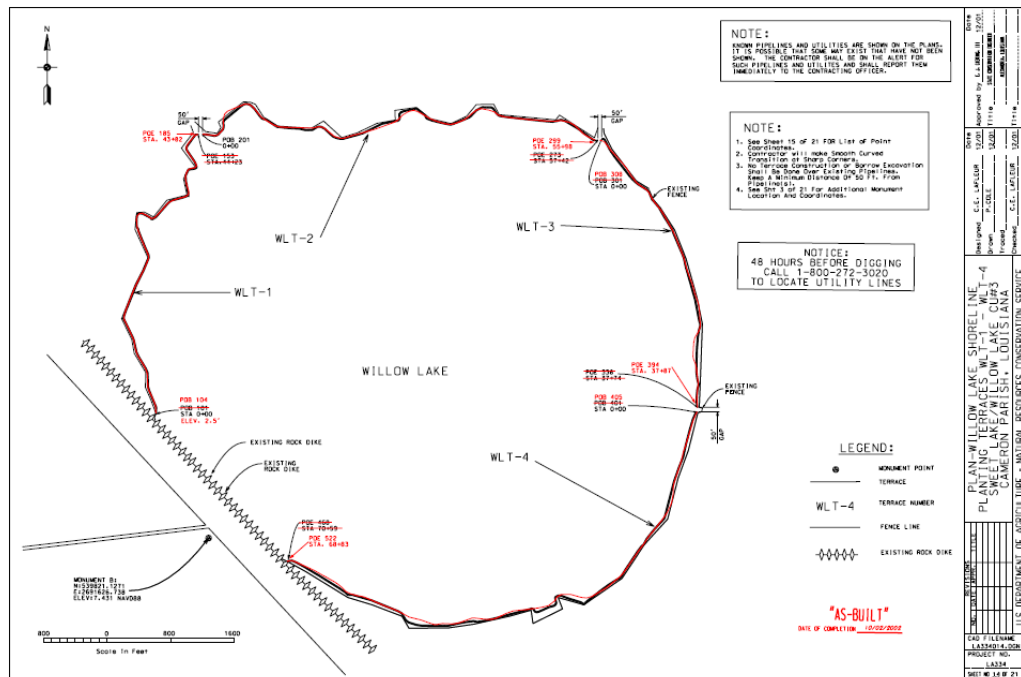
Figure 2. As-built location of shoreline terraces within the Willow Lake area of the Sweet Lake/Willow Lake Hydrologic Restoration (CS-11b) project area.

The open water terraces north of Sweet Lake and along the shoreline of Sweet Lake and Willow Lake deteriorated early in the project life due to wind-induced fetch. With the degradation of the earthen terraces, the vegetative plantings were unsuccessful in establishing. Overall, the terraces were ineffective at combating shoreline erosion within the Sweet Lake/Willow Lake project area.

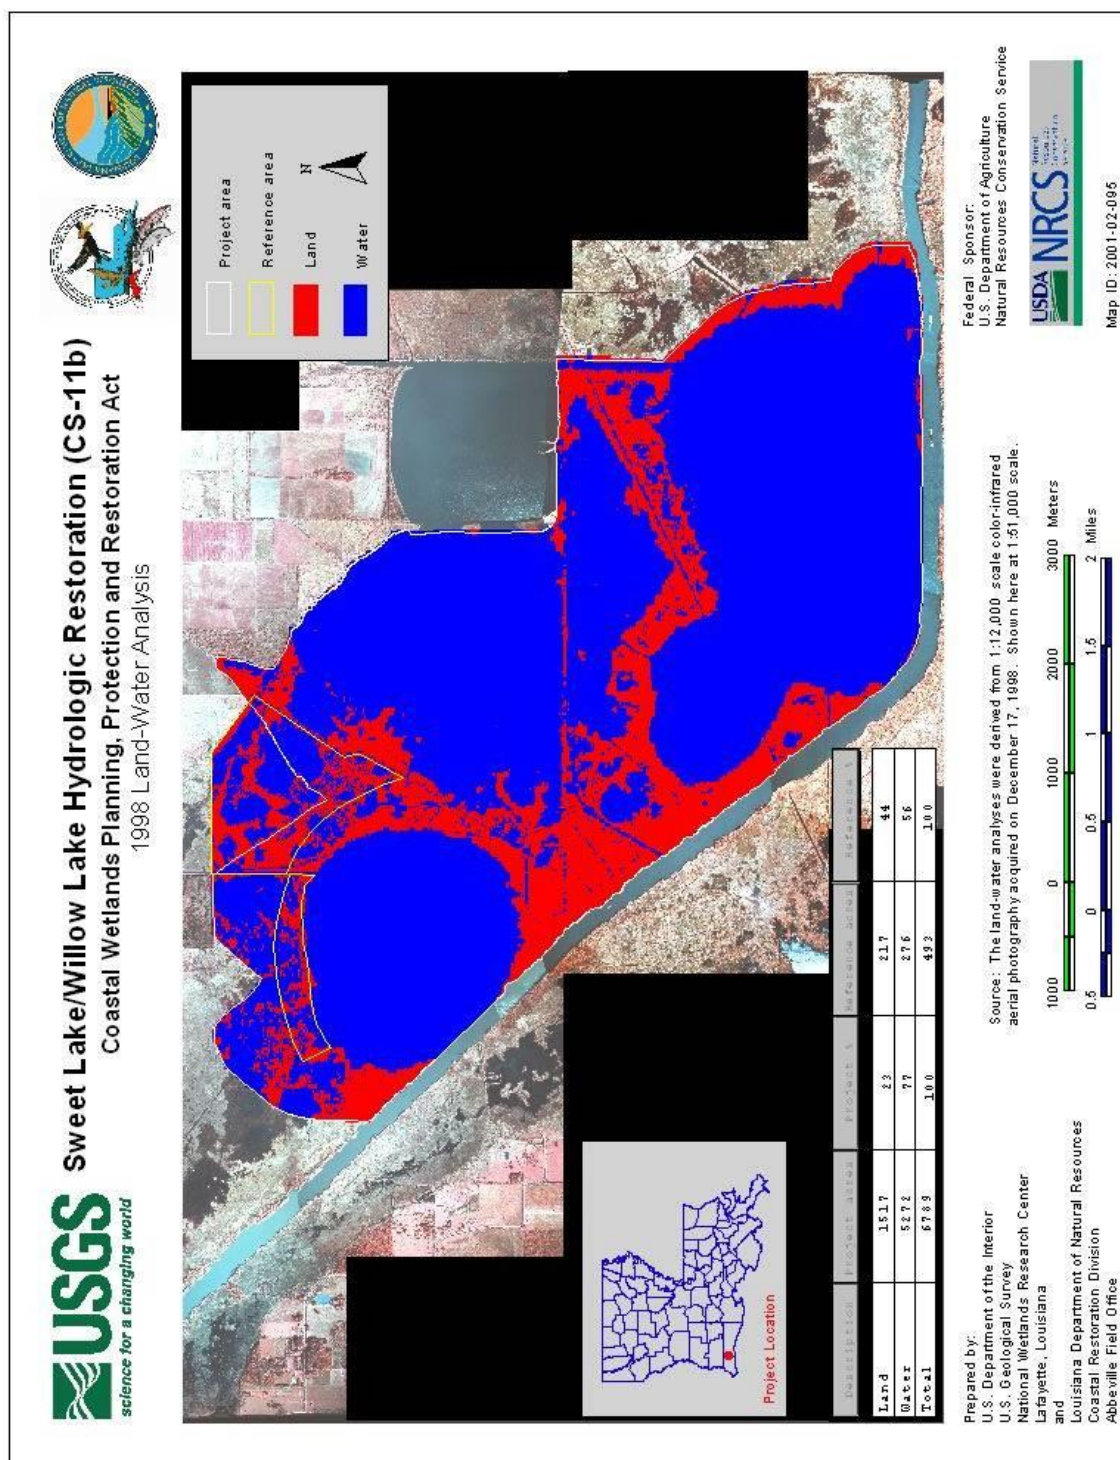
Figure 4. Land to Water analysis of the Sweet Lake/Willow Lake Hydrologic Restoration (CS-11b) project area from photography obtained December 17, 1998.

Land to water analysis for pre-construction photography collected on December 17, 1998, indicated 23.0% land and 77.0% water within the project area versus 44.0% land and 56.0% water within reference area (Figure 4). Due to project ineffectiveness and budgetary constraints post construction land to water analysis was eliminated.

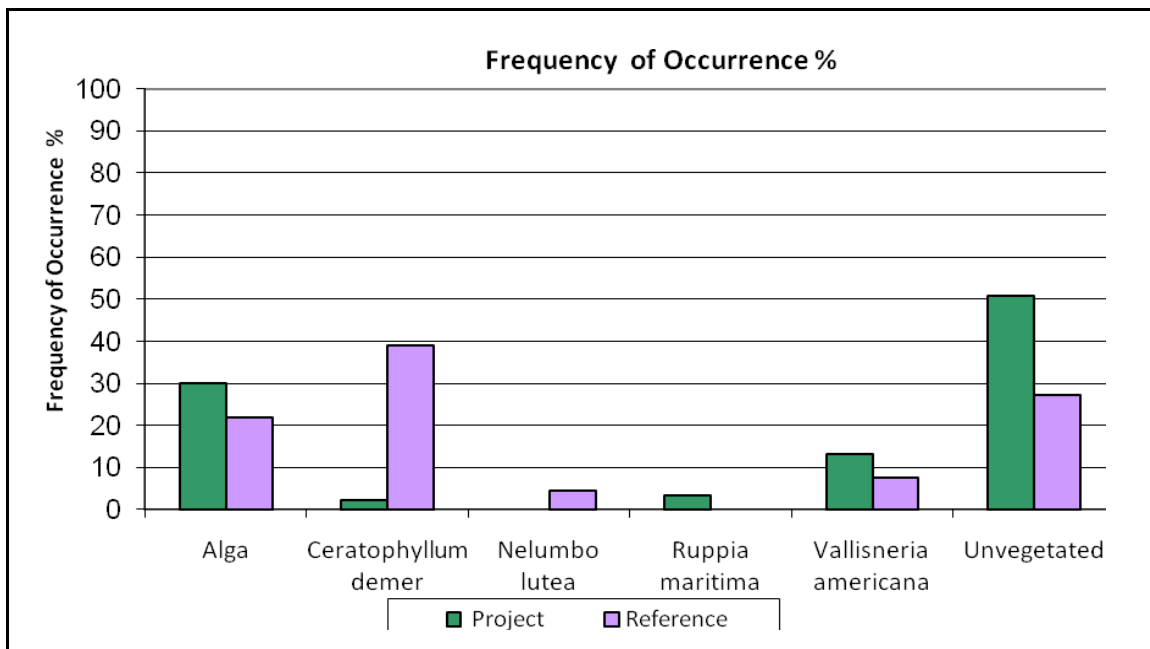
Figure 7. 2000 pre-construction data for frequency of occurrence (%) of submerged aquatic vegetation within the Sweet Lake/Willow Lakes Hydrologic Restoration (CS-11b) project and reference areas.

SAV data collected pre-construction in May 2000 indicated there was a limited amount of SAV in the project and reference area with most of it being located in the reference area. (Figure 7). Based on recommendations from the CRMS review, SAV sampling originally scheduled for 2004, 2009, and 2016 was canceled. Due to the limited data set and rapid deterioration of the terraces within the first year, it is assumed that the project did not meet its goal of increasing SAV. This was confirmed on a recent site visit conducted on September 2, 2021, when no submerged aquatic vegetation was noted in the project and reference areas.
