2022 Operations, Maintenance, and Monitoring Report

Black Bayou Hydrologic Restoration

State Project Number CS-27 Priority Project List 6

September 2023 Calcasieu and Cameron Parishes

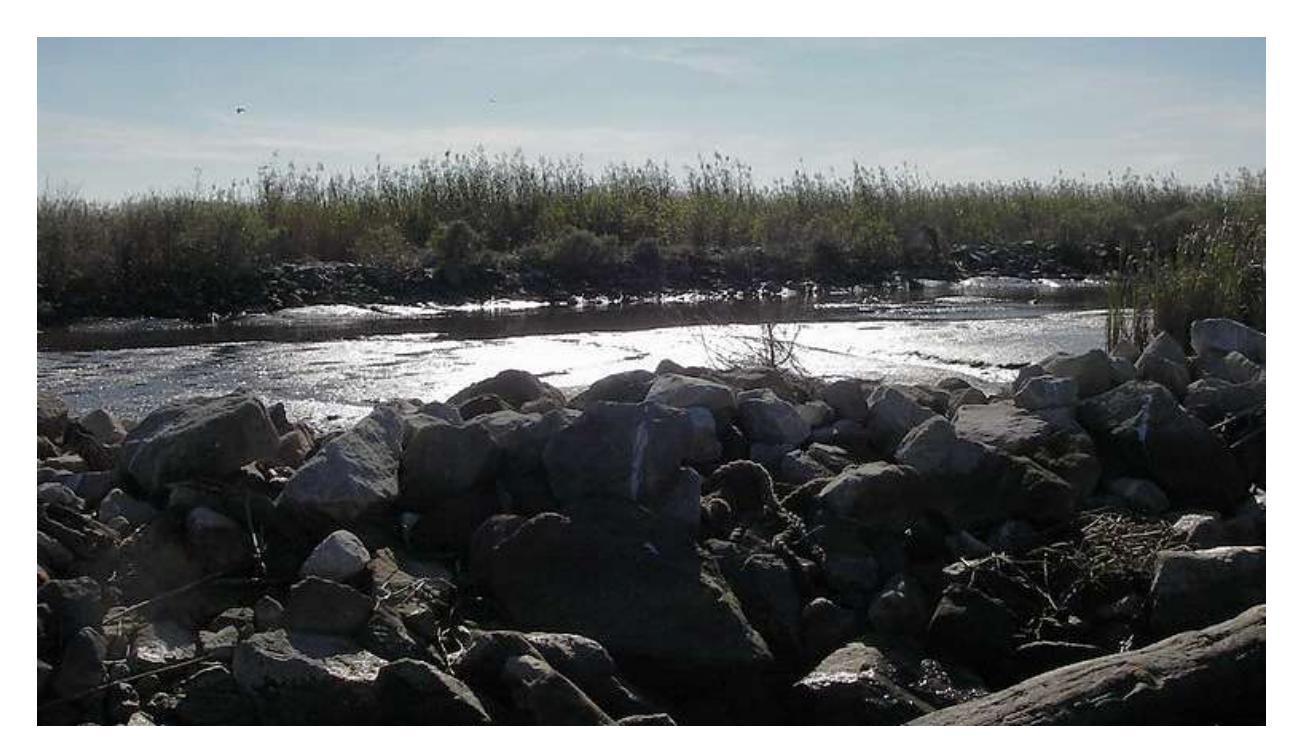
Figure 14. Sedimentation and vegetative growth between the GIWW rock dike and dredge material levee along the north side of the impoundment within the Black Bayou Hydrologic Restoration (CS-27) project.

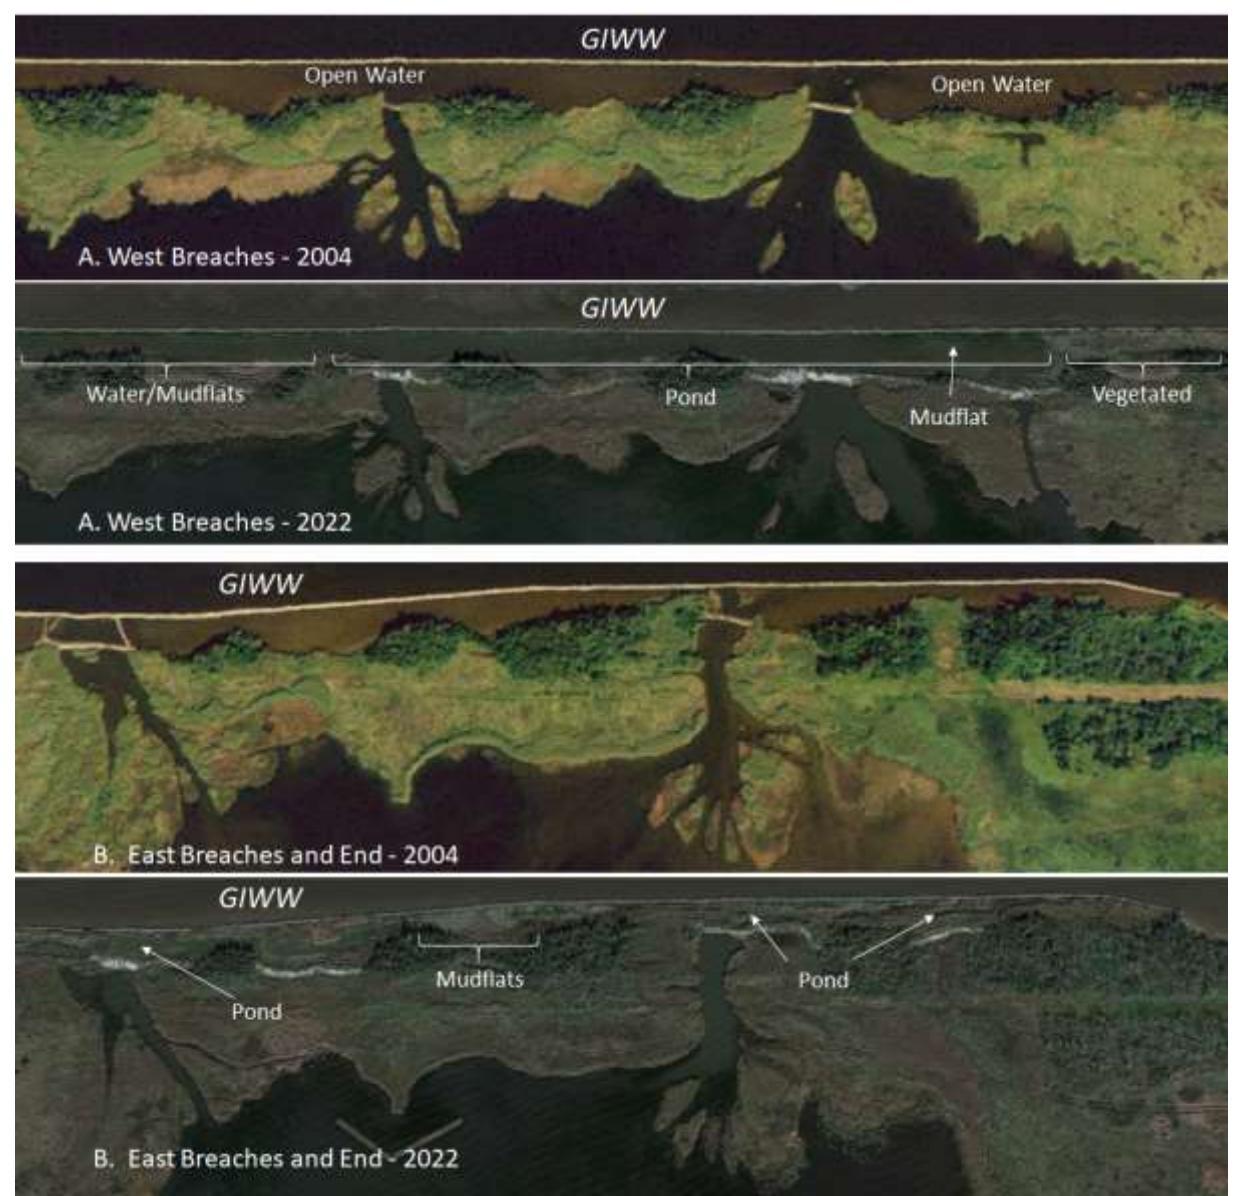
Since 2004, the breached shoreline detailed in the GIS analysis remained steady with areas east and west of the breach filling in between the shoreline and dike (Figure 16A). The east end appears to have been filling in as intended with the exception of ponding near the breaches. The unprotected shoreline east of the dike has eroded about 130 ft (~6 ft/y) since installed (Figure 16B). Areas such as the breached stretches are deeper between the dike and the shoreline from the sediment being exported into the impoundment as evident from the delta splays that form at the breaches. In-filling of these deeper areas are difficult to determine by only looking at the shoreline change. A more conclusive monitoring would need topographic/bathymetric surveys to determine elevation changes and possibly soil volume changes over time.

Figure 16A-B. Changes in the area between the foreshore rock dike and shoreline along the GIWW were described from 2004 and 2022 Google Earth imagery.
