## **2020 Operations, Maintenance, and Monitoring Report**

### **Black Bayou Culverts Hydrologic Restoration**

State Project Number CS-29  
Priority Project List 9

DEC 2020  
Calcasieu and Cameron Parishes

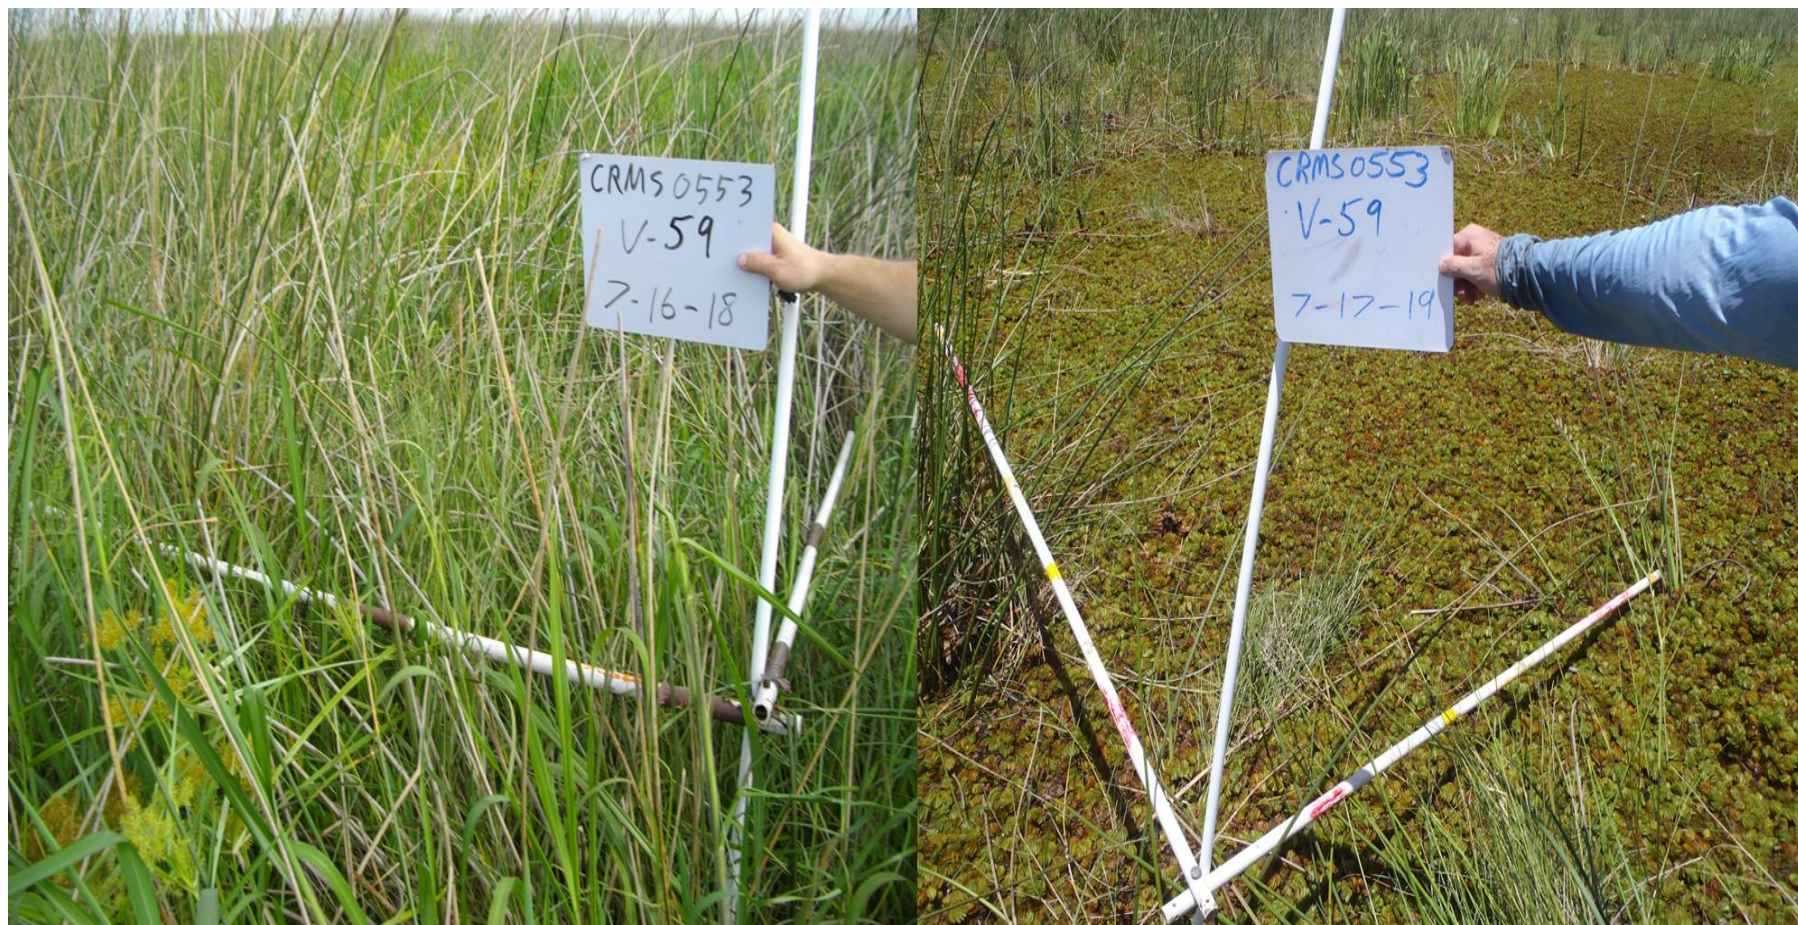
**Figure 6.** Area of marsh possibly converting to open water through the combination of invasive *Salvinia Molesta* and prolonged elevated water levels at CRMS0553 in Area 2B of CS-29 between 2018 and 2019.

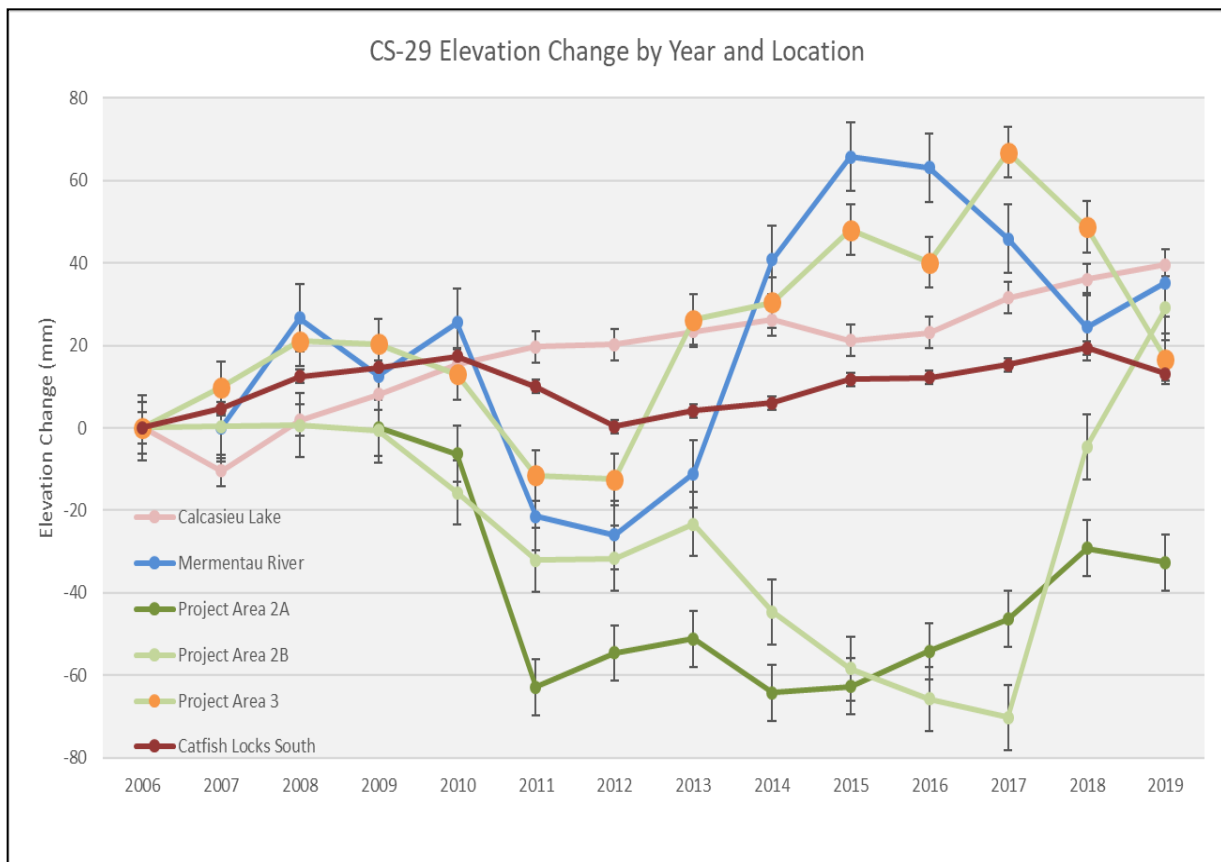
**Figure 28.** Elevation change from 2006-2019, experienced at project area CRMS sites in CS-29 project area and in reference locations, showing a loss and recovery in elevation through time at most locations tied to water level fluctuations; namely an increasing water level and the soil keeping pace post drought.

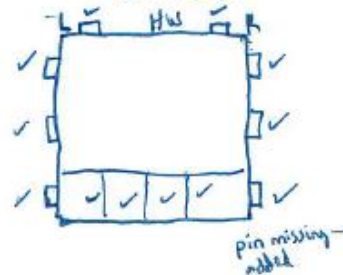
GATE 10

Rings look 1/4" thick - Sch 40

Verify if ring is Schedule 80
