**State of Louisiana  
Coastal Protection and Restoration Authority**

**2019 Annual Inspection Report**

**Lake Borgne Shoreline Protection  
Project**

State Project Number PO-30  
Priority Project List 10

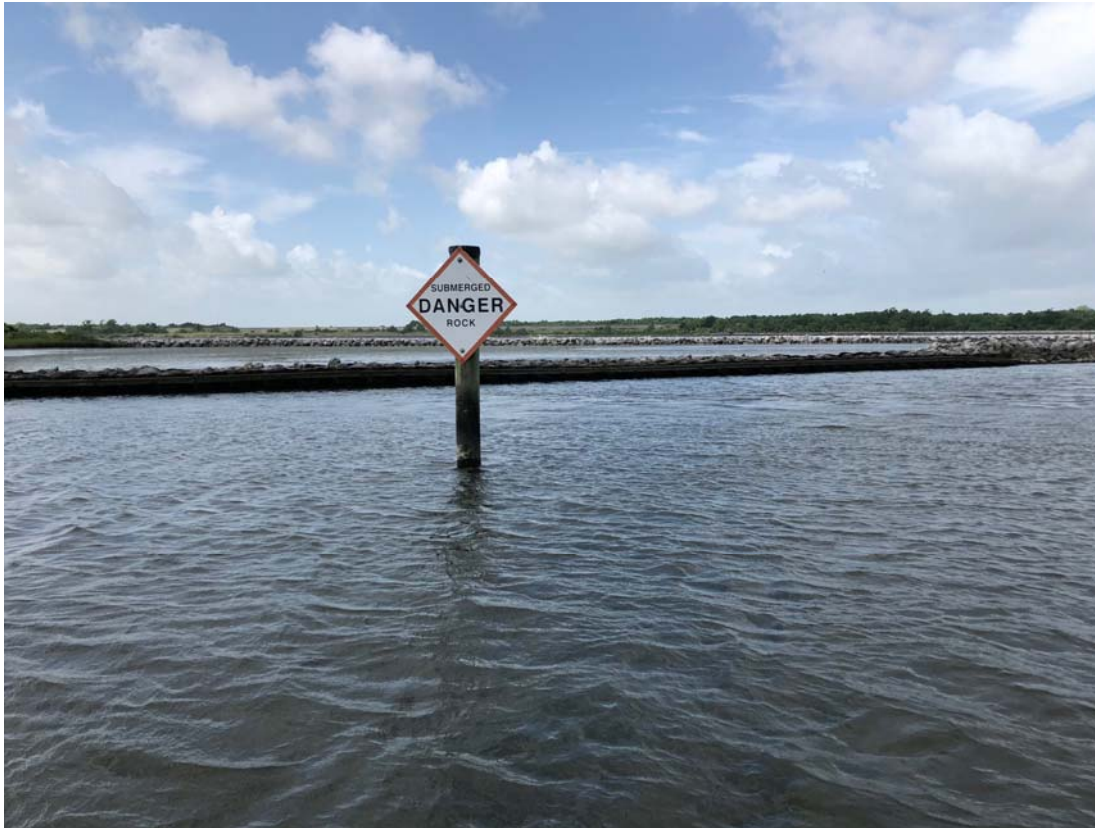
**Photo 18: Reach 2**  
29°56'35.12", -89°50'14.92"

- B. Breakwater Reach 2 (South of Bayou Dupre)** – The rock breakwater appears to be mostly in good condition. There is a section approximately 100 feet long at 29°56'30.55", -89°49'59.21" that appears to be approximately 0.5 feet lower than the adjacent rock.
