## **2022 Operations, Maintenance, and Monitoring Report**

### **Freshwater Bayou Canal Wetland Protection and Freshwater Bayou Bank Stabilization**

State Project Number ME-04 and ME-13  
Priority Project List 2 and Priority Project List 5

June 2022  
Vermilion Parish

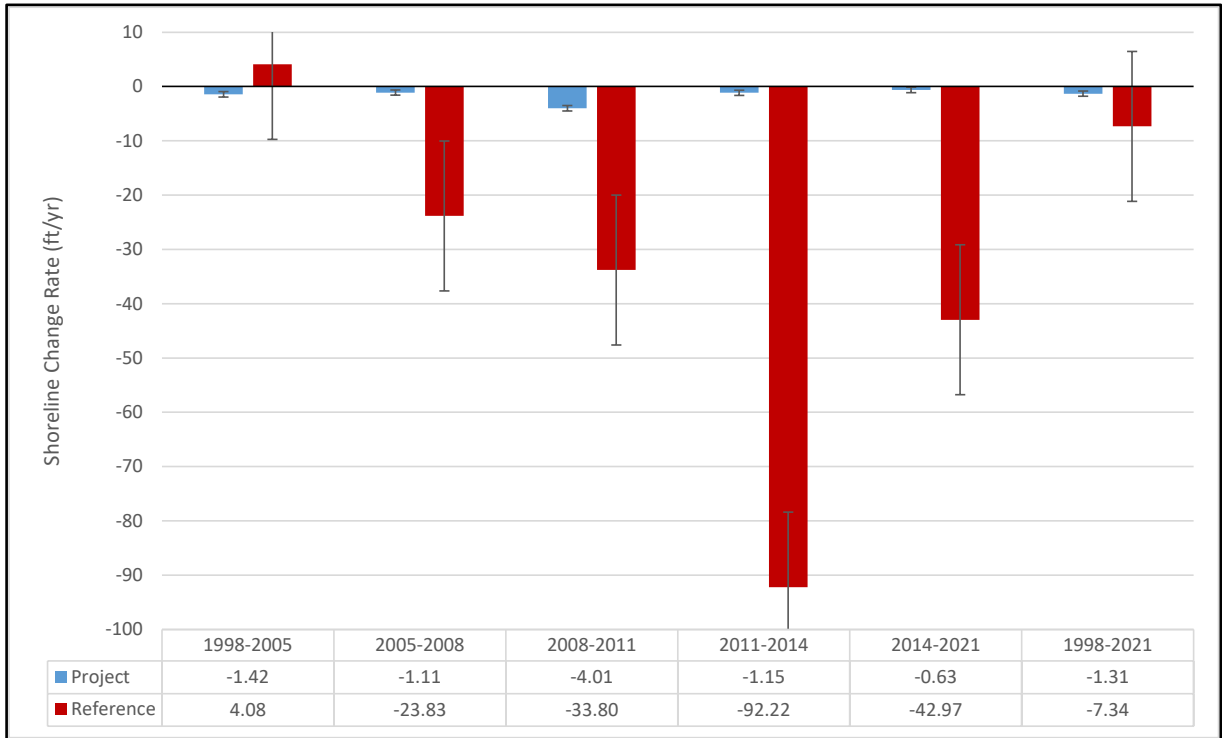
The rocks effectively protected the project area shoreline from wake, wave, and tidal forces along Freshwater Bayou, while the shoreline in the reference area continued to erode significantly faster (Figures 11 and 12). Higher rates of erosion along the project area shoreline typically took place in and around areas where the rocks were low or breached. The most recent data collection effort in December 2021 revealed continued erosion in the project area although this is occurring at a much slower rate than the reference area.

**Figure 11.** ME-04 shoreline change rates broken down between sampling periods over the life of the project.

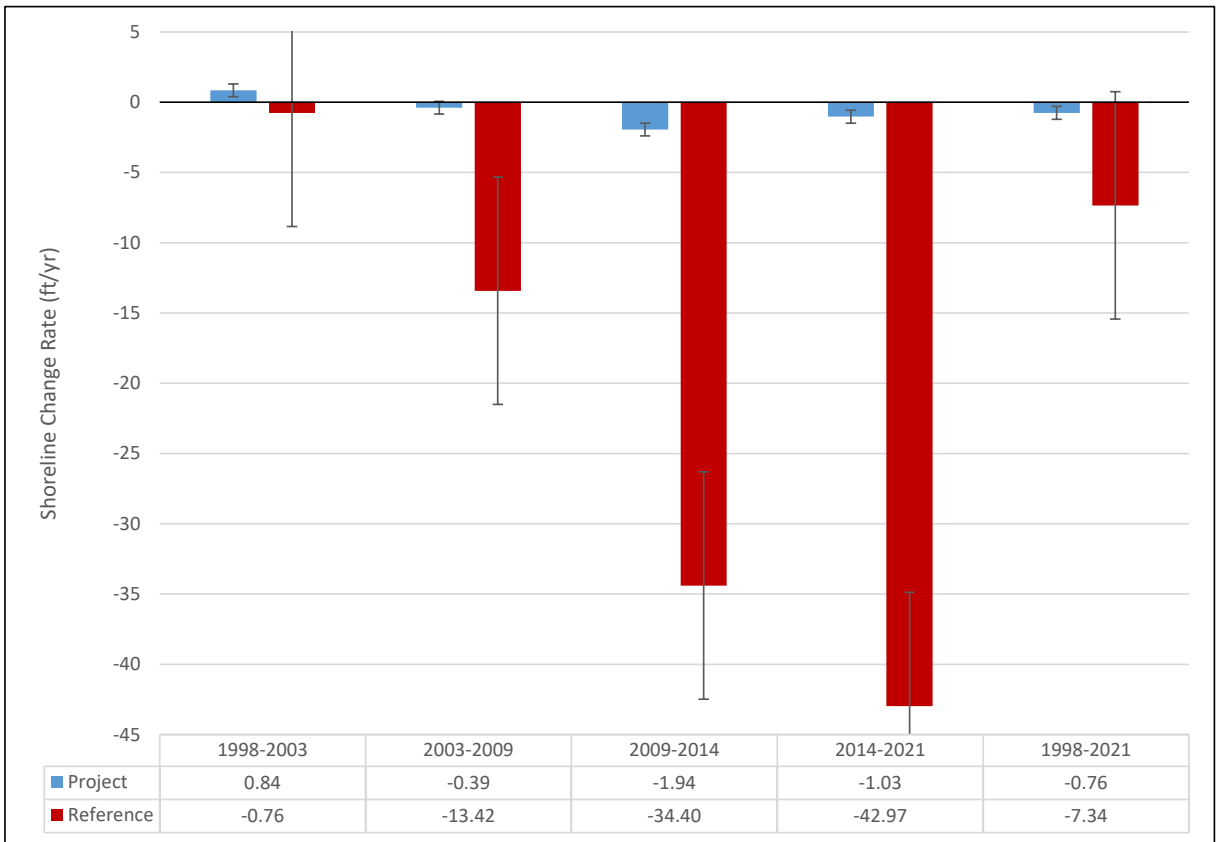
**Figure 12.** ME-13 shoreline change rates broken down between sampling periods over the life of the project.

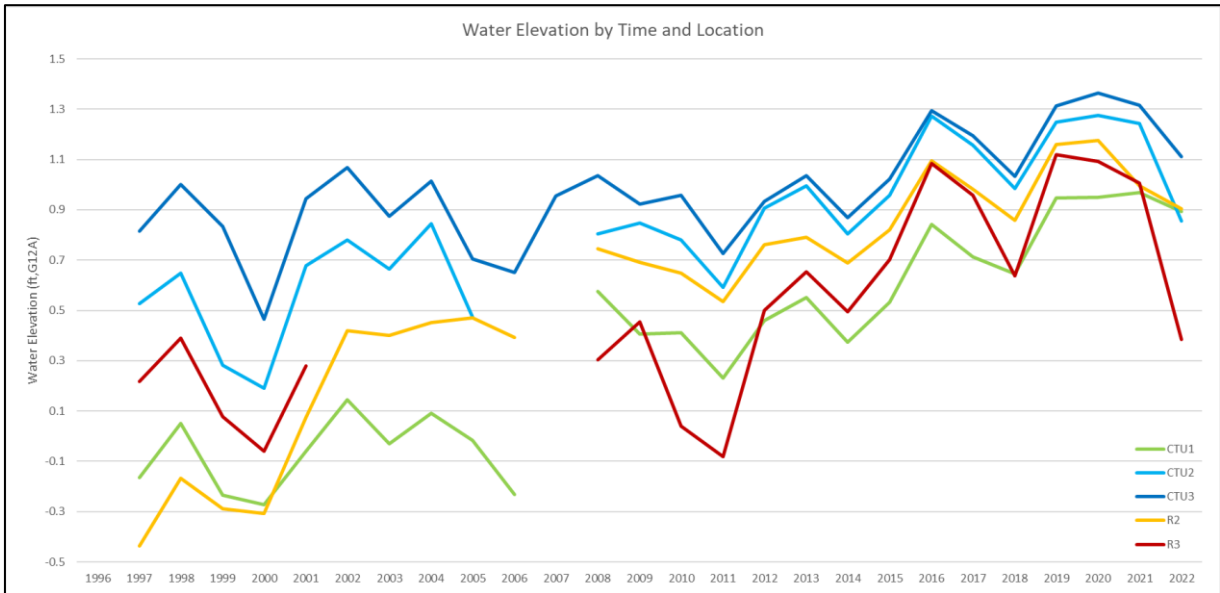
Hydrologic data collected for the ME-04/13 project indicates that overall, water levels were higher in the project areas than the reference areas with the exception of CTU1, which generally tracks at or below the reference areas. (Figure 14). There is also a dramatic increase in water level from project construction through the most current data collection in 2022. This is due to higher than normal Gulf of Mexico water levels along with consistent upland rains with the project area between these two opposing forces driving water elevation higher. This has had a homogenizing effect on project reference differences as the overall increased water level has reduced drainage and stratification, but the relationships between units has remained constant ( $F_{4,1885}=203.80$ ,  $p<0.0001$ ). CTU1 (0.32ft) had the lowest project or reference water elevation due to its proximity and connectivity to the southern reach of Freshwater Bayou Canal, this is similar to R2 (0.53 ft) and R3 (0.46) which were not distinct from one another (Table 1). R3 would seemingly be higher than most of the project and reference areas because it is on the Mermentau Basin side of HWY82, but it is isolated from the GOM and Vermilion Bay thus periods of drought can maintain reduced water levels for longer periods of time. The highest water level was CTU3 (0.90 ft) with CTU2 (0.80 ft) distinct but similar comparatively. These locations likely receive high water from both the Mermentau basin drainage and the high GOM and Vermilion Bay with localized droughts offering only a marginal effect.

**Figure 14.** Annual project CTU’s water elevations compared to R2 and R3, the reference area is generally always lower than the project area with the exception of the southern CTU1.

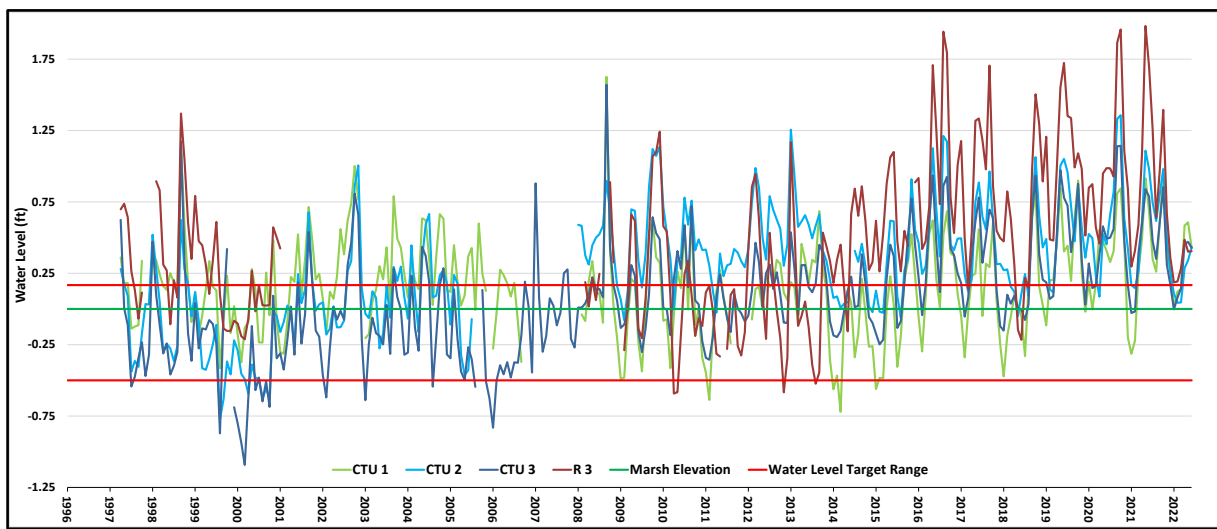
Flooded conditions have dominated the project area from 2016-2022, during those seven years the water elevation has rarely been below or even at marsh elevation except during winter months or the previously discussed drought conditions (Figure 17). One of the goals of this project is to maintain water levels between 6 inches below marsh level and 2 inches above marsh level. By and large, water levels in the CTU's were within target range more often than the reference area (Figure 18). However, water levels varied significantly over the years generally in both the project and reference area simultaneously, explained by location, connectivity, local and regional forces and are generally not related to project features. This is principally due to the lack of water control structure operations in the project area and that the rock dike is not a hydrologic barrier. Outside hydrologic forces have dominated the ME-04/13 project area and without more hydrologic control the project water level and flooding are likely to continue to get worse without elevation gains through sediment addition.

**Figure 17.** Mean monthly flooding within the project and reference area CRMS stations from 1996-2022.

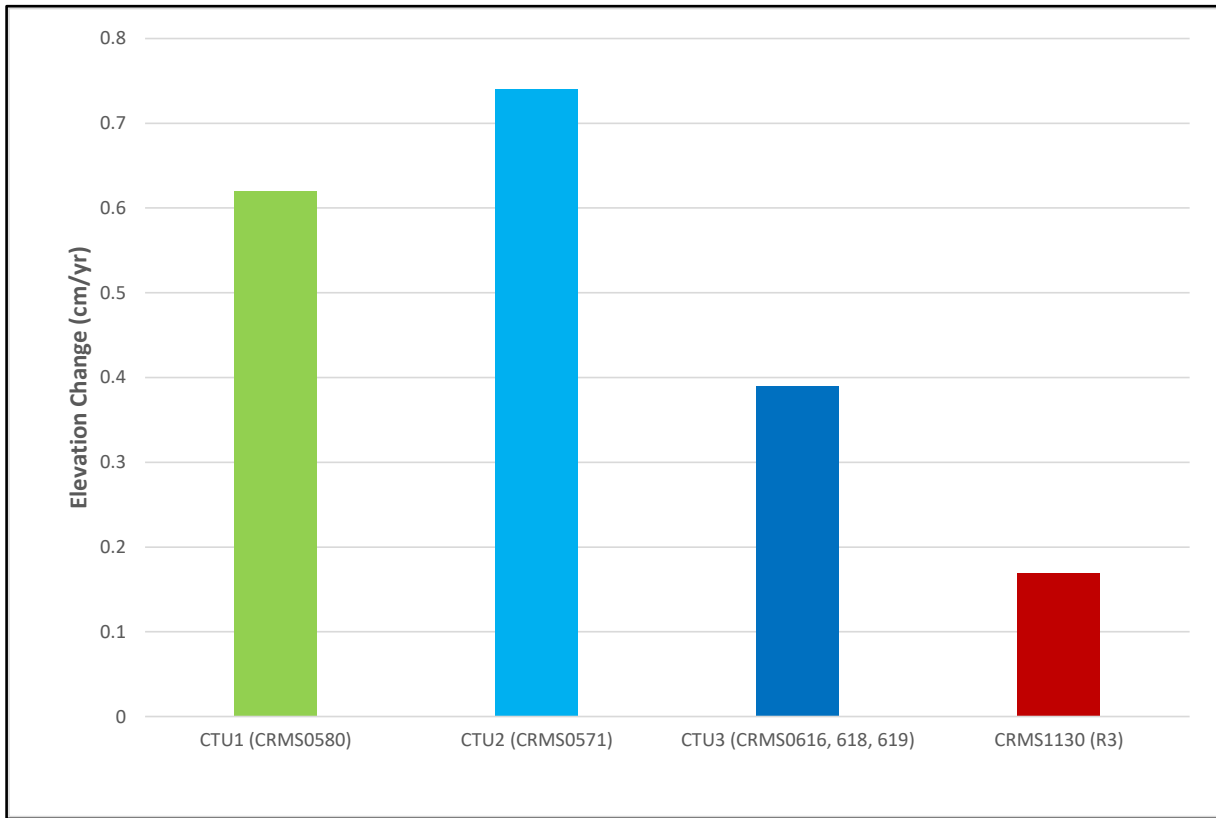
Data collected through the CRMS network indicate positive elevation changes at all project areas and reference area (Figure 28). Elevation change rates ranged from 0.4 cm/yr to 0.7 cm/yr in the project areas. Elevation change is lower in the reference area, at 0.17 cm/yr. Actual elevations were higher in the project areas as well, ranging from 0.6 ft to 0.9 ft while elevation at the reference area was recorded at 0.1 ft (Figures 29-34). Furthermore, submerged vulnerability scores (SVI) were much higher in the project areas (41.1 – 69.7) than the reference area (10.7) (Table 5). SVI scores range from 0 – 100 and those values relate the susceptibility of a site to submergence. The higher the SVI score the less vulnerable a site is to submergence. Marshes with lower elevations tend to have lower SVI scores and thus are more vulnerable to submergence. All these factors indicate that the project areas ought to perform better than the reference area should sea level rise in the future. The rock dike that spans the eastern border of the ME-04/13 project area is one feature that protects the interior marshes from continued erosion along Freshwater Bayou Canal contributing to the better performance of the project area compared to the reference area.

**Figure 28.** Elevation change per year (2008 – 2022) in the project CRMS sites and reference CRMS sites.
