### 2022 Operations, Maintenance, and Monitoring Report

### Grand-White Lake Land Bridge Protection

State Project Number ME-19  
Priority Project List 10

September 2022  
Cameron Parish

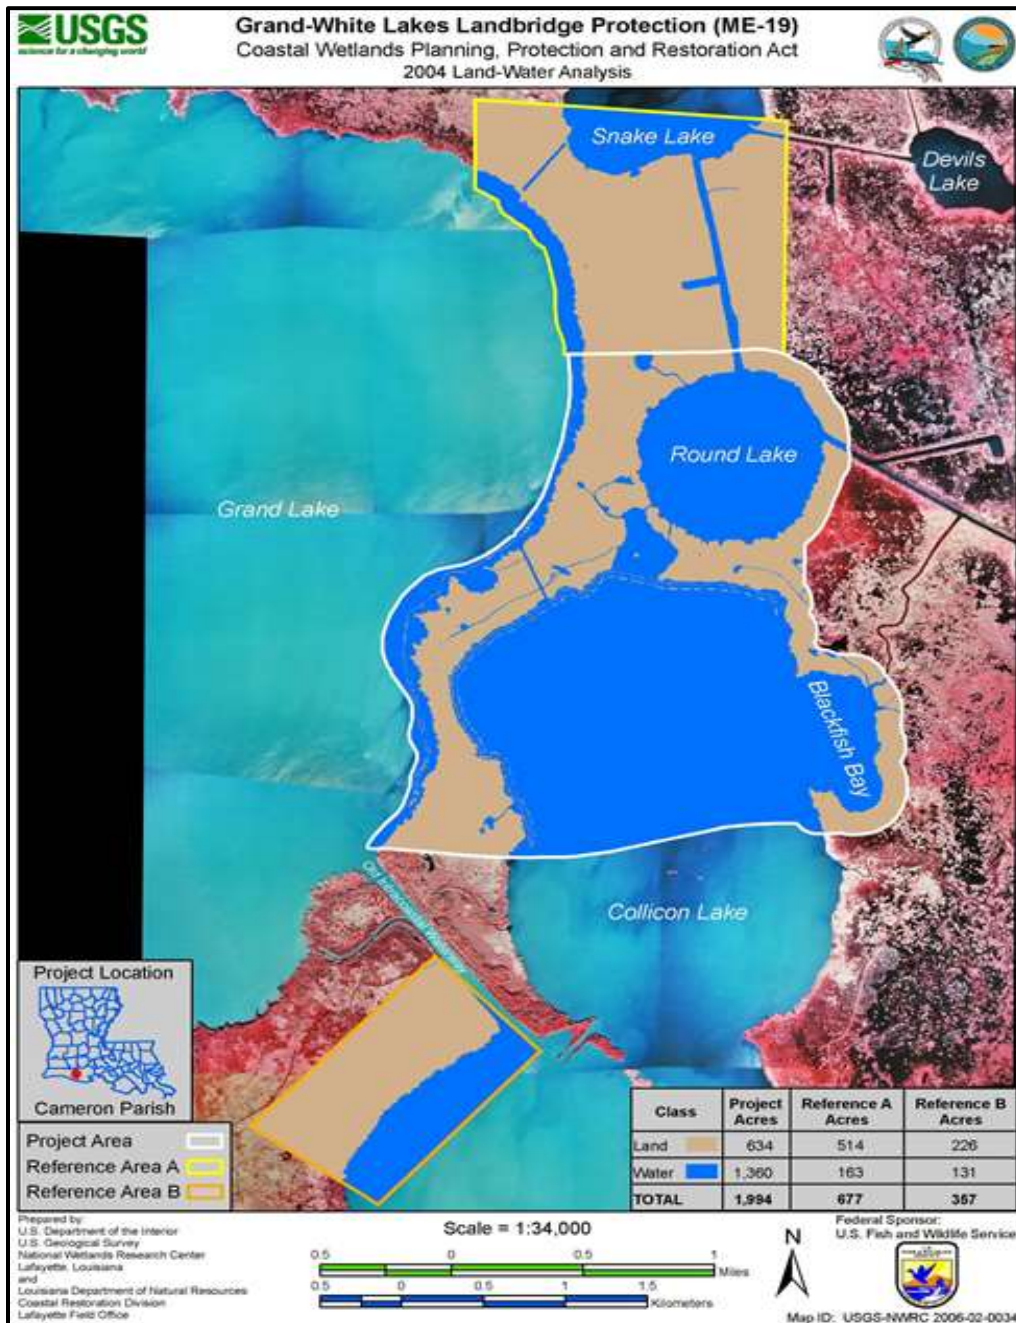
**Figure 2.** Land to water analysis for Grand-White Lake Landbridge Protection (ME-19), flown November 24, 2004 following completion of construction.

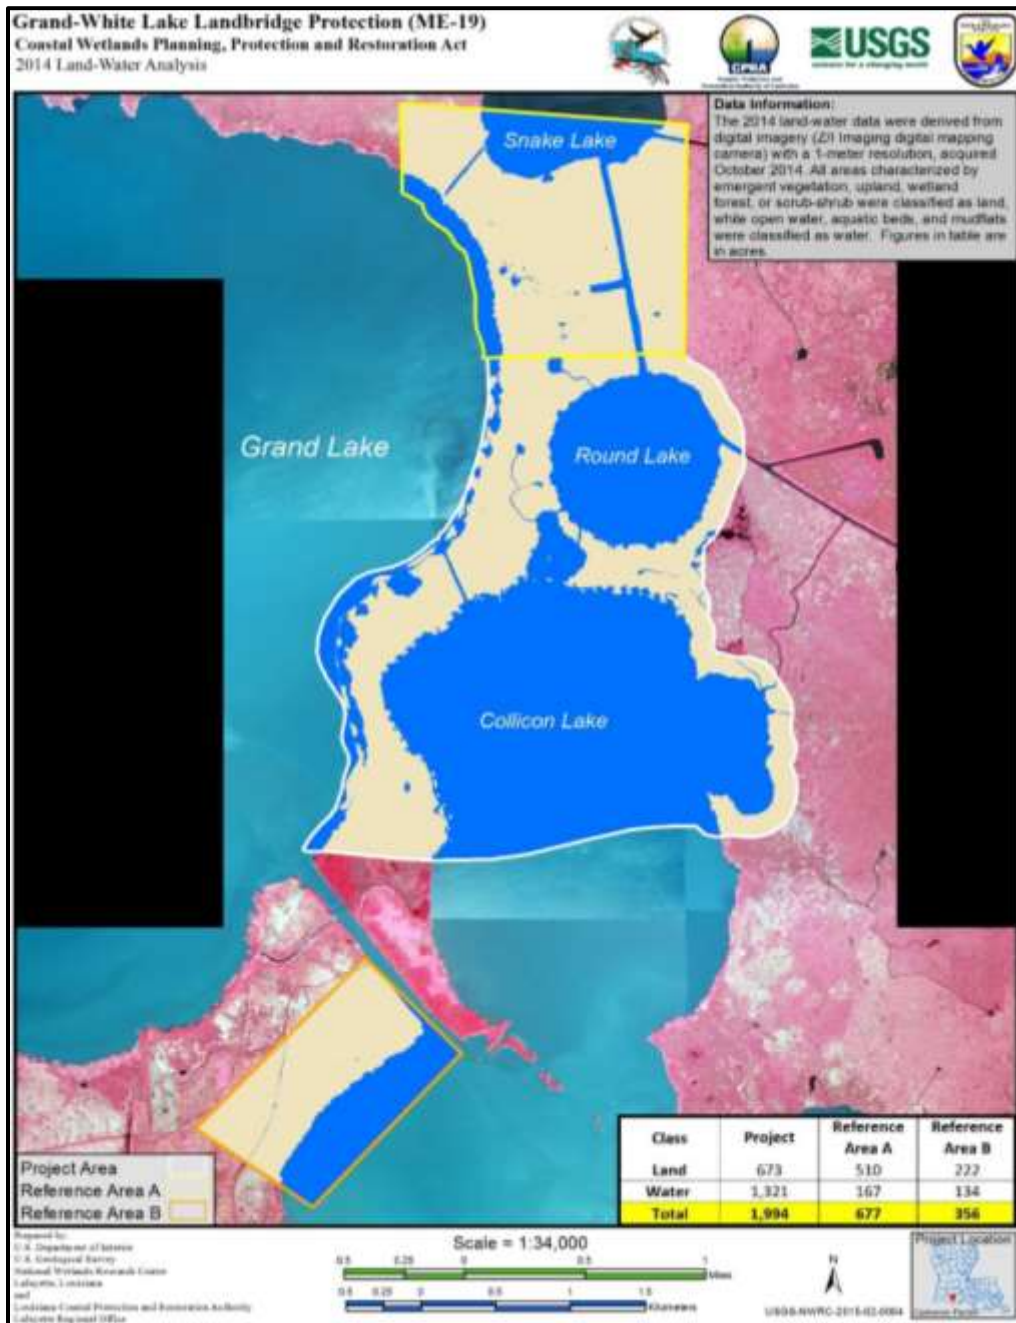
**Figure 3.** Land to water analysis for Grand-White Lake Landbridge Protection (ME-19), flown October 2014 post-construction.

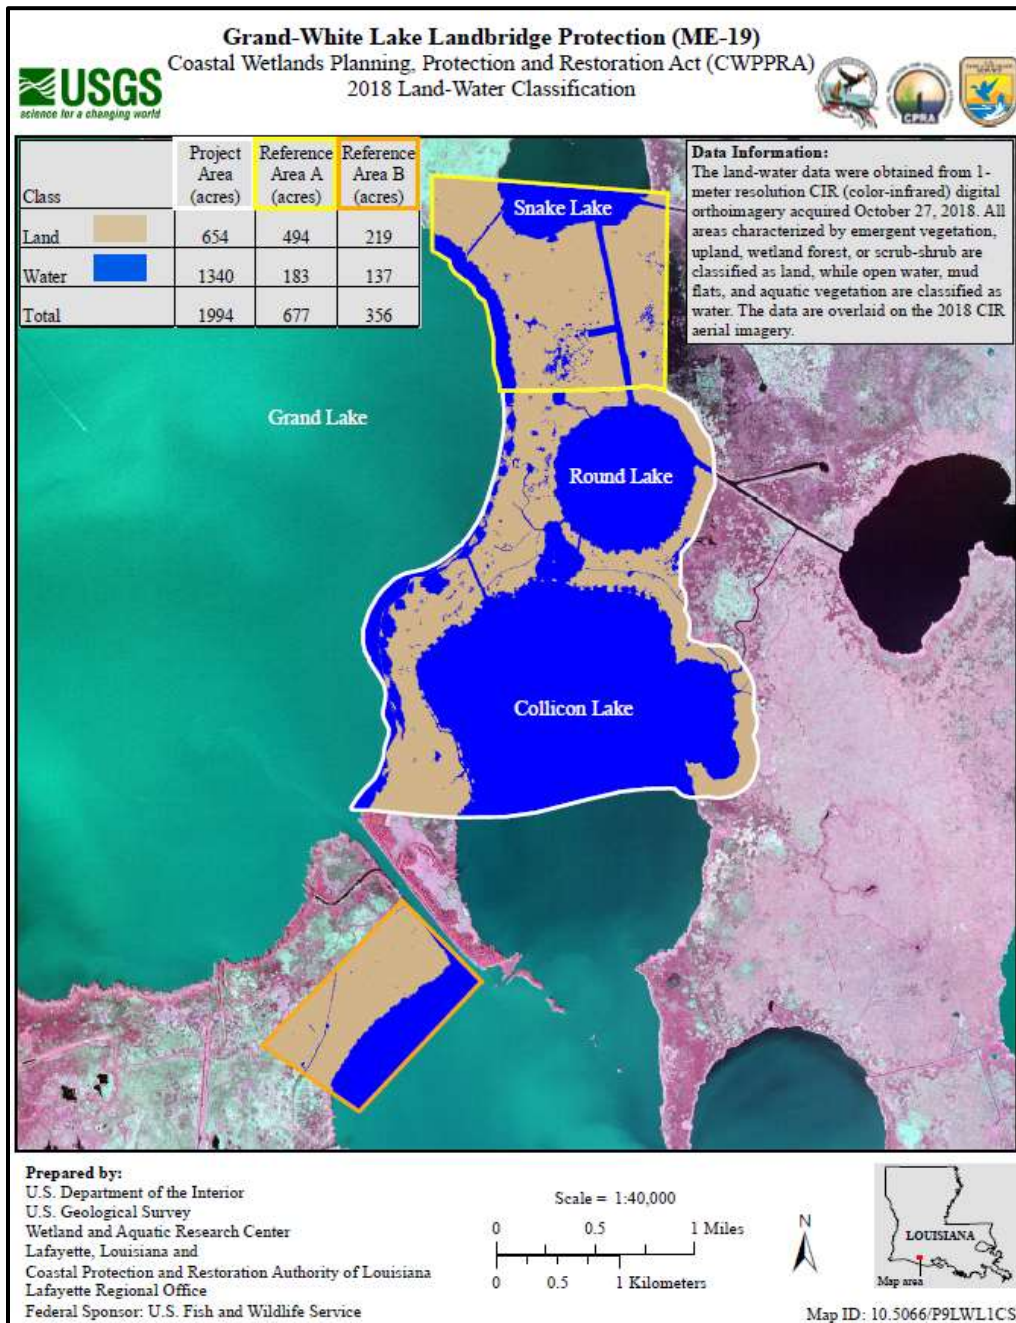
**Figure 4.** Land to water analysis for Grand-White Lake Landbridge Protection (ME-19), flown October 2018 post construction.

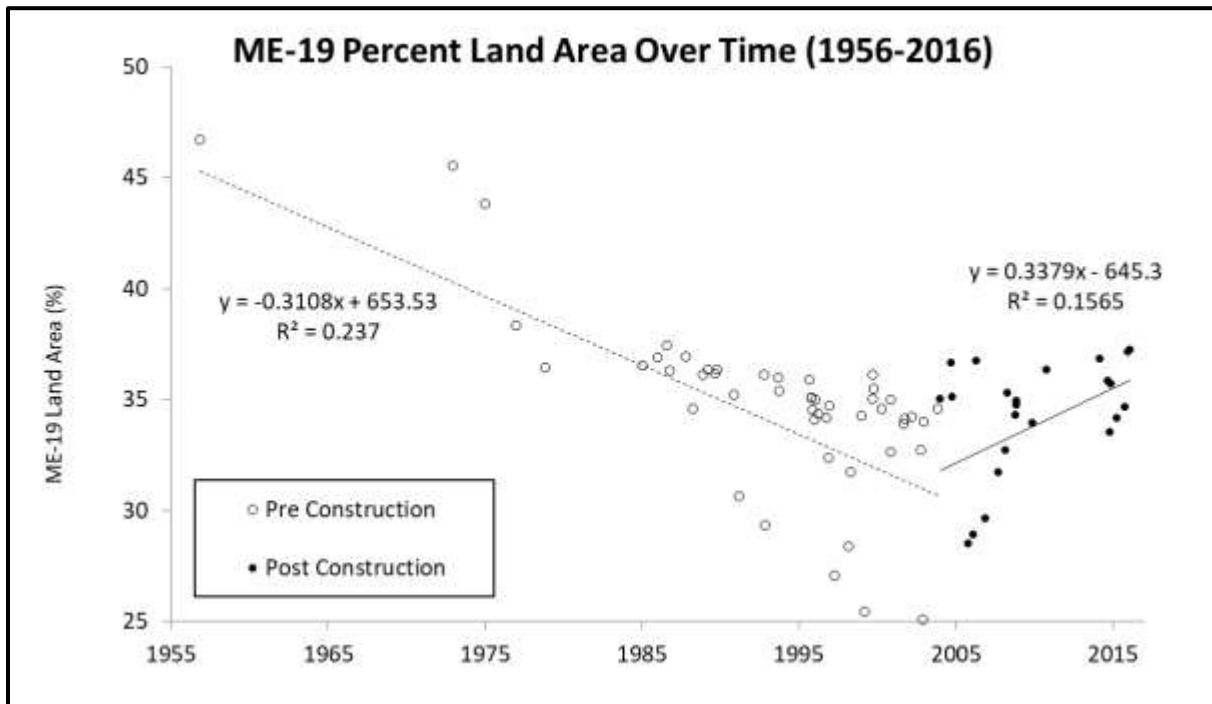
Percent land area stored on the CRMS website ([http://www.lacoast.gov/crms\\_viewer/](http://www.lacoast.gov/crms_viewer/)) was used to provide a historical perspective on the ME-19 project area (Figure 5). Prior to construction in 2004, the ME-19 project area was losing land at a rate of -0.31%. From 2004 to 2016 the ME-19 project area began gaining land at a rate of 0.33% with the addition of terraces, dredge spoil deposition, and increases in land in addition to dredge material deposition. Based on the land area change map from Couvillion et al. (2011), pre-construction loss appeared to be more associated with shoreline erosion, whereas post construction loss is more associated with interior marsh loss.

Within the project area, the land bridge narrowed significantly at a rate of -22.2 ft/y (6.6 m/y) during pre-construction (1956-2004; Figure 5). Since construction, the land bridge has slowly broadened at a rate of 4.9 ft/y (1.5 m/y). To reference this, the narrowest width of the land bridge (Transect 9) shrunk from 1405 ft (428 m) in 1956 to 422 ft (129 m) in 1998. Since construction of the ME-19 project the land bridge broadened to 568 ft (173 m) at this transect. Of the 10 transects, 8 have broadened from 1998 to 2018 at an average of 103 ft (31 m). The two transects that narrowed averaged -77 ft (-24 m). This land gain resulted from several of the marsh side terraces merging with the land bridge.

**Figure 5:** Pre and post construction change in land area over time (1956-2016) in the ME-19 project area. The values are the percent land area before (1956-2004) and after (2004-2016) project construction.

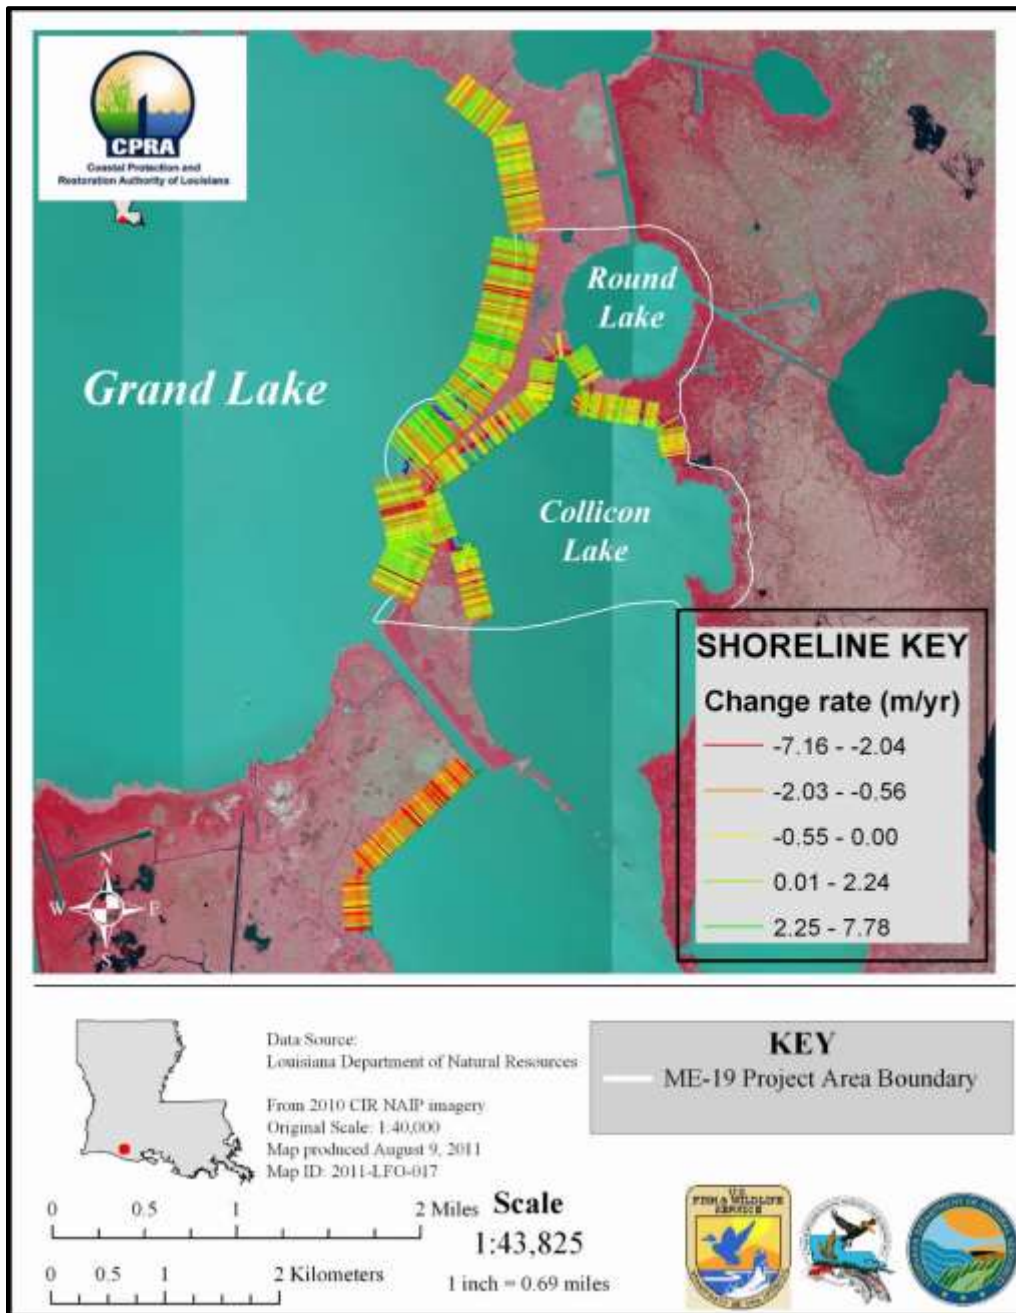
From construction to 2008 the only area to gain land was the project area behind the rock dike on Grand Lake (1.9 m/yr; Figure 6). The rock dike reference area, Collicon Lake project area and reference area lost land (-0.33, -0.06, and -1.26 m/yr, respectively). Since 2008, land has continued to erode in both Grand Lake and Collicon Lake reference areas (-1.73 and -1.38 m/yr, respectively; Figure 7-8). However, there has been land expansion behind the Grand Lake rock dike (0.52 m/yr) and the Collicon Lake project area (1.48 m/yr). Shoreline mapping in 2013 and 2021 revealed several terraces had expanded and merged with the existing shoreline along Collicon Lake (Figure 7). These terraces had vegetation growth that was clearly rooted and not simply floating on the water surface.

**Figure 6.** Shoreline mapping was conducted behind project structures (foreshore rock dike along Grand Lake and terraces along Collicon Lake) and corresponding reference areas of the ME-19 project area soon after construction (foreshore rock dike, November 2003; terraces, October 2004) and in October 2008, 2013 and 2021. The figure is from shoreline mapping post construction and in October 2008. Shoreline movement rates (mean, m/y) were calculated from 20 m spaced transects along Grand Lake and Collicon Lake; negative change rates indicate loss while positive change rates indicate gains.

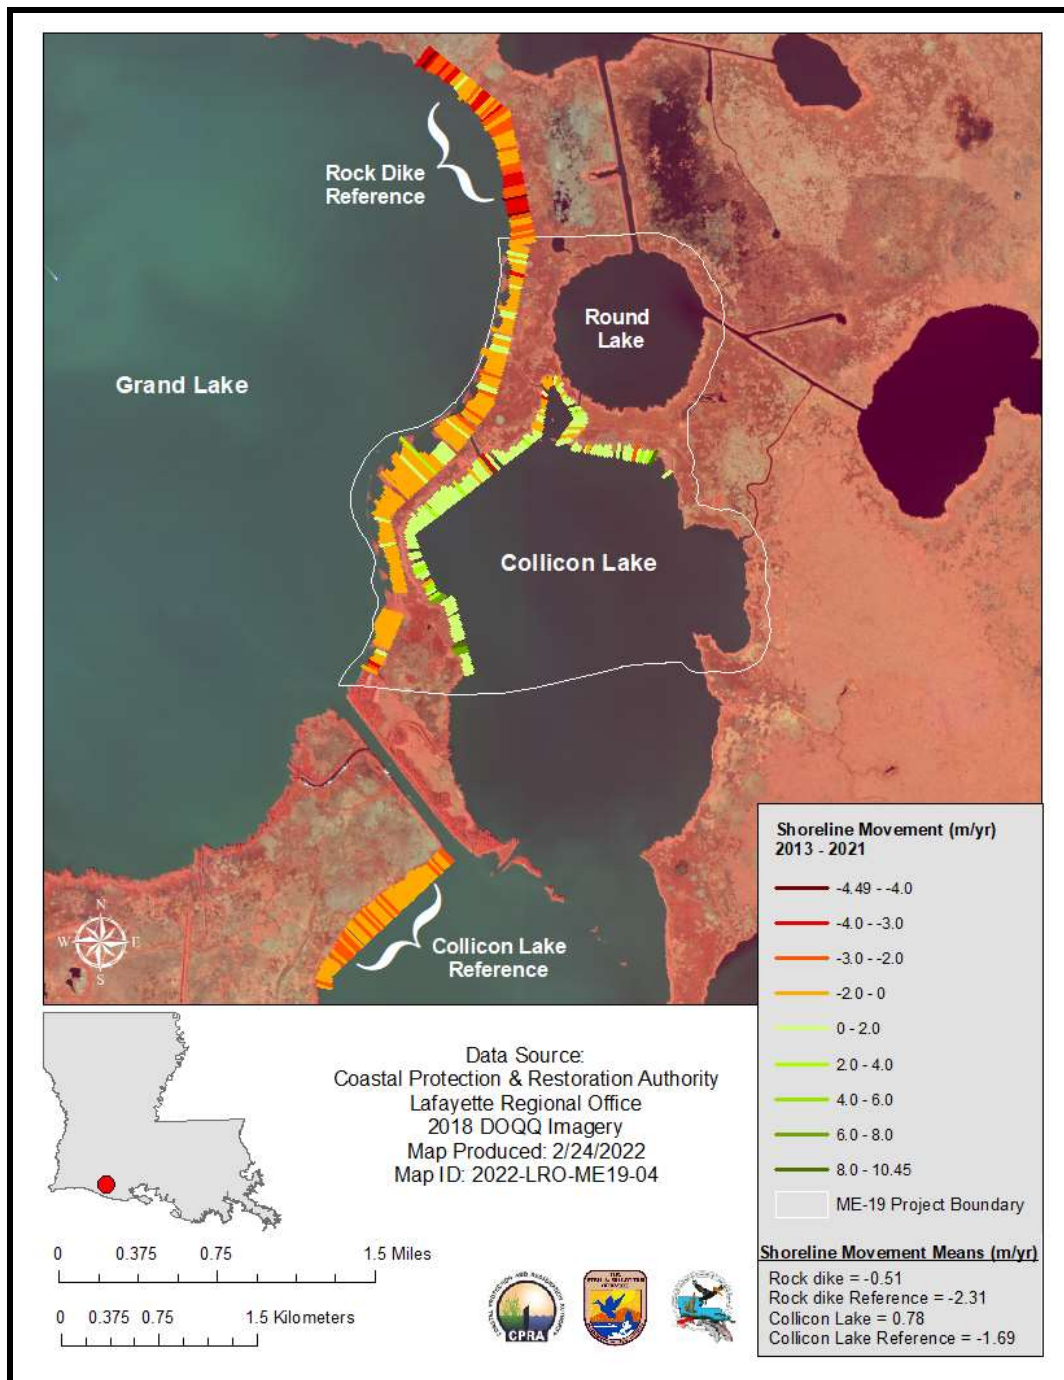
**Figure 7.** Shoreline mapping behind project structures (foreshore rock dike along Grand Lake and terraces along Collicon Lake) and corresponding reference areas of the ME-19 project area in October 2013 and 2021. Negative change rates indicate loss while positive change rates indicate gains.

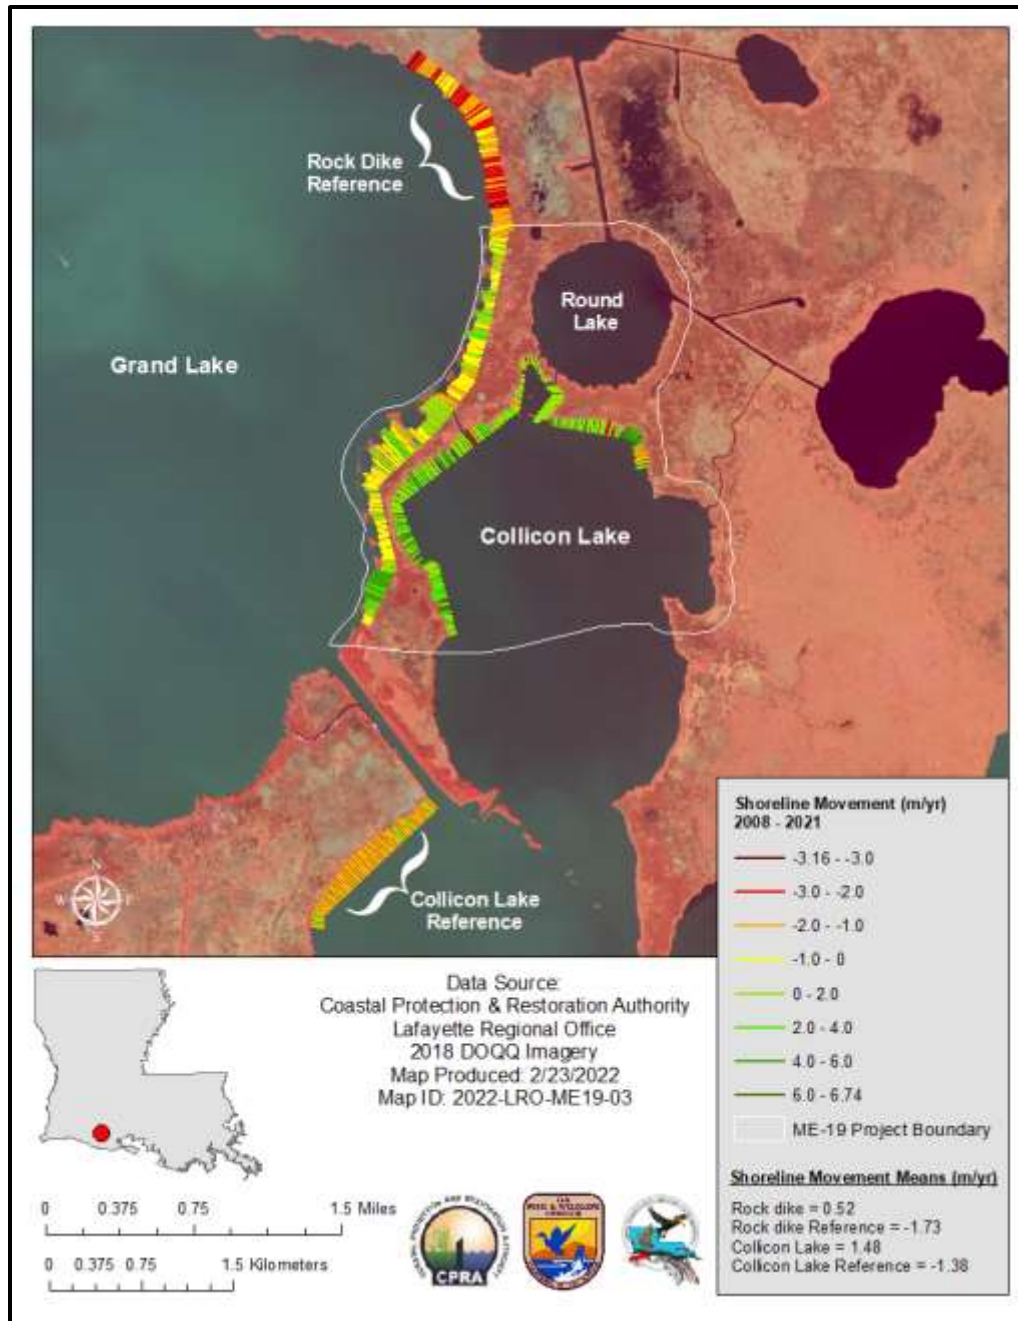
**Figure 8.** Shoreline mapping behind project structures (foreshore rock dike along Grand Lake and terraces along Collicon Lake) and corresponding reference areas of the ME-19 project area in October 2008 and 2021. Negative change rates indicate loss while positive change rates indicate gains.

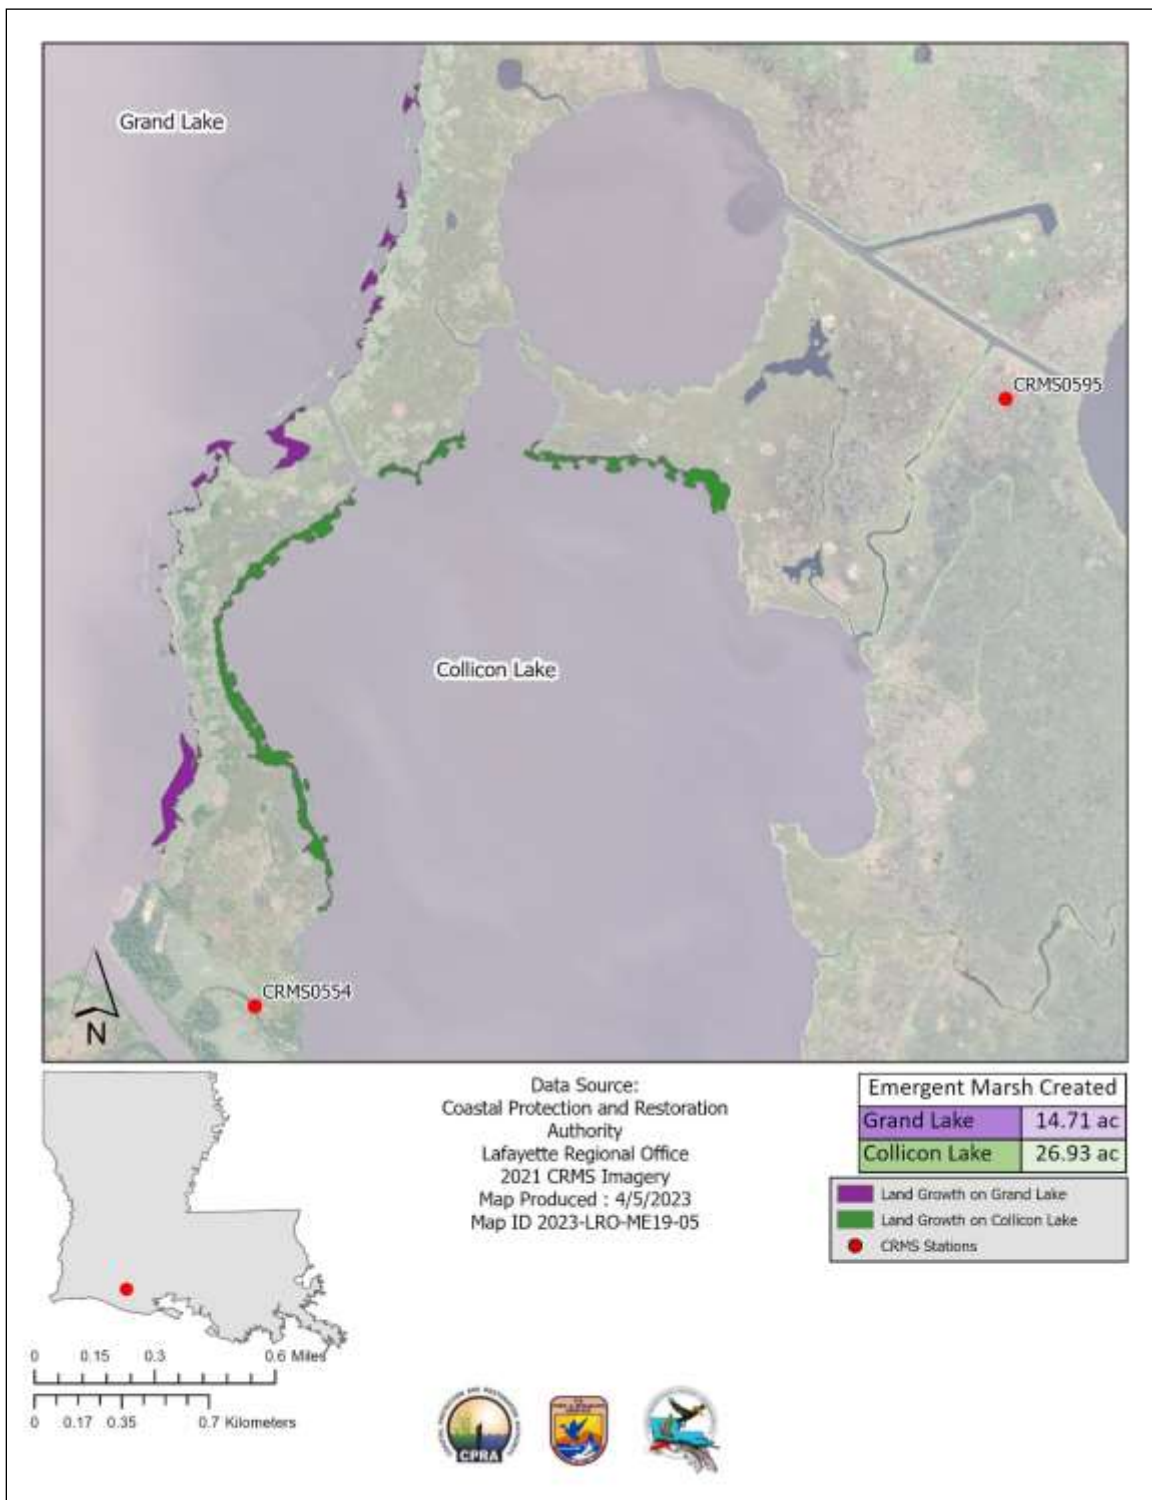
Based on data collected in 2021, the goal of creating more than 10 acres of emergent marsh on the north and west shores of Collicon Lake was achieved, yet the project's goal of creating 17 acres of emergent marsh for the southeastern shore of Grand Lake wasn't achieved (Figure 9). For Collicon Lake, 43 acres of emergent marsh were established, meaning that the marsh creation goal was exceeded by more than 33 acres. For Grand Lake, the goal of 17 acres wasn't achieved as only 10 acres were created by the end of the 2021 data collection. This puts the total amount of created emergent marsh at 53 acres total with the total goal only being set at 27 acres for the combined areas.

**Figure 9.** Illustrated above are the areas that gained emergent marsh after completion of the project. The marsh creation numbers are from the 2004 shoreline shapes subtracted from the 2018 shoreline shapes, giving us the amounts of acreage created.

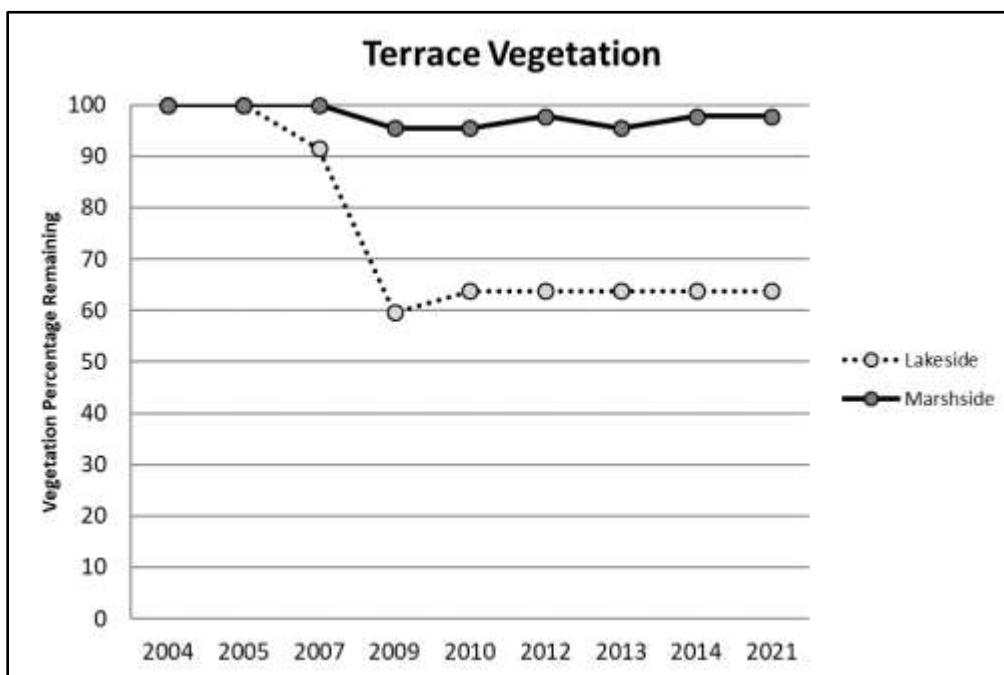
The purpose of the Collicon Lake terraces is to reduce erosion of fringing fresh marsh, create marsh, facilitate marsh building, and stimulate the growth of submerged aquatic vegetation. To achieve this goal, larger lakeside terraces (LS) were constructed to be sacrificial to the marsh side terraces (MS) long enough for the MS terraces to become established and fully revegetate. Based on 2021 aerial imagery, two-thirds (64%) of the LS terraces are still remaining while majority (98%) of the marsh side terraces remain (Figure 11). The 32% decline in LS terraces from 2007 to 2009 is attributed to the immaturity of the planting in a highly exposed environment and the effects of Hurricane Rita. Following the decline, both the LS and MS terraces have remained stable through 2021.

**Figure 11.** Percentages of terraces with vegetation remaining from construction in 2004 to 2021.

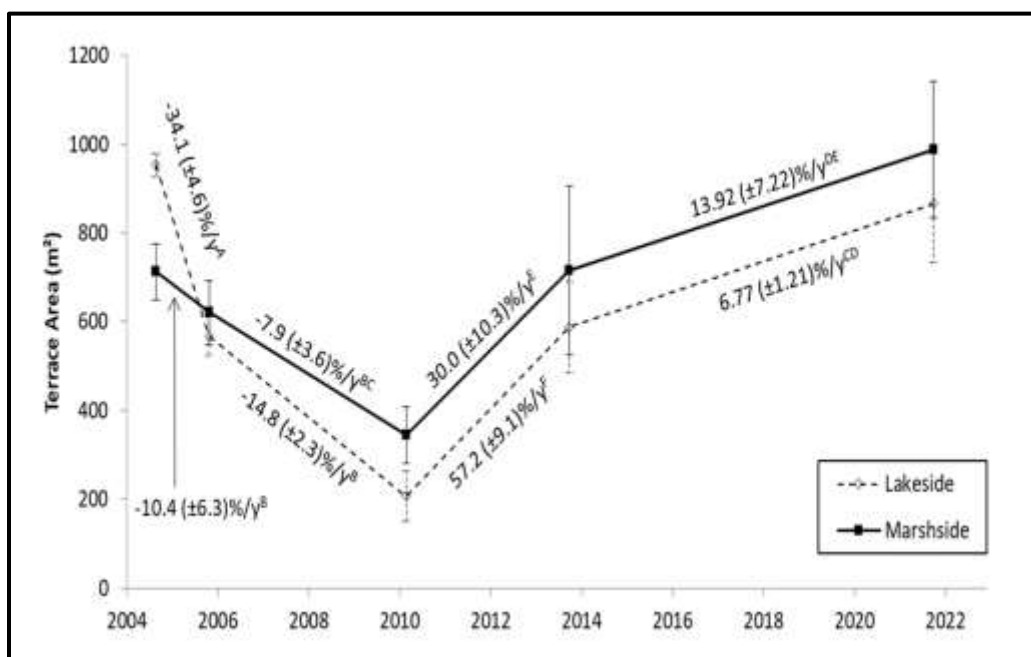
At the twelve terraces used for vegetative evaluation (6 LS and 6 MS), the percent vegetated area of the terraces changed differently by position (lakeside and marsh side) over time intervals based on a robust, full factorial Analysis of Variance terrace position (lakeside and marsh side) and time intervals; the greatest effect was Time Interval while the Position  $\times$  Time Interval effect was significant (Table 2). Initially after construction of the terraces (2004-2005), terrace area sharply eroded as the sacrificial LS terraces also eroded and protected the MS terraces (Figure 12). Erosion slowed, but continued at both terraces positions from 2005 to 2010 (Figure 13). From 2010 to 2013, both terraces began increasing in areas at rates of 57%/yr on the marsh side and 30%/yr on the lakeside. This expansion is attributed to *Phragmites australis* (Roseau cane) expansion on the remnants of the terraces (Figure 14). The LS terraces added a greater percent of area because there

**Figure 12.** Terrace areas were determined for the Collicon Lake terraces for September 2004 (as-built), November 2005, March 2010, October 2013, and October 2021. Rates of change (values over lines) interactions were compared for terrace position (lakeside and marsh side) by time intervals (2004-2005, 2005-2010, 2010-2013, and 2013-2021); different superscript letters indicate significant difference among the rates.

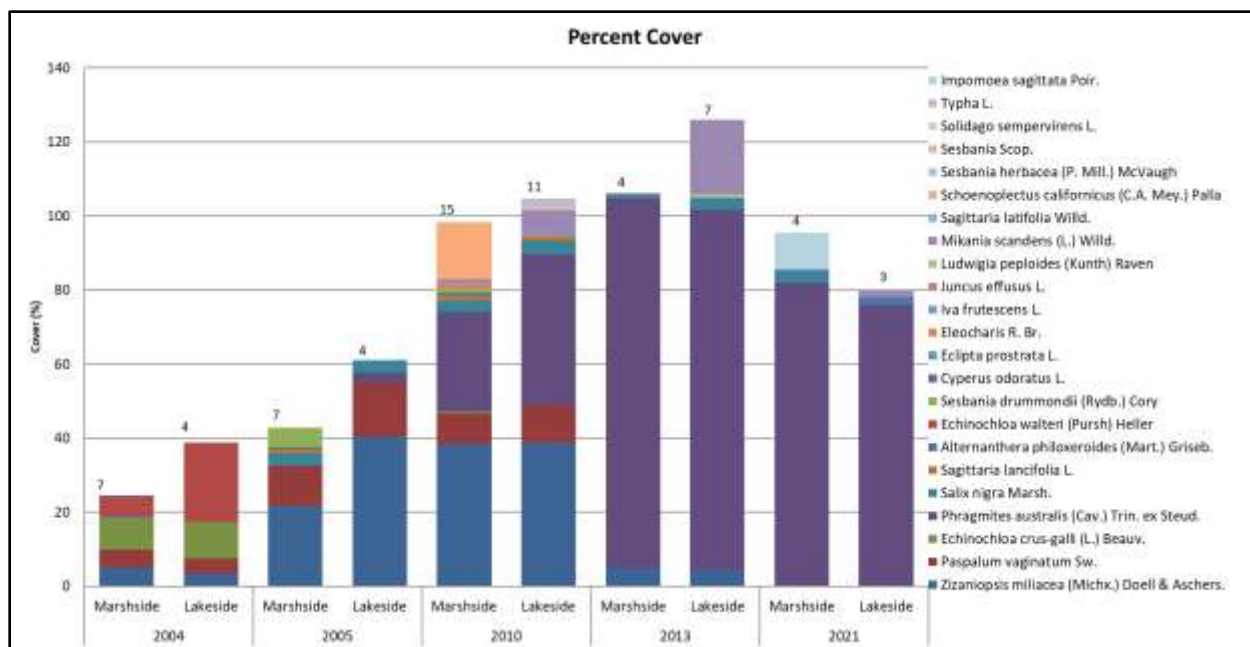
**Figure 15.** Vegetation observed on lakeside and marsh side terraces along Collicon Lake over time in ME-19 project area. Values are the percent area coverage (% Coverage).

During terrace construction, *Zizaniopsis miliacea* was planted on the terrace slopes and *Paspalum vaginatum* was planted on the terrace crowns. These species persisted on the terraces through 2013 before disappearing from both the LS and MS terraces in 2021 (Figure 15). *Echinochloa crus-galli*, which had been manually seeded on the crown, did not occur in the 2005 sampling but was found on one marsh side terrace in 2010 and was gone by 2013. The occurrence and coverage of *Phragmites australis* (Roseau cane) increased over time on both terrace positions. Roseau cane was not planted during the construction of these terraces and in 2005 it occurred at only 1 terrace (LS). By 2010, Roseau cane occurred on all but 1 terrace (MS) and continued to expand on all terraces as it out-competed other species such as *Zizaniopsis miliacea* and *Paspalum vaginatum* to become the dominant species on both terraces. Both percent cover and occurrence experienced a decline from 2020 to 2021 due to the effects of Hurricanes Laura and Delta.
