2024 Operations, Maintenance, and Monitoring Report

Grand-White Lake Land Bridge Protection

State Project Number ME-19
Priority Project List 10

February 2024
Cameron Parish

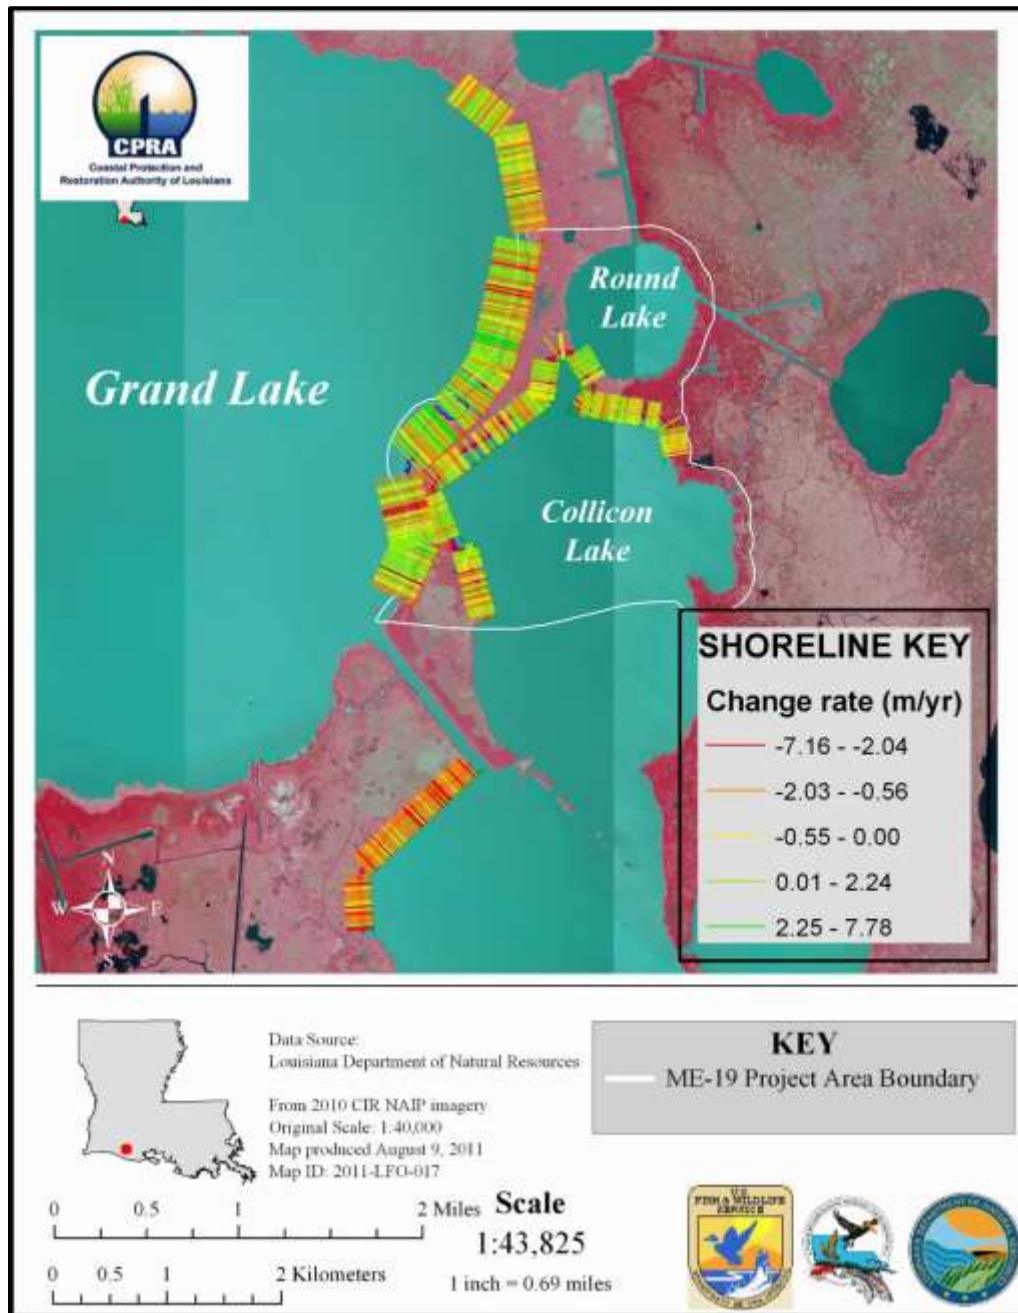
From construction to 2008 the only area to gain land was the project area behind the rock dike on Grand Lake (1.9 m/yr; Figure 6). The rock dike reference area, Collicon Lake project area and reference area lost land (-0.33, -0.06, and -1.26 m/yr, respectively). Since 2008, land has continued to erode in both Grand Lake and Collicon Lake reference areas (-1.73 and -1.38 m/yr, respectively; Figure 7-8). However, there has been land expansion behind the Grand Lake rock dike (0.52 m/yr) and the Collicon Lake project area (1.48 m/yr). Shoreline mapping in 2013 and 2021 revealed several terraces had expanded and merged with the existing shoreline along Collicon Lake (Figure 7). These terraces had vegetation growth that was clearly rooted and not simply floating on the water surface.

Figure 6. Shoreline mapping was conducted behind project structures (foreshore rock dike along Grand Lake and terraces along Collicon Lake) and corresponding reference areas of the ME-19 project area soon after construction (foreshore rock dike, November 2003; terraces, October 2004) and in October 2008, 2013 and 2021. The figure is from shoreline mapping post construction and in October 2008. Shoreline movement rates (mean, m/y) were calculated from 20 m spaced transects along Grand Lake and Collicon Lake; negative change rates indicate loss while positive change rates indicate gains.

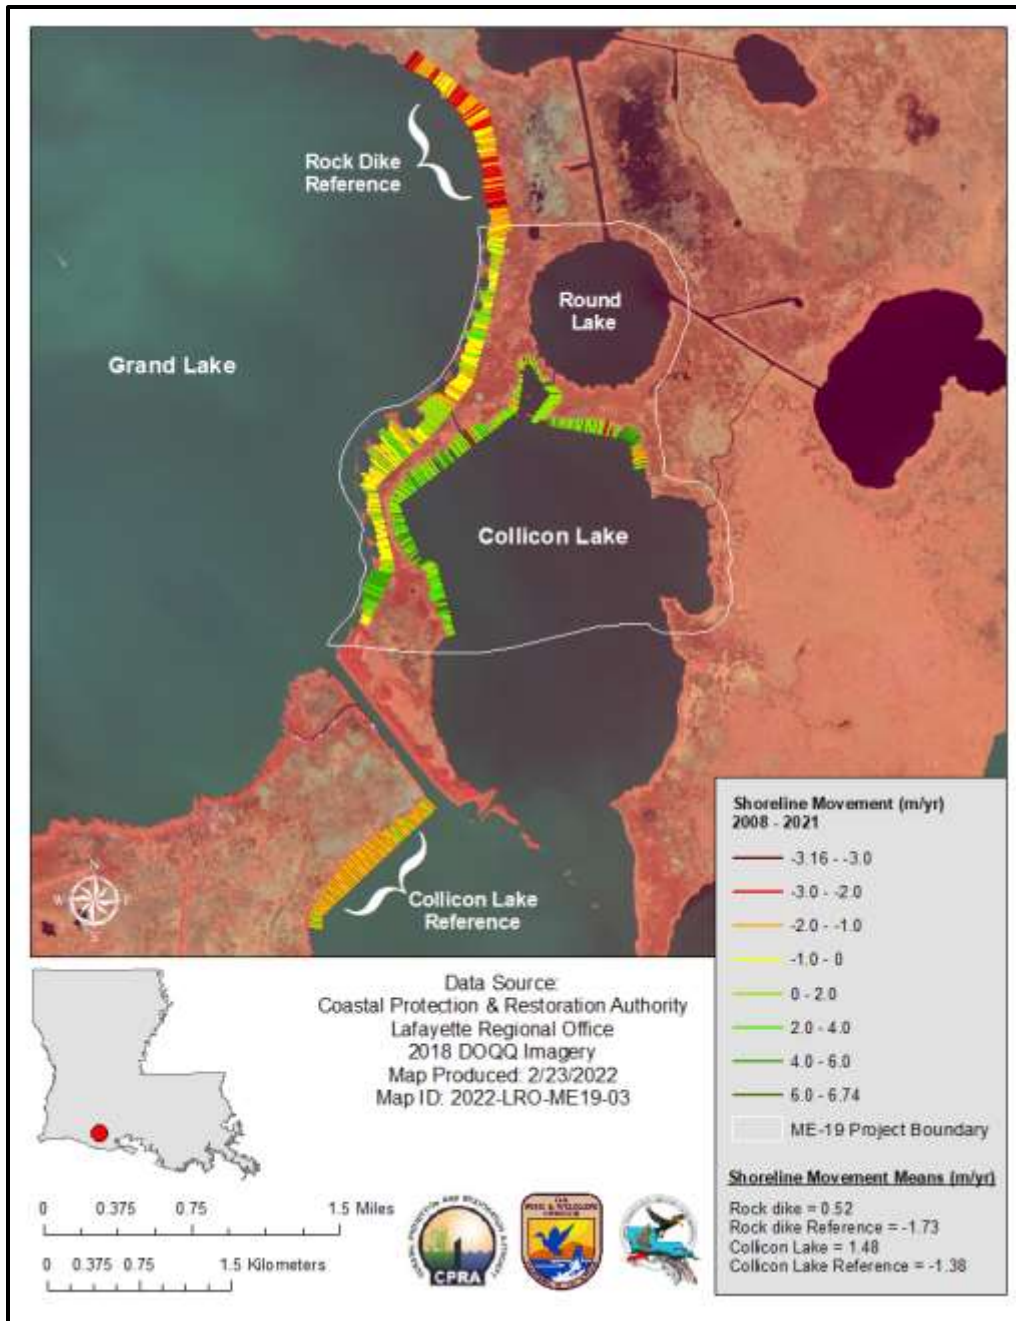
Figure 8. Shoreline mapping behind project structures (foreshore rock dike along Grand Lake and terraces along Collicon Lake) and corresponding reference areas of the ME-19 project area in October 2008 and 2021. Negative change rates indicate loss while positive change rates indicate gains.

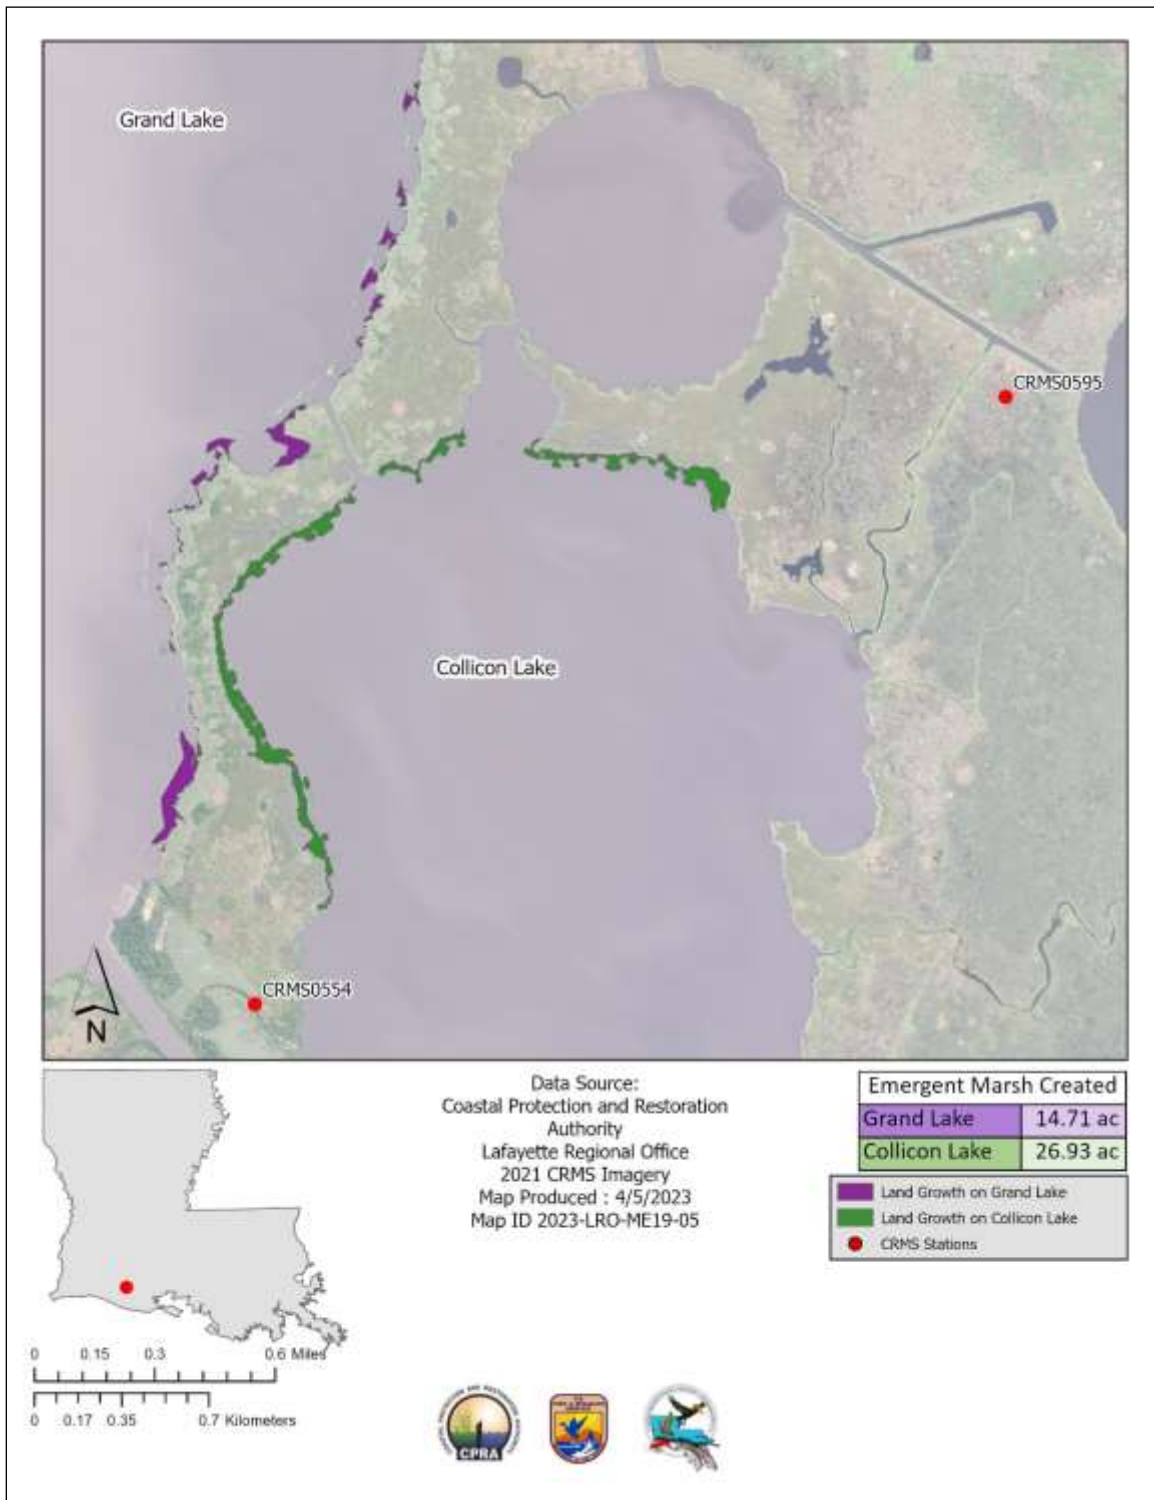
Based on data collected in 2021, the goal of creating more than 10 acres of emergent marsh on the north and west shores of Collicon Lake was achieved, yet the project's goal of creating 17 acres of emergent marsh for the southeastern shore of Grand Lake wasn't achieved (Figure 9). For Collicon Lake, 43 acres of emergent marsh were established, meaning that the marsh creation goal was exceeded by more than 33 acres. For Grand Lake, the goal of 17 acres wasn't achieved as only 10 acres were created by the end of the 2021 data collection. This puts the total amount of created emergent marsh at 53 acres total with the total goal only being set at 27 acres for the combined areas.

Figure 9. Illustrated above are the areas that gained emergent marsh after completion of the project. The marsh creation numbers are from the 2004 shoreline shapes subtracted from the 2018 shoreline shapes, giving us the amounts of acreage created.

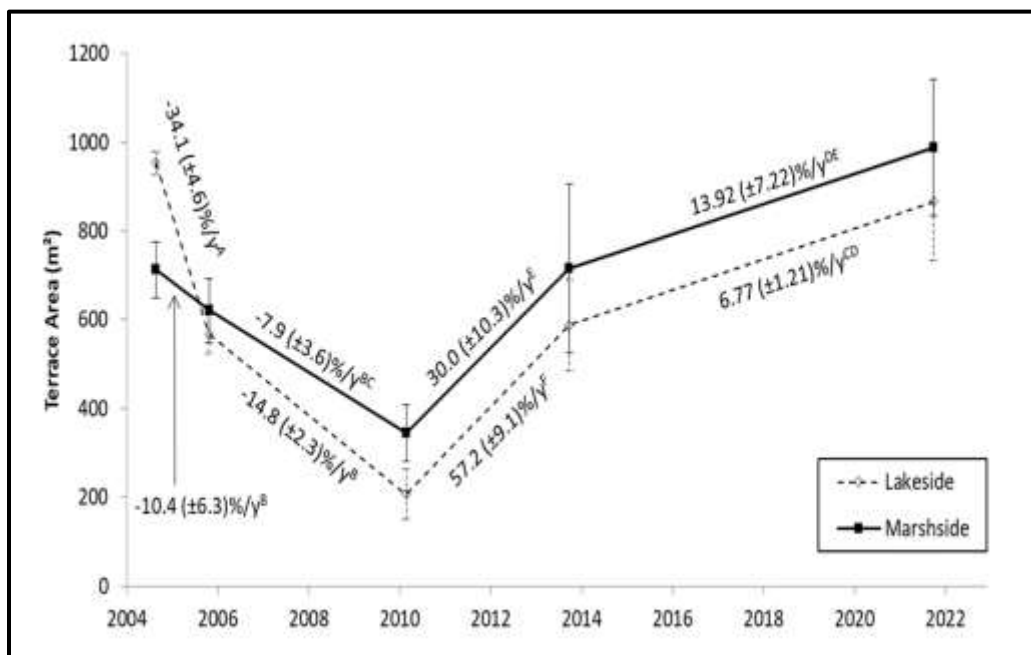
At the twelve terraces used for vegetative evaluation (6 LS and 6 MS), the percent vegetated area of the terraces changed differently by position (lakeside and marsh side) over time intervals based on a robust, full factorial Analysis of Variance terrace position (lakeside and marsh side) and time intervals; the greatest effect was Time Interval while the Position \times Time Interval effect was significant (Table 2). Initially after construction of the terraces (2004-2005), terrace area sharply eroded as the sacrificial LS terraces also eroded and protected the MS terraces (Figure 12). Erosion slowed, but continued at both terraces positions from 2005 to 2010 (Figure 13). From 2010 to 2013, both terraces began increasing in areas at rates of 57%/yr on the marsh side and 30%/yr on the lakeside. This expansion is attributed to *Phragmites australis* (Roseau cane) expansion on the remnants of the terraces (Figure 14). The LS terraces added a greater percent of area because there

Figure 12. Terrace areas were determined for the Collicon Lake terraces for September 2004 (as-built), November 2005, March 2010, October 2013, and October 2021. Rates of change (values over lines) interactions were compared for terrace position (lakeside and marsh side) by time intervals (2004-2005, 2005-2010, 2010-2013, and 2013-2021); different superscript letters indicate significant difference among the rates.
