**Coastal Protection and Restoration
Authority of Louisiana (CPRA)**

2024/2025 Annual Inspection Report

SOUTH WHITE LAKE SHORELINE PROTECTION

State Project Number ME-0022
Priority Project List #12

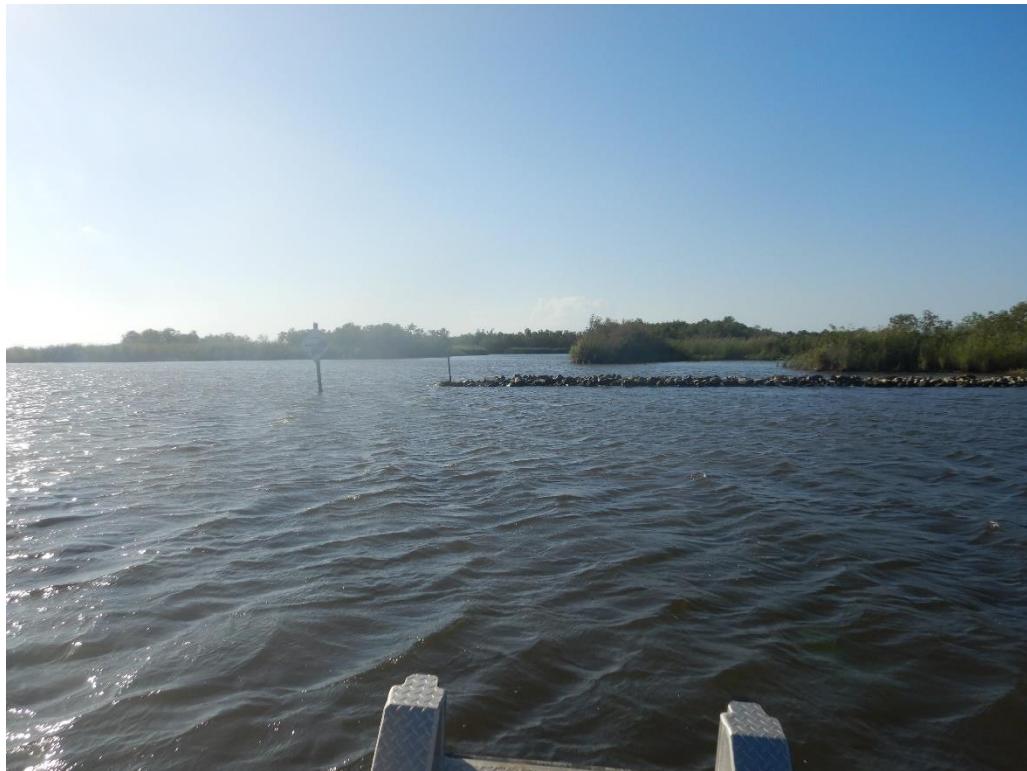
Photo 3: Photograph of ME-22 Rock Rip Rap Shoreline Protection Feature, Pictured Near Eastern End of Project Footprint, Warning Sign Shown, Facing South

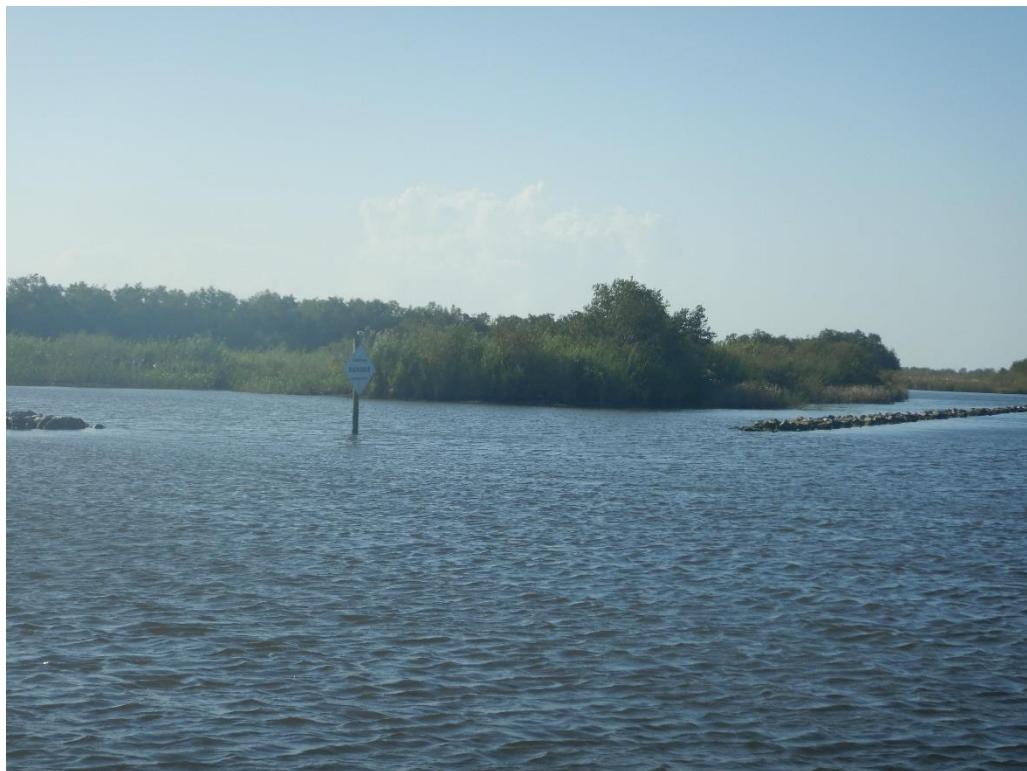
Photo 4: Photograph of ME-22 Rock Rip Rap Shoreline Protection Feature, Pictured Near Eastern End of Project Footprint, Warning Sign and Fisheries Access Gap Shown, Facing Southwest

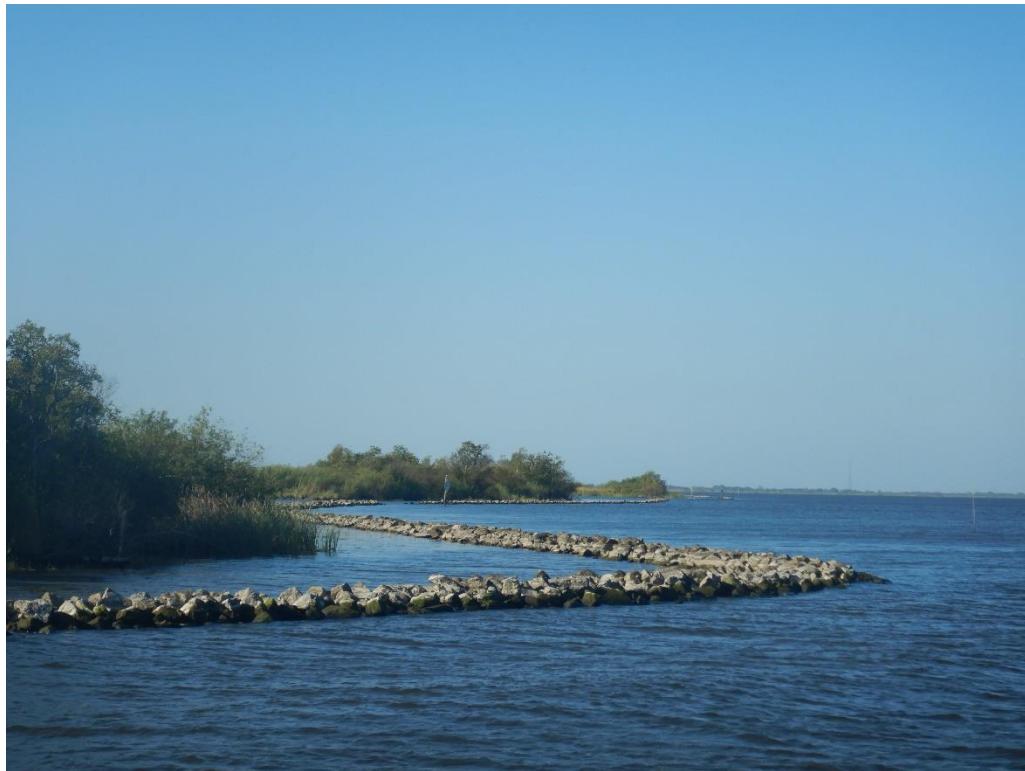
Photo 5: Zoomed-In View of ME-22 Rock Rip Rap Shoreline Protection Feature, Facing West

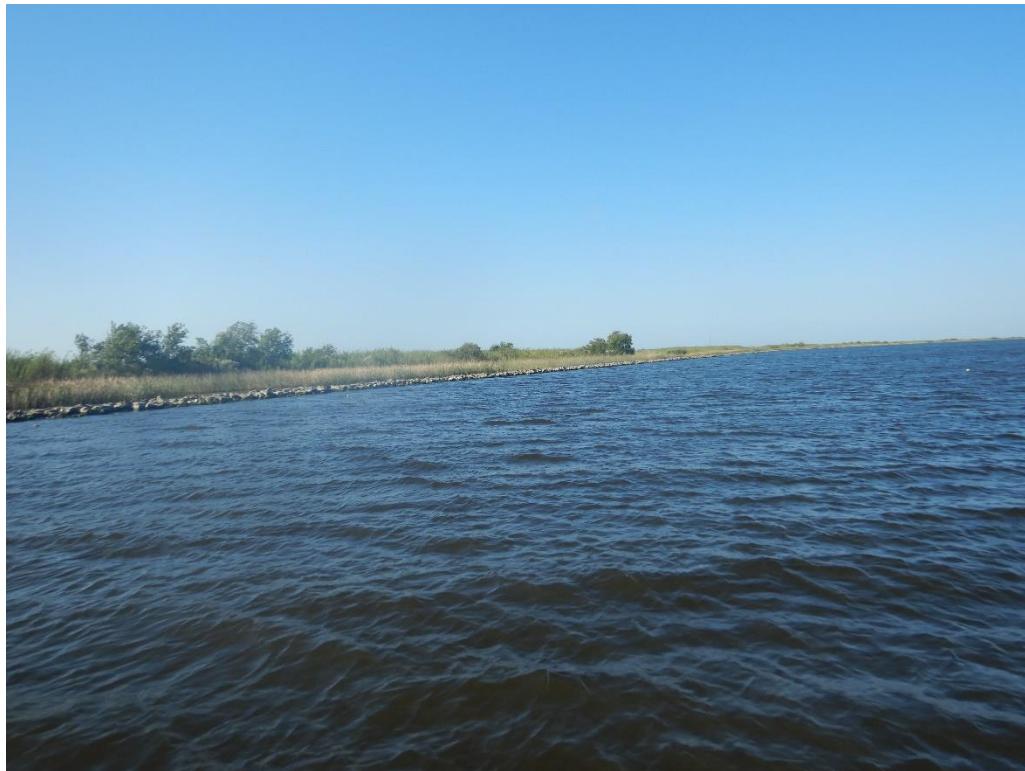
Photo 9: Photograph of ME-22 Rock Rip Rap Shoreline Protection Feature, Pictured Near Central Portion of Project Footprint, Facing Southwest

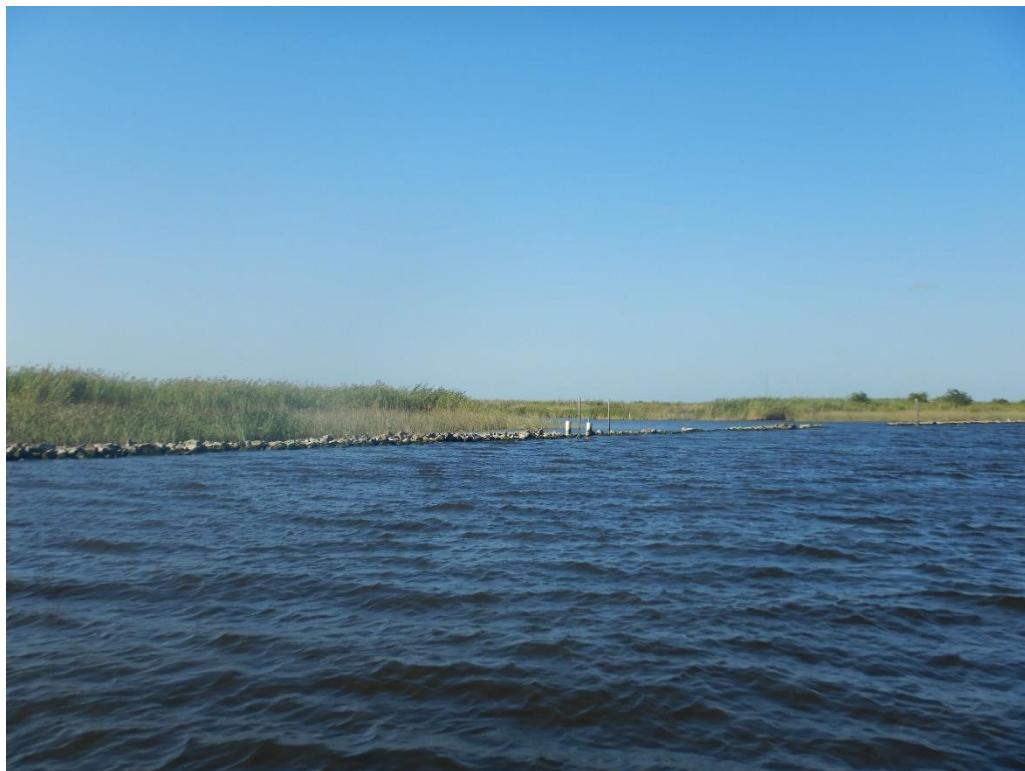
Photo 10: Photograph of ME-22 Rock Rip Rap Shoreline Protection Feature, Pictured Near Central Portion of Project Footprint, Facing Southwest

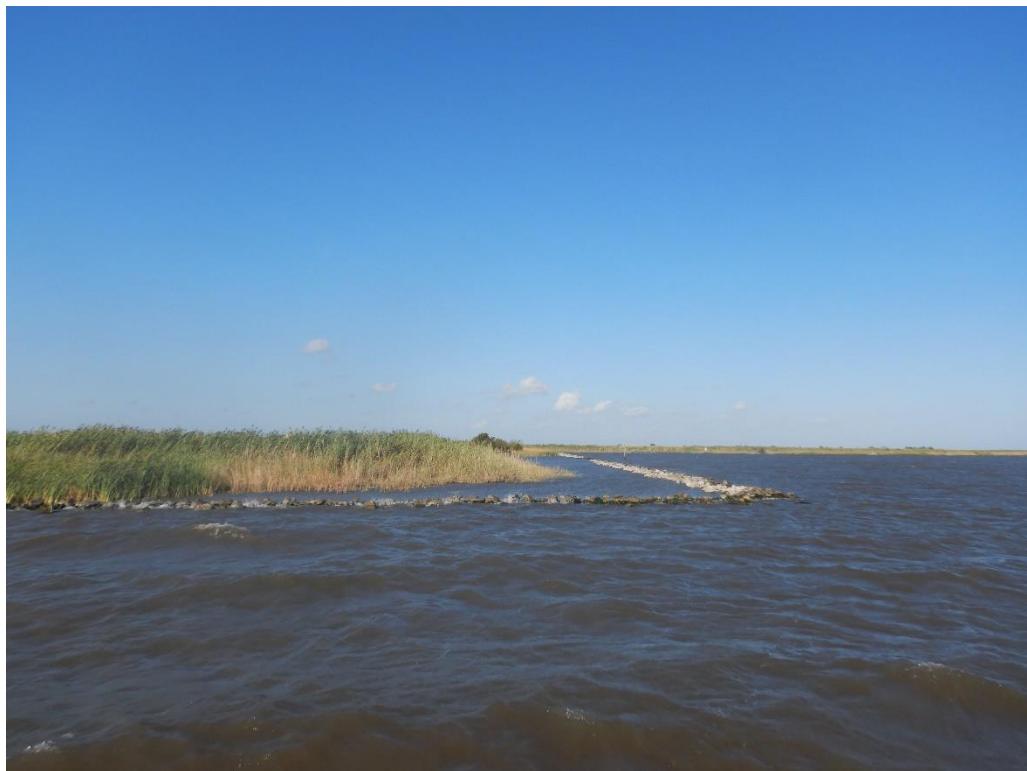
Photo 14: Photograph of ME-22 Rock Rip Rap Shoreline Protection Feature, Pictured Near Western End of Project Footprint, Facing West

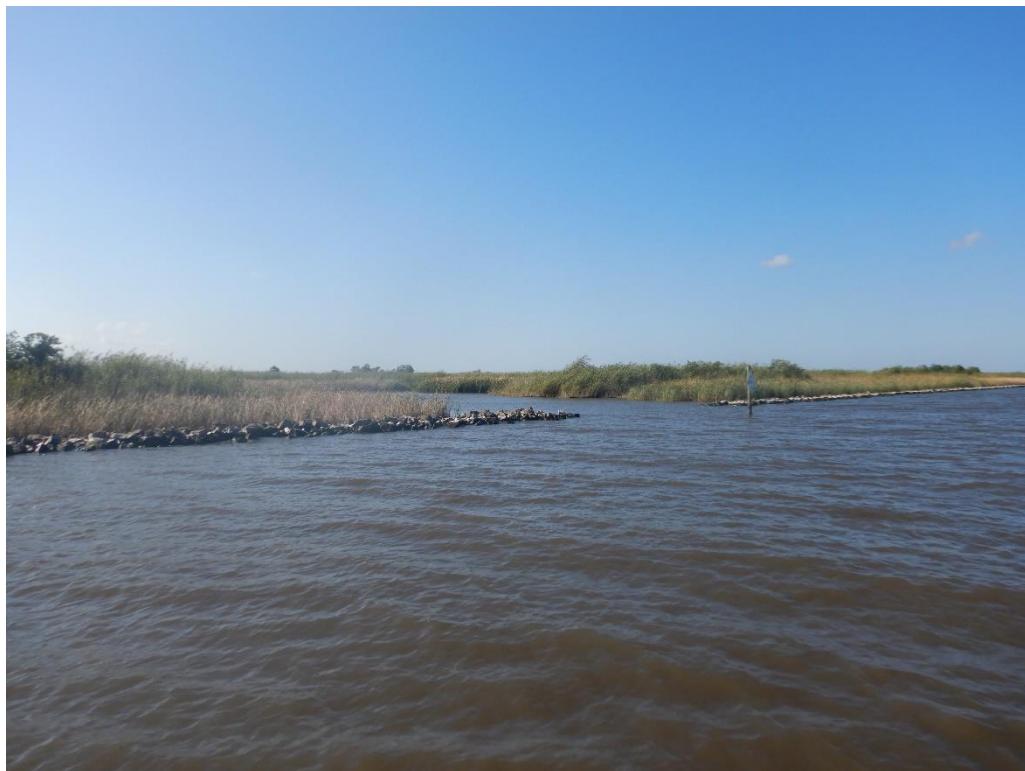
Photo 16: View of ME-22 Rock Rip Rap Shoreline Protection Feature, Near Warning Sign and Fisheries Access Gap, Facing Southwest

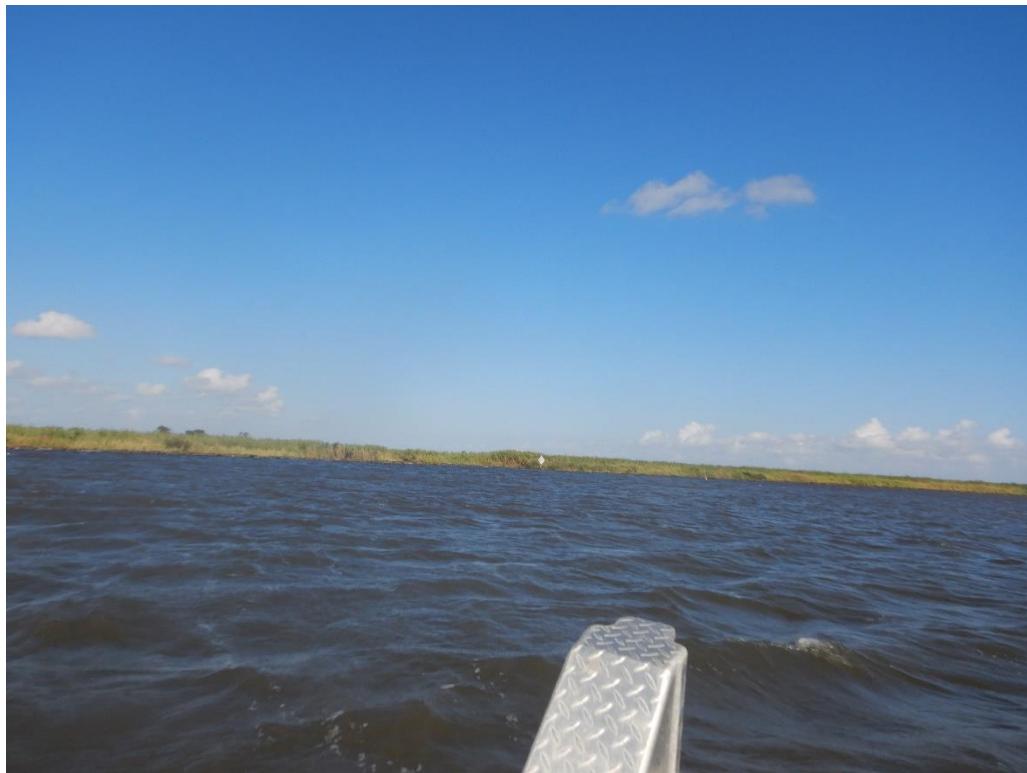
Photo 17: View of ME-22 Rock Rip Rap Shoreline Protection Feature, Facing Southwest

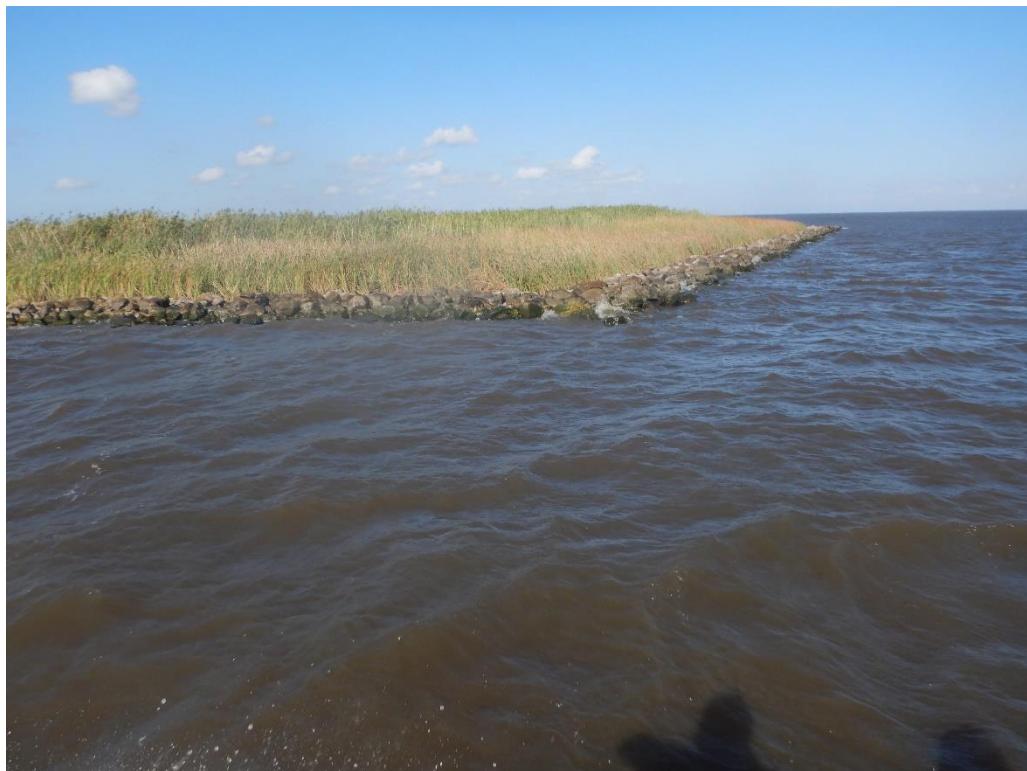
Photo 18: View of ME-22 Rock Rip Rap Shoreline Protection Feature, Pictured Near Entrance Into Bear Lake, Facing West

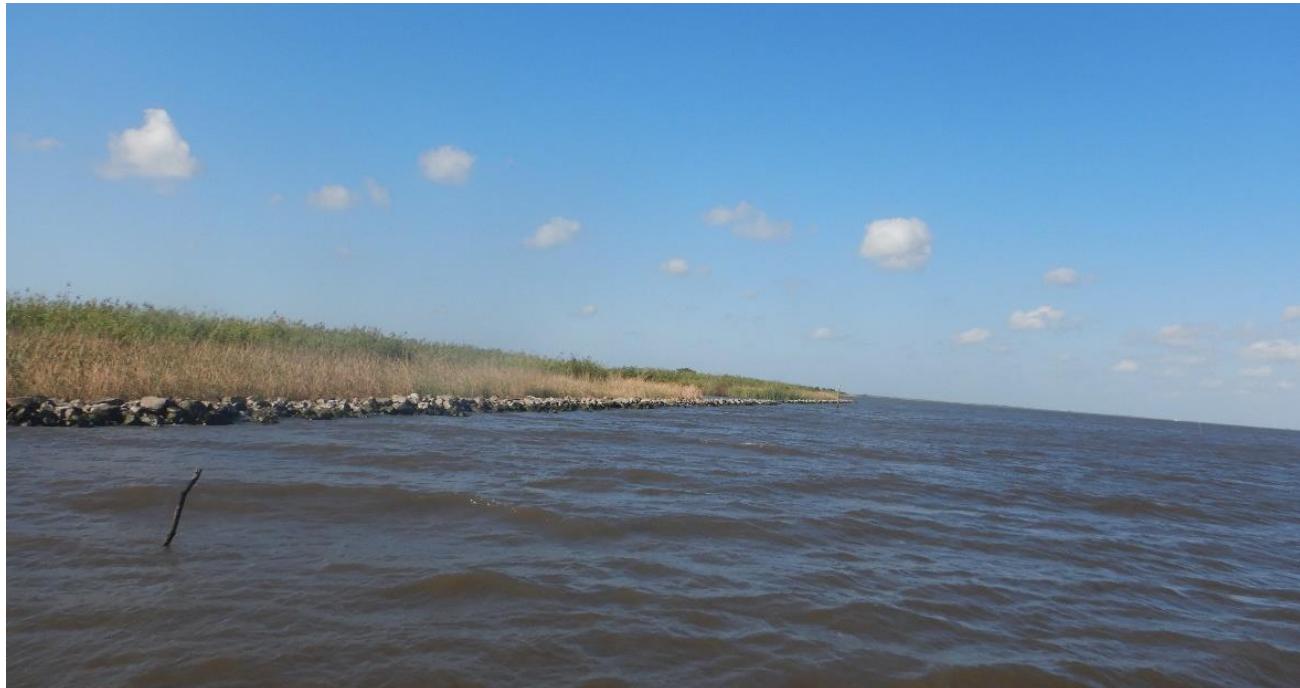
Photo 19: View of ME-22 Rock Rip Rap Shoreline Protection Feature, Pictured From Within Bear Lake

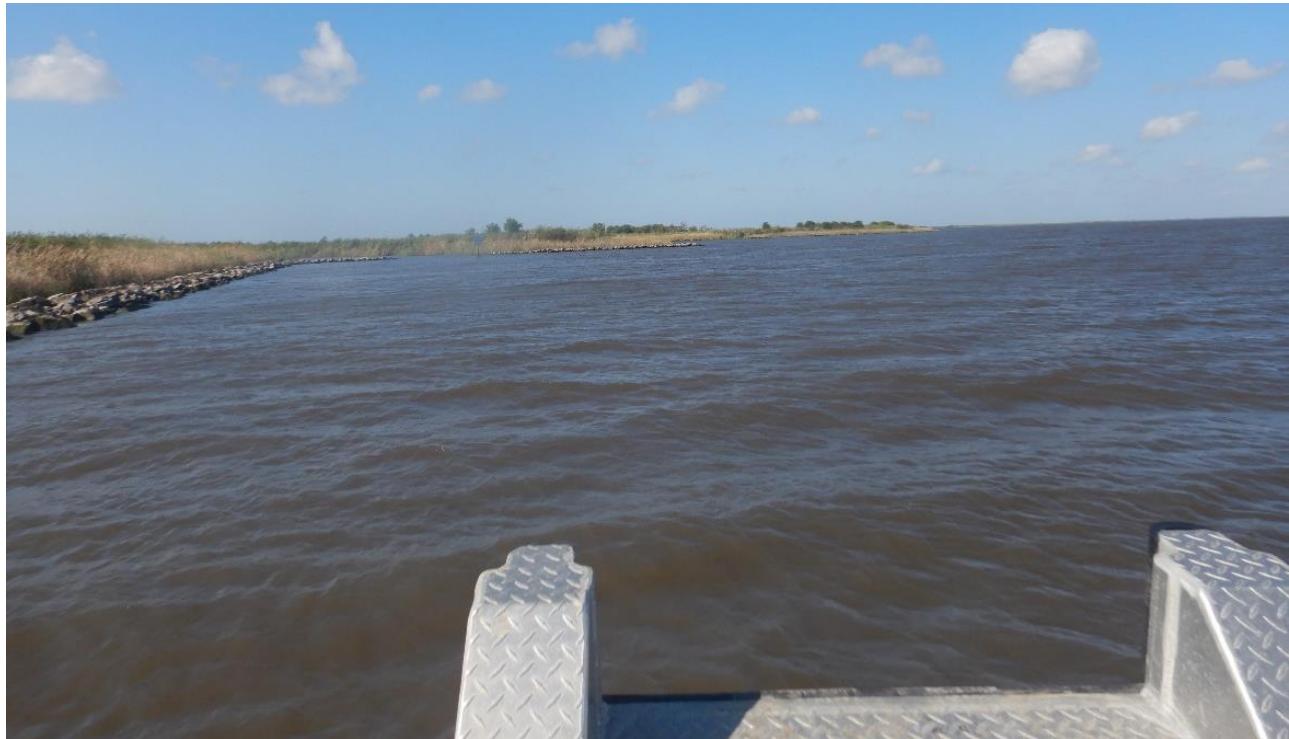
Photo 20: View of ME-22 Rock Rip Rap Shoreline Protection Feature, Pictured From Within Bear Lake

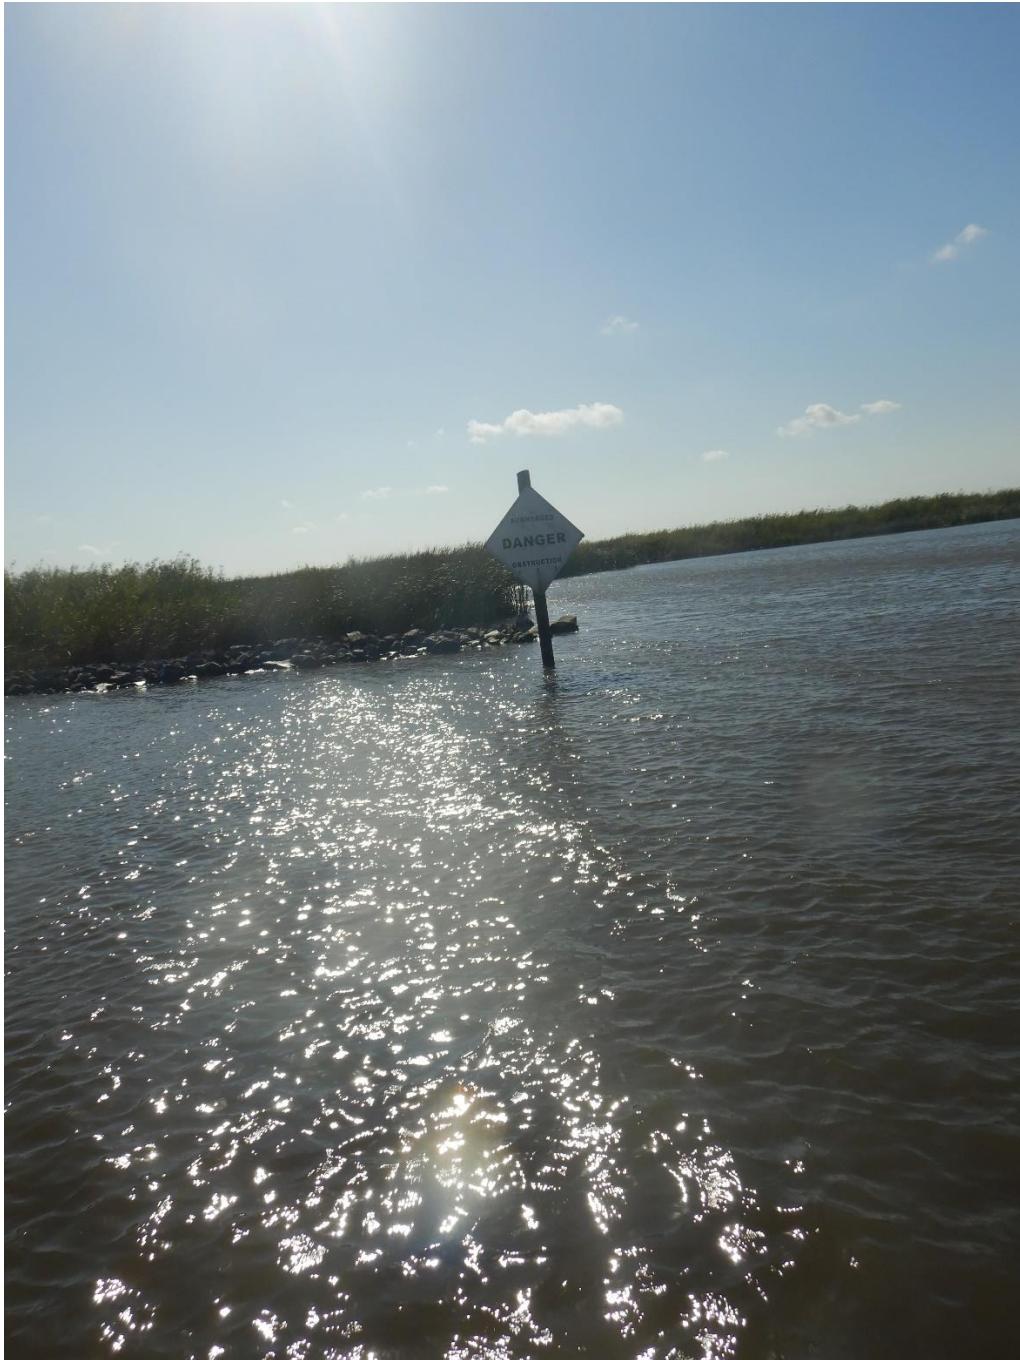
Photo 21: Photograph of ME-22 Rock Rip Rap Shoreline Protection Feature, Pictured Near Western End of Project Footprint, Warning Sign Shown, Facing South
