2022 Operations, Maintenance and Monitoring Report

South White Lake Shoreline Protection

State Project Number ME-22 Priority Project List 13

December 2022 Vermilion Parish

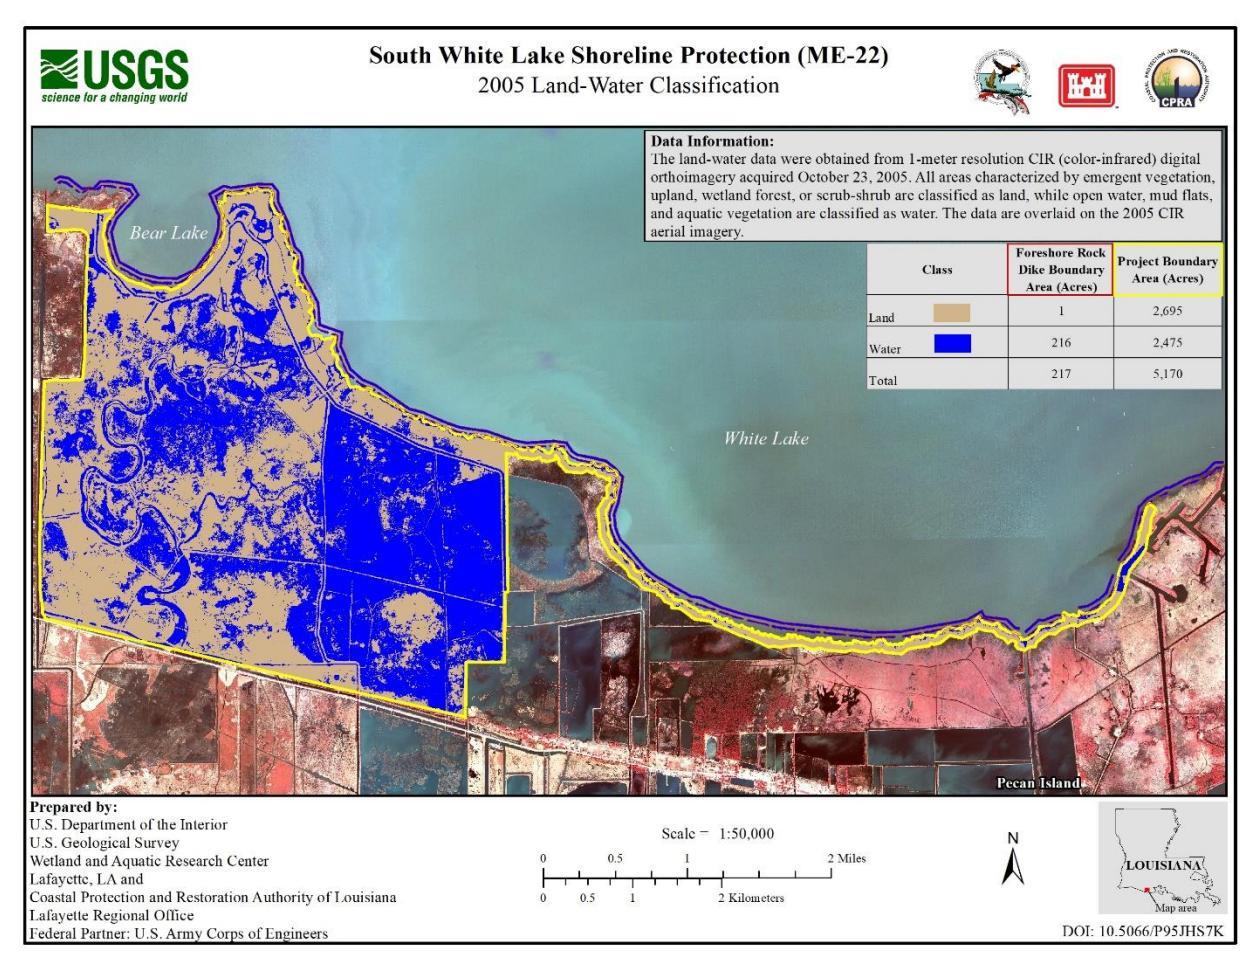
Imagery collected in 2005 (Figure 2) indicated that between the foreshore rock dike and the White Lake shoreline there was one acre of land and 216 acres of water. Subsequent imagery obtained in 2018 (Figure 3) shows an increase in land to 80 acres with 137 acres of water. While the project goal to create 157 acres of emergent marsh was not achieved, the installation of a foreshore rock dike and beneficial use of dredge material was successful in creating 79 acres of new emergent marsh where there was once only water.

Figure 2. Analysis showing the acreage of land and water in the project area of South White Lake Shoreline Protection (ME-22) in 2005.

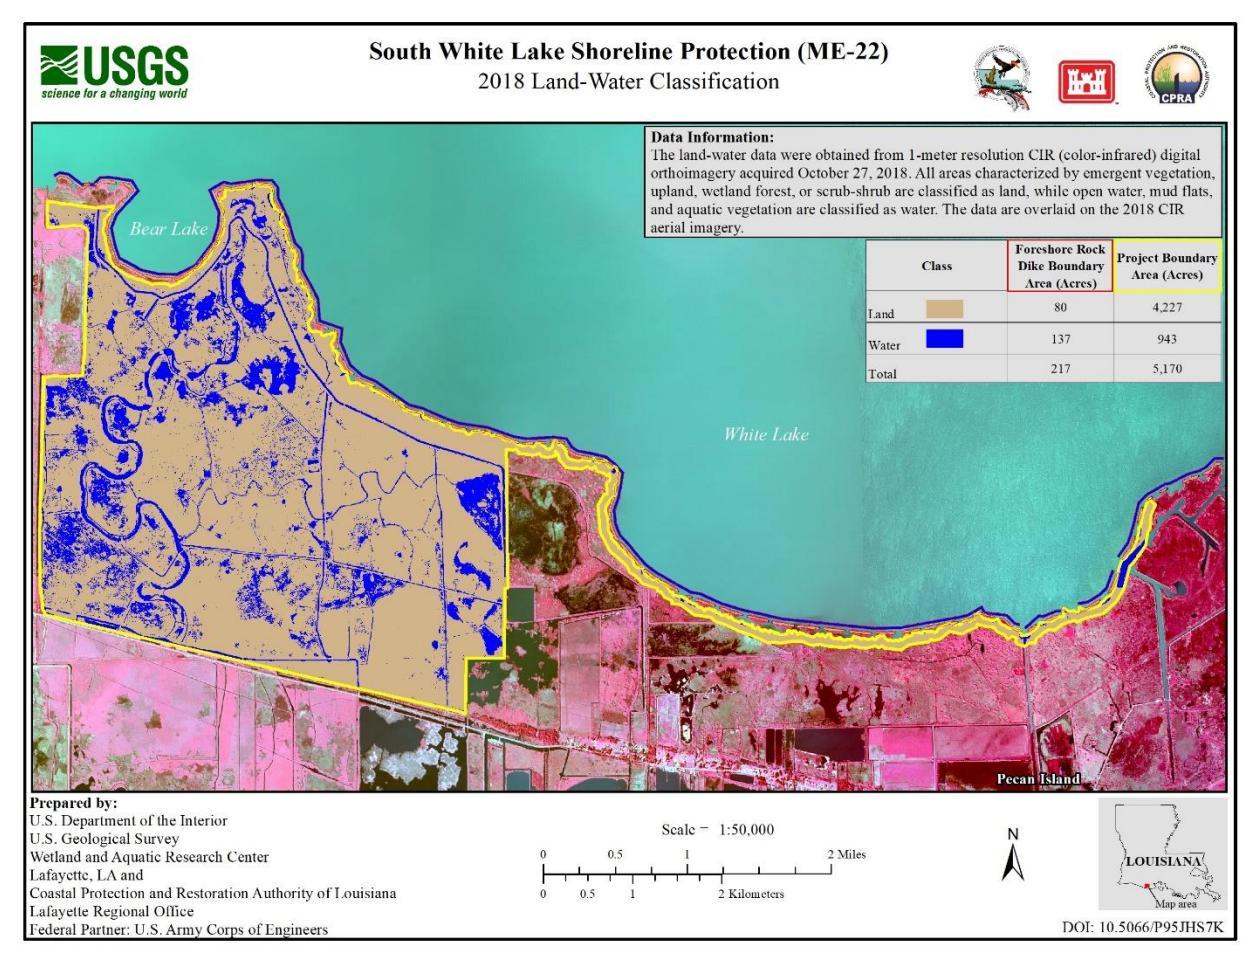
Figure 3. Analysis showing the acreage of land and water in the project area of South White Lake Shoreline Protection (ME-22) in 2018.

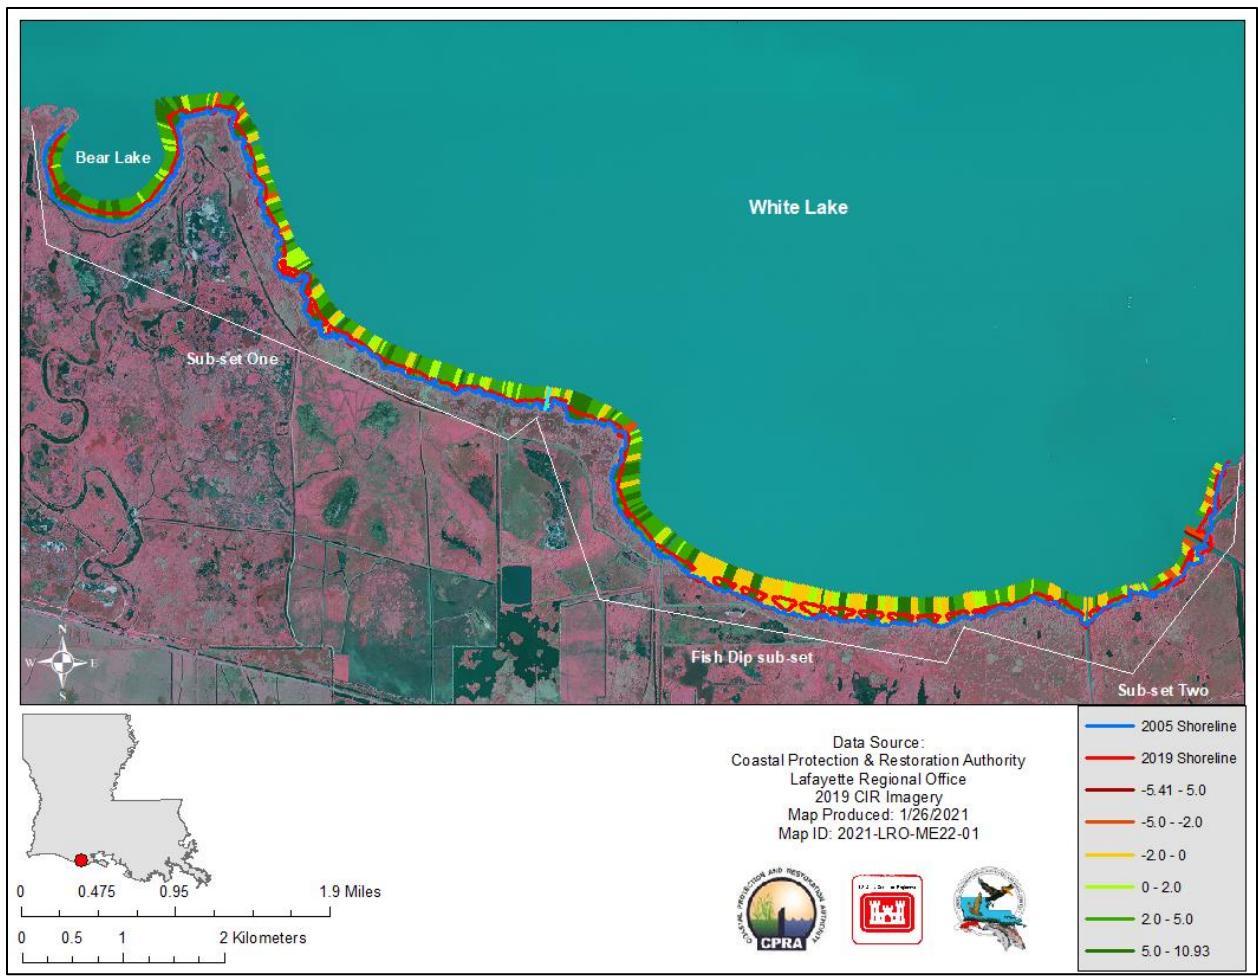
Figure 4. Overall shoreline change rates between 2005 (pre-construction) and 2019. Initial construction was completed in August 2006; Hurricane Lili occurred in October 2002, Hurricane Rita occurred in September 2005, Hurricane Ike occurred in September 2008 and Hurricane Barry occurred in July 2019.

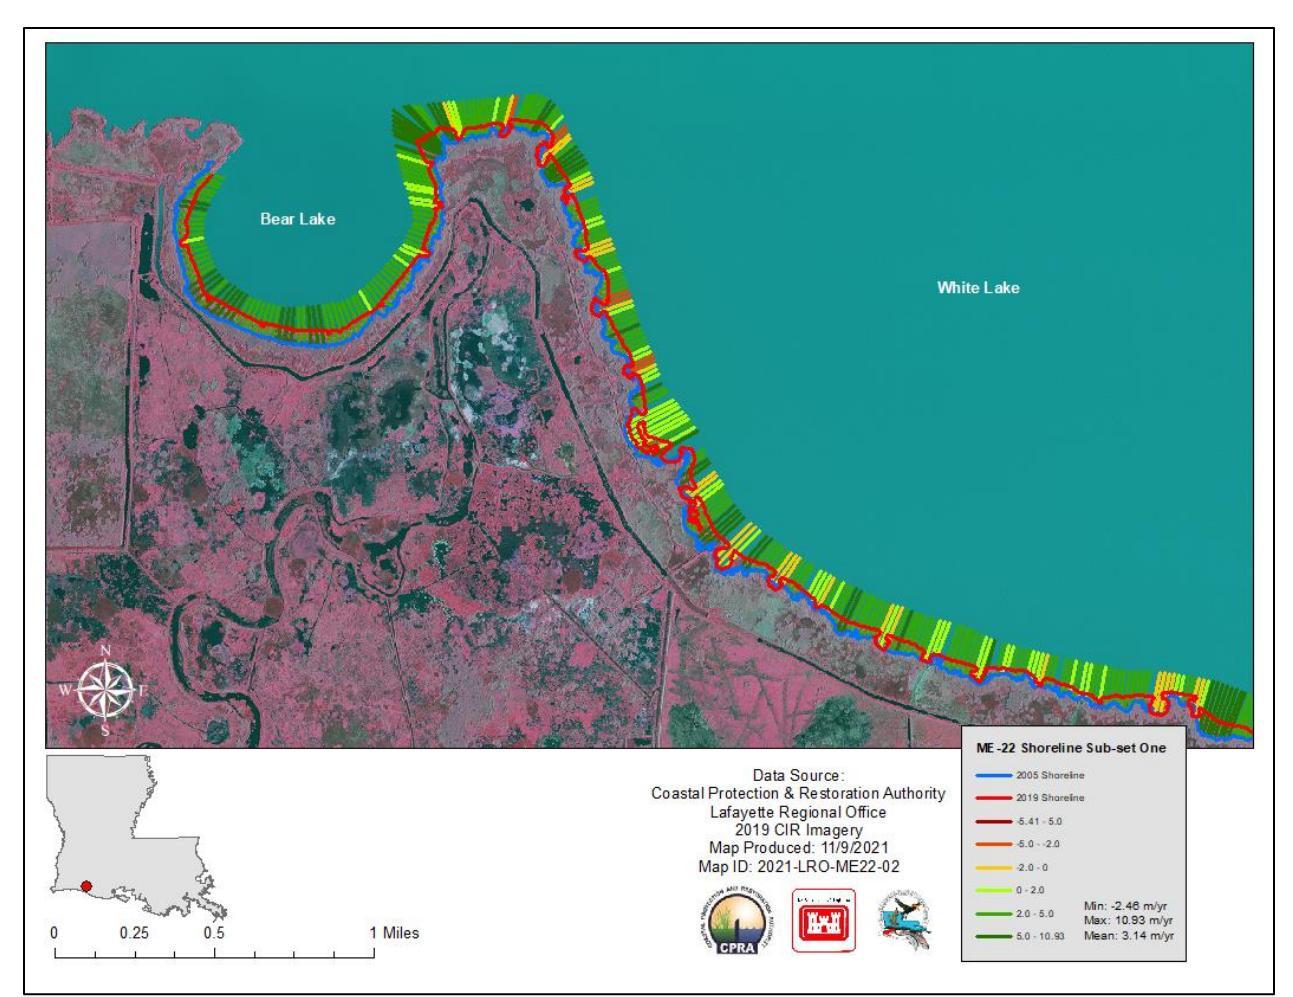
Figure 5. Shoreline change rates of Sub-set One between 2005 (pre-construction) and 2019.

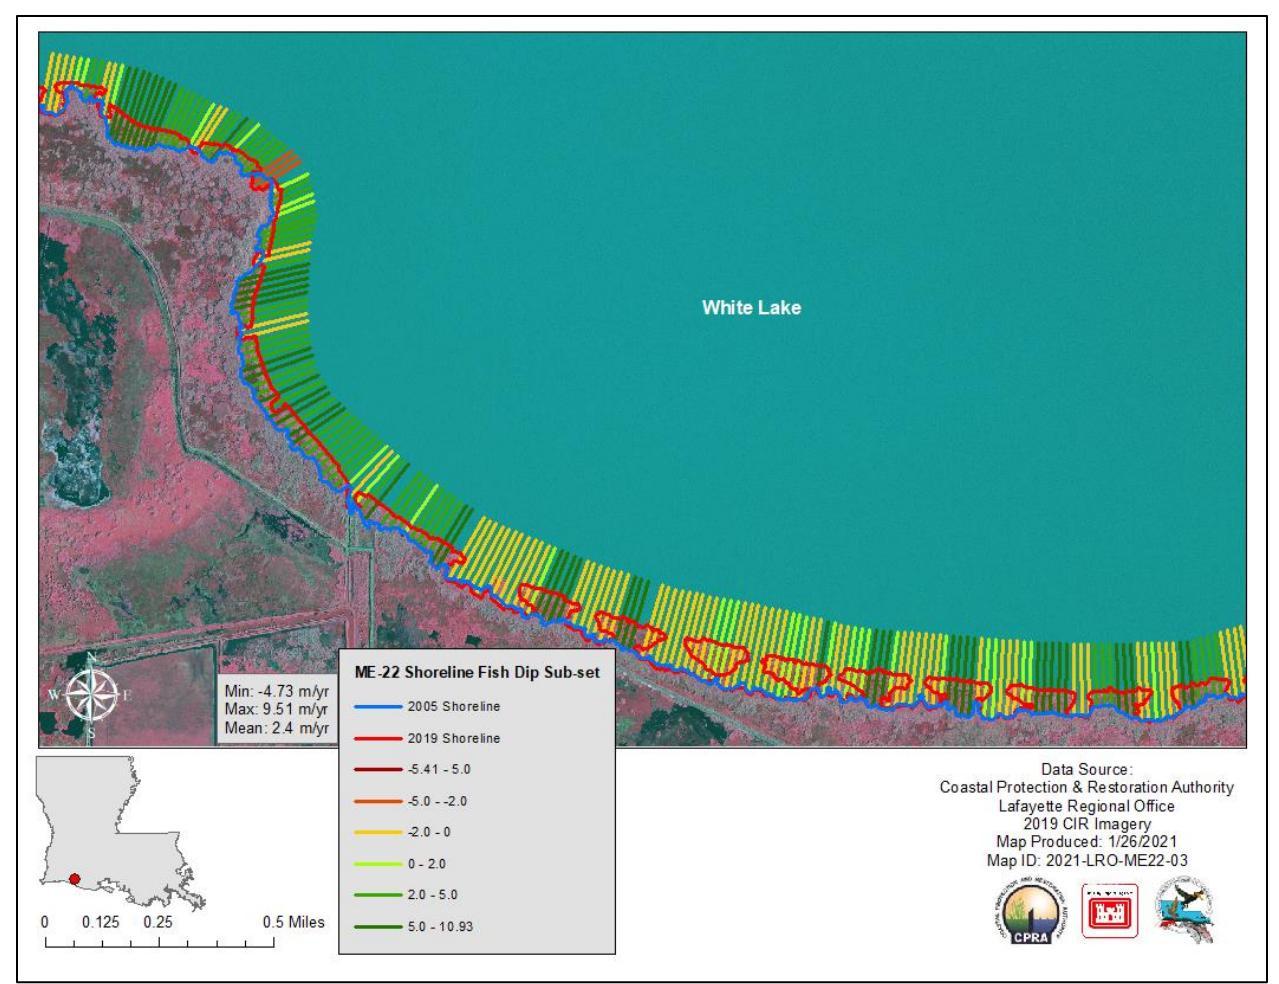
Figure 6. Shoreline change rates of Fish Dip Sub-set between 2005 (pre-construction) and 2019.

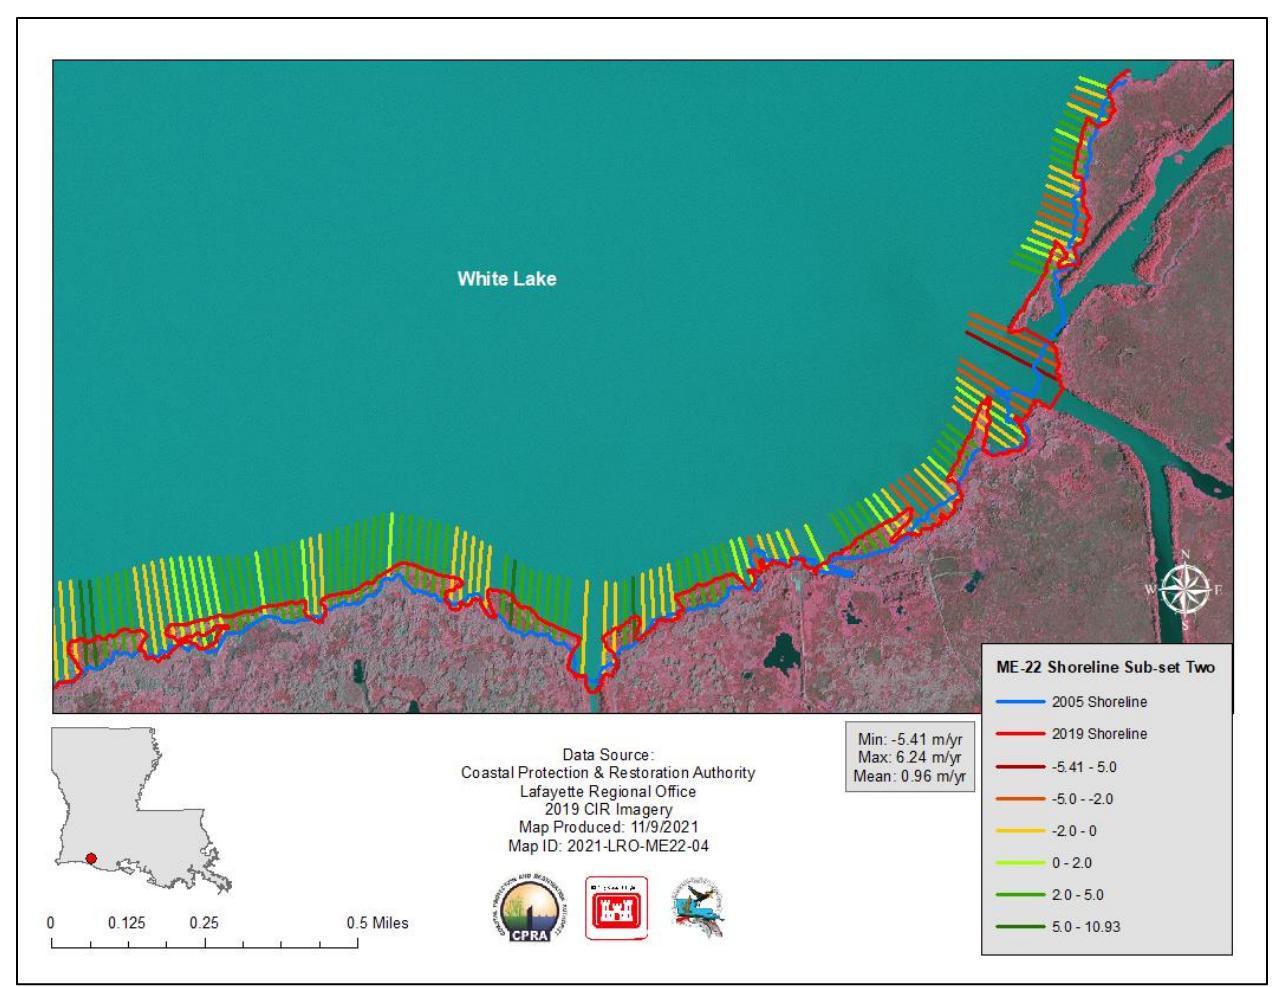
Figure 7. Shoreline change rates of Sub-set 2 between 2005 (pre-construction) and 2019.

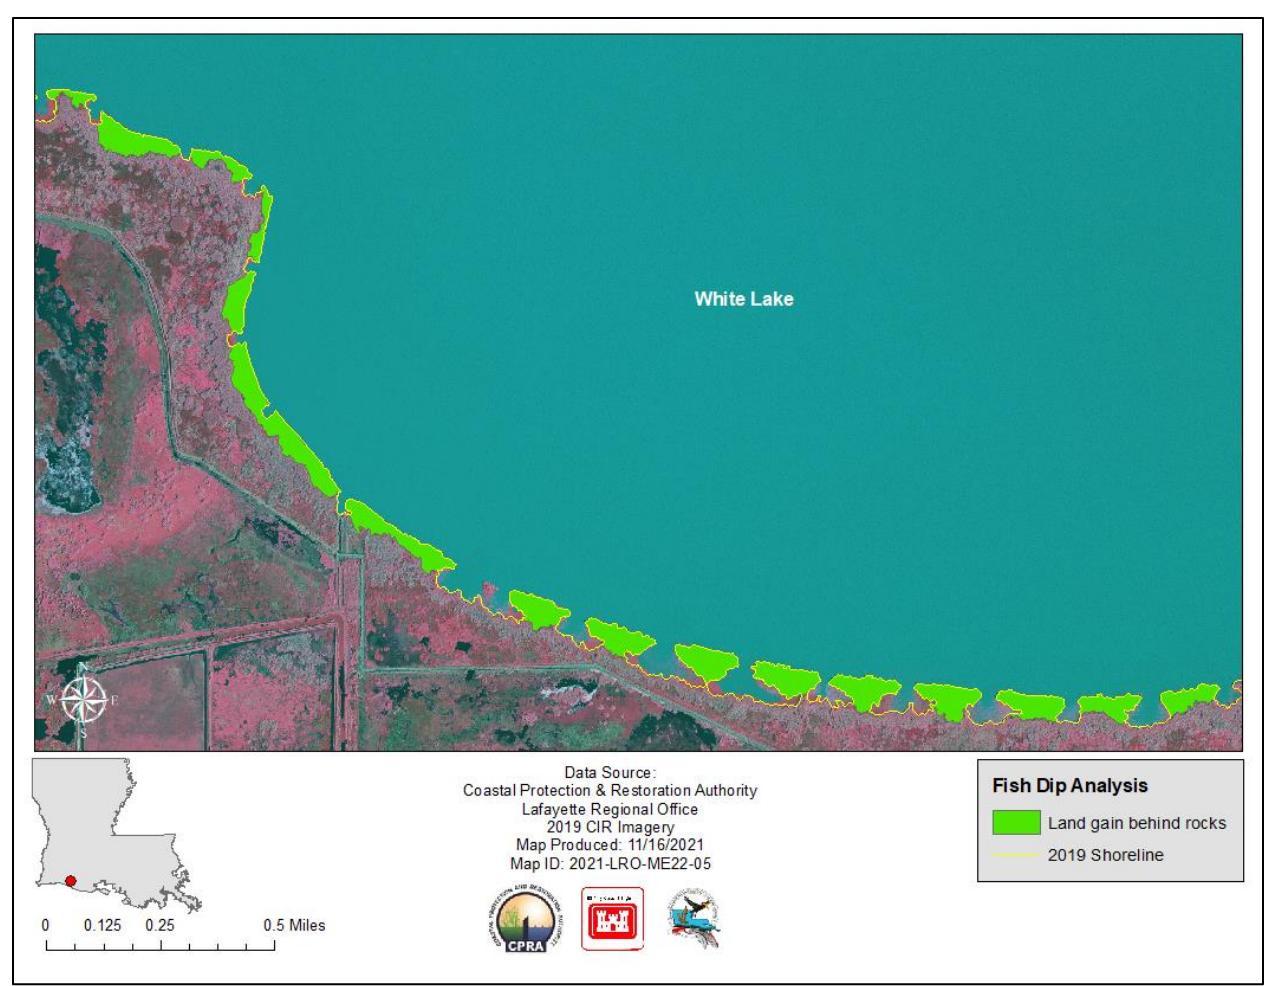
In addition to shoreline change analysis, the effect of fish dips in the rock dike was evaluated. Acres of marsh created behind sections of rock dike were calculated. Land gain behind 16 sections of rock dike averaged 4.22 acres. Multiplying this average by 57, the number of gaps in the rock dike, in total, if there were no gaps, an additional 240.5 acres of land could have accumulated behind the rock dike (Figure 8).

Figure 8. Portion of fish dips used to analyze potential land gain behind the rock dike.

Upon analysis of the effect of fish dips incorporated into the rock dike, it is recommended to remove the fish dips and install a continuous length of foreshore rock dike, or at the very least, reduce the number of fish dips and install in more specific areas. This would allow more emergent marsh to accumulate between the existing marsh and the rock dike.
