**State of Louisiana
Coastal Protection and Restoration
Authority**

2018 Operations, Maintenance, and Monitoring Report

Delta Wide Crevasses (MR-09)

State Project Number MR-09
Priority Project List 6

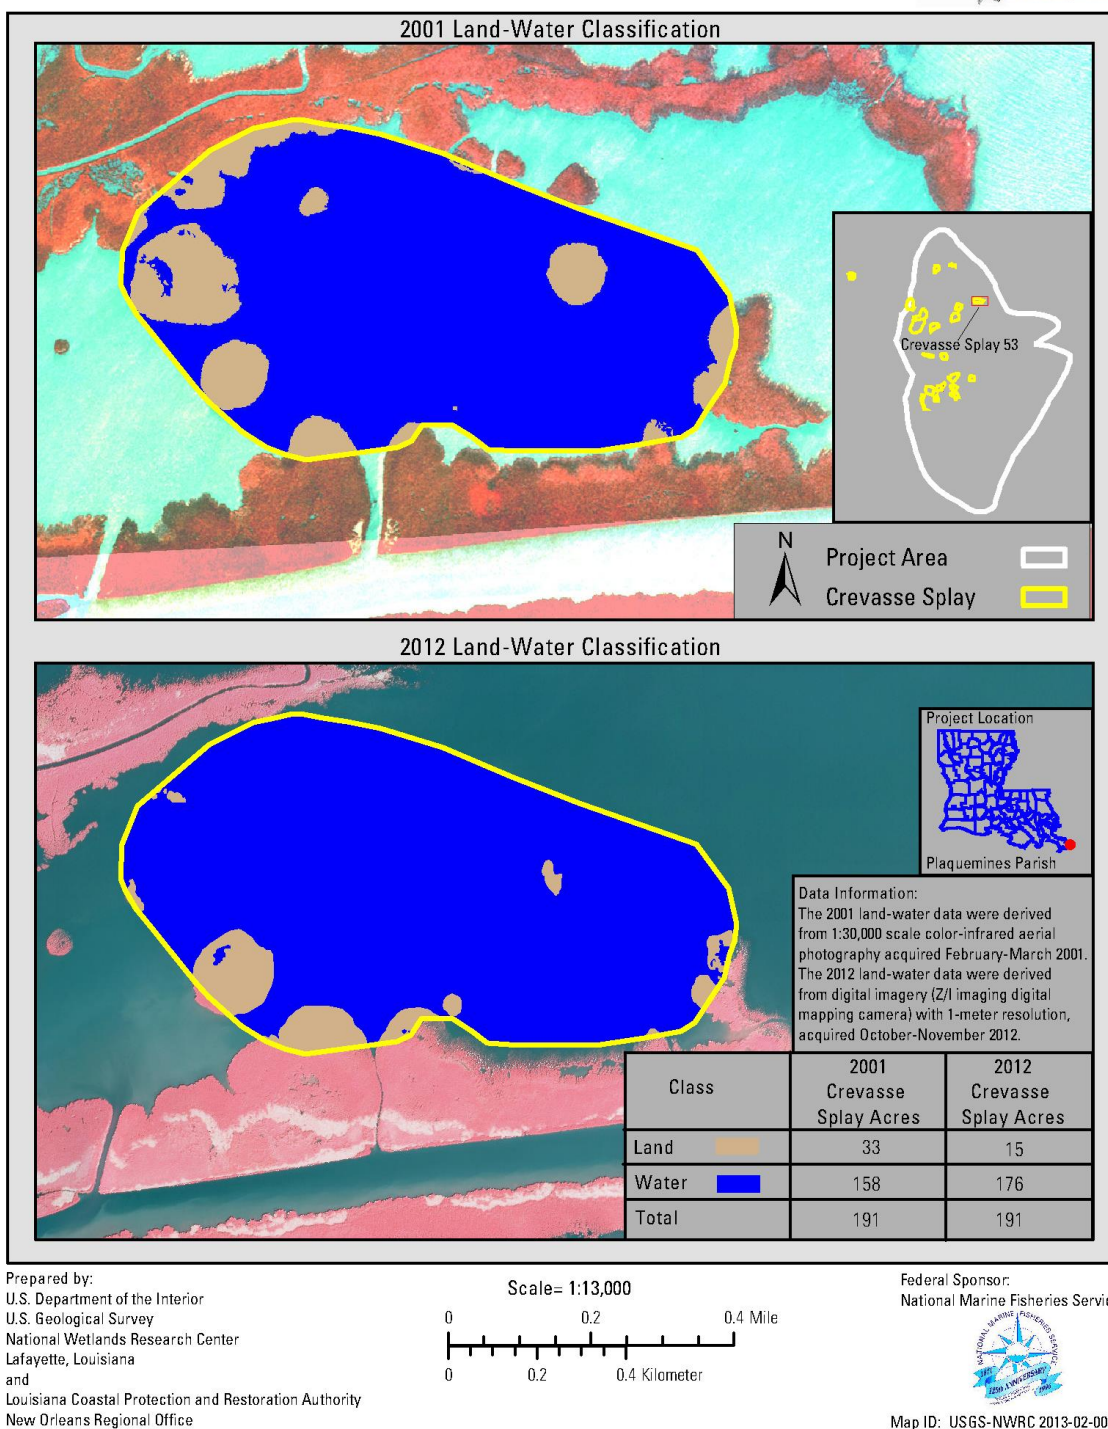
Color infrared aerial photography obtained in 2000, 2002, 2007, 2012, and 2016 has been analyzed by the USGS to determine the acreages of land and water within each crevasse receiving area. There were a total of 23 crevasses analyzed including the 6 used for vegetation data. Table 1 shows a summary of land gain/loss in acres including the relative change and rate (per year). The total land gain recorded for the MR-09 project area since construction is 739 ac. with an average land gain of 32 ac. per crevasse. The largest land gain for a single crevasse occurred at Crevasse 31 (Figures 4 and 5) with a land gain of 164 ac. (+244.8%). The largest relative gain occurred at Crevasse 81 (Figures 6 and 7) with an increase of 330% (33 ac). One crevasse experienced net land loss. Crevasse 53 (Figures 8 and 9) lost 21 ac of land between 2001 and 2016.

Figure 8. Land-water analysis for Crevasse 53 in 2001 and 2012.

For the 2012 – 2016 time period, 20 crevasses gained land acreage, 2 crevasses (Crevasses 53 and NC-1) lost land acreage, and one (Crevasse 24) was excluded from analysis. It was noted in the 2013 OM&M report (Gossman and Breau, 2013) that 5 crevasses (Crevasses 6, 7, 8, 9, and 38) had lost land acreage between the 2007 and 2012 analyses. However, during the period from 2012 to 2016, all 5 of those crevasses experienced land gains, offsetting or reversing the earlier losses. Crevasse 6 was maintenance dredged during Phase III, and that may account for the 16-ac. land gain seen there. A closer analysis of the aerial photography for the other crevasses show that most of these crevasses have either narrowed significantly or closed completely. Although these crevasses are no longer delivering much sediment or fresh water to the receiving bays, conditions still exist there that allow for land creation through vegetative expansion of the existing marsh.

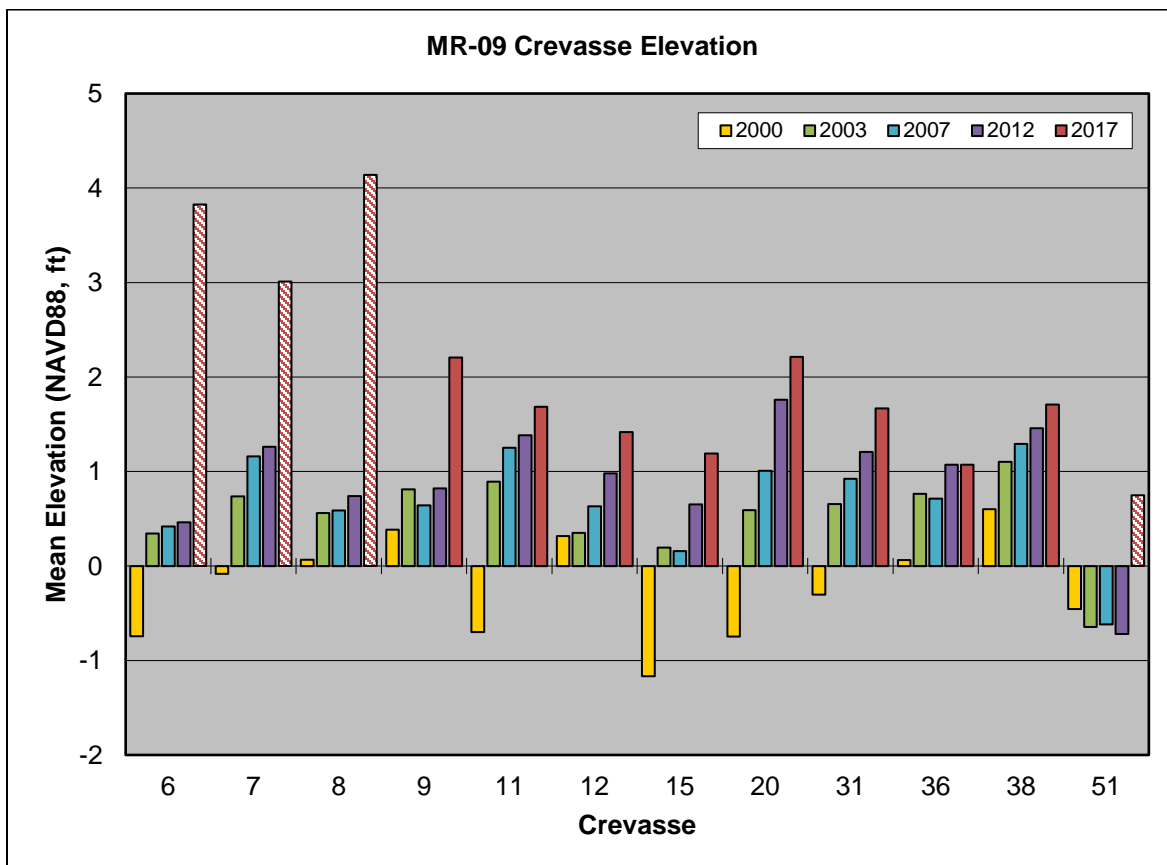
Analysis of the elevation data in the receiving areas shows a trend in elevation gain across all crevasses except Crevasse 51 (Table 2, Figures 14 and 15) since construction of the project. When analyzed across all 12 crevasses, there has been a mean gain in elevation of 1.64 ft in the project area from construction to 2012 (Table 2). Mean elevation gain from 2000 to 2003 was 0.76 ft., while mean elevation gains from 2003-2008, 2008-2012, and 2012-2017 were 0.15 ft., 0.23 ft., and 0.49 ft. respectively. The highest rate of elevation gain was observed in the first measurement period following construction. This may be explained by the fact that, at that time, the crevasses were at or near their constructed depth and moving higher volumes of water and sediment into the receiving bays. Rates of elevation gain then begin to slow as crevasse channels become narrower and shallower due to siltation. Elevation gain was impacted by crevasse angle of orientation and width. Mean elevation gain from 2000 to 2017 for crevasses oriented 60° from the parent channel was 1.72 ft, while crevasses oriented at 90° gained 1.22 ft. Similarly, wide crevasses (>150 ft. across) outgained narrow crevasses (<100 ft. across) 1.67 ft. to 1.27 ft. for the same time period. The greatest elevation gains were observed in wide, 60° crevasses (1.79 ft), while the least gains were observed in the narrow, 90° crevasses (0.89 ft).

Figure 14. Mean elevation (NAVD 88, ft) in the receiving bays of twelve MR-09 Phase I crevasses in 2000 (as-built), 2003, 2008, 2012, and 2017 (post construction). Hatched bars indicate disturbance within the receiving bay.

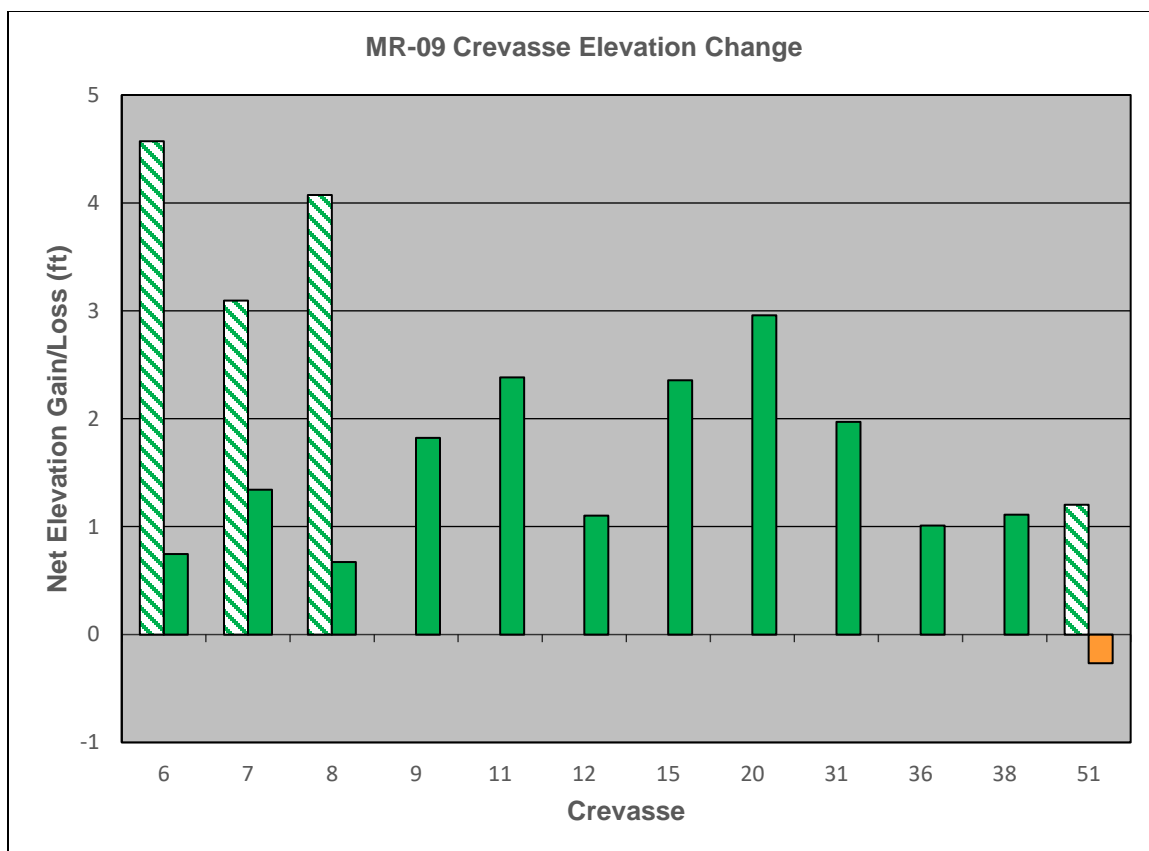
Figure 15. Elevation gain/loss between 2000 and 2017 for each of twelve MR-09 Phase I crevasses. Green bars represent an overall increase in mean elevation while orange bars represent an overall decrease in mean elevation. Hatched bars represent actual elevation change; solid bars represent change that can be attributed to MR-09.

The elevation loss in the Crevasse 51 receiving area prior to 2017 may be due to sedimentation of the crevasse channel. The elevation survey of the crevasse channel and the land-water analysis of the aerial photography suggest that the channel is filling in with sediment. Sedimentation in the crevasse channel prevents water and sediments from passing through the crevasse into the receiving area.
